# National Transportation Safety Board Aviation Accident Final Report

Location:	Kake, Alaska	Accident Number:	ANC19FA012
Date & Time:	January 29, 2019, 18:11 Local	Registration:	N13LY
Aircraft:	Beech 200	Aircraft Damage:	Destroyed
Defining Event:	Loss of control in flight	Injuries:	3 Fatal
Flight Conducted Under:	Part 91: General aviation

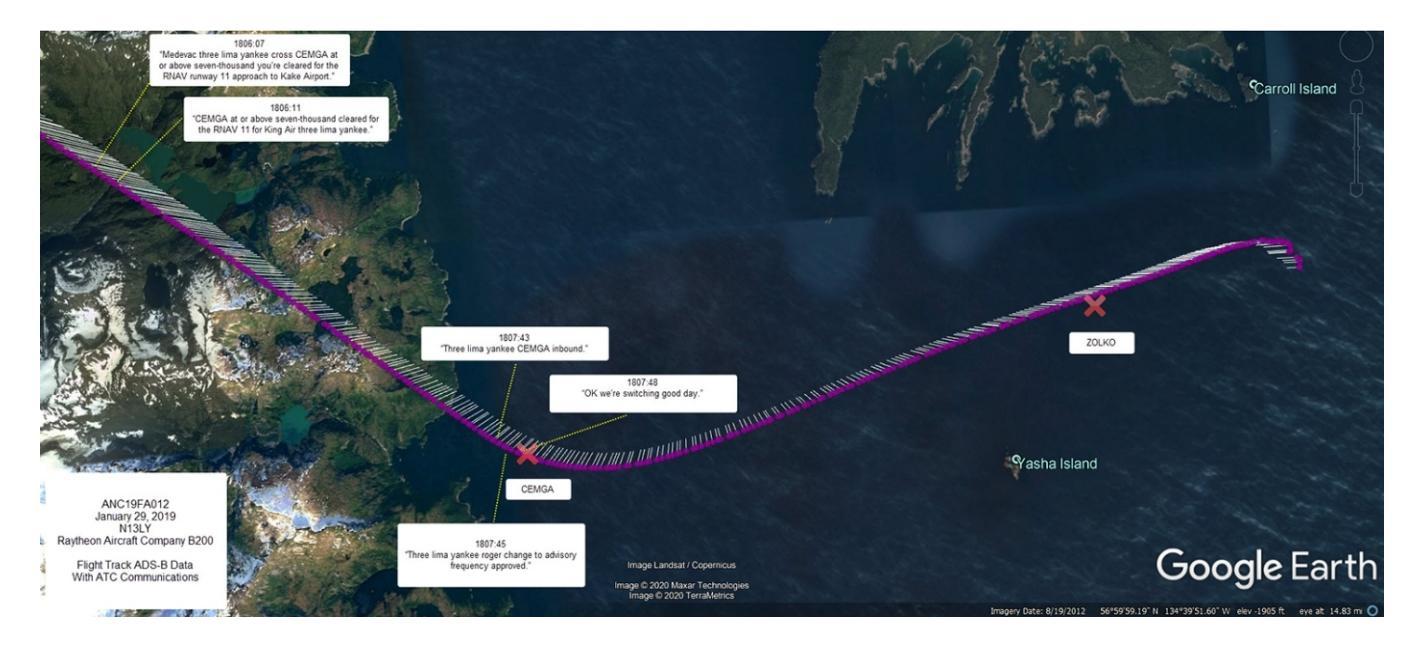
A review of archived FAA radar and ADS-B data revealed that the accident airplane crossed the CEMGA waypoint on the RNAV runway 11 approach at an altitude of about 7,000 ft above mean sea level (msl), then turned northeast and crossed the ZOLKO initial approach fix about 5,000 ft msl. The airplane then initiated a gradual descent and continued northeast toward the JOJOE intermediate fix. About 1810, while the flight was between ZOLKO and JOJOE, the airplane entered a right turn toward a southerly heading and began a rapid descent, losing about 2,575 ft of altitude in 14 seconds. The last radar data point was at 1810:36 when the airplane was at 1,300 ft msl and heading 143° with a ground speed of 174 knots. (See figure 1 and figure 2.)

Figure 1 - ADS-B track of the accident airplane with air traffic communications for the approach clearance.

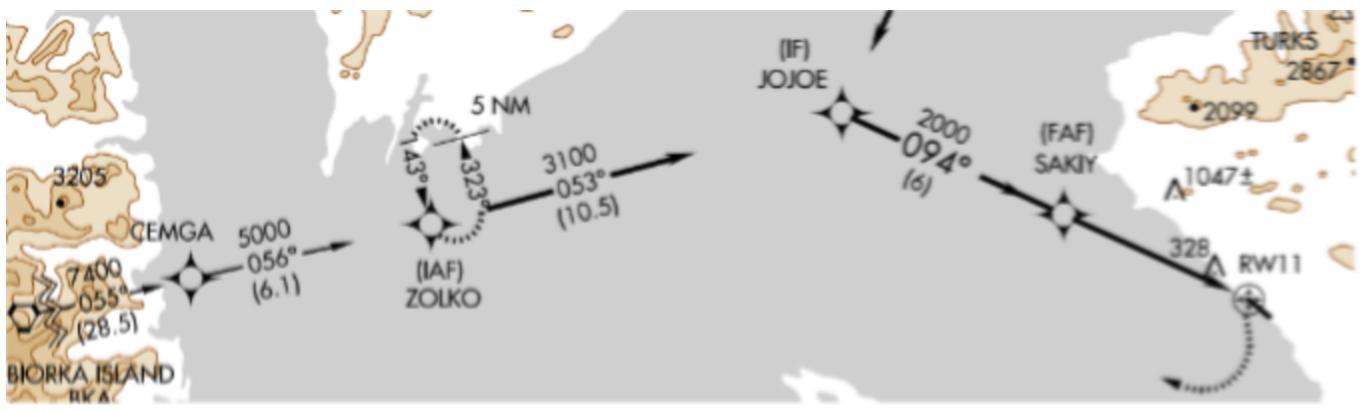
Figure 2 - Excerpt RNAV (GPS) RWY 11 Approach PAFE.

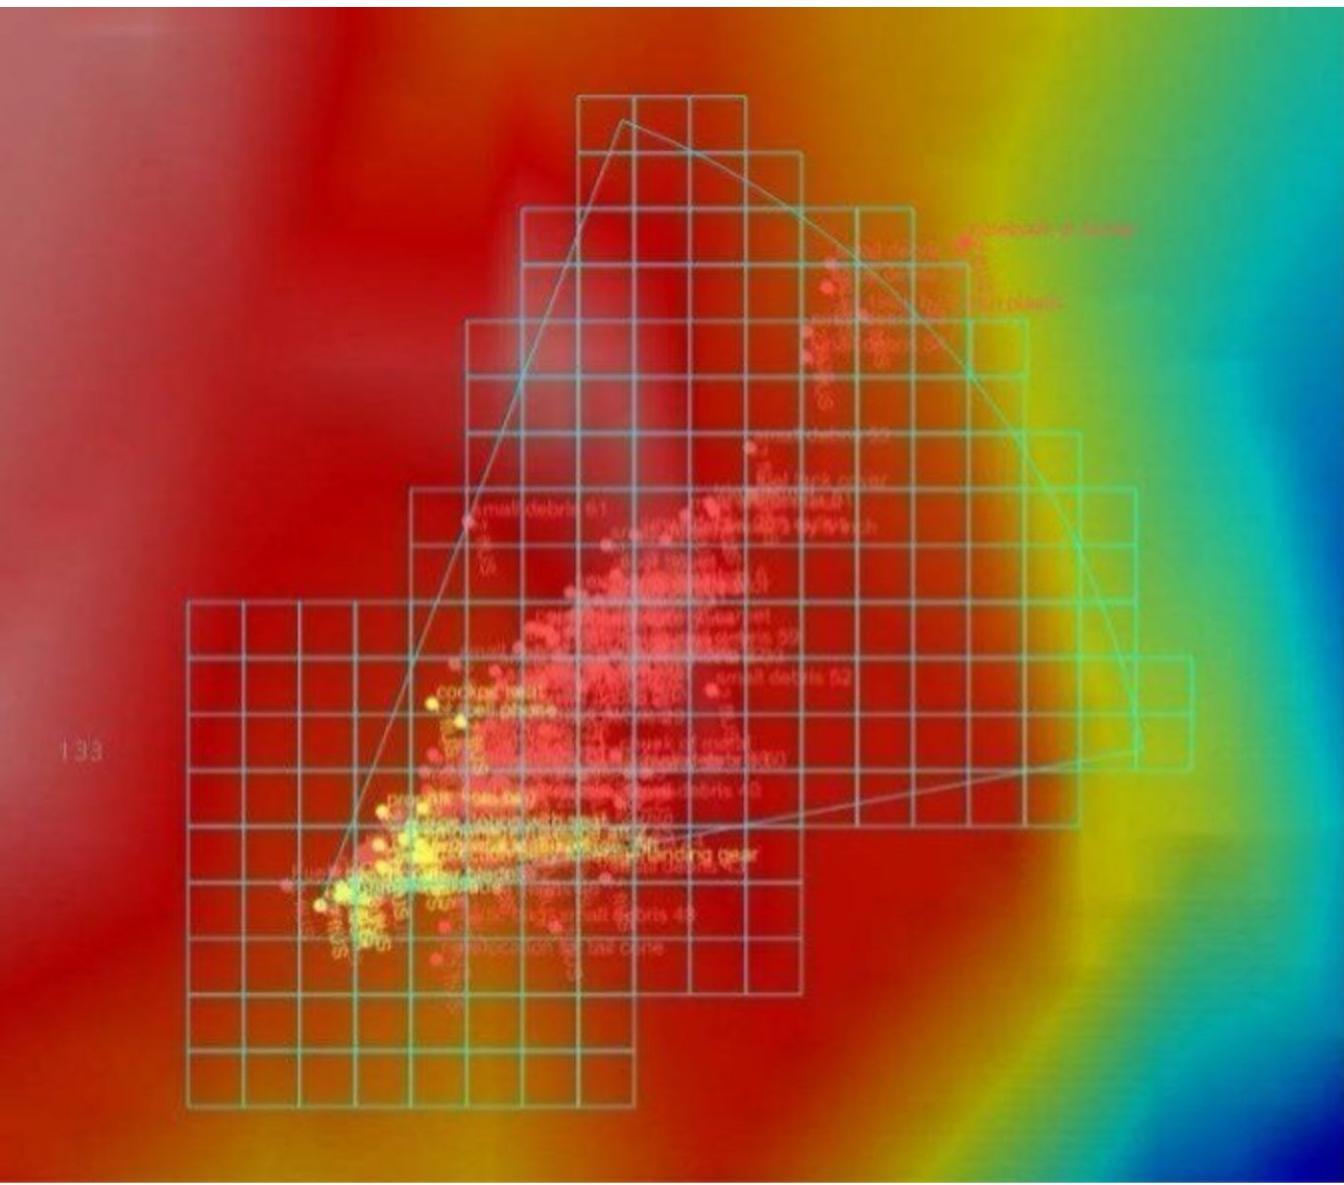
The airplane impacted the ocean waters of Frederick Sound and was located with the assistance of a remote operated vehicle (ROV) on March 19, 2019, at a depth of about 500 ft. A cone shape debris field spanned about 1,650 ft on a bearing of 45°, with the lighter debris farther northeast due to the ocean current. (see figure 3.)

Figure 3 - Debris field figure produced by TerraSond courtesy of Alaska Claims Services, Inc.
