Bundesstelle für Flugunfalluntersuchung

Investigation Report

Type of Occurrence:	Accident
Date:	24 April 2019
Location:	Siegerland Airport
Aircraft:	Airplane
Manufacturer:	Cessna Aircraft Company
Туре:	551 Citation II/SP
Injuries to Persons:	No injuries
Damage:	Aircraft substantially damaged
Other Damage:	Asphalt of the runway damaged

BFU19-0411-3X

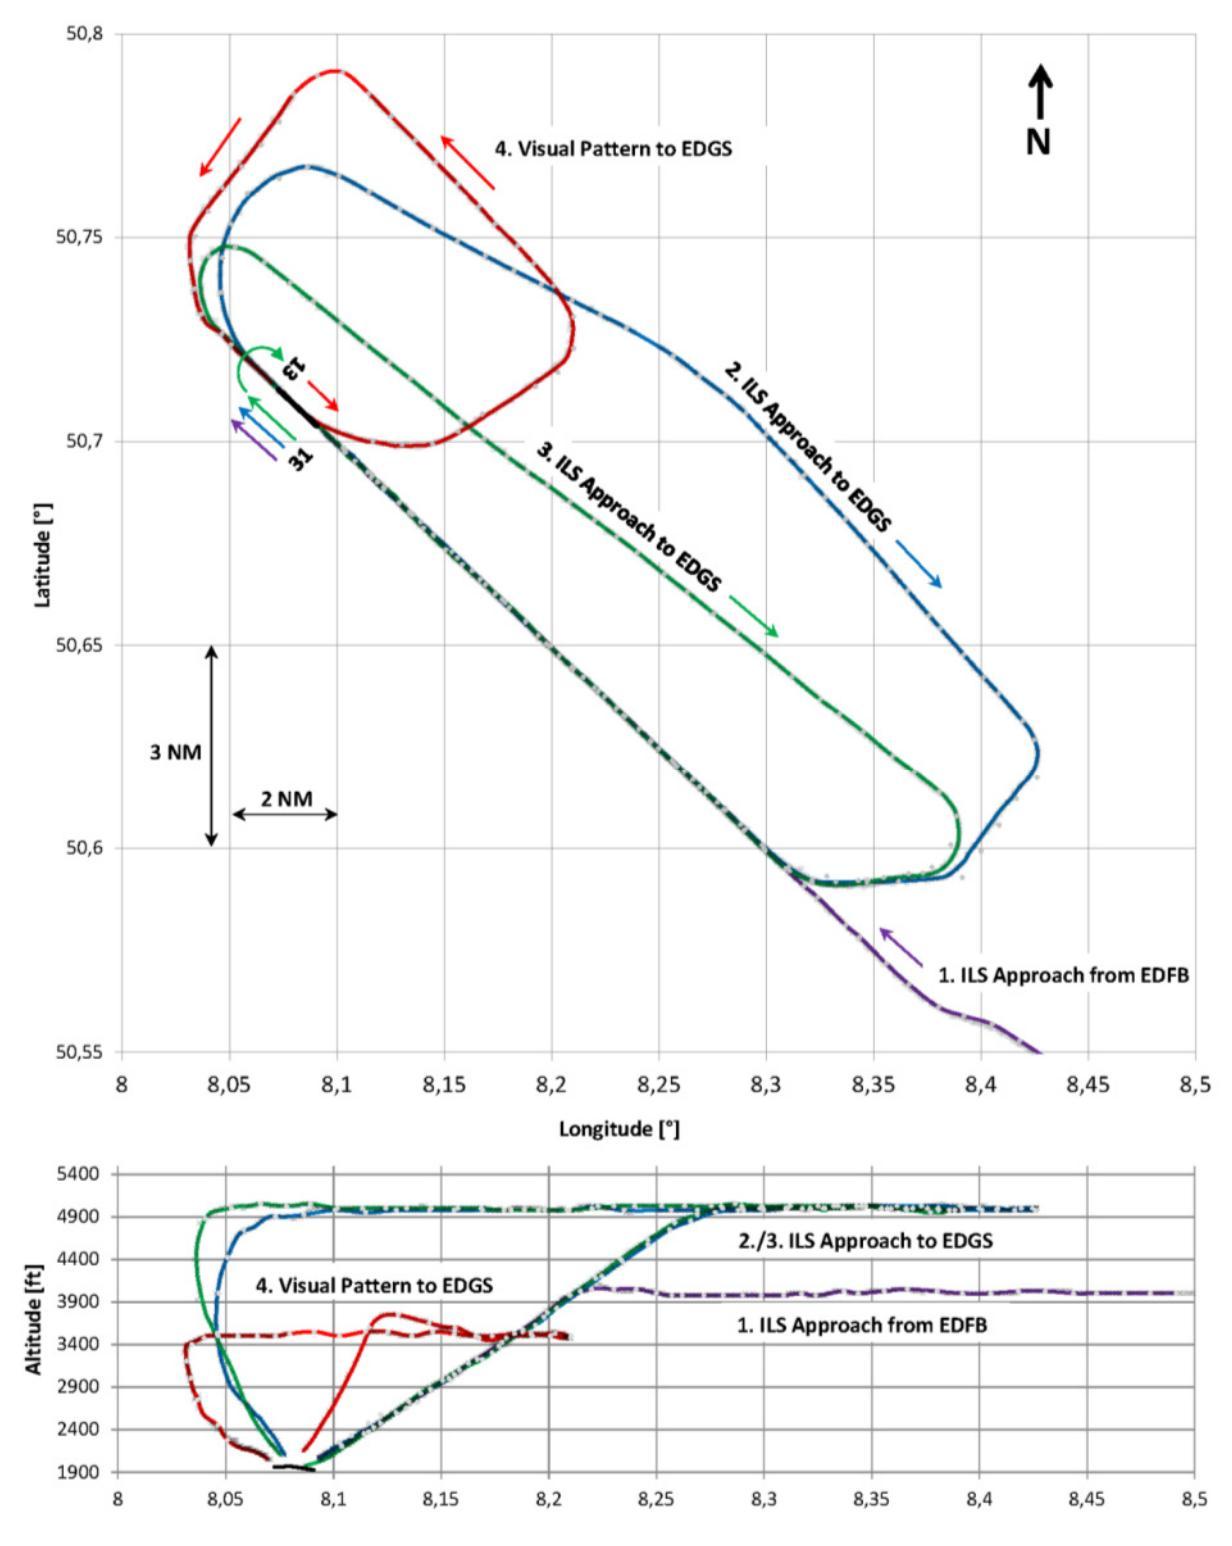
Fig. 4: Flight and altitude profile of the Cessna 551 Citation II/SP at Siegerland Airport

The data of the first approach (on approach from Reichelsheim), the two other approaches to runway 31 and the occurrence flight to runway 13 at Siegerland were analysed. Figure 4 shows all four approaches.

According to the flight crew's statement, the first 3 flights were conducted using the ILS of runway 31. From a distance of about 9 NM from Siegerland Airport, the subsequent traffic pattern ran right with a straight ILS approach segment. The mean airspeed during the three ILS approaches were analysed and compared with the wind condition at the airport (Tab. 1).

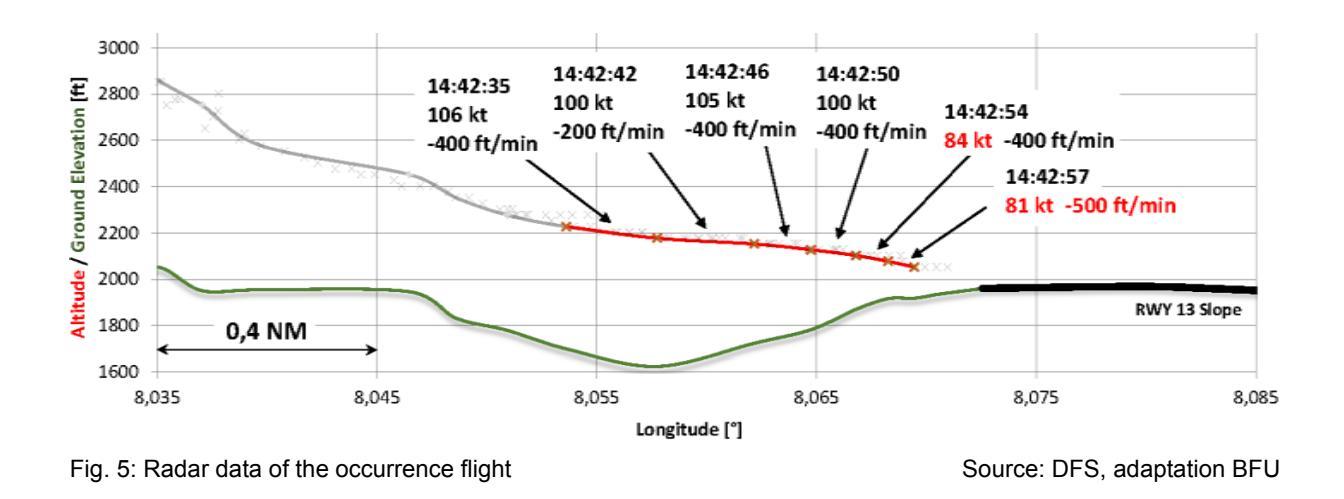
The fourth approach was conducted as visual approach under visual meteorological conditions to runway 13. At about 3,500 ft AMSL, the flight crew conducted a traffic pattern. During the segment between downwind leg and base leg, the aircraft descended in a left-hand turn from about 3,500 ft AMSL to about 2,800 ft AMSL. The radar recording showed a straight approach segment of about 1.5 NM (Fig. 5) from this altitude. In the last 20 seconds of this segment (highlighted red) airspeed decreased by about 20 kt and the sink rate increased by about 100 ft/min.

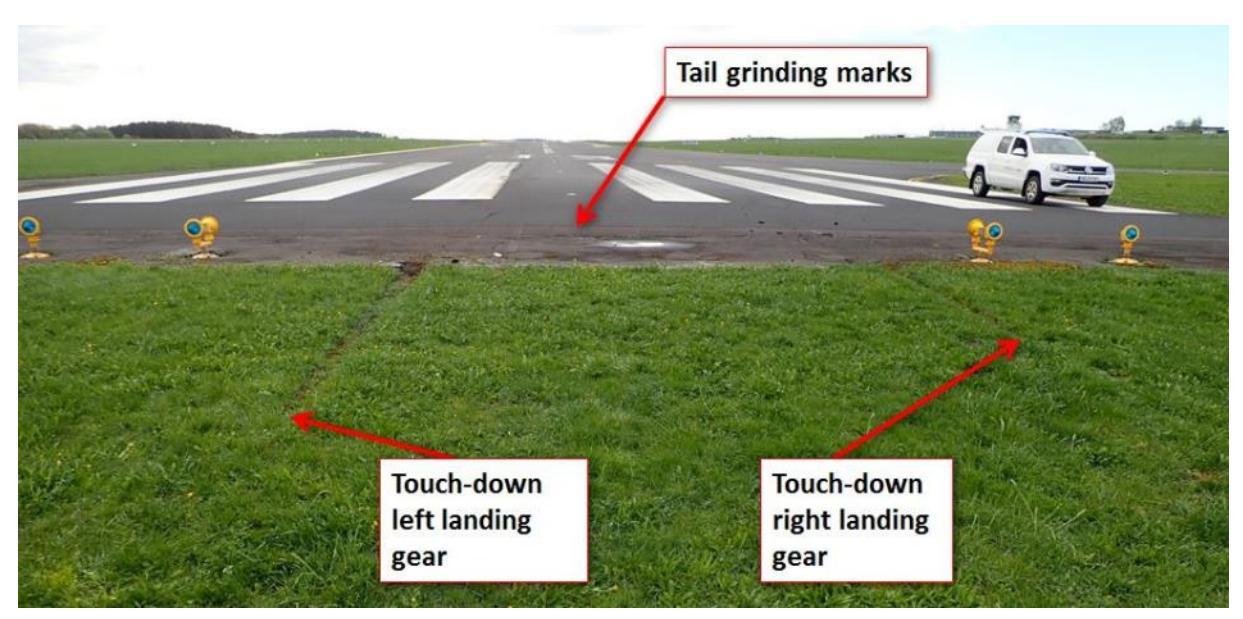
Fig. 6: Touchdown traces of the main landing gears ahead of runway 13

During the on-site investigation the BFU determined that the aircraft touched down in the grass first with the wheel of the left main landing gear approximately 5.20 m ahead of the asphalt strip of runway 13.

The right wheel of the main landing gear touched down about 3.40 m ahead of runway 13 in the grass (Fig. 6).

There was an edge of about 10 cm between the grass and the asphalt.

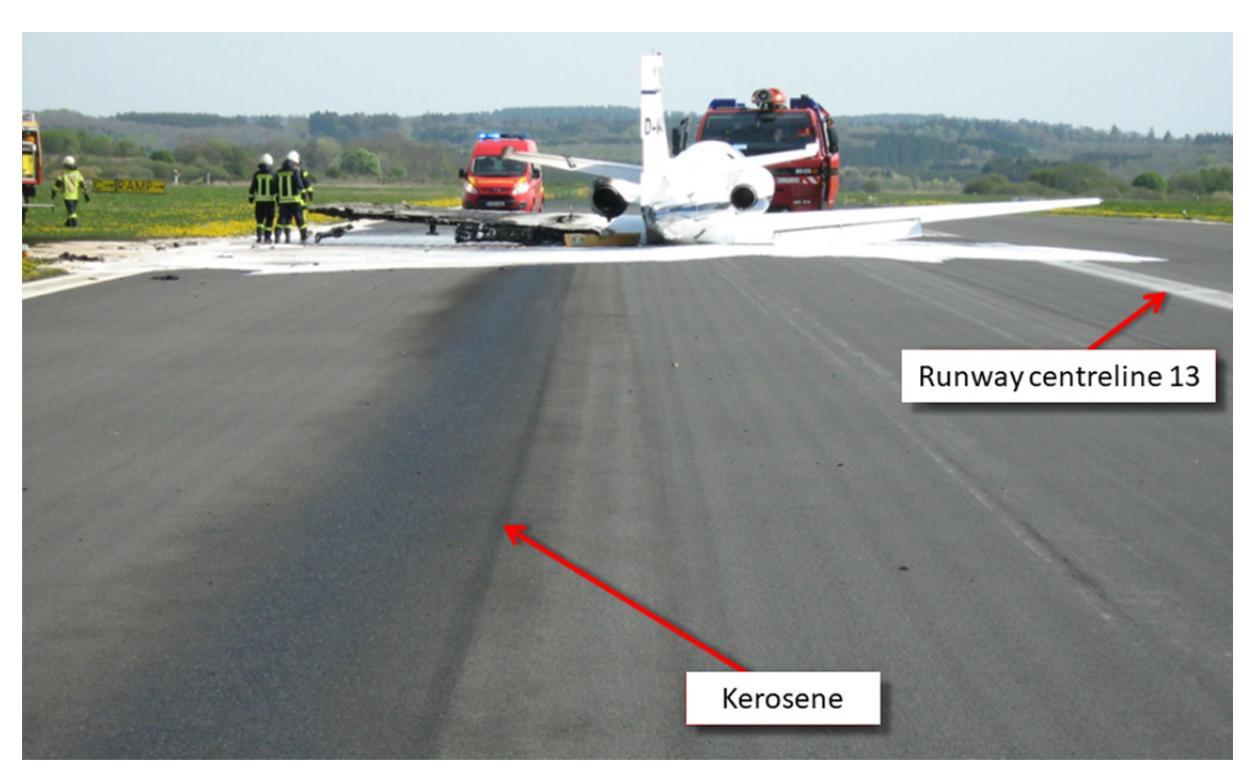
Fig. 8: Kerosene trail and final position of the aircraft

The traces on the asphalt of the runway and on the aircraft show that it skidded on the fuselage underside along the runway until it came to a stop approximately 730 m past the runway threshold (Fig. 8 and 9). Antennas, flaps, and panelling on the fuselage underside were damaged. A kerosene trail ran along the left runway side, from the threshold to the final position of the airplane. The aircraft's nose pointed toward 140°. It was lying about 5 m left of the runway centreline (Fig. 8).

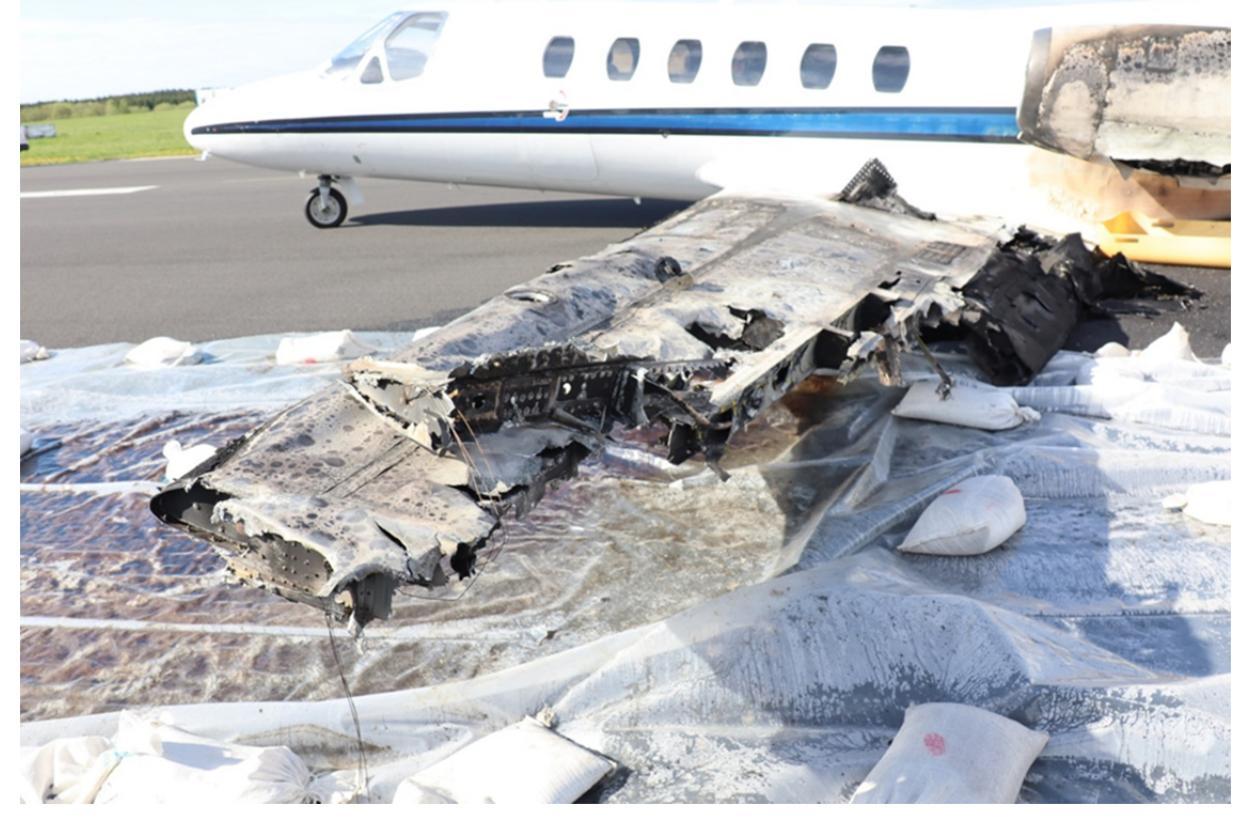
Fig. 9: Damage on the left wing and left engine

The left main landing gear mounting damaged the left wing tank. The right wing tank was not damaged. The fire destroyed the left wing (Fig. 9). Due to the damage, function test of the left aileron was not possible. The underside of the left engine cowling was substantially damaged. The inside of the engine did not show any traces of fire. The left and right engine shafts could be rotated without effort. The engine inlets and fan blades showed no damage.

Both main landing gears were substantially damaged. They were laying bend beneath their respective wings. The nose landing gear was compressed; there was no damper spring deflection anymore.
