Aviation Investigation Final Report

Location:	Olathe, Kansas	Accident Number:	CEN22FA119
Date & Time:	February 13, 2022, 10:20 Local	Registration:	N2445F
Aircraft:	PIPER AIRCRAFT INC PA46-500TP	Aircraft Damage:	Destroyed
Defining Event:	Loss of control in flight	Injuries:	1 Fatal
Flight Conducted Under:	Part 91: General aviation - Personal

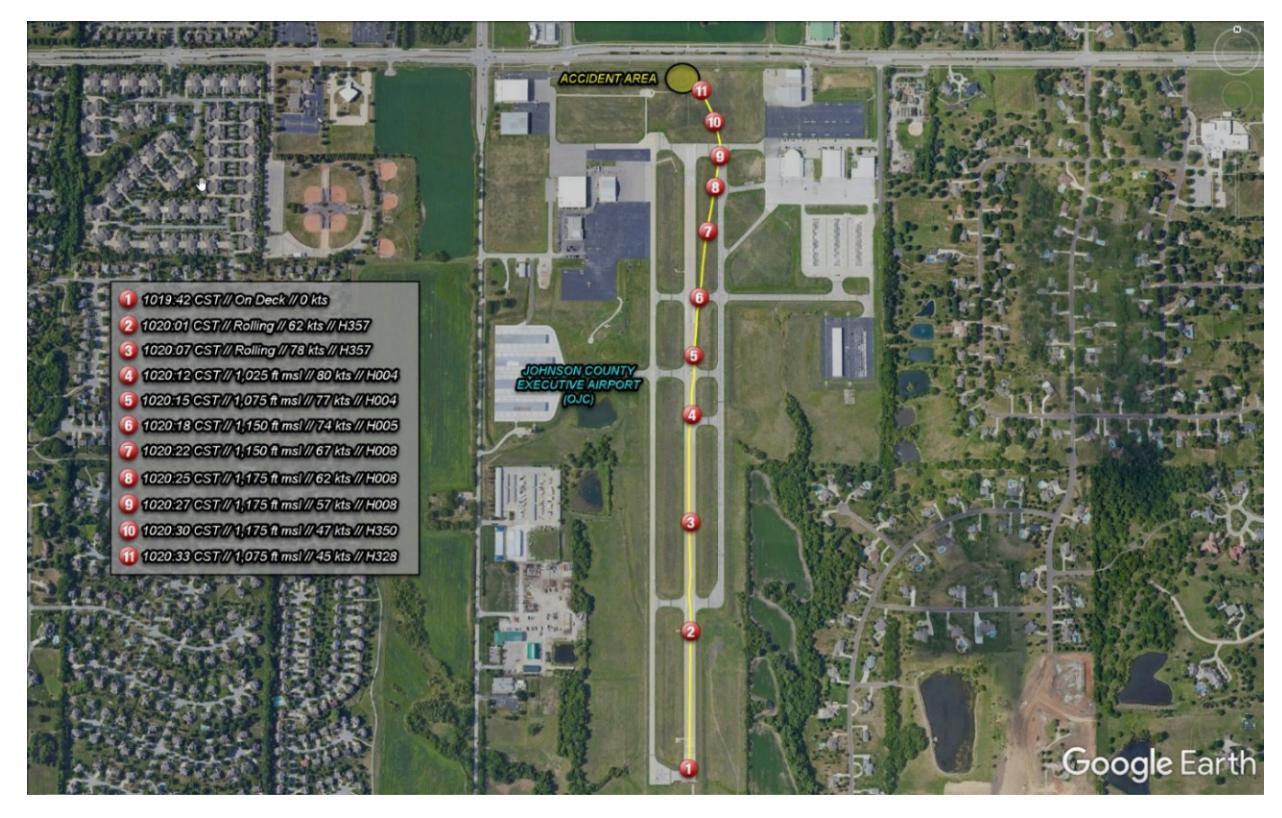
Flight track data for the accident flight showed that the airplane began the takeoff roll on runway 36 at OJC at 1019:42. The airplane accelerated and reached a peak ground speed of 81 kts about 2,075 ft down the 4,097 ft long runway. Once airborne, the airplane drifted slightly to the right and slowed before it turned back toward the left. The airplane's groundspeed continued to decrease throughout the remainder of the data. The final three data points showed the airplane's groundspeed as 49 kts, 47 kts, and 45 kts respectively. The final recorded position was about 100 ft southeast of the initial impact point.

Figure 1. Overview of accident flight track with time, altitude, ground speed, and heading information.

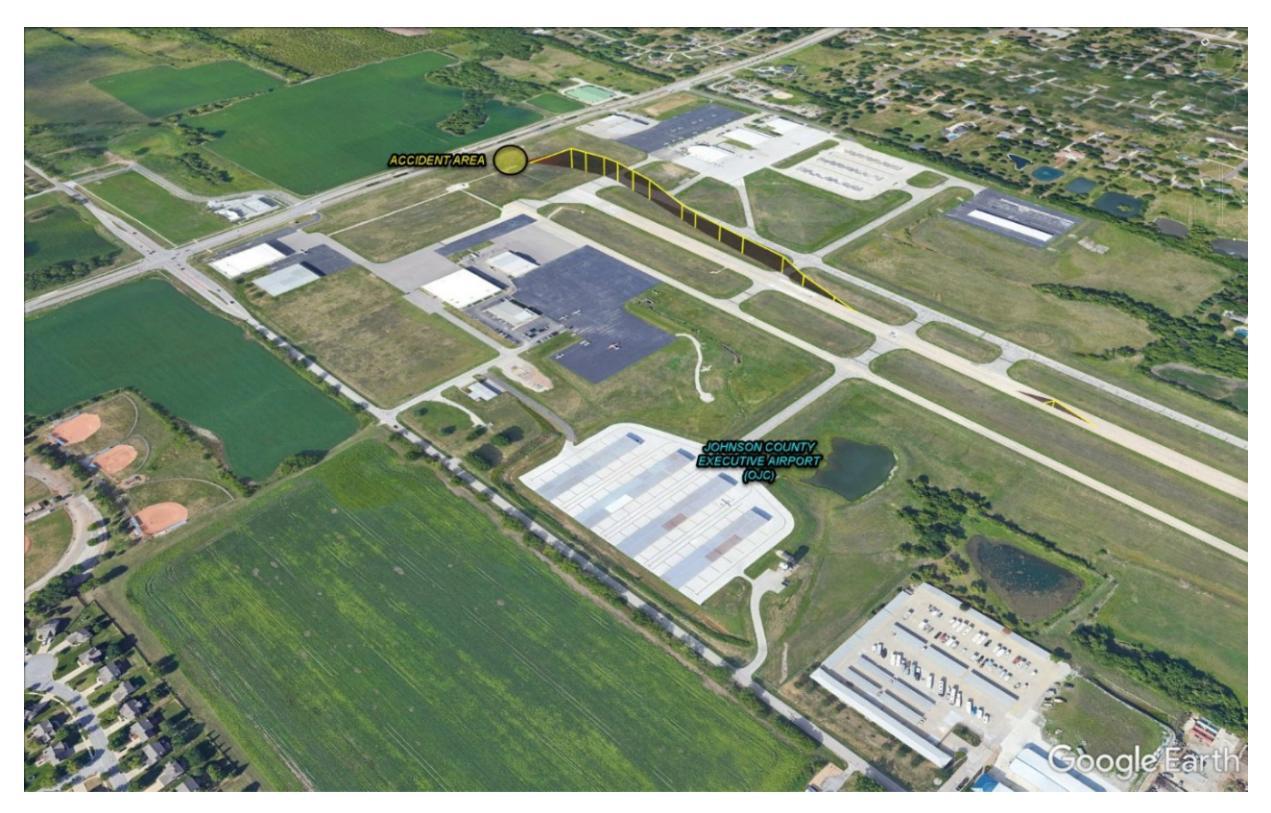
Figure 2. Final segment of accident flight track in profile view looking from southwest to northeast.

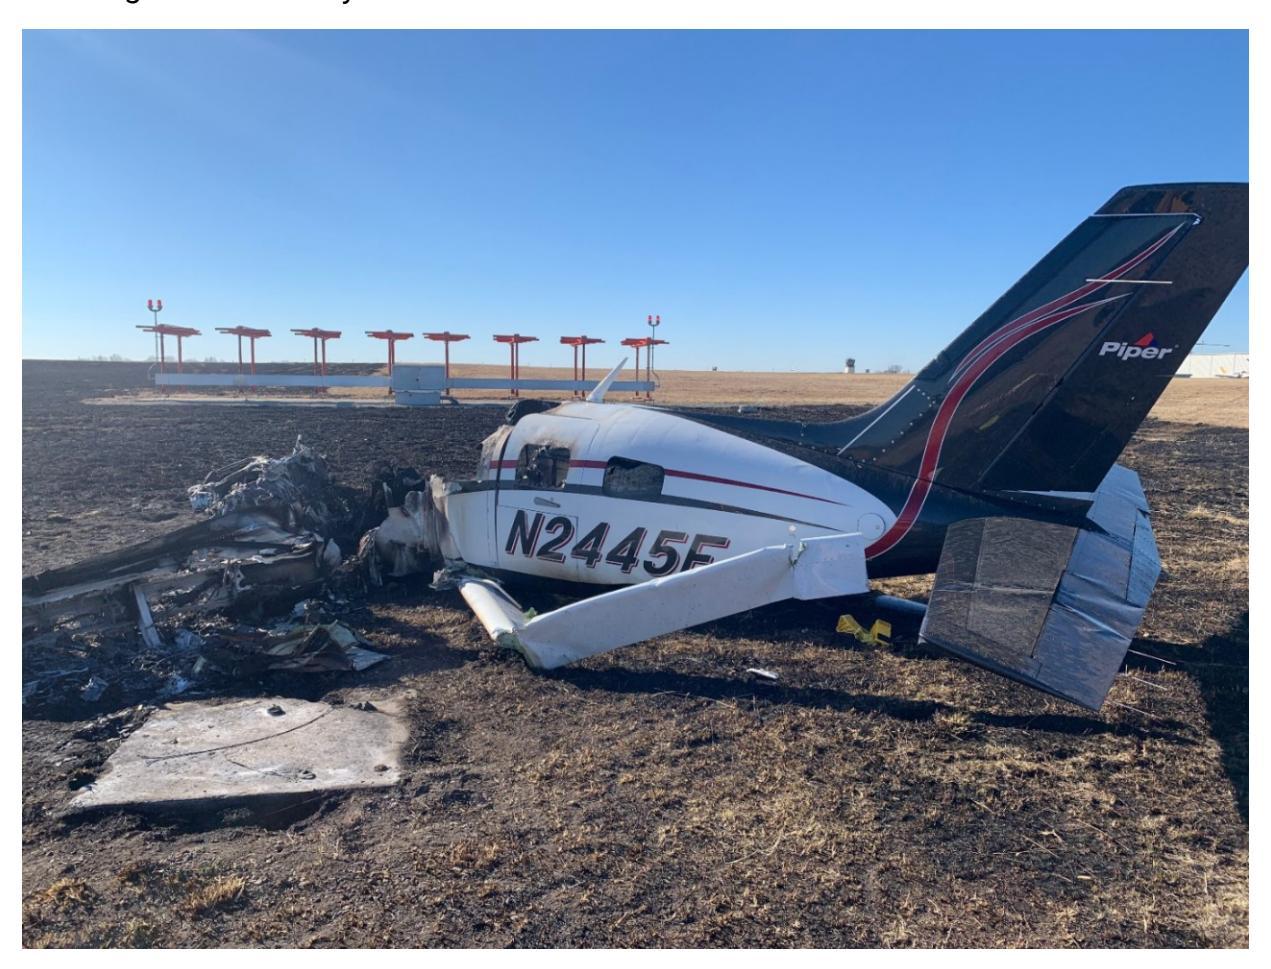
The airplane impacted the ground on the extended runway centerline about 400 ft past the departure end of runway 36. The airplane came to rest upright with its fuselage oriented in a southeasterly direction. A postimpact fire that burned the wings and forward fuselage aft to the rear spar carry-through structure. The fuselage aft of the cabin, including the empennage,

was intact. There was a fan shaped burn area on the ground that extended from the aircraft wreckage in a southerly direction.

Figure 3. The aircraft wreckage at the accident site looking south.
