Aircraft Accident Investigation Interim Report

Crash Into The Sea After An In-Flight Fire Asiana Airlines B747-400F/HL7604 130 km West Of Jeju International Airport July 28, 2011

September 17, 2012

Aircraft and Railway Accident Investigation Board

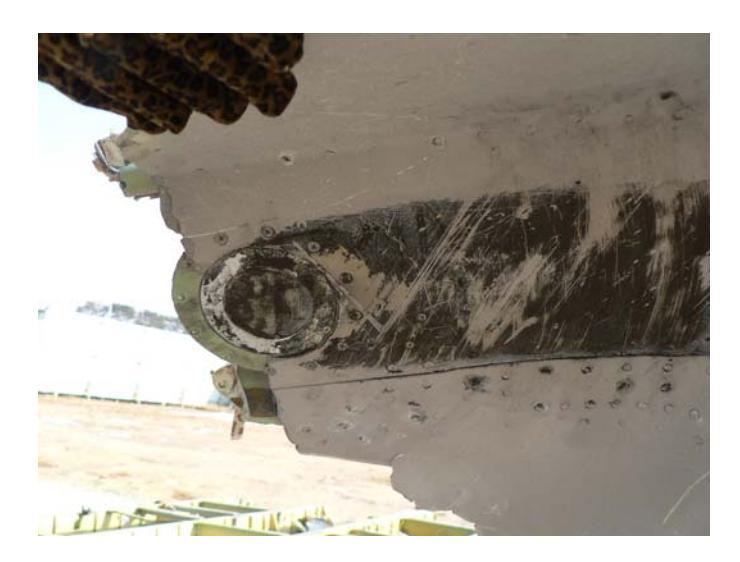
[Figure 19] Exterior Skin of the Cockpit Smoke Evacuation Shutter

As shown in [Figure 19], the cockpit smoke evacuation shutter was found closed, but a well defined soot trail was discovered on the exterior skin (tag # 1128). As a result of an examination, it was assumed that impact forces closed the shutter.

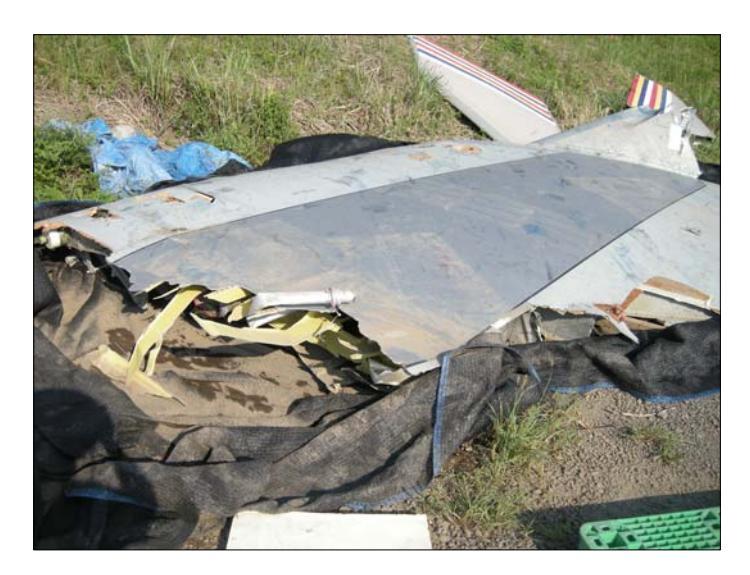
[Figure 20] Damage to the Right Wing

As shown in [Figure 20], the right wing tip was separated from the wing at wing station (hereinafter referred to as "WS") 1500. Blue dye splatters were found on the top surface of the wing, and multiple small electrical components with a diameter of 5 mm were imbedded in the composite wing upper surfaces.

The top and bottom surface of the wing contained multiple black waffle-like markings caused by collisions with electrical components containers as well as sporadic blue dye splatters.

The forward facing surface of the fuel jettison tube as well as the inside surface of a skin fragment in the right wing fracture at WS1516 also contained black waffle-life markings. No indications of hydro forming were found on the top and bottom surface of the wing.

The winglet was separated from the right wing. Blue dye was discovered inside the wingtip at the point where the winglet was fractured from the wing as well as on the upper surface of the right wing. No blue dyd was found on the recovered right or left winglet.

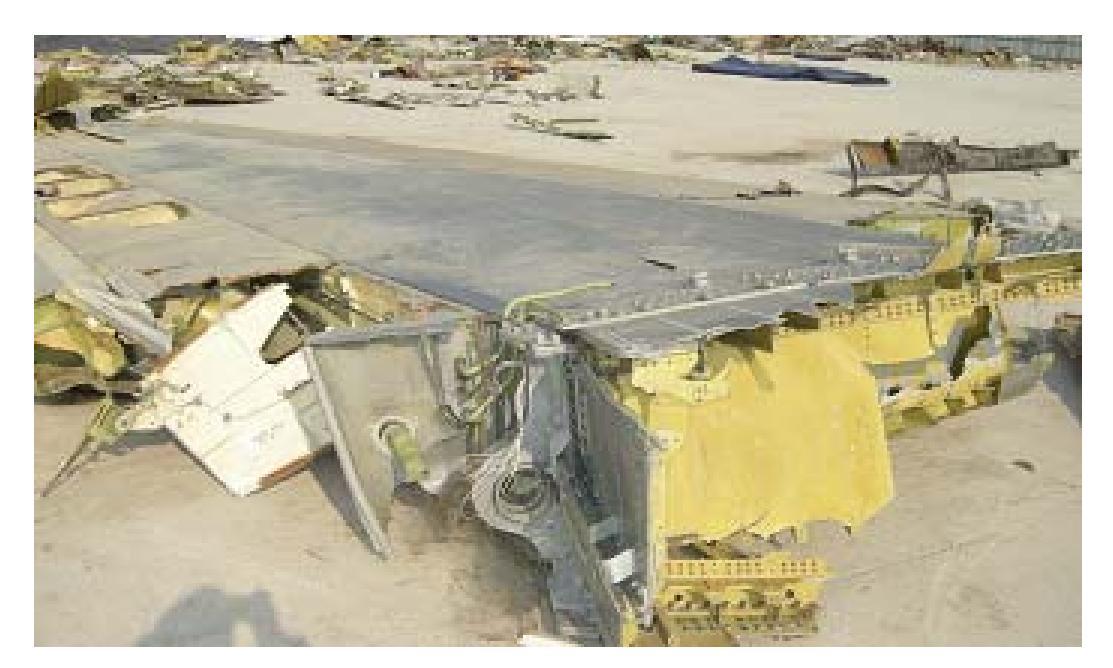
[Figure 21] Left Horizontal Stabilizer

As shown in [Figure 21], the left horizontal stabilizer was separated from the empennage. The remaining skin fragments along the upper and lower fracture areas were bent upwards.

The skin on the top side of the fracture zone contained areas of compressive buckling tearing.

The inboard elevator was separated from the stabilizer just aft of the hinge, and the trailing edge of the outboard elevator was damaged. The outboard tip (tag #1069) of the stabilizer was fractured at station 510 and was recovered separately from the stabilizer (tag #1056).

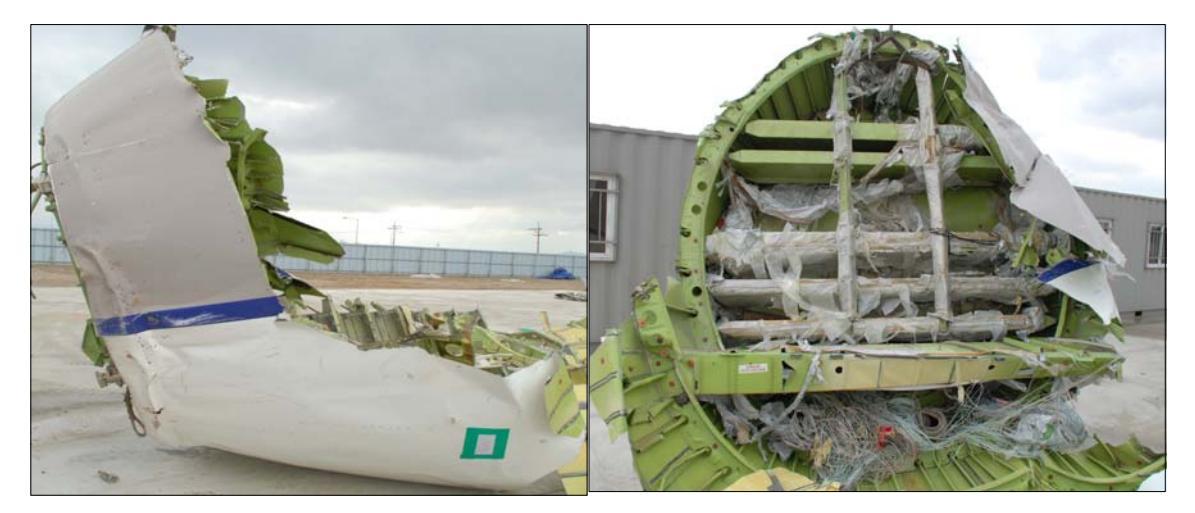
[Figure 22] Nose Cargo Door

As shown in [Figure 22], a forward section of the nose cargo door was separated from the fuselage at FS160/180, and the radome was missing.

The skin of the nose cargo door without the radome demonstrate compressive buckling 360 degrees along the leading edge. The forward pressure bulkhead was hydro formed. Upper potions of both sides of the door, including the hinges, were recovered with the cockpit section (tag #1151).

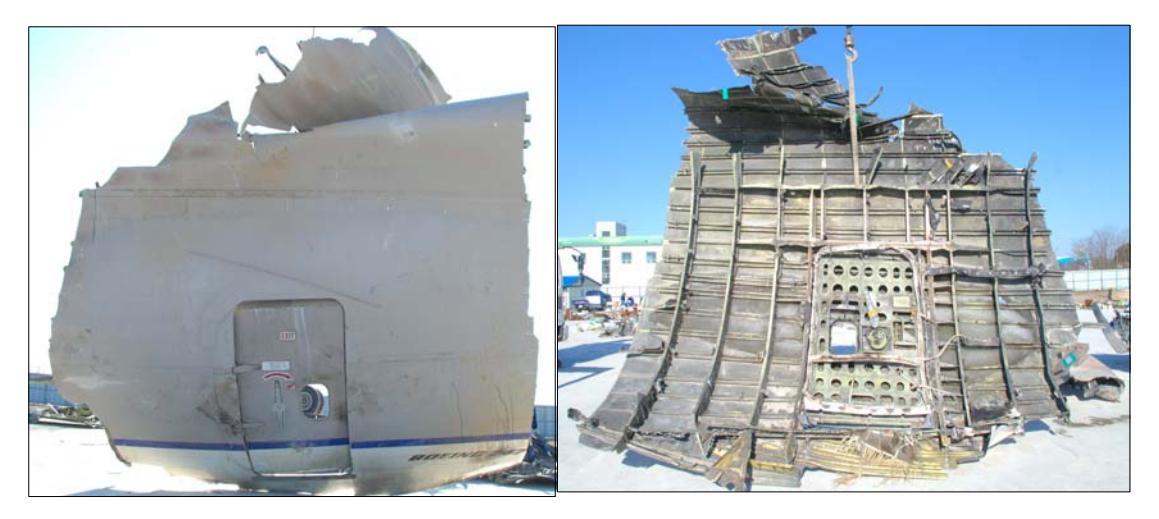
[Figure 23] Exterior and Interior Side of the L5 Door

As shown in [Figure 23], the flight data recorder rack mounted close to the L5 door was separated. The upper portion of the frame was thermally damaged, and the interior surface of the L5 door was heavily sooted.

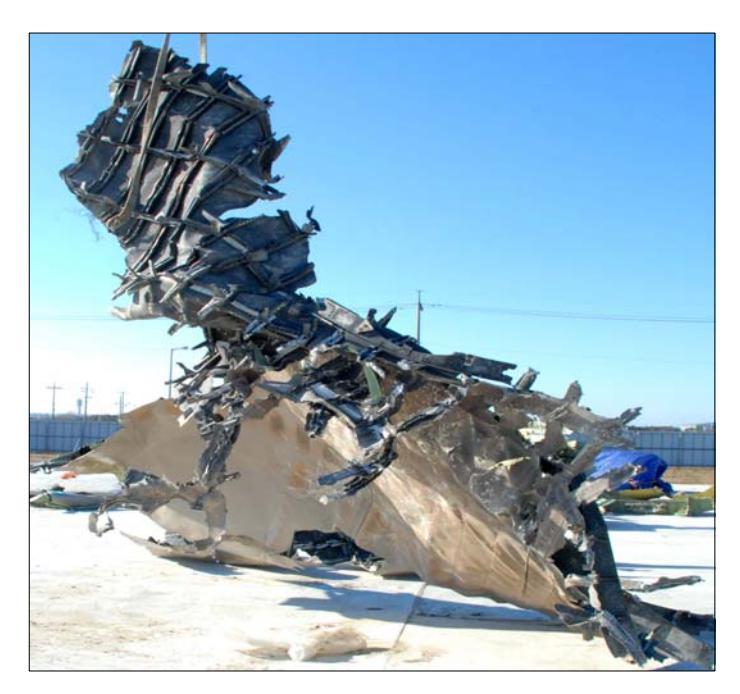
[Figure 24] Fire Damage to the Skin

the region between FS1740 and FS2360 contained thermal damage on the exterior skin as evidenced by discoloration of the exterior paint and internal metal structure. The recovered skin panel that extended from FS2180 to FS2360 (tag #511) was representative of this level of thermal damage and also contained areas where the skin had been burned through.

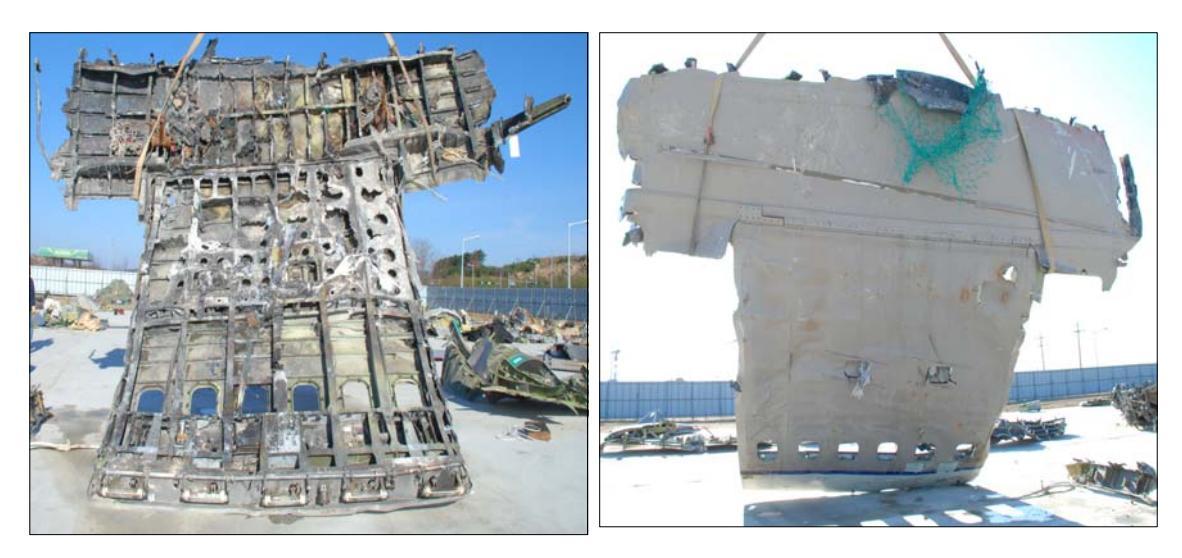
[Figure 25] Interior and Exterior Side of the Main Deck Cargo Door

As shown in [Figure 25], the inner insulation materials of the main deck cargo door aft of the left fuselage was burned, and some cargo items melt and charred stuck to the interior surface of the wreckage. The frame and cargo items were melt and stuck to the upper side of the door hinge.

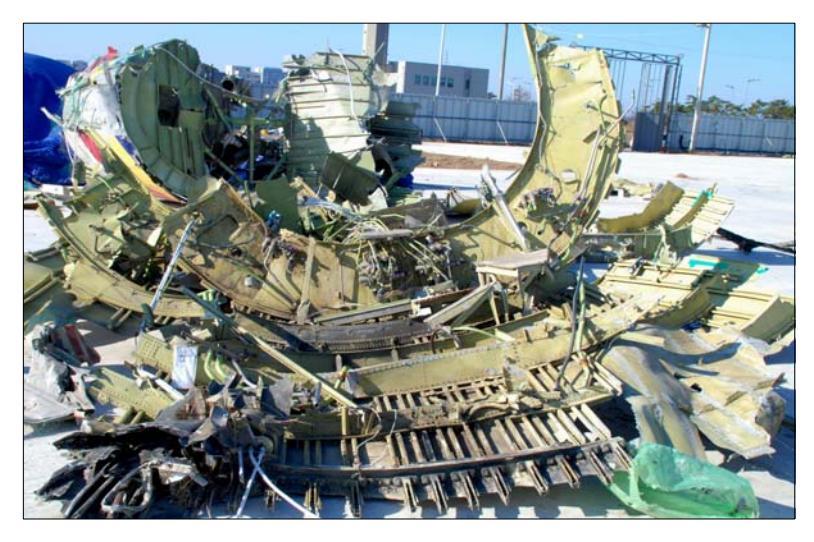
[Figure 26] Damage to the Section 48 of the Aft Fuselage

As shown in [Figure 26], the section 48 of the aft fuselage contained no internal sooting or fire damage but did have external soot accumulation on the underside of the left and right skin panels. Most of the damage appeared to have been caused by impact forces during the crash into the sea.

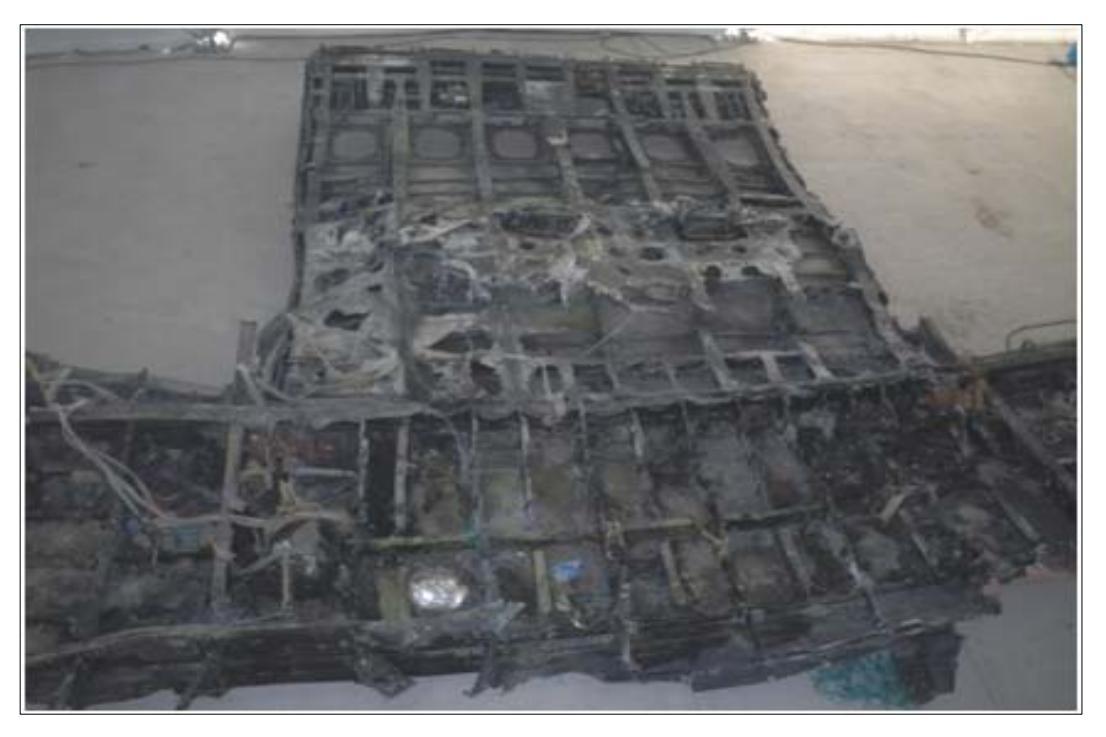
[Figure 27] Aft Main Deck Cargo Door

The aft main deck cargo door sustaining fire damage is shown in [Figure 27], and the thermal damage map for the wreckage with severe fire damage is shown in [Figure 28].

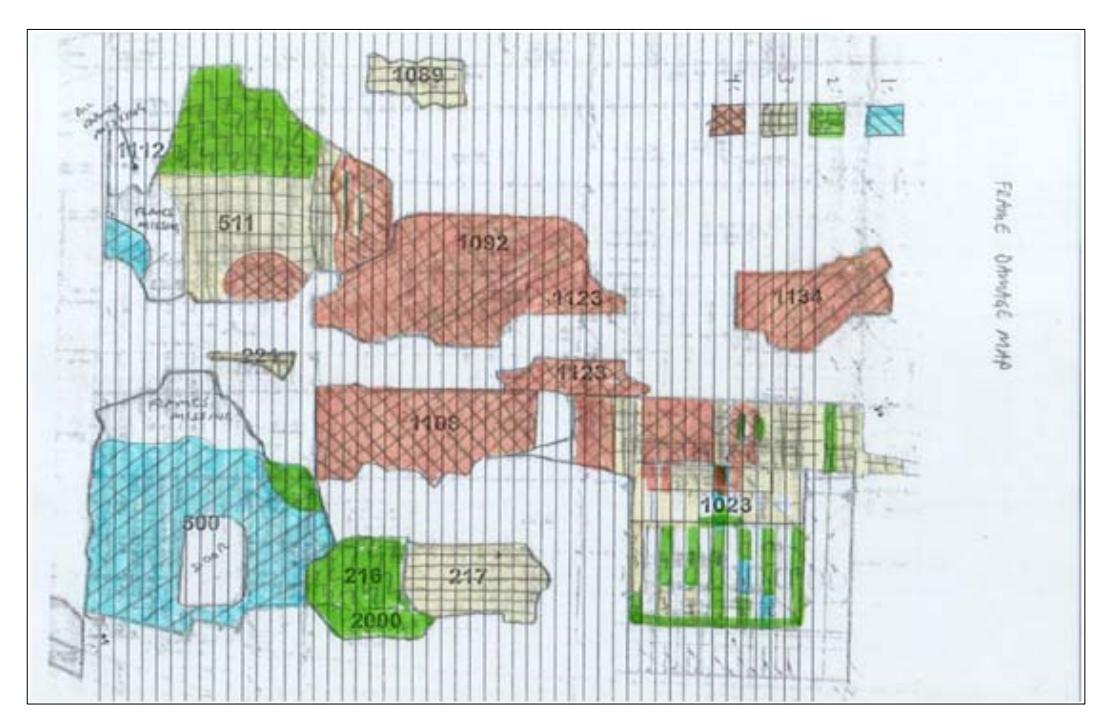
The wreckage from this area have the most fire damage of all the wreckage collected to date. Detailed thermal damage maps were generated for these portions of the aircraft. These portions included tag numbers 1089, 1112, 511, 1092, 1123, 1134, 221, 1108, 500, 216, 217, 2000, and 1023. They were mostly between the aft main deck cargo door and the L5 door as shown in [Figure 28]. This area can be characterized overall as having been exposed to the highest temperatures as evidenced by severe thermal damage on the interior structure and discoloration of the paint on the exterior of the aircraft's skin.

Numbering Convention: #1 (Blue), #2 (Green), #3 (Gray), #4 (Red) [Figure 28] Airframe Thermal Damage Map

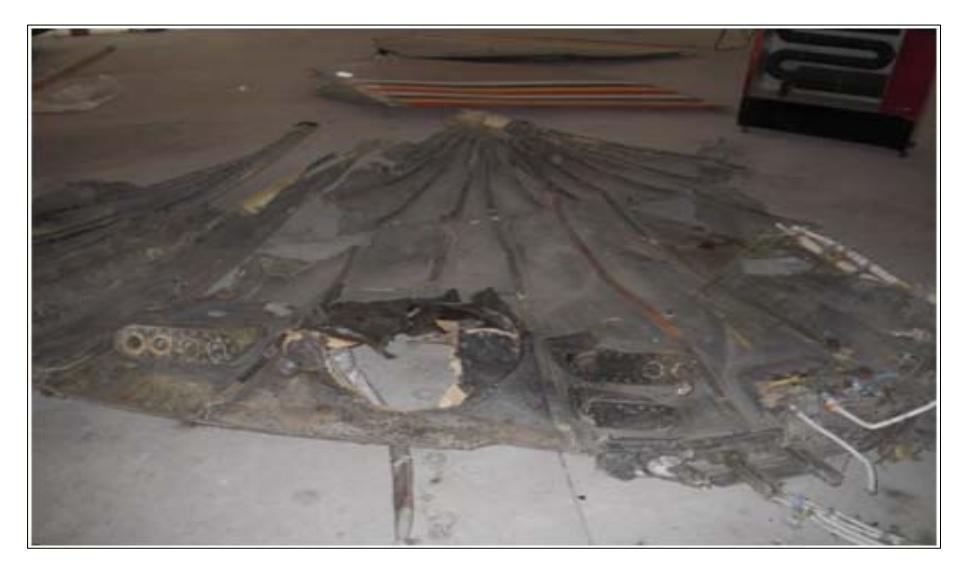
[Figure 29] Aft Pressure Bulkhead Showing Side Facing Main Cargo Deck

The aft pressure bulkhead was partially recovered in multiple pieces. They had sustained thermal damage originating on the side facing the interior of the main cargo deck.

Portions of the aft pressure bulkhead showing the side facing the main cargo deck is shown in [Figure 29]. As shown in [Figure 30], portions of the wreckage aft of the pressure bulkhead did not have evidence of fire damage.

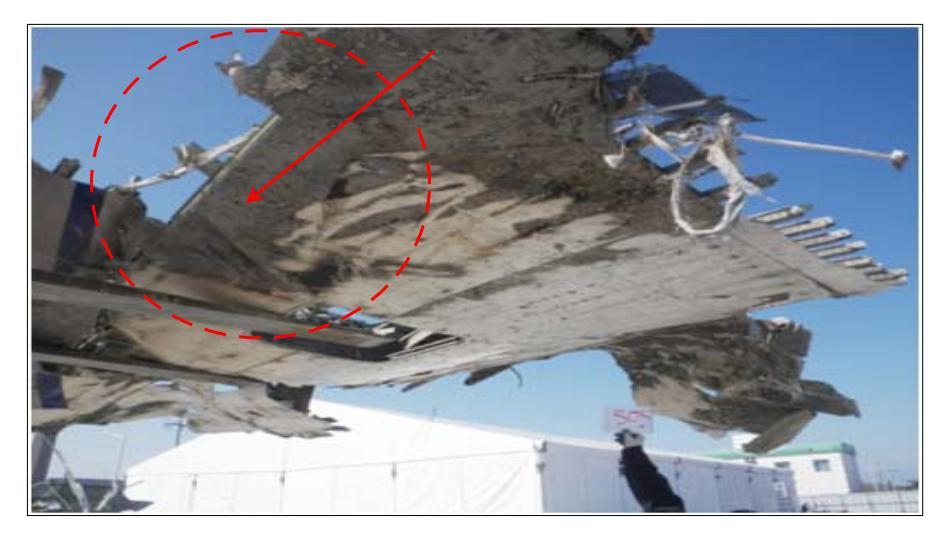
[Figure 31] Soot Trails from Outflow Valves

As shown in [Figure 31], on the exterior of the skin panels on the right and left side of the wreckage aft of the pressure bulkhead were soot trails (marked as arrow) caused by smoke exiting the outflow valves.

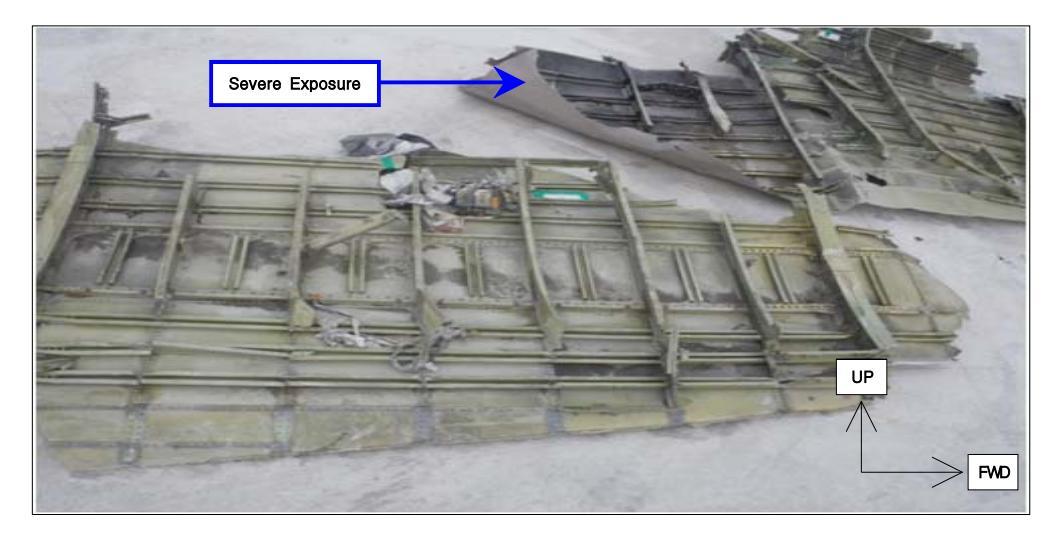
[Figure 32] Wreckage forward of FS1700

As shown in [Figure 32], portions of the wreckage forward of FS1700 generally had fire damage consisting of sooting with areas of more severe damage along the upper areas of the aircraft's crown²⁷). Evidence of sooting was found all the way forward in the main cargo deck on the bottom face of the ceiling liners under the flight deck.

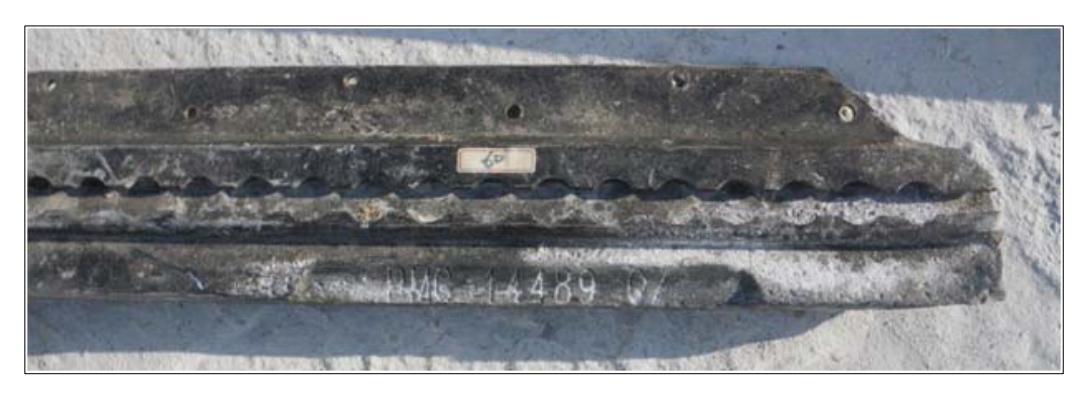
[Figure 33] Cargo Pallet Edge Rail

An example of a cargo pallet edge rail with fire damage is shown in [Figure 33].

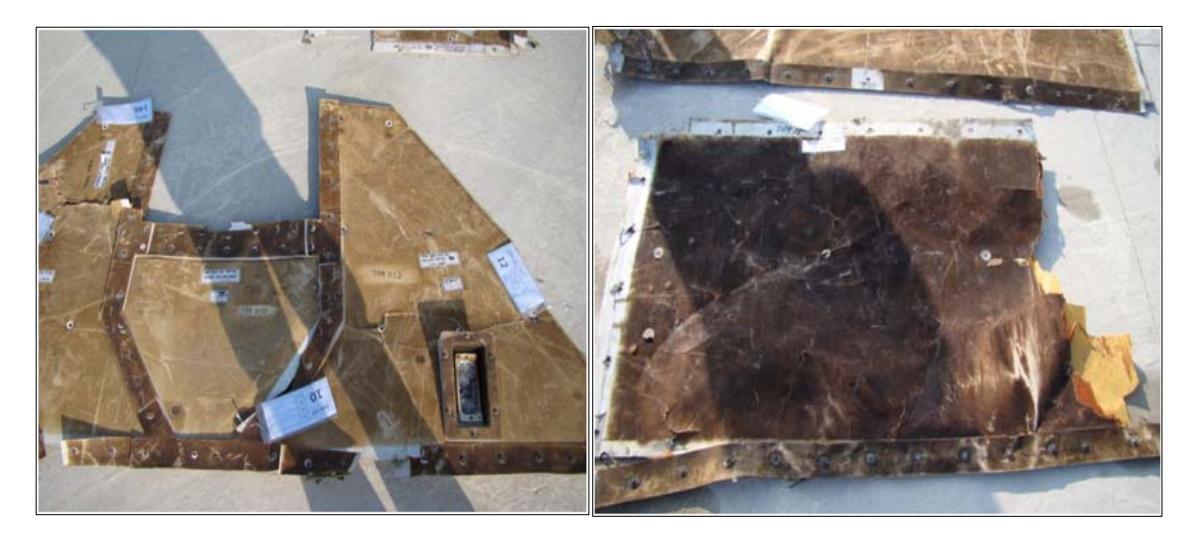
[Figure 36] Liners from Vicinity of and Aft of FS360

Portions of the ceiling panels belonging to the area under the flight deck were examined. As shown in [Figure 36], the forward most ones from the vicinity of FS360 had a layer of soot adhering to the surface. Ceiling liners aft of FS360 were also sooted and had a darker appearance.

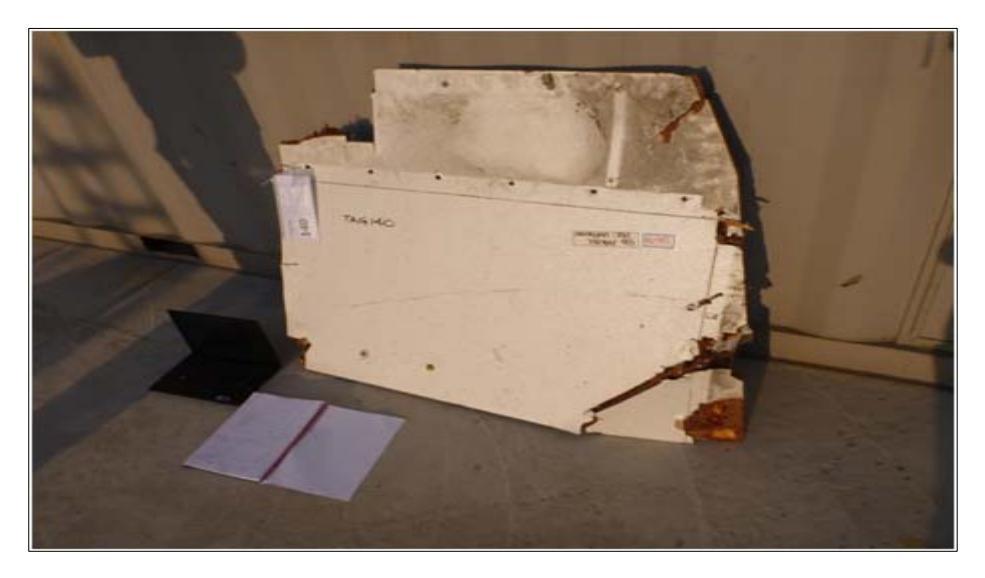
[Figure 37] Upper Deck Interior Panel with Area of Sooting

As shown in [Figure 37], a panel from the interior of the upper deck area was found to have an area exhibiting soot accumulation. The panel is part of the lavatory module wall where the cabin attendant panel and emergency equipment is installed.

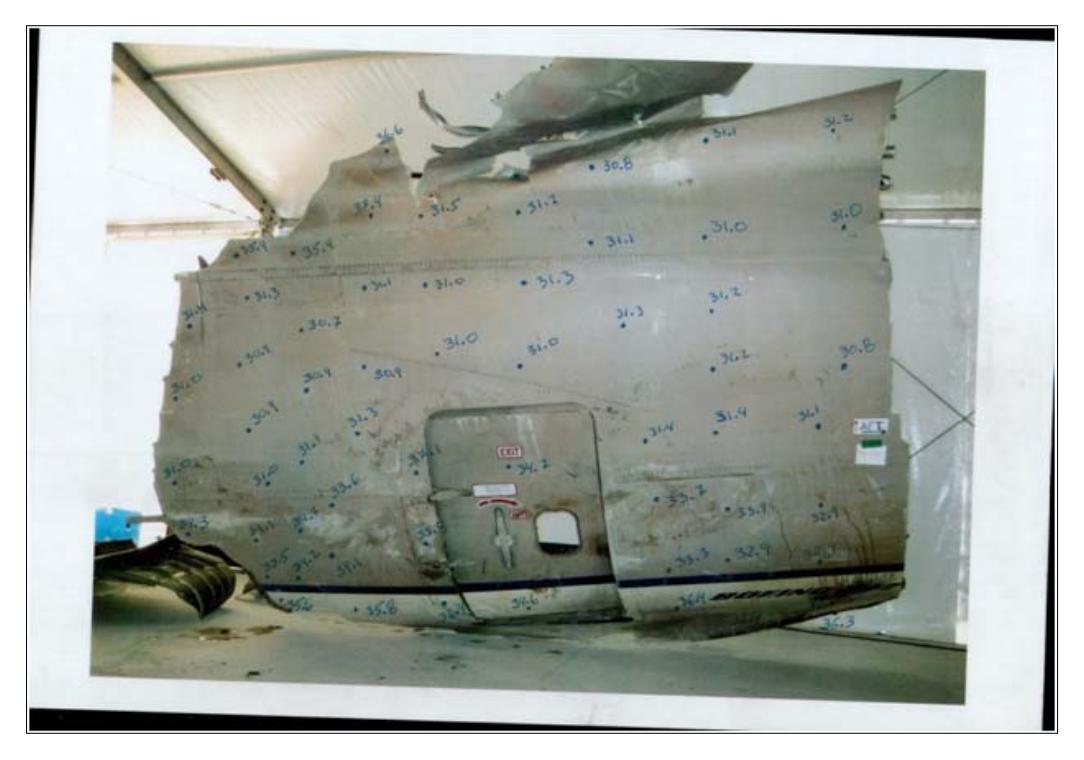
[Figure 38] Conductivity Measurement Points and Values

On a few of the large portions of the wreckage (#500, #1089, #511 and portions of the aft pressure bulkhead), measurements of the electrical conductivity were taken in an effort to see if that information would provide any additional insight beyond what can be accomplished by a traditional visual examination. An example of the conductivity measurements is shown in [Figure 38].
