Accident Investigation Board Denmark

FINAL REPORT

Accident to De Havilland DHC 8-106 Registration TF-JMB Nuuk Airport (BGGH), Greenland The 4th of March 2011

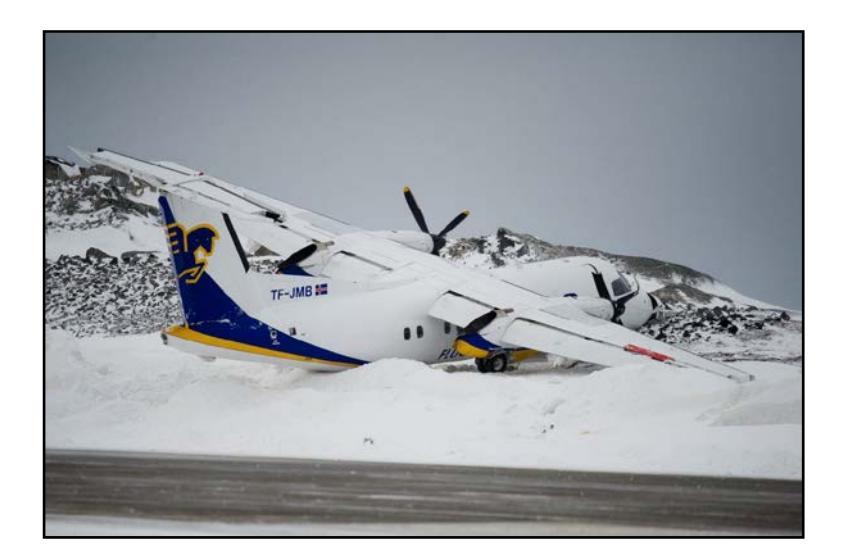
The right nacelle, the right wing, the flaps and aileron were damaged as a result of the runway contact.

The right main landing gear was substantially damaged due to the collapse of the gear.

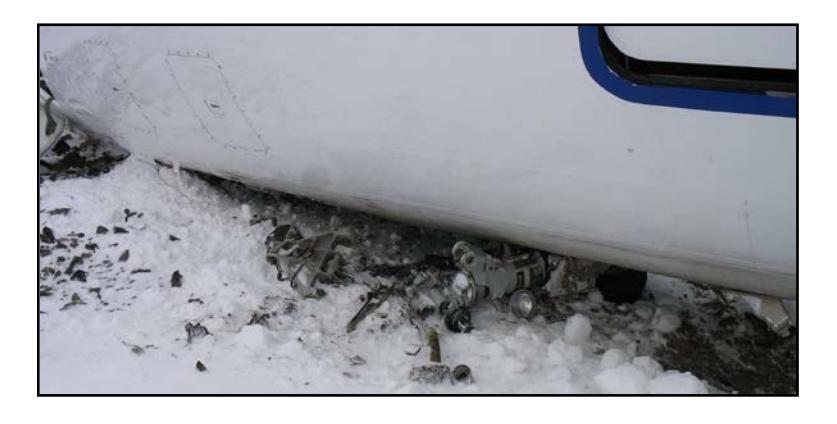
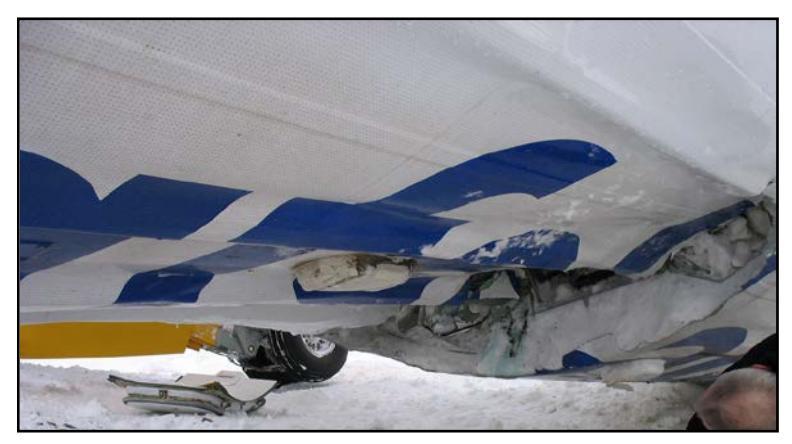
As a result of hitting the rocks, the nose landing gear was destroyed and the aft fuselage suffered substantially damage.

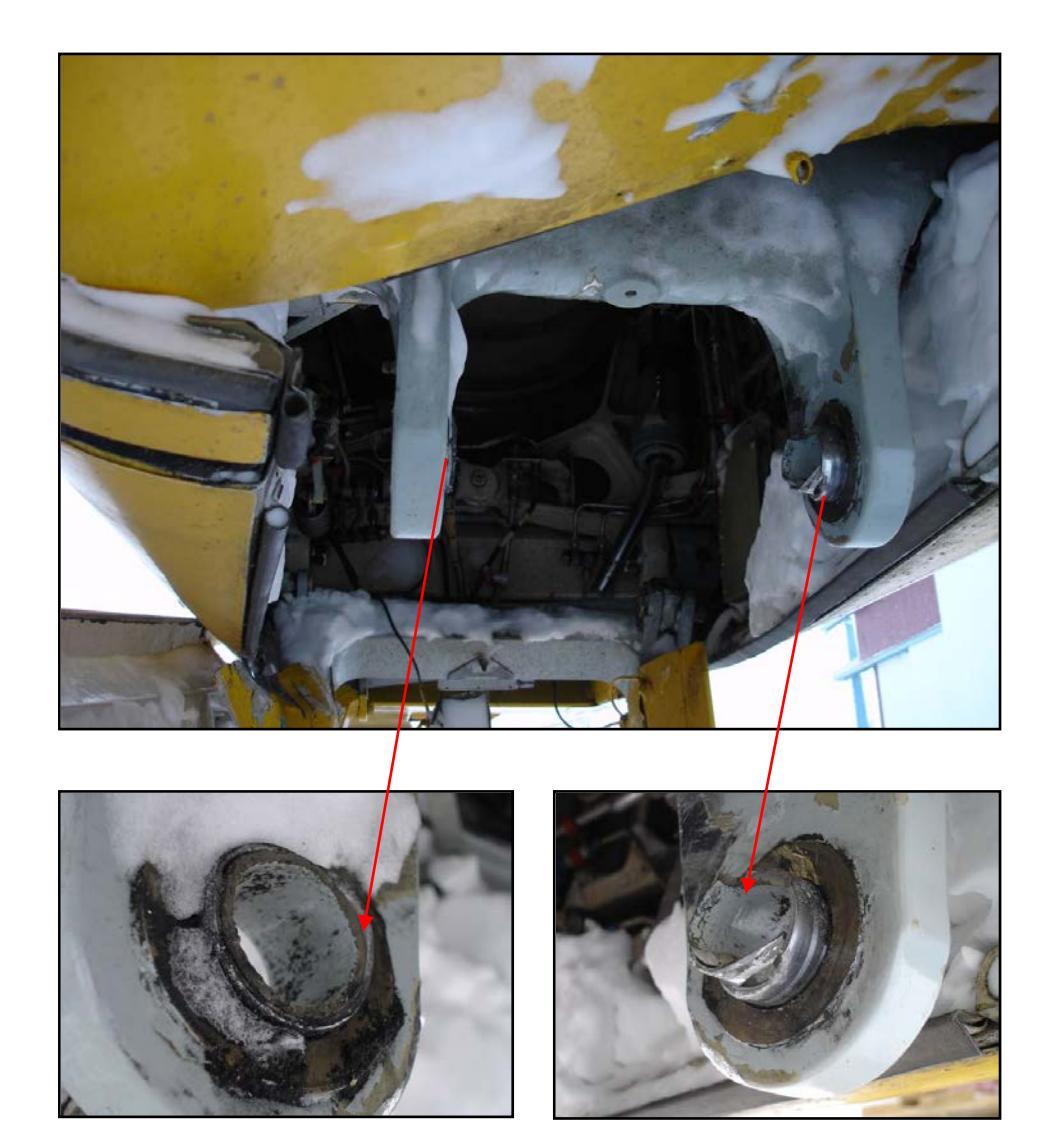
The fuse pin of the right main landing gear was found sheared at two places.

Both ends of the fractured fuse pin were found at place in the junction.

Due to fracture of the fuse pin, the shock strut was separated from the main gear yoke.

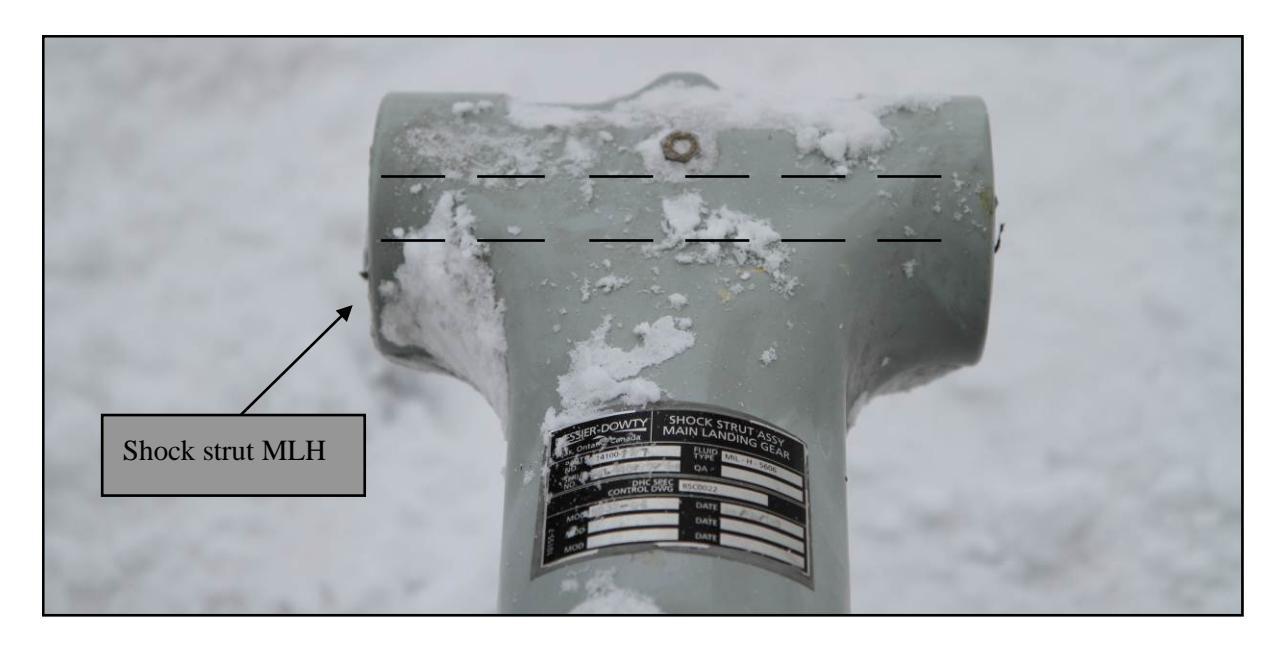
The rest of the fuse pin was found inside the head of shock strut to yoke.

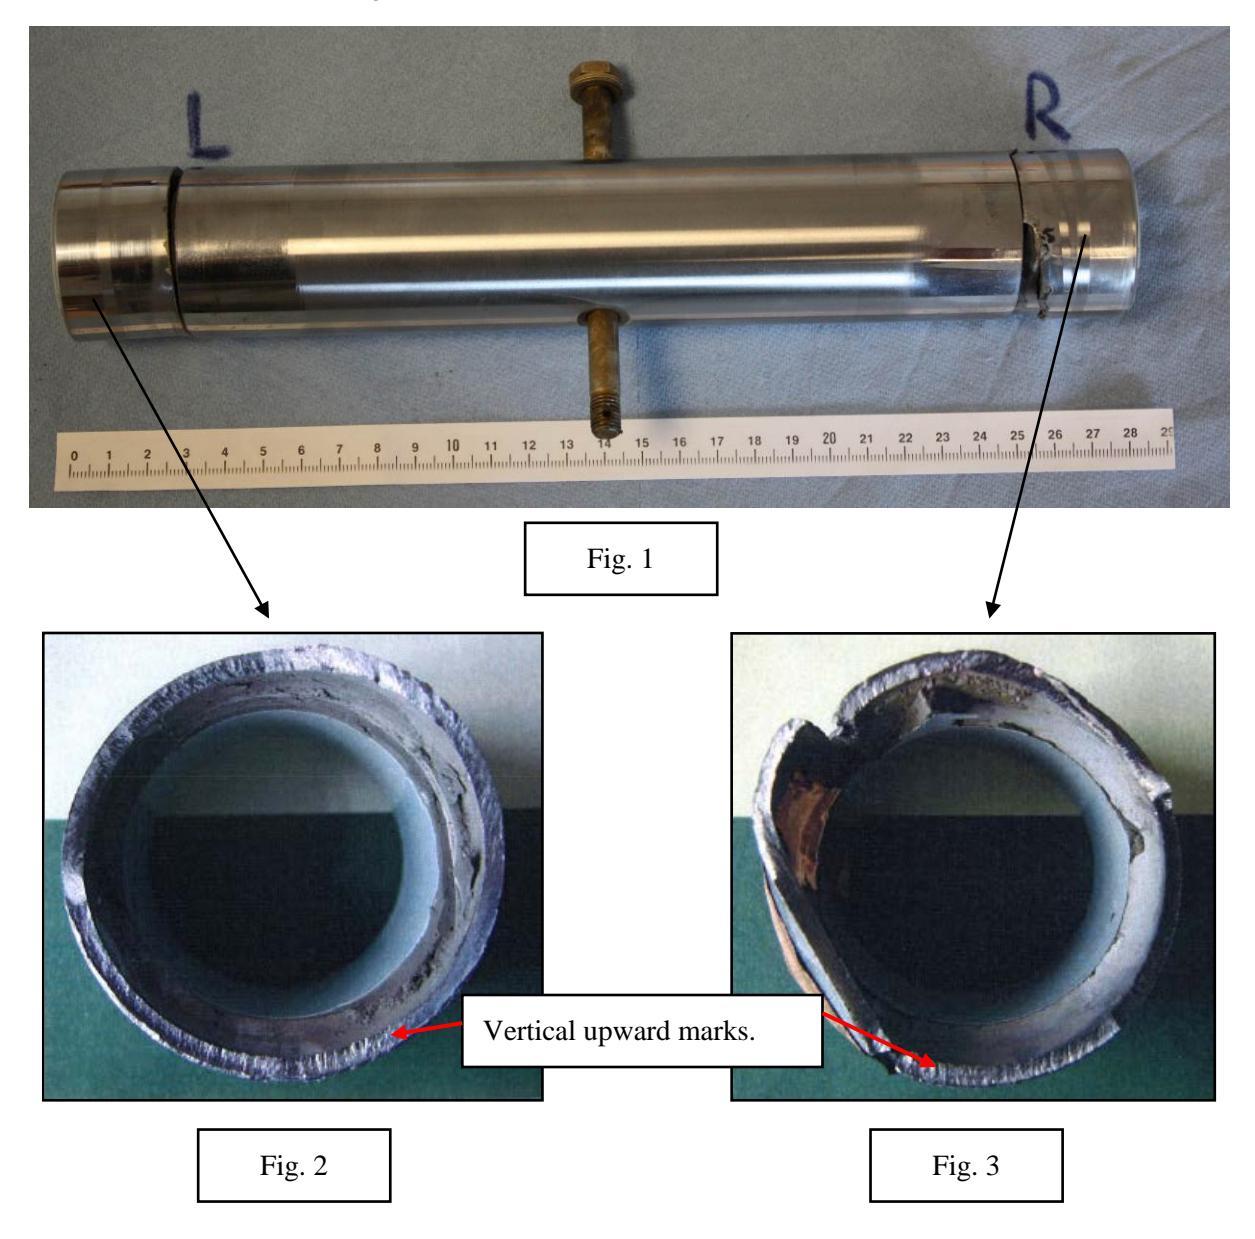
The mid-section of the fuse pin, (fig. 1 with the bolt) was found inside the head of shock strut to yoke.

The head of the bolt indicates the forward direction (flight direction). The two ends (L & R) of the fuse pin were found inside yoke junction to shock strut.

A hint of inflection on the upper side of the fuse pin can be seen, fig 1. The remaining of the fracture in the nature of a clean shear - see figure 1, 2 and 3.

The surface of the fractures from those pieces found in the gear yoke, showed marks coming from vertical upward force. This force triggered the fracture. See fig. 2 and 3.

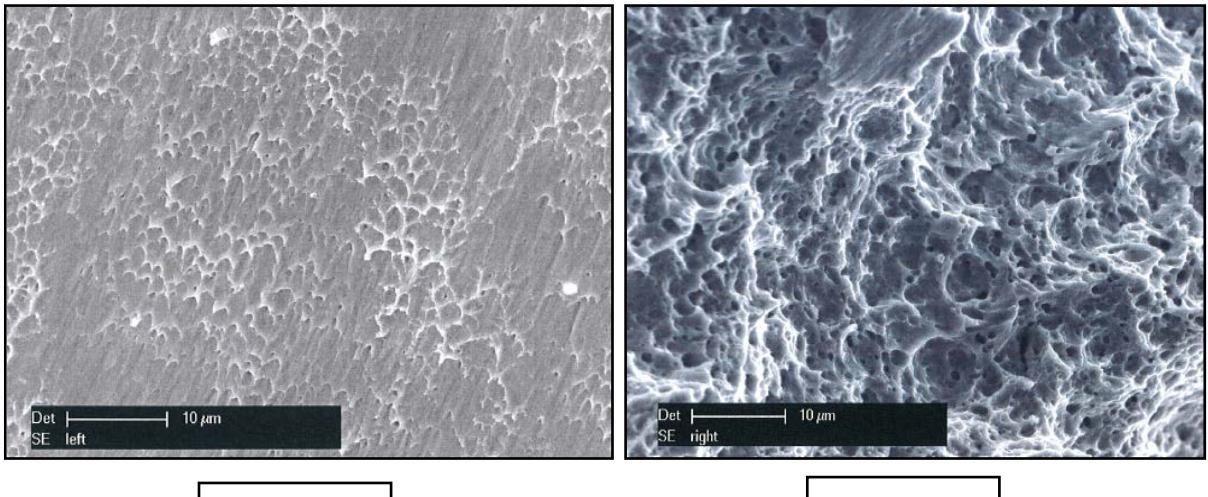
The investigation only found areas there were smeared, which did not give fractographic information and areas with dimples. Examples of areas that were found dimpled are shown in the fig. 4 (distinct shear dimples) and fig 5 (dimples characterize as overload breakage in wholesome materials).

Fractures in the fuse pin were caused by shear (shearing).

It predominantly was a vertical-shear leading to the fractures.

There was no evidence of fault or pre-existing cracks in the fuse pin.

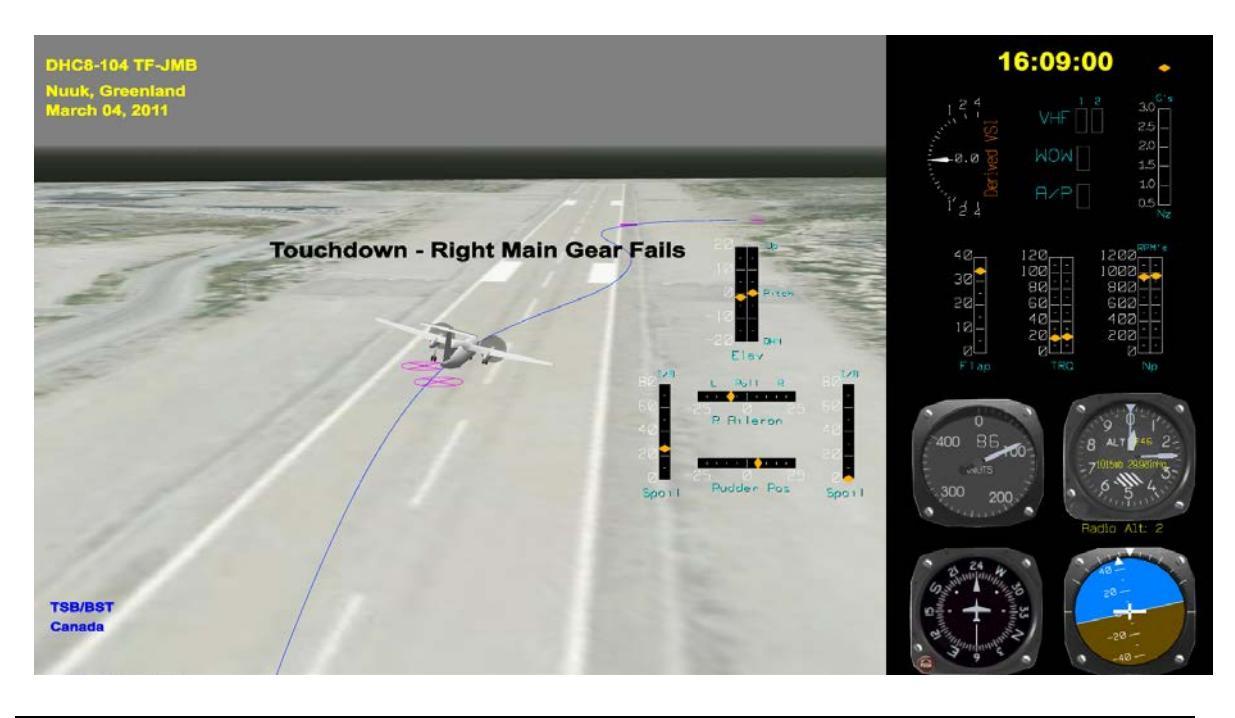
Time 16:09:00 - touchdown

The RA had dropped from 14.7 feet to 1.2 feet in one second. The average rate of descent from RA 14.7 feet to RA 1.2 feet was 13.5 fps (810 fpm).

The right MLG fuse pin sheared and consequently, the right MLG collapsed.
