#### No. 18

Gulf Aviation Company Ltd.. De Havilland Heron, G-APJS, accident on Mount Scifarello, Italy, on 19 February 1958. Report released by the Ministry of Defence-Aviation, Republic of Italy

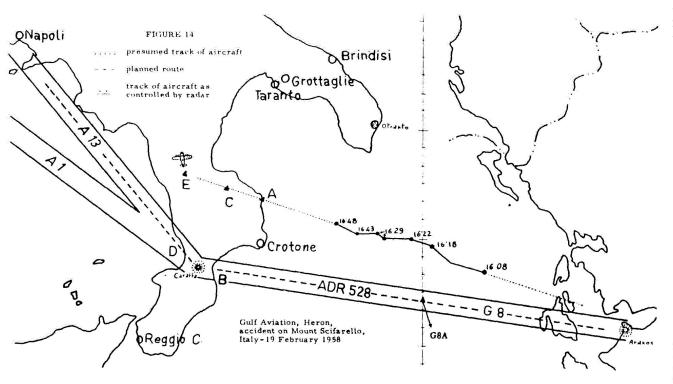
Beyond Araxos the flight was most likely conducted not along the line joining Araxos and point B (airway G8 and ADR 528) but along the line joining Araxos and point A. (See Figure 14) This latter path corresponds to the radar scans and the times transmitted by the aircraft.

It very likely arrived in the area of point A at approximately 1721, the pilot possibly mistaking the lights along the coast for those in area B.

This would explain the message at 1725Z estimating overflight of Caraffa at 1730Z.

The pilot, believing he was over B, intended to fly over Caraffa at 1730Z and then fly to D, over the sea, and thereafter to turn towards airway A-13 on a heading of 320°. Presumably he mistook his position abeam of Caraffa at C for over Caraffa, and then flew towards E thinking it was D.

From this last point E, the aircraft turned approximately 320° (parallel to A-13) arriving at the point of impact at approximately 1808Z.
