NATIONAL TRANSPORTATION SAFETY BOARD

AIRCRAFT ACCIDENT REPORT
Texas International Airlines, Inc., Douglas DC-9-14, N910
Stapleton International Airport, Denver, Colorado,
November 16, 1976, Report Number - NTSB-AAR-77-10.

AIRCRAFT ACCIDENT REPORT

TEXAS INTERNATIONAL AIRLINES, INC.
DOUGLAS DC-9-14, N9104
STAPLETON INTERNATIONAL AIRPORT
DENVER, COLORADO
NOVEMBER 16, 1976

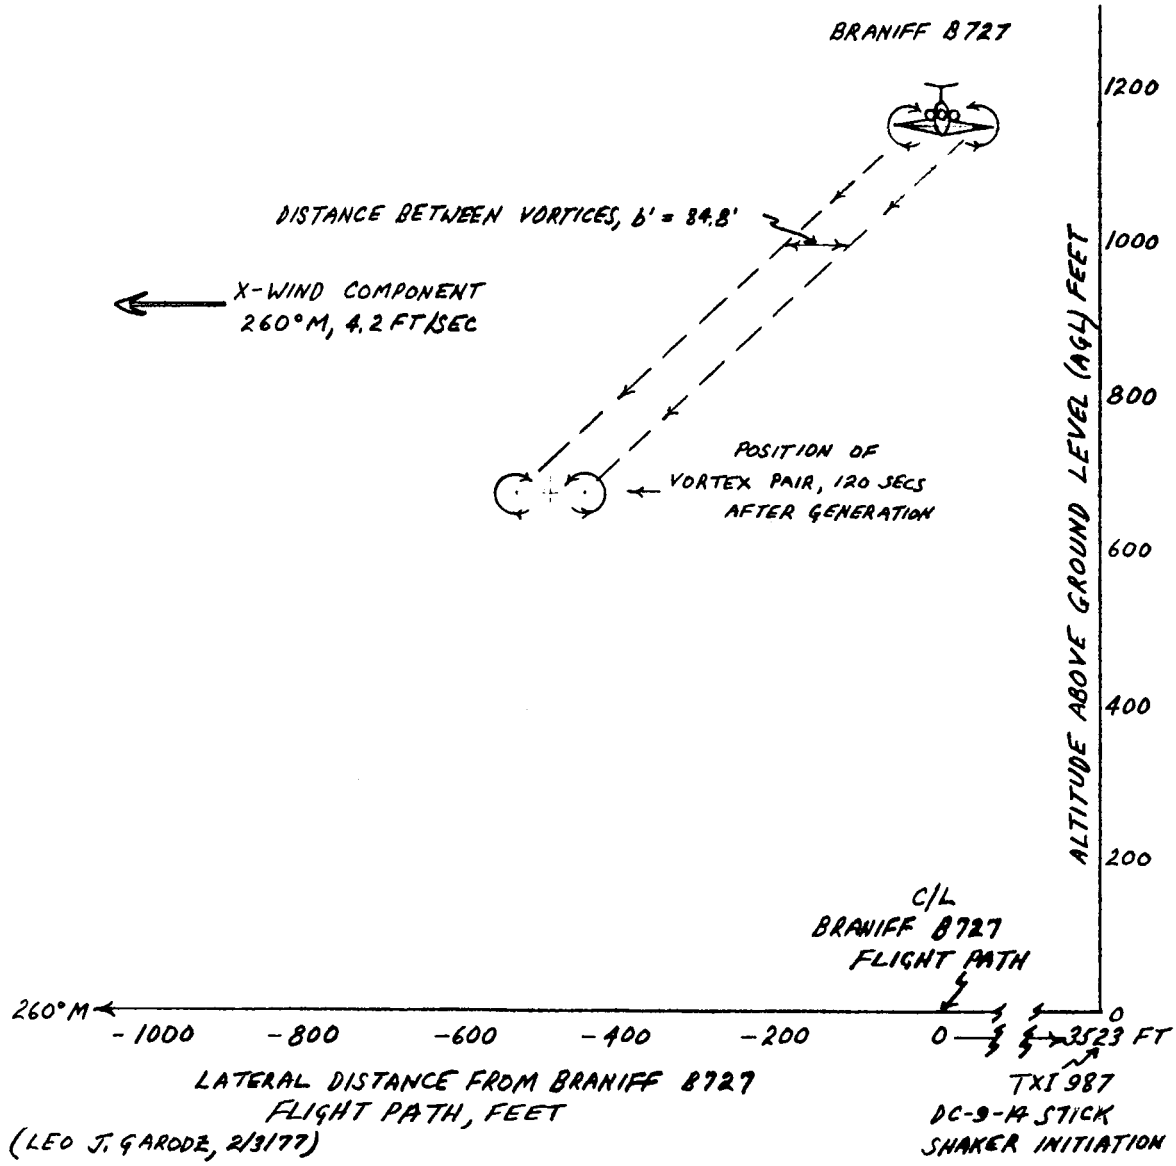
FIGURE 1

Summary: The probability is extremely low that the Braniff B-727 vortices could have impinged upon the Texas International DC-9 because: (1) based on the best available data to date, it has been found that the B-727 vortices persist at lower altitudes for less than 120 seconds which is less than the separation time between the flight path intersection for the two aircraft; (2) even if they did, for whatever reason, it is extremely unlikely that they would have descended to the level of the DC-9 airplane taking off or create a problem; and (3) regardless of the separation time interval between the two aircraft, assuming valid assumptions on wind speed and direction from the B-727's flight altitude to the surface, the B-727 vortices are drifting downwind of the projected flight path intersection of the two airplanes which is another 3,523 feet downwind of the DC-9 stick shaker initiation position.

BRANIFF FLIGHT 928 - B727-100 - VORTEX TRAJECTORY - NOV 16, 1976
RELATED TO RWY 8R-26L, COMMON FLIGHT PATH POINT
B727 & TXI DC 9-14 (B727 PROJECTED TO GROUND)
STAPLETON INT'L AIRPORT

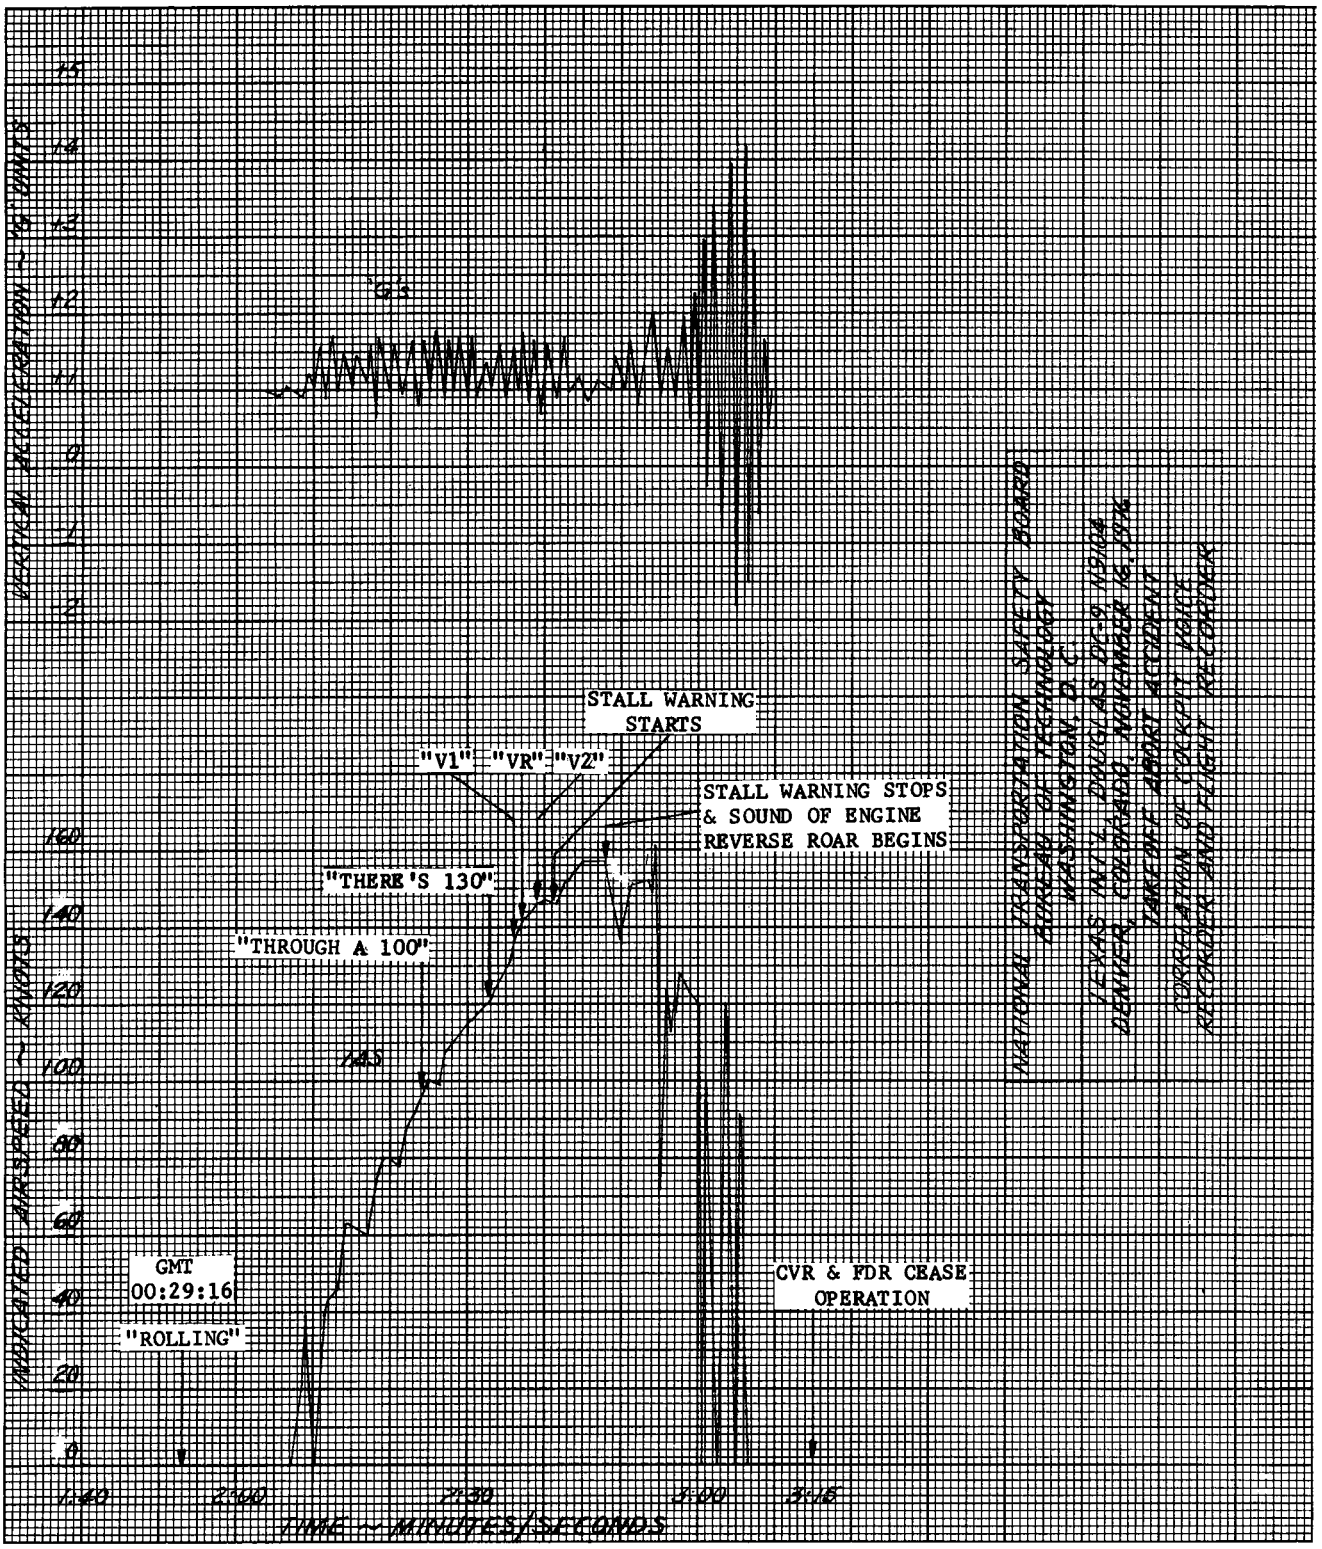
APPENDIX G

STALL WARNING STARTS
"V1" "VR" "V2"
STALL WARNING STOPS & SOUND OF ENGINE REVERSE ROAR BEGINS
"THERE'S 130"
"THROUGH A 100"
GMT 00:29:16
"ROLLING"
CVR & FDR CEASE OPERATION
INDICATED AIRSPEED KNOTS
TIME - MINUTES/SECONDS
2:00
3:00
NATIONAL TRANSPORTATION SAFETY BOARD
BUREAU OF TECHNICAL SAFETY
WASHINGTON, D.C. 20594
DOUGLAS DC-9-15, N1090A
DELTA AIR LINES, INCORPORATED
BOSTON-LOGAN AIRPORT ACCIDENT
JANUARY 18, 1973
CONGRESSIONAL HEARINGS
RECORDER AND FLIGHT RECORDER

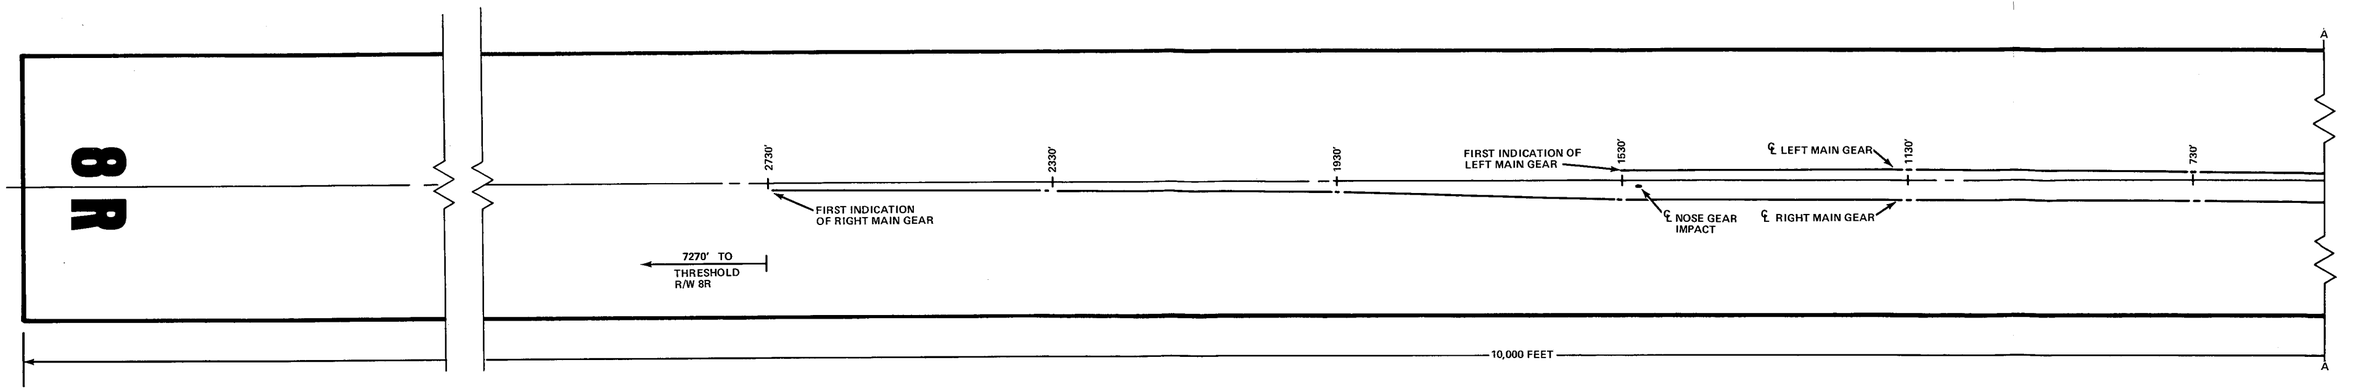
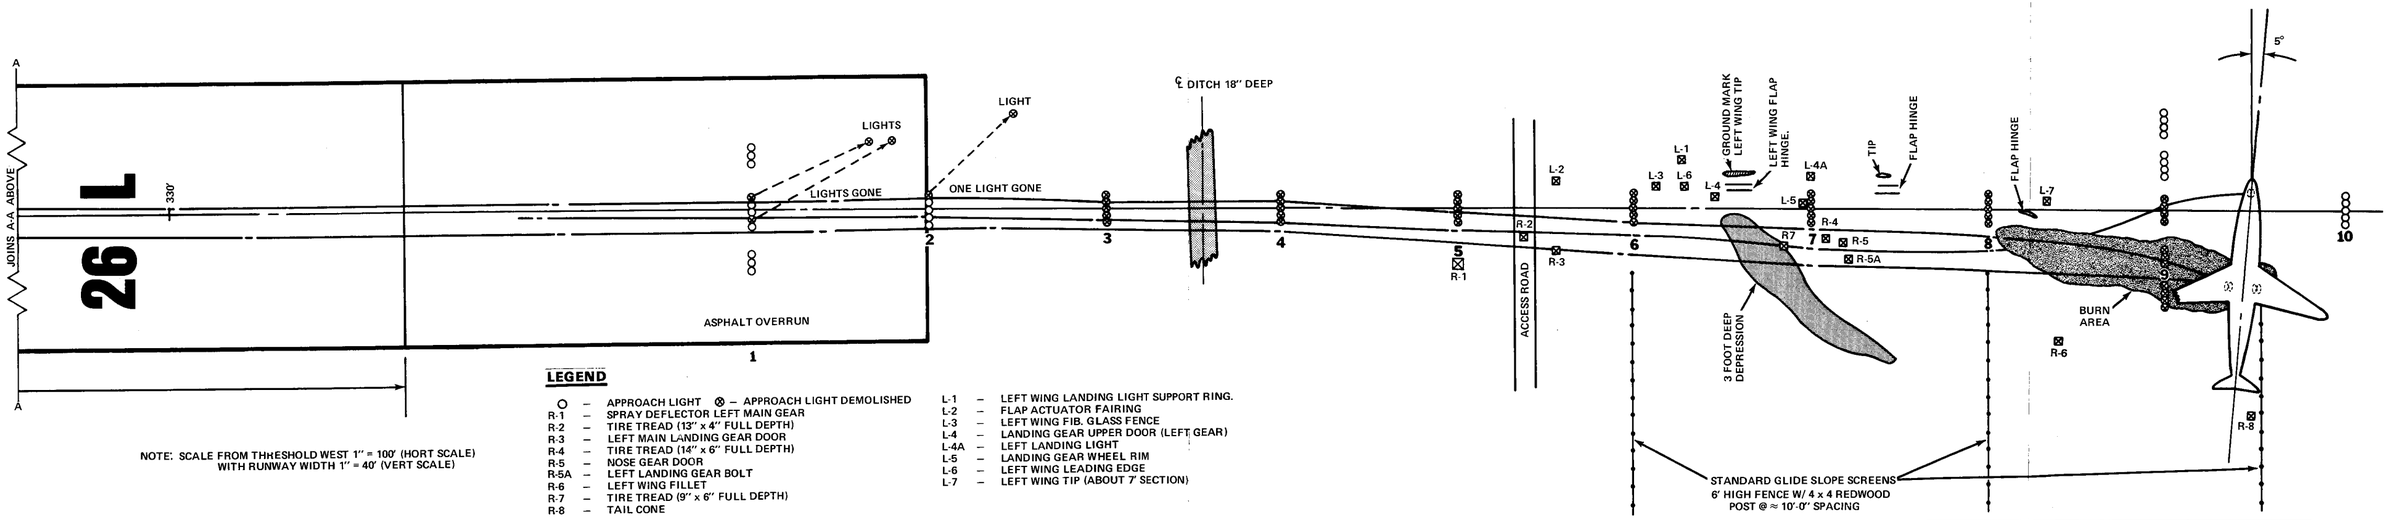
○ – APPROACH LIGHT ⊗ – APPROACH LIGHT DEMOLISHED
R-1 – SPRAY DEFLECTOR LEFT MAIN GEAR
R-2 – TIRE TREAD (13" x 4" FULL DEPTH)
R-3 – LEFT MAIN LANDING GEAR DOOR
R-4 – TIRE TREAD (14" x 6" FULL DEPTH)
R-5 – NOSE GEAR DOOR
R-5A – LEFT LANDING GEAR BOLT
R-6 – LEFT WING FILLET
R-7 – TIRE TREAD (9" x 6" FULL DEPTH)
R-8 – TAIL CONE
