AIRCRAFT ACCIDENT REPORT

SOUTHERN AIRWAYS, INC. DC-9, N97S

Tri-State Airport

November 14, 1970

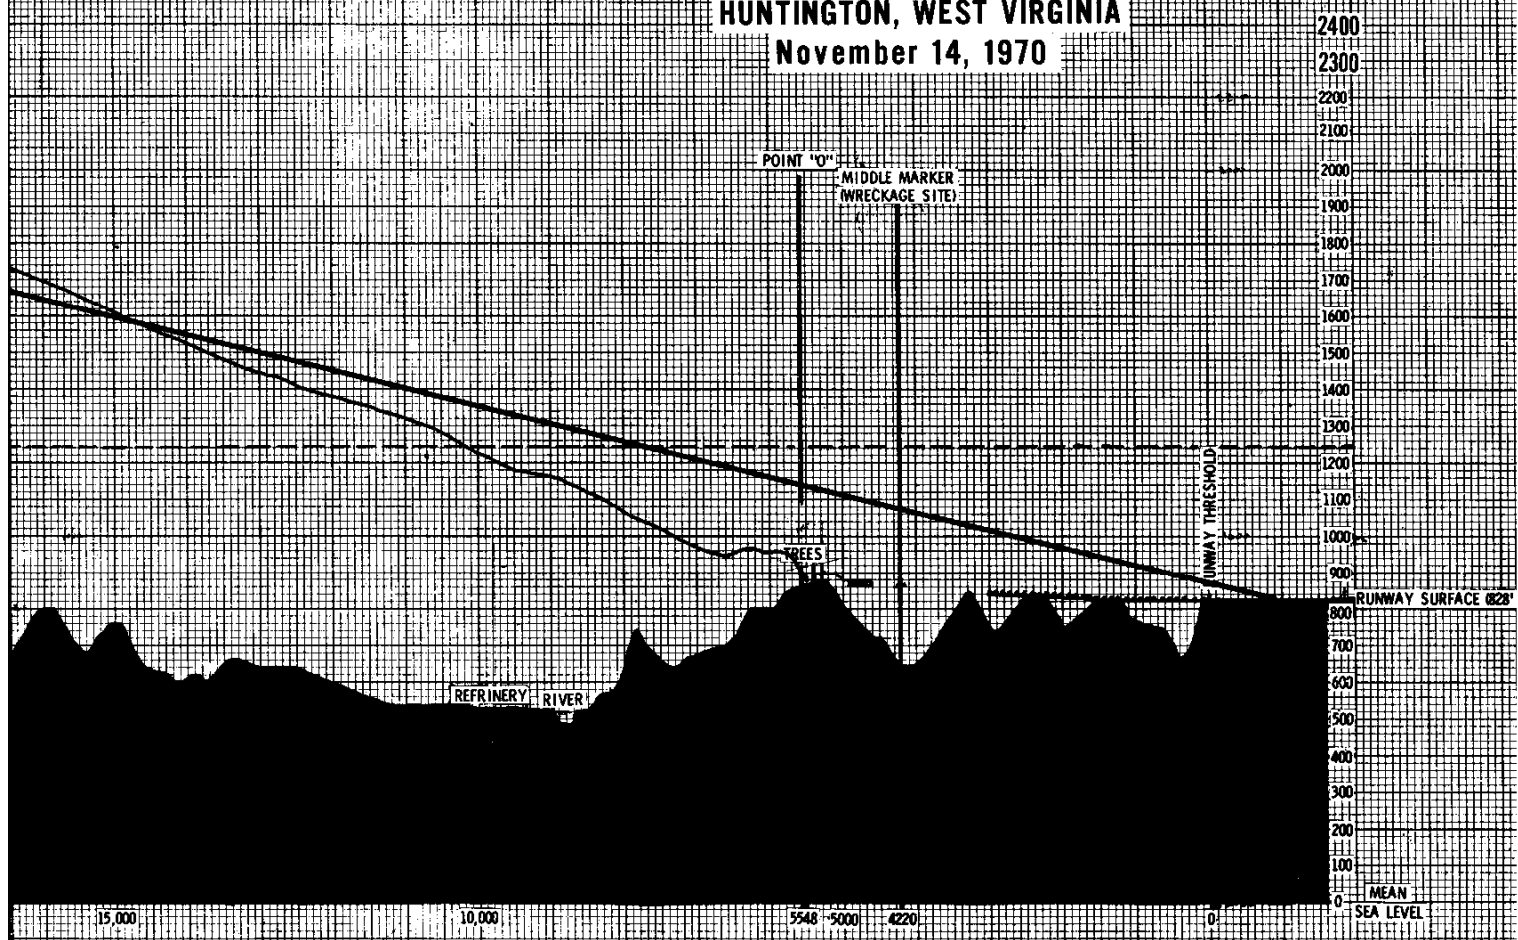
COMPARISON OF DESCENT PROFILE AND 3° GLIDE SLOPE
SOUTHERN AIRWAYS, INC.
DC-9-31, N97S
HUNTINGTON, WEST VIRGINIA
November 14, 1970

ALTITUDE
s runway 960 feet beyond
ted by ratio of 5:1.

BASIC TERRAIN PROFILE
LOC COURSE RUNWAY 11
