Aircraft Accident Investigation Board

Interim Report

State File Number: A961129EPATS
Type of Occurrence: Accident
Date of Occurrence: Feb 18th 2018
Place of Occurrence: Near Yasouj Airport
IRI of IRAN
Aircraft Type: ATR 72-212
Registration: EP-ATS
Operator: Iran Aseman Airlines

Accident Investigation Report
Aircraft ATR72-212 registered EP-ATS
Operated by Iran Aseman Airline
Enroute Tehran to Yasouj
18 Feb, 2018

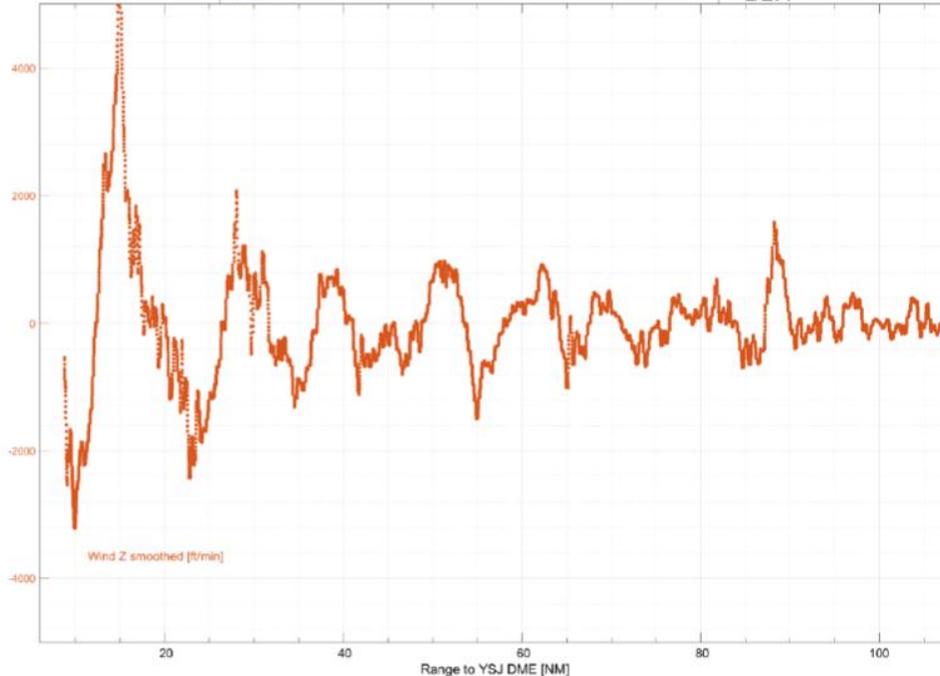
Figure No; 6 calculated Vertical Wind

Based on FDR Analysis by BEA, Drawing the computed vertical wind values versus the range to the DME of Yasouj really shows the oscillations of the vertical wind (Figure 6) with a long range period during the accident flight.

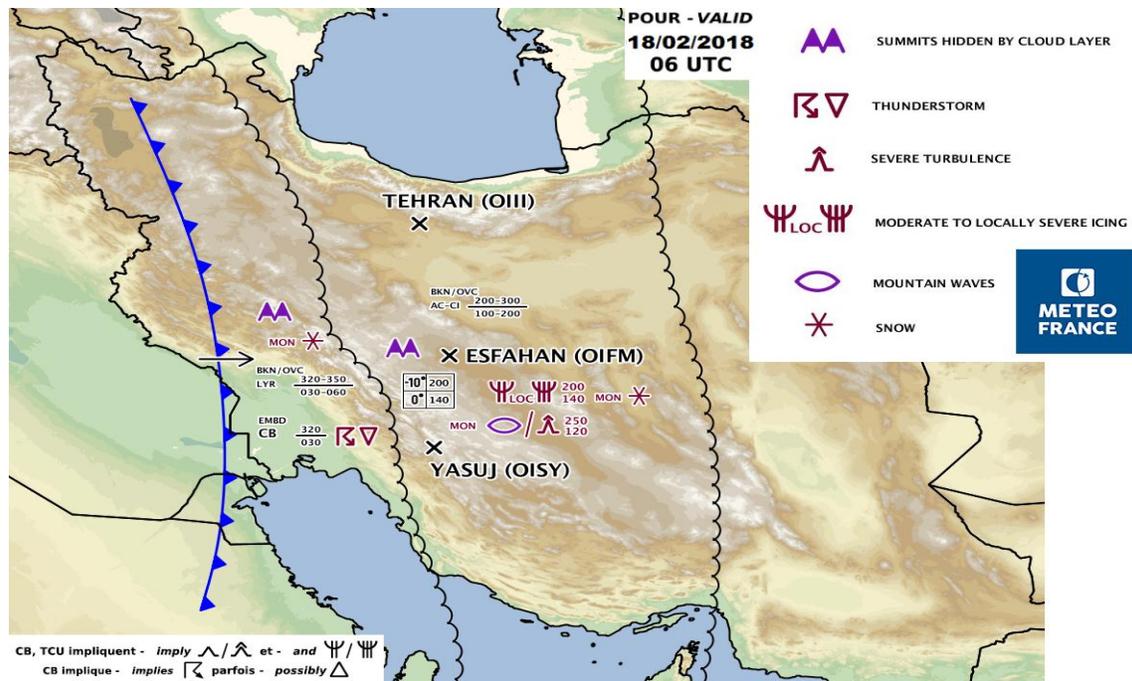
Figure No; 7 Area Forecast about Icing condition

It was estimated that the accident site had moderated turbulences with condition moderate up to locally severe icing. There was unstable conditions and stormy in the accident site and it was covered by clouds. The Area Forecast at the time of accident was received on 03/03/2018 from METEO France which shown in Fig7 .

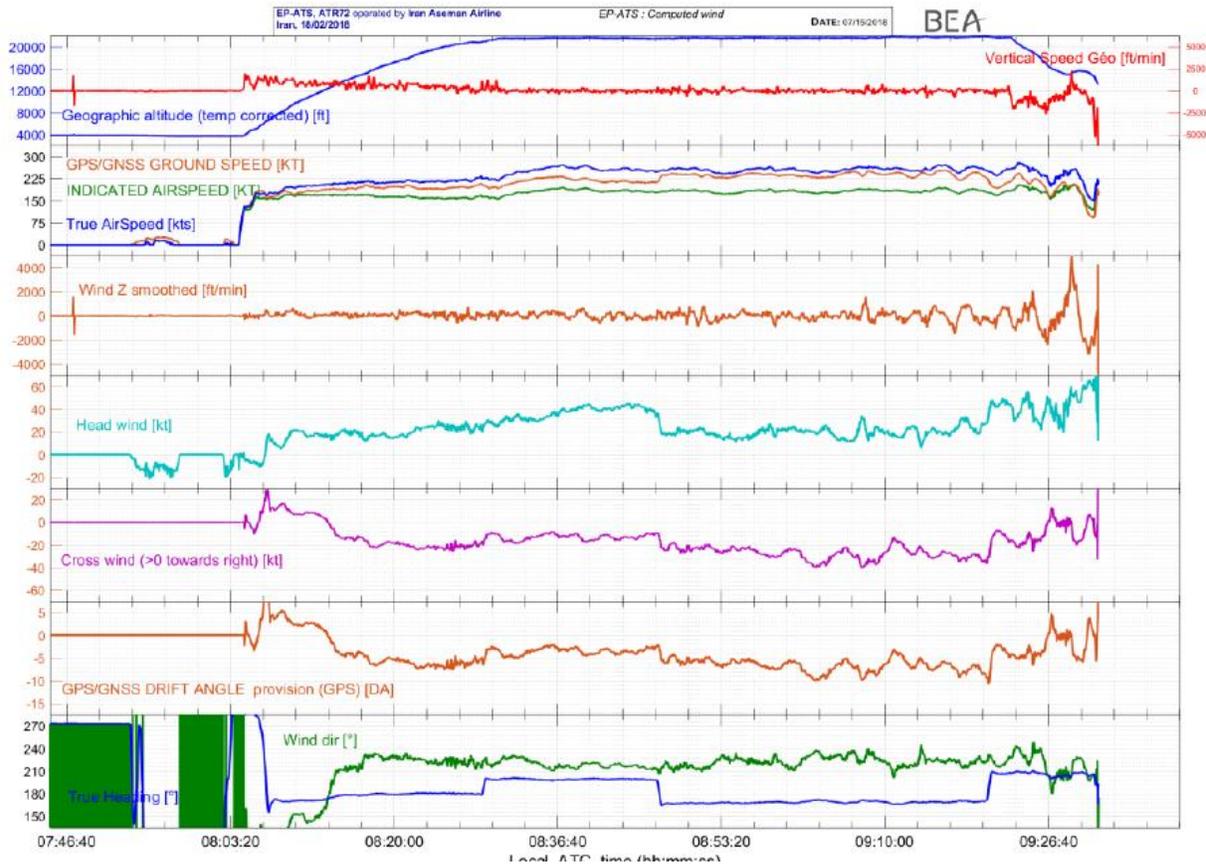
Figure No; 10 Computed wind

The computed wind showed consistencies between the true heading, the true wind direction, the head wind, and the cross wind, the TAS, the GPS/GNSS Ground Speed and the computed drift angle:

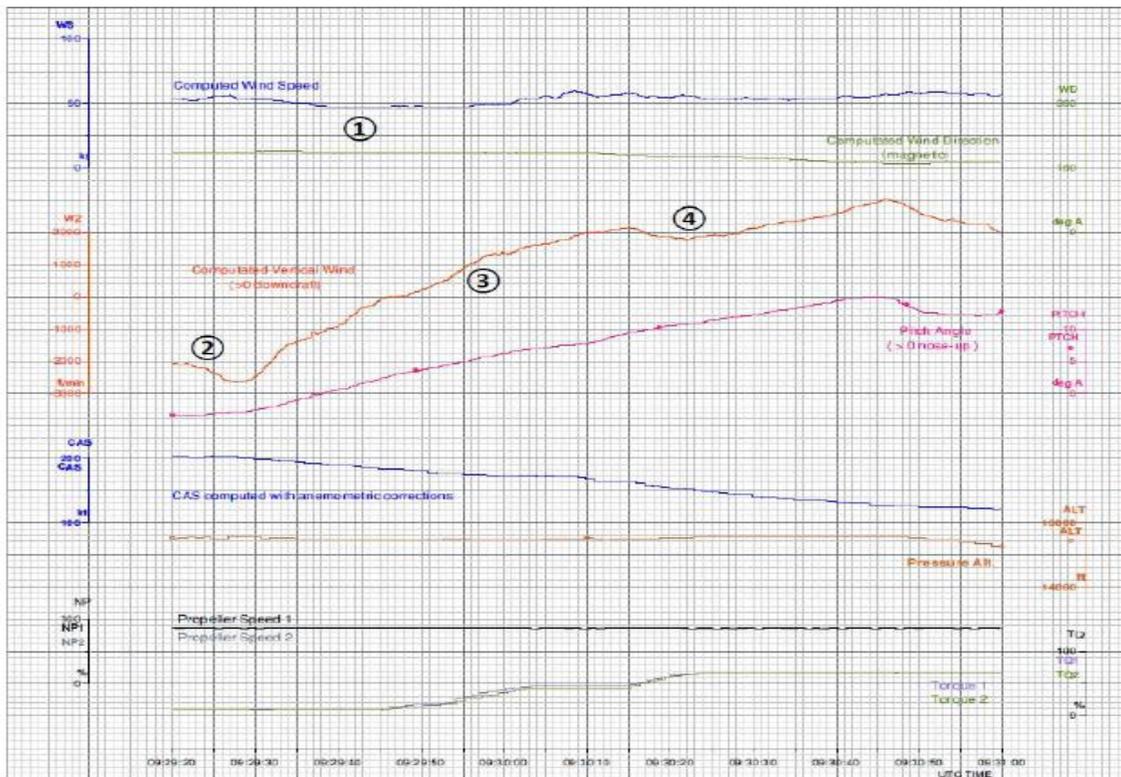
Figure No; 11 Wind computation by the manufacturer (9 h 29 min 20 s to 9 h 31 min 00 s)

From 09:31:18 to 09:31:30 UTC:

- The computed wind speed increased up to around 70 kt and the computed wind direction slightly decreased to about 195°.
- The computed vertical wind decreased.

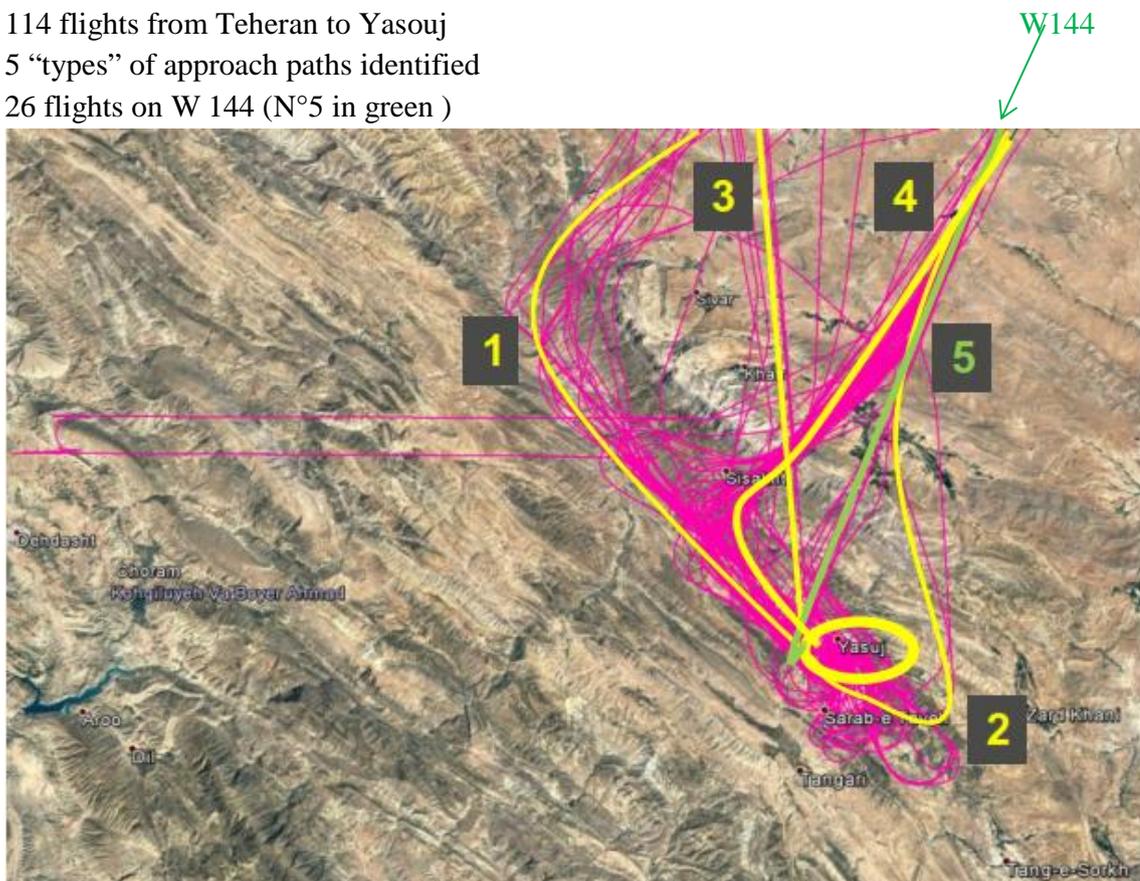
Figure No; 18 Flight Paths of ATR Fleet previous flights

The Airline supported 6 months raw data files of ATR fleets to the manufacturer by their request and the data included:

- 114 flights from Teheran to Yasouj
- 5 “types” of approach paths identified
- 26 flights on W 144 (N°5 in green)

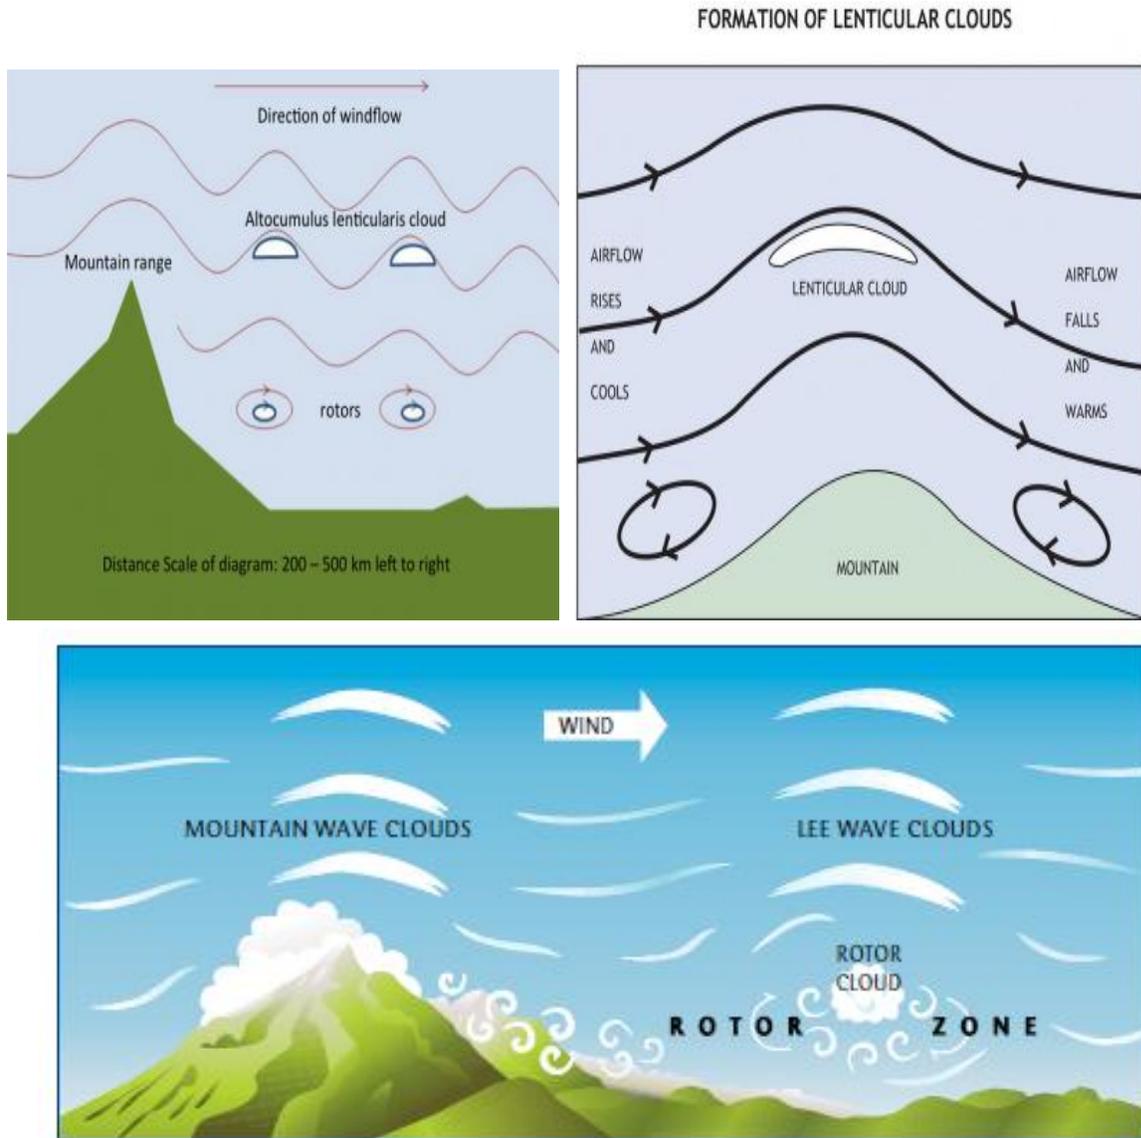
Figure No; 19 Effect of Mountain Wave

Vertical air stream (up & down Drafts) with turbulences can reach more than 3,000 ft/min. Mountain Waves are associated with severe turbulence, strong vertical currents, and icing. The combination of these strong vertical winds and surface friction may cause rotors to form beneath the mountain waves causing severe turbulences with high load and acceleration on the aircraft. Usually, the pilots like to fly with minimum safe speed to prevent vertical oscillation of the aircraft. They should be careful for speed monitoring and stall prevention.

The aircraft tracking and FDR analysis showed the flight crossed the Up & down draft. The updraft and downdraft computed wind values were confirmed by the airplane attitude. Following the engagement of the altitude hold mode, an updraft wind made the autopilot request a pitch down attitude, while a downdraft wind made the autopilot request a pitch up attitude. The reactions of the autopilot were consistent with maintaining the airplane at the target altitude. The crew increased the engine power from 47% to 73% TQ to prevent speed drop but aircraft performance was not enough against high rate of down draft (about 3200 ft/min). So near the mountain the aircraft experienced significant reduction in airspeed and wing lift factor as effect of down draft.

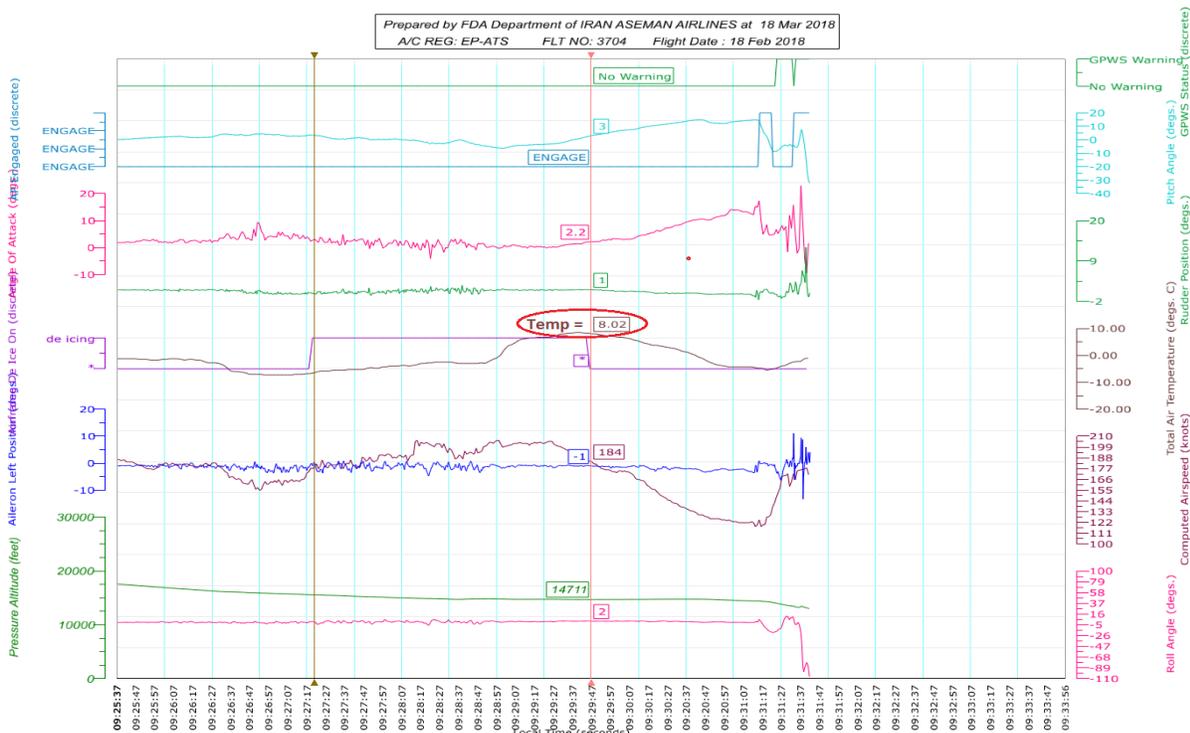
Figure No; 23 Temperature Graph of FDR

R **Note:** Experience has shown that the last part to clear is the ice evidence probe. As
 R long as this condition is not reached, the icing speeds must be observed and the
 R ICING AOA caption must not be cancelled.

Based on FDR & CVR crew canceled Icing AOA caption and never spoke about any observation on Ice Evidence Probe (IEP).

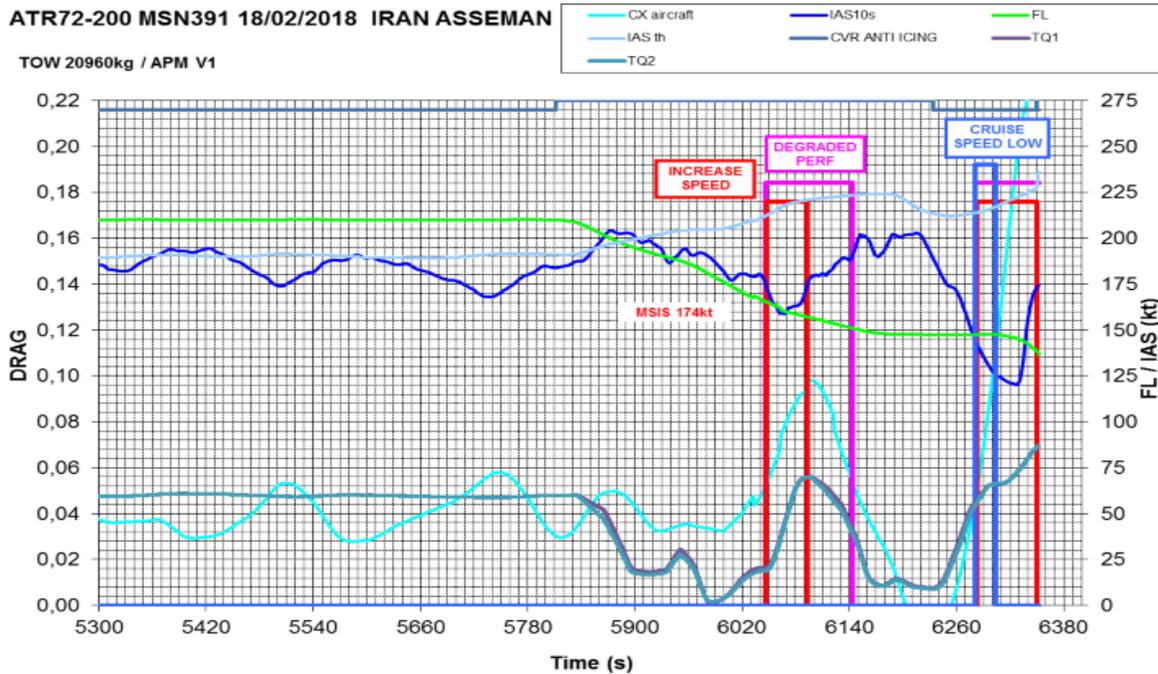
Figure No; 24 APM Simulation Analysis

9 h 30 min 56 sec	Simulated CRUISE SPEED LOW	Aircraft is not considered in cruise any more by APM	
9 h 31 min 44 sec	Simulated INCREASE SPEED	Speed increases above minimum severe icing speed

The APM system was designed to monitor the energy state of the aircraft and alert the flight crew when some conditions are met, any external phenomenon having an influence on the aircraft TAS will have an influence on the total mechanical energy, and will be detected by the aircraft performance monitoring as a low aircraft energy state. The system alerts are based on calculation of Drag coefficient (C_x). The average C_x was computed from:

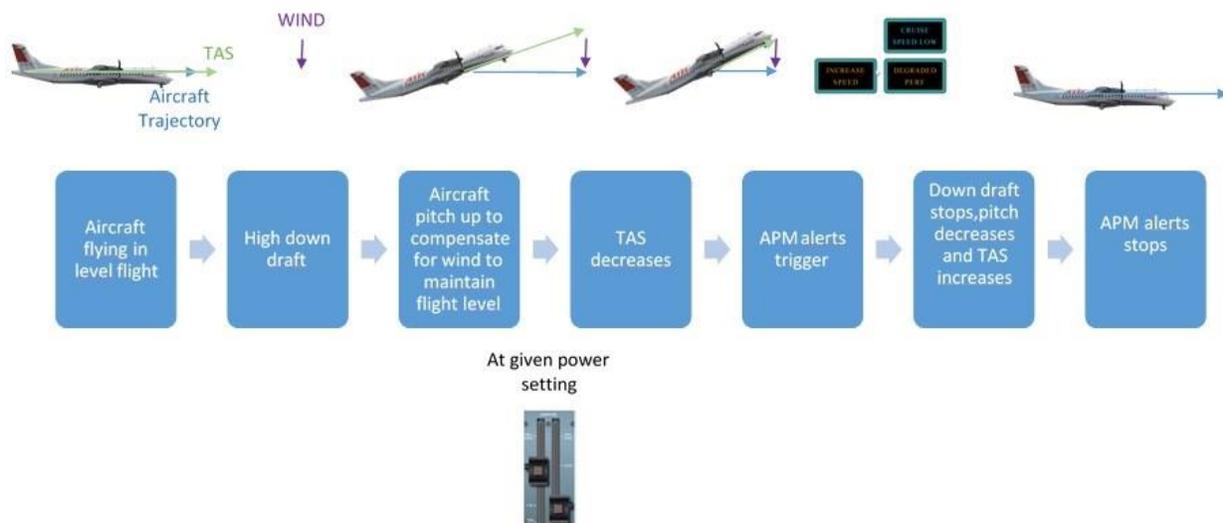
Figure 25, Illustration of wind effect on APM calculation

As a conclusion, the APM simulation tends to show that the alerts that would have triggered are linked to a decrease in performance due to external conditions (wind gradient) rather than icing, as illustrated in the following Figure:

The average value of the computed C_x was 0.043 during the level off at FL 210 which is a consistent value for this airplane. Specific periods of interest that are highlighted in the figure:

All those periods occurred during the cruise at FL 210. The airplane was flying outside of any icing conditions. However the estimated drag coefficient reached values higher than the APM threshold triggering. The performance of the airplane during the cruise was analyzed as:

- The first simulated APM alerts (both Degraded Performance and Increase Speed) would have triggered at 9 h 26 min 40 s. The first simulated APM alerts:
 - They triggered more than 30 s before the ice detector caution and the true Cx increasing occurred 70 s before the ice detector caution.
 - The degraded performance alert stopped while the SAT was still lower than -10°C .
- ❖ *Note: when SAT is below -10°C and De-ice system ON, the condition of ice contamination exists, so stopping APM alerts means aircraft performance is normal with no ice contamination.*

The second simulated APM alerts (9 h 30 min 35 s to at least 9 h 31 min 22 s) were due to the downdraft wind encountered by the airplane. The airplane was facing worse conditions than during the first simulated APM alerts. However in this period of time De-ice and maybe Anti-ice systems were OFF.
