No. 17

Panarctic Explorations, Lockheed L-188, CF-PAB, accident at Rea Point, Melville Island, Canada, on 30 October 1974. Report not dated, released by the Ministry of Transport, Canada.

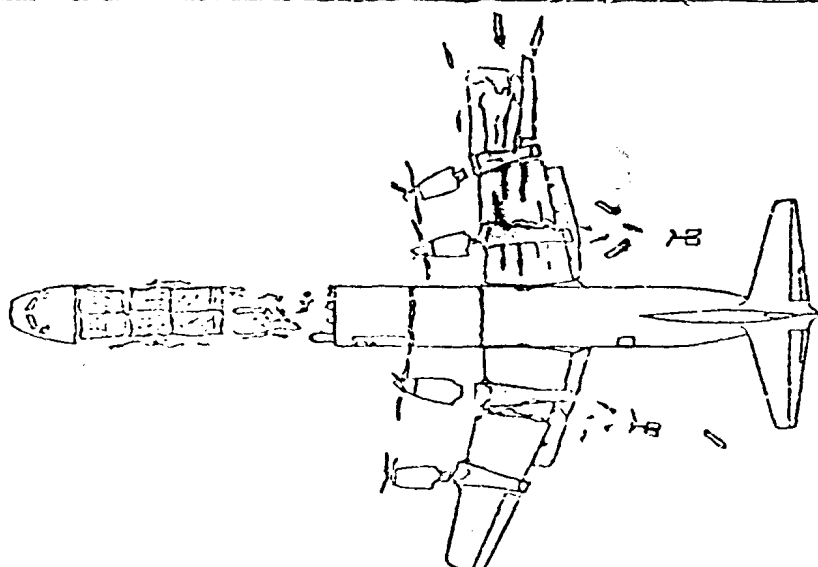
The nacelles and wing centre box contact the ice, the propellers, gearbox and engines separate from the wings, the fuselage ruptured at FS 570, the right wing exploded outboard of WS 170, the left wing separated intact outboard of WS 170 and the centre wing box disintegrated. The cockpit and bulk cargo slid ahead of the decelerating structure, and the passengers, seats and emergency gear cabinet broke free within the aft fuselage.
