1. Report No. NTSB-AAR-79-2		2. Government Accession No.		3. Recipient's Catalog No.	
4. Title and Subtitle Aircraft Accident Report - Allegheny Airlines, Inc., BAC 1-11, N1550, Rochester, New York, July 9, 1978				5. Report Date February 8, 1979

AIRCRAFT ACCIDENT REPORT

ALLEGHENY AIRLINES, INC.
BAC 1-11, N1550
ROCHESTER, NEW YORK
JULY 9, 1978

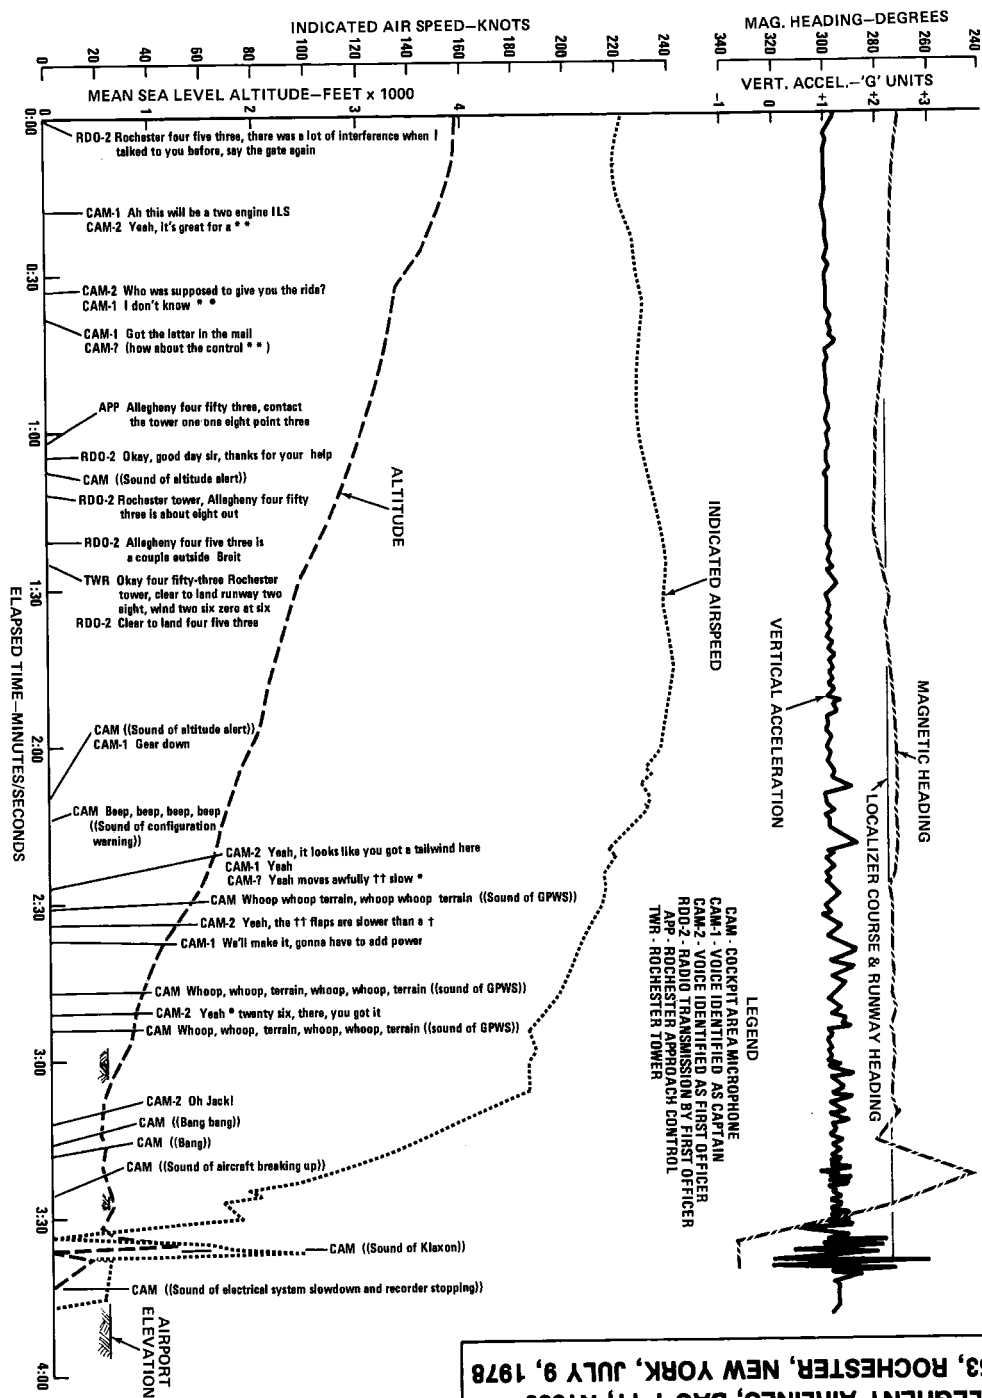
NATIONAL TRANSPORTATION SAFETY BOARD
WASHINGTON, D.C.
PLOT OF FLIGHT DATA AND
COCKPIT VOICE RECORDER DATA
ALLEGHENY AIRLINES, BAC 1-11, N1550
FLT. 453, ROCHESTER, NEW YORK, JULY 9, 1978

10. The captain applied brakes before the main landing gear was on the runway.
11. The captain's decision to land was improper and causal.
12. The right main landing gear contacted the runway 3,010 ft from the landing threshold at 159 kn and the left main landing gear initially contacted the runway about 3,800 ft from the threshold at 140 kn.
