AVIATION INVESTIGATION REPORT

A16A0032

Collision with terrain

Mitsubishi MU-2B-60, N246W

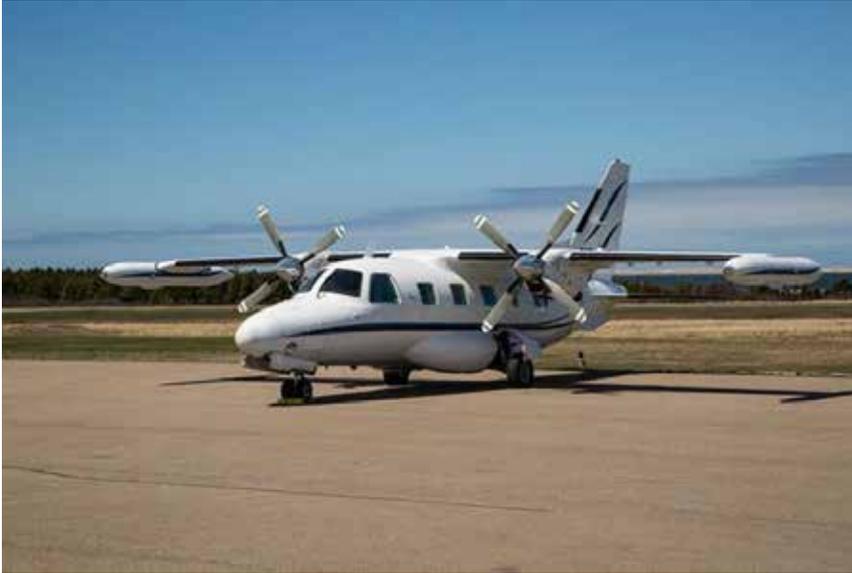
Figure 3. The occurrence aircraft (Source: Daniel Villeneuve)

The MU-2B-60 is a high-performance, twin-engine, turbo-prop aircraft certified for single-pilot operations (Figure 3).¹⁷ It is a high-wing aircraft with a pressurized cabin, retractable tricycle landing gear, and counterclockwise-rotating propellers. The aircraft has a spoiler¹⁸ system instead of ailerons¹⁹ for roll control, which allows for a full span-wing flap.

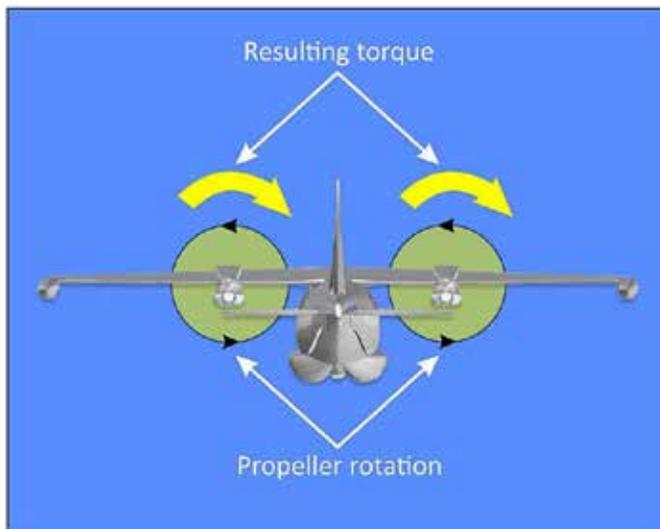
Figure 5. Effect of propeller torque

Propeller torque causes the aircraft to roll on its longitudinal axis in the direction opposite to propeller rotation (Figure 5). Propeller torque is typically counteracted by the pilot moving or trimming the ailerons or spoilers. For example, to counter the aircraft rolling to the right, the pilot must apply the left spoiler. This correction induces adverse yaw, which is corrected by moving or trimming the rudder.

When there is a sudden increase in power, such as when a pilot advances the power levers quickly, there is also a sudden increase in torque. This situation can be critical when landing because the aircraft is at a relatively low speed. When the speed of the air passing over the wings and vertical stabilizer is low, the control surfaces are much less effective and may not be able to counteract the torque.⁵⁰ This condition can be exacerbated in multi-engine aircraft.
