Final Report on aircraft accident

Case no: **2015-075-F-021**

Date: **9. August 2015**

Description: **Aircraft crashed in a narrow valley with a low cloud base, while attempting to turn around**

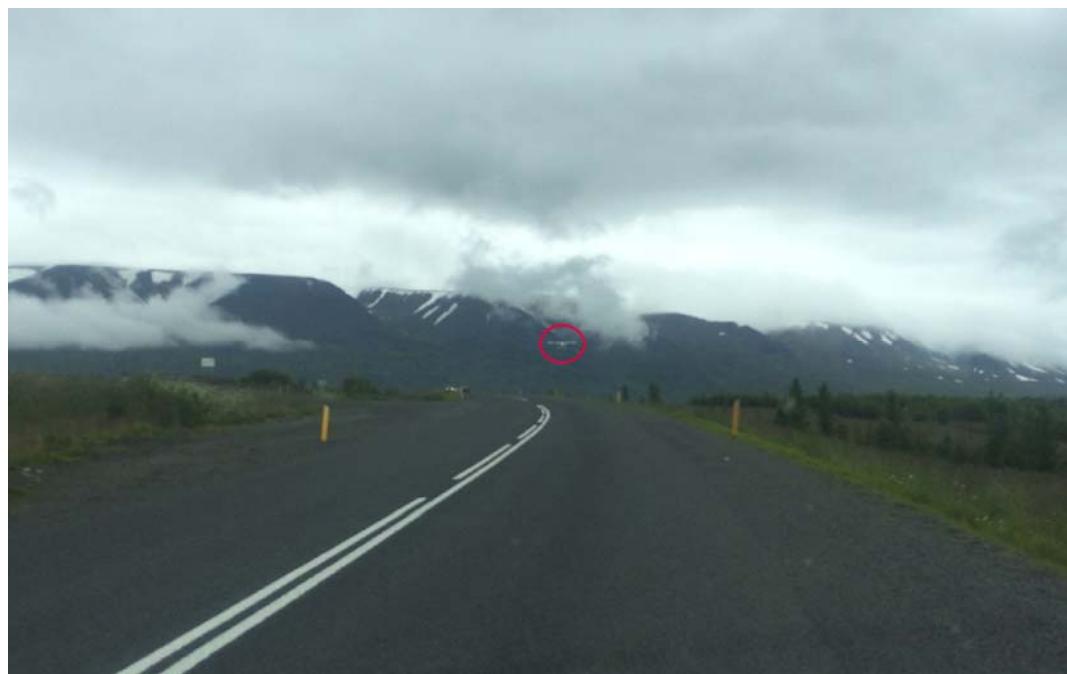
Figure 2: Airplane N610LC (in red circle) passed over Route 1 in Þelamörk

During the investigation the ITSB noted that the witness reports and pictures taken of the airplane during the flight indicated that the airplane was flying at low altitude. This could partially be explained by the low cloud cover over Tröllaskagi. It did however catch the ITSB's attention that witnesses reported the airplane flying at an unusually low altitude over Þelamörk. Figure 2 was therefore analyzed using photogrammetry. According to the analysis, the airplane in the red circle on Figure 2 was calculated to be at an altitude of about 475 feet MSL.

The location of airplane N610LC in Figure 2 is approximately 6.8 miles away from the end of RWY 01 at Akureyri Airport. The ITSB estimated that it would take the airplane about 6 minutes to cover that distance after takeoff, both based on calculations and the fact that the PF communicated with Akureyri Airport ATCO 6 minutes after takeoff and reported being over Þelamörk.

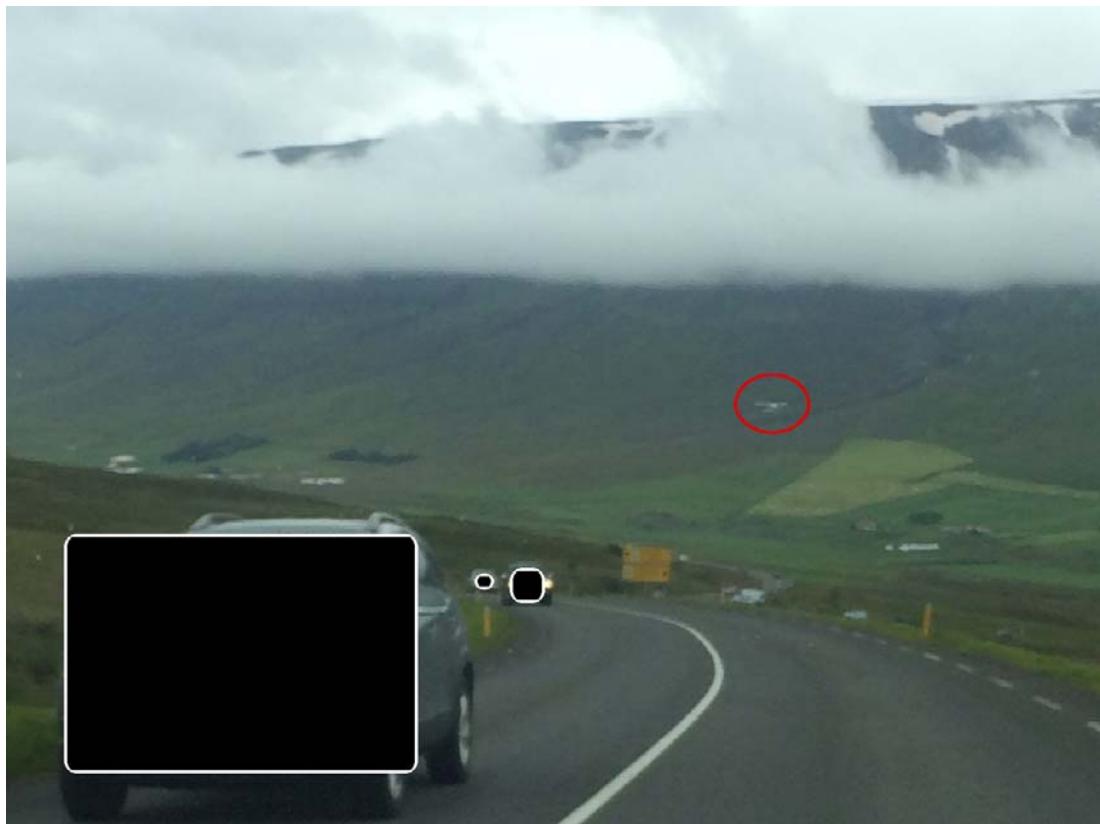
Figure 3: Airplane N610LC (in red circle) in Þelamörk over the junction between Route 1 and Route 82

As can be seen on Figure 3, there were clouds present at a lower altitude than the mountain tops in the mouth of the valley of Hörgárdalur on the way towards the valley of Öxnadalur. According to witnesses' statements, this cloud cover got thicker towards the head of the valley of Öxnadalur and the head of the valley of Hörgárdalur. According to the pilot flying, the plan was to fly into the valley of Öxnadalur to see if there was a break in the cloud cover at the valley head [Item 5 on Figure 1], where they could fly over the heath/ridge of Öxnadalsheiði⁷ and then towards Keflavik Airport.

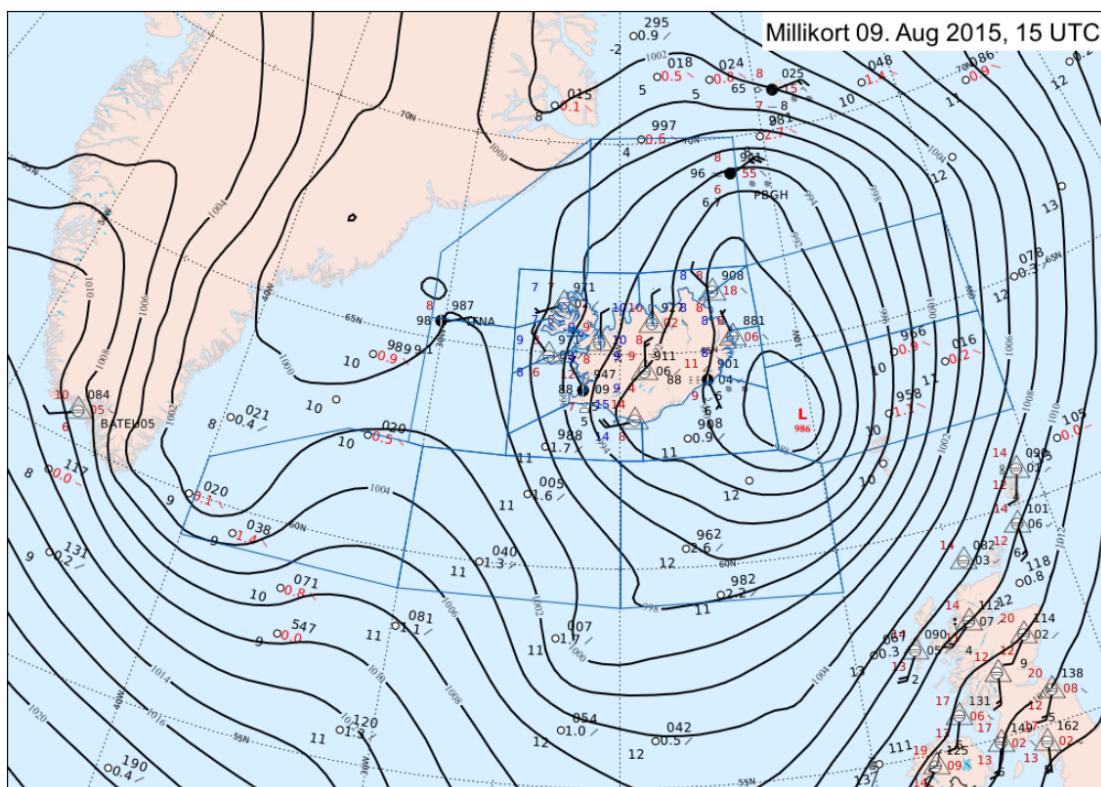
Figure 10: Low pressure area over Iceland on August 9th 2015 at 15:00 UTC [time of accident 14:45]

According to the PF, he checked the weather on the Icelandic Meteorological Office (IMO) website before the flight. He was aware of low cloud ceiling in the northern part of Iceland, but believed the visibility to be good below the mountains tops. He also noted that the weather at Keflavik Airport and in the southwestern part of Iceland was good. The plan was to fly into the valley of Öxnadalur and see if there was a break in the cloud cover at the valley head, where they could fly over the heath/ridge of Öxnadalsheiði and then towards Keflavik Airport. The plan was to stay in the Keflavik area overnight and then to continue the journey to Greenland early in the morning the day after (August 10th). Figure 10 shows that a low pressure area was moving over Iceland during the flight from Akureyri.

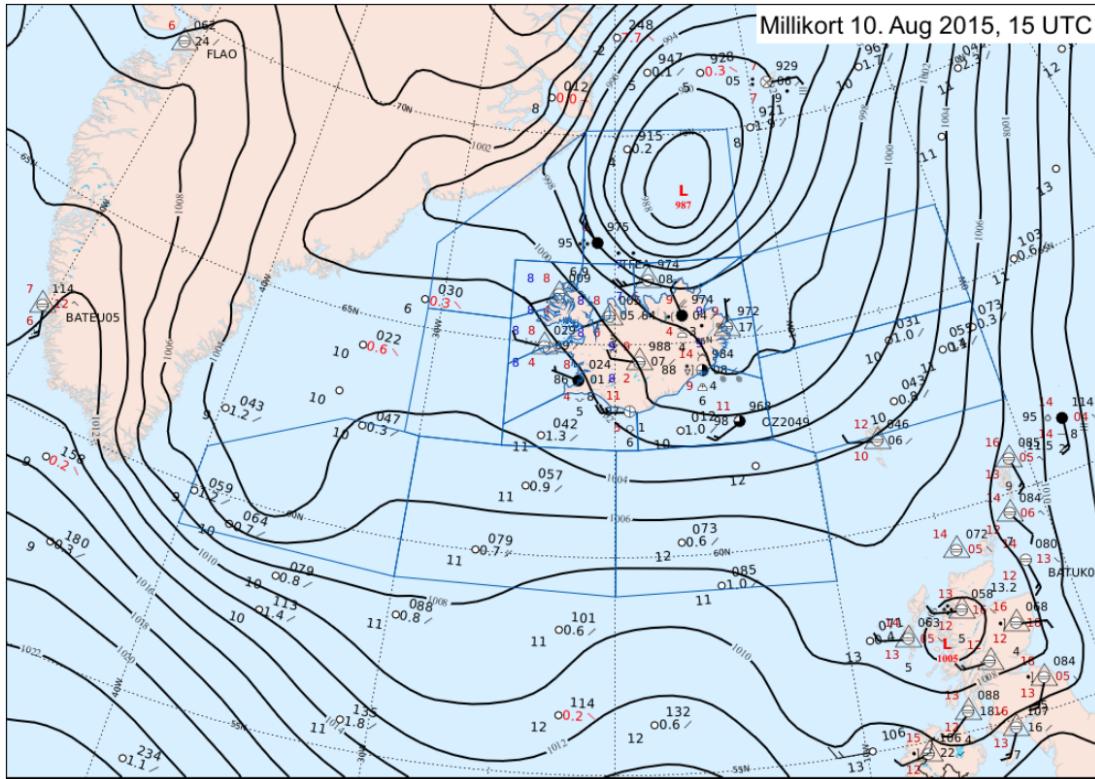
Figure 11: Low pressure area has moved north of Iceland on August 10th 2015 at 15:00 UTC

According to Figure 11, the low pressure area had passed when they planned to fly to Greenland the day after.

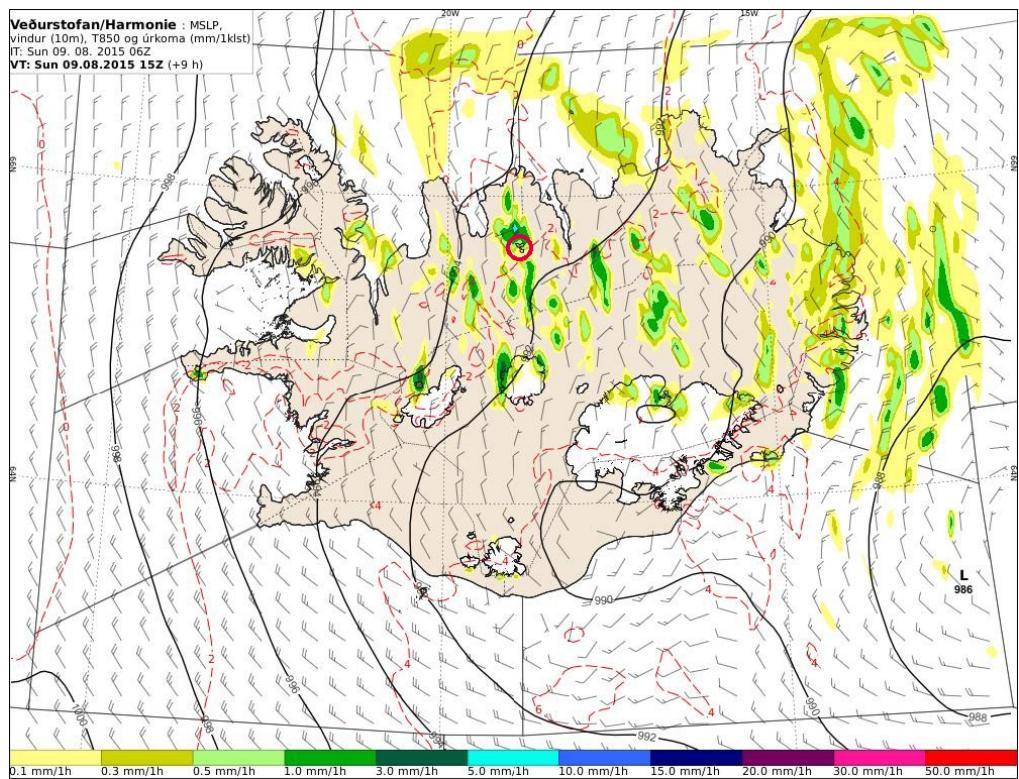
Figure 12: Wind and rain over Iceland at 15:00 on the day of the accident (red circle indicates Barkárdalur)

The IMO also compiled an HARMONIE high resolution weather model, which gave a good indication of the wind and the weather in the area at 15:00 at the day of the accident. According to the model, in Eyjafjörður and on Tröllaskagi, there was slow breeze from northerly direction, rain and mild weather. See Figure 12.

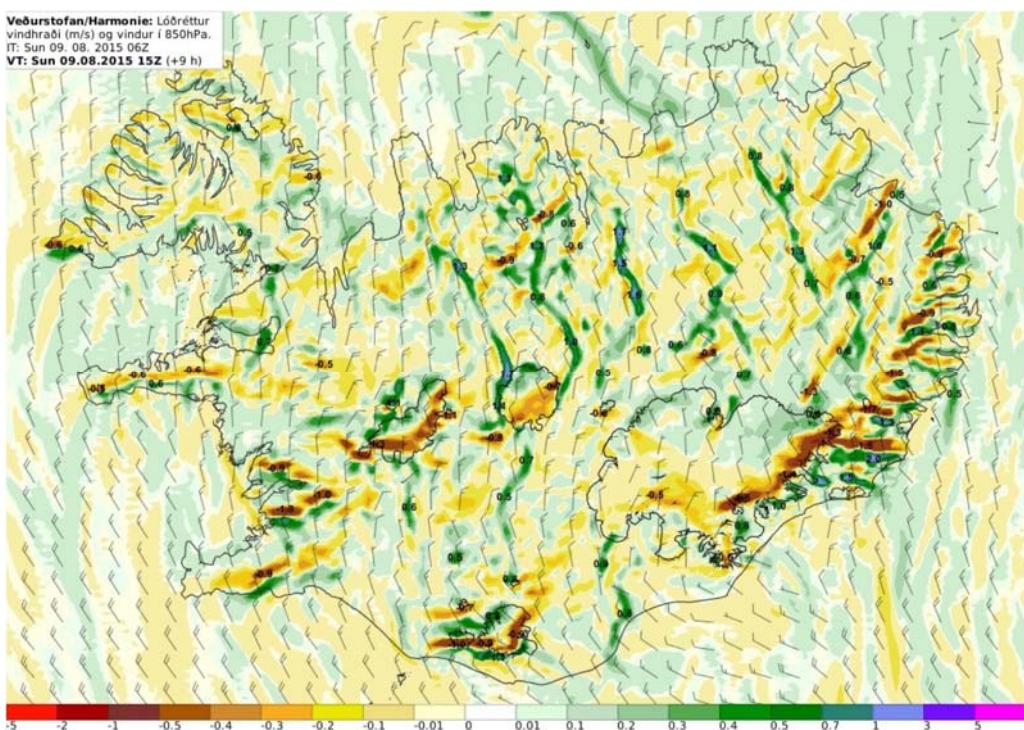
Figure 13: Mountain waves over Iceland at 15:00 on the day of the accident

The HARMONIE model from the Icelandic Meteorology Office also indicated minor mountain waves on Tröllaskagi, in the area of the valley of Hörgárdalur and also in the valley of Barkárdalur. According to the data, a minor downdraft of 0.8 m/s, or 157 fpm, was estimated in the valley of Barkárdalur. See Figure 13.

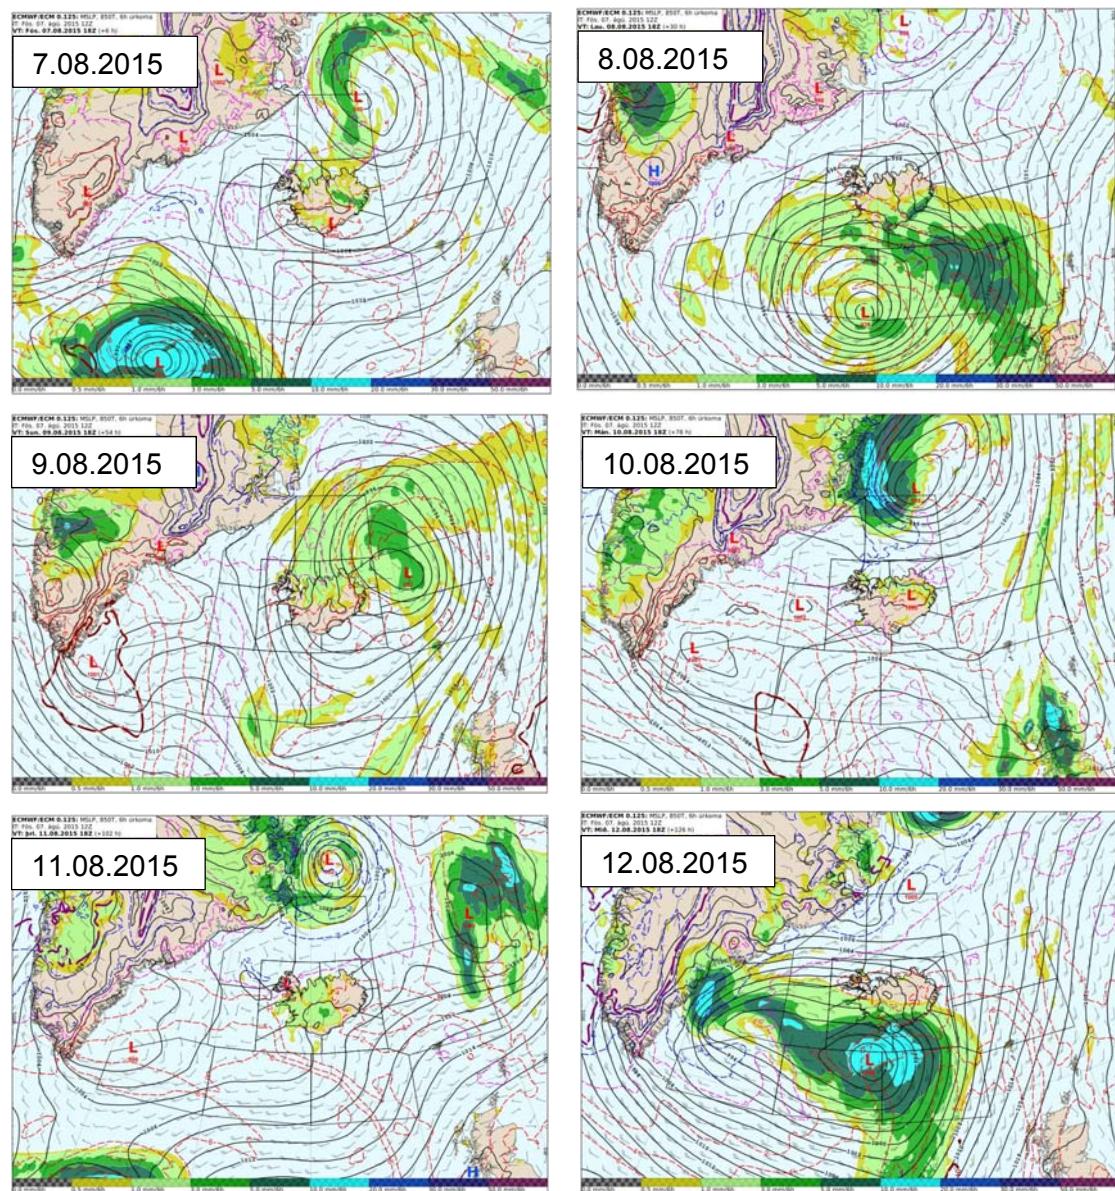
Figure 16: Weather forecast from 12:00 on August 7th 2015, for 18:00 on August 7th – 12th

The investigation revealed that on August 7th the flight crew was committed to fly out of Keflavik Airport early on August 10th, due to the weather forecast, and planned to arrive in Minneapolis/St Paul (United States) on August 13th. The weather forecast from 12:00 on August 7th valid at 18:00 on August 7th – 12th can be seen in Figure 16. At this time the weather forecast on the route between Akureyri Airport and Keflavik Airport did not support VFR flight until August 10th.

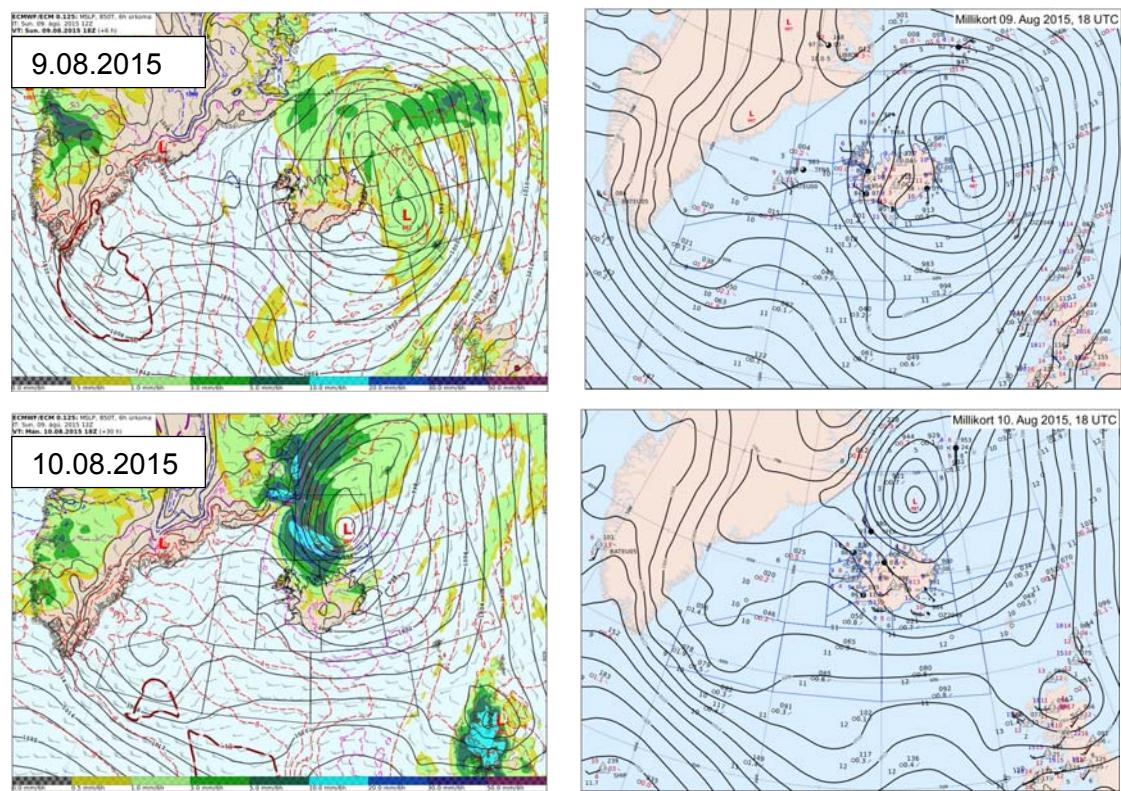
Figure 17: Weather in between and over Iceland and Greenland (forecast from 12:00 on August 9th 2015 valid at 18:00 on August 9th – 14th on left side and SYNOP observations on right side)

According to the weather forecast prior to the departure on August 9th for the following days, low pressure areas were forecasted on the flight route between Iceland and Greenland in all periods between August 10th and August 16, except on August 10th. The best “window” for visual flight between Iceland and Greenland therefore existed on August 10th. Prior to departure on August 9th, the weather forecast on the route between Akureyri Airport and Keflavik Airport did not support VFR flight until August 11th. Figure 17 shows the weather forecast from 12:00 on August 9th valid at 18:00 on August 9th – 14th on the left side and the actual SYNOP weather observations on the right side.

The ITSB believes that this may have placed pressure on the pilots to fly to Keflavik Airport on August 9th, regardless of the poor weather conditions for VFR flight during that flight leg.
