NATIONAL TRANSPORTATION SAFETY BOARD

AIRCRAFT ACCIDENT REPORT

REDCOAT AIR CARGO, LTD.
BRISTOL BRITANNIA 253F, REGISTRATION G-BRAC
BILLERICA, MASSACHUSETTS
FEBRUARY 16, 1980

NTSB-AAR-81-3

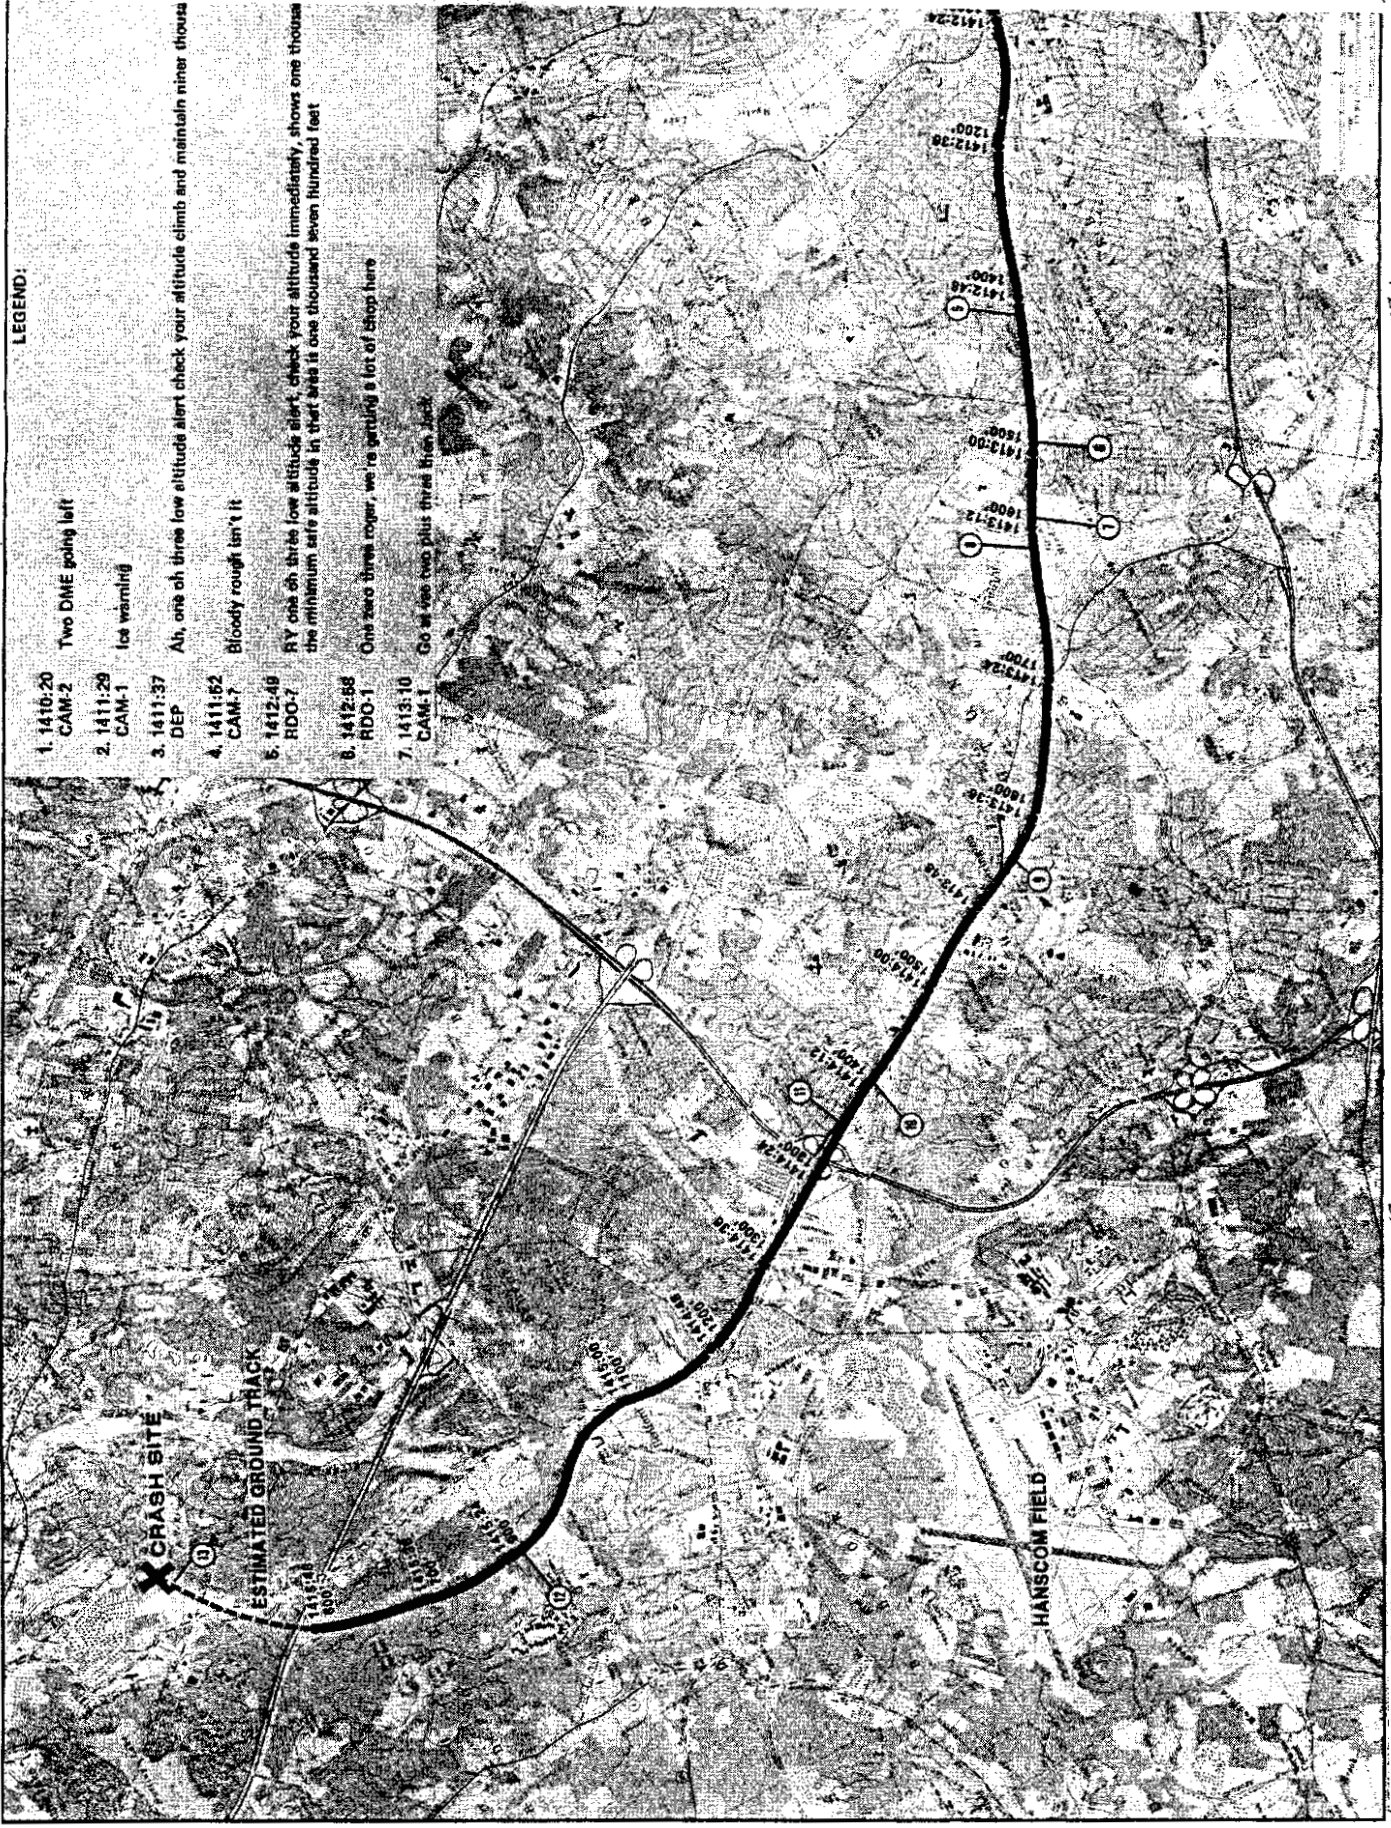
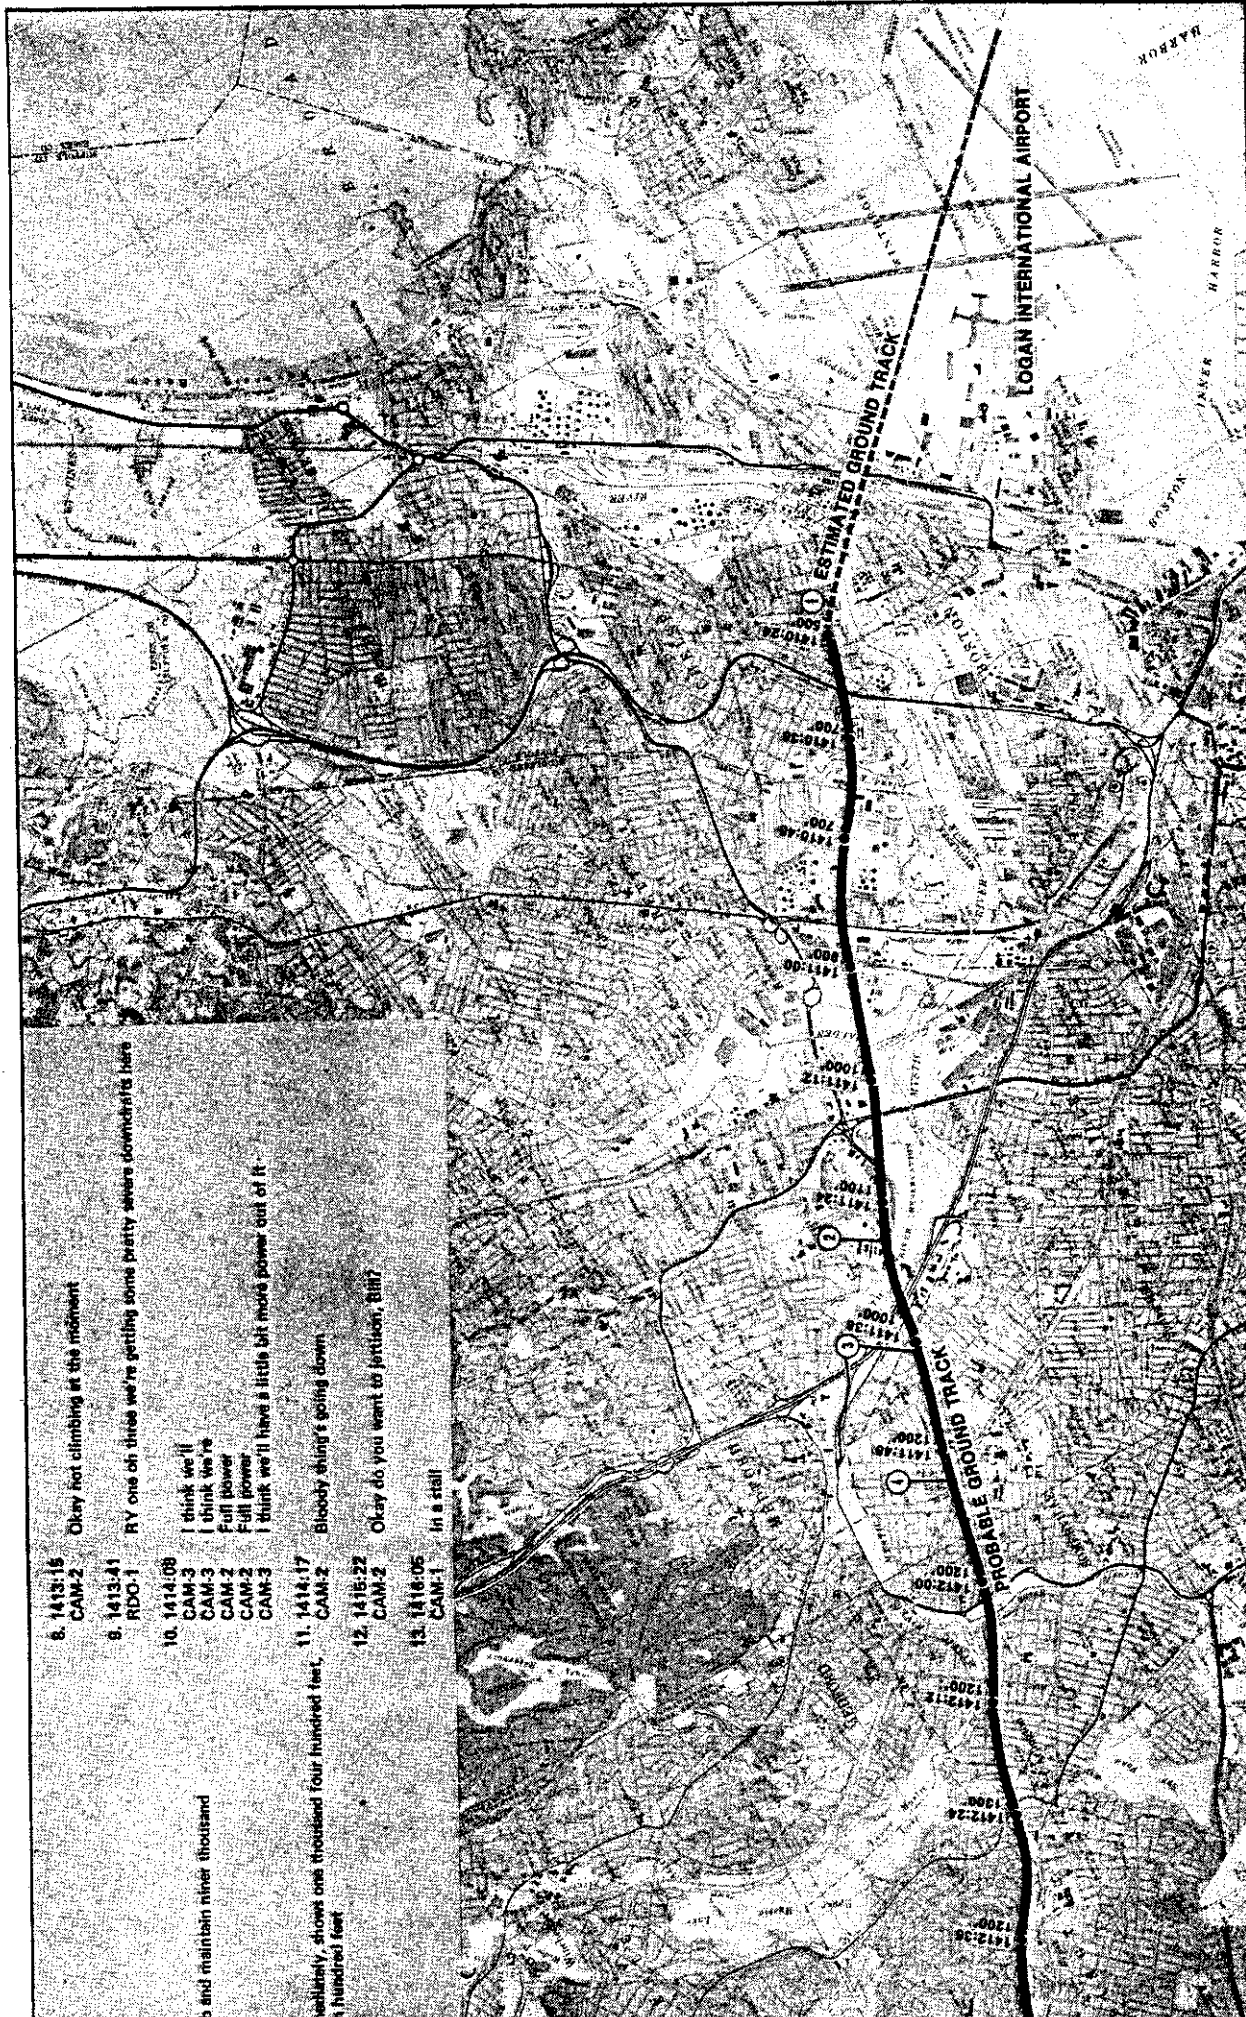
APPENDIX F
PROBABLE AND ESTIMATED GROUND TRACKS
 (AS DERIVED FROM NAS STAGE A DATA AT BOSTON ARTCC)

- 1. 1410:20
CAM-2
Two DME going left
- 2. 1411:20
CAM-1
Ice warning
- 3. 1411:37
DEP
Ah, one oh three low altitude alert check your altitude climb and maintain nine thousand
- 4. 1411:52
CAM-7
Bloody rough isn't it
- 5. 1412:46
RDO-7
RY one oh three low altitude alert, check your altitude immediately, shows one thousand the minimum safe altitude in that area it one thousand seven hundred feet
- 6. 1412:56
RDO-1
One zero three roger, we're getting a lot of chop here
- 7. 1413:10
CAM-1
Go we see two plus three then Jack

- 8. 1413:15
CAM-2 Okay hot climbing at the moment
- 9. 1413:41
RDO-1 RY one oh three we're getting some pretty severe downbursts here
- 10. 1414:08
CAM-3 I think we'll
CAM-3 I think we're
CAM-2 Full power
CAM-2 I think we'll have a little bit more power out of it
CAM-3
- 11. 1414:17
CAM-2 Bloody thing's going down
- 12. 1415:22
CAM-2 Okay do you want to jettison, Bill?
- 13. 1416:05
CAM-1 In a stall
