NATIONAL TRANSPORTATION SAFETY BOARD

AIRCRAFT ACCIDENT REPORT

**GEORGIA-PACIFIC CORPORATION
CESSNA 500 CITATION, N501GP
MERCER COUNTY AIRPORT
BLUEFIELD, WEST VIRGINIA
JANUARY 21, 1981**

NTSB-AAR-81-9

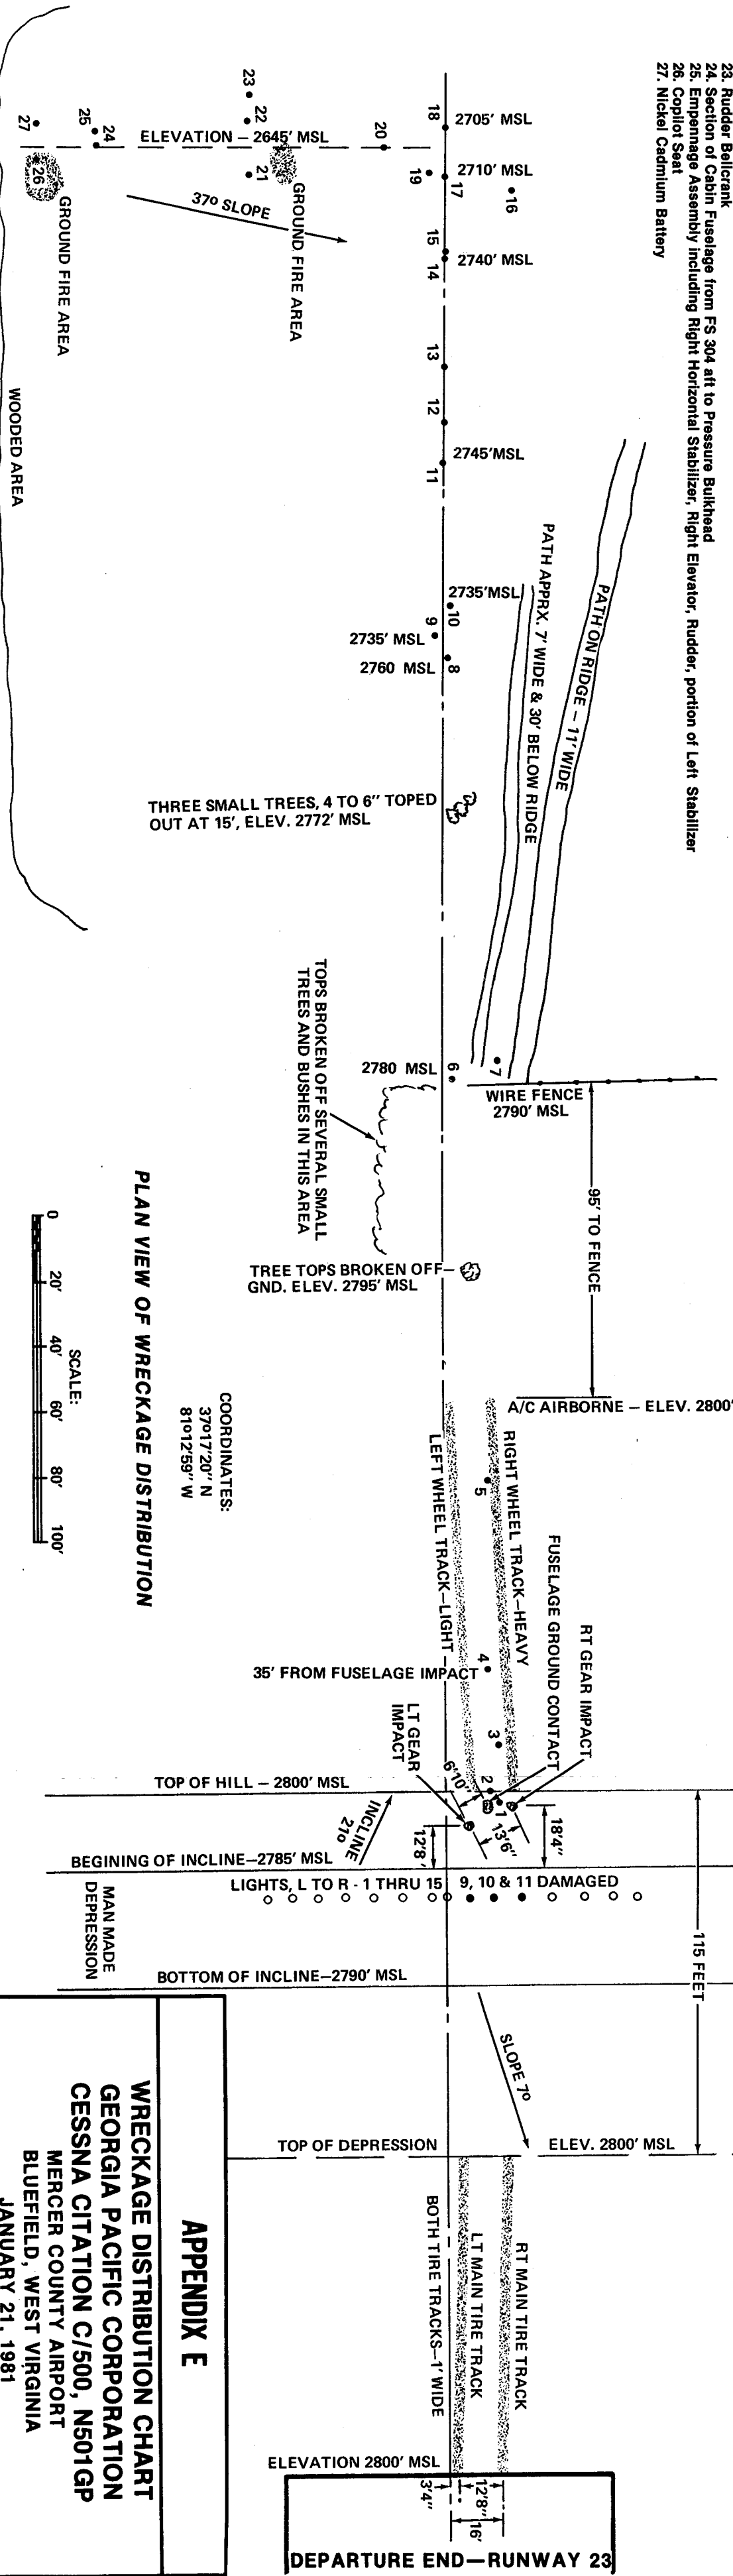
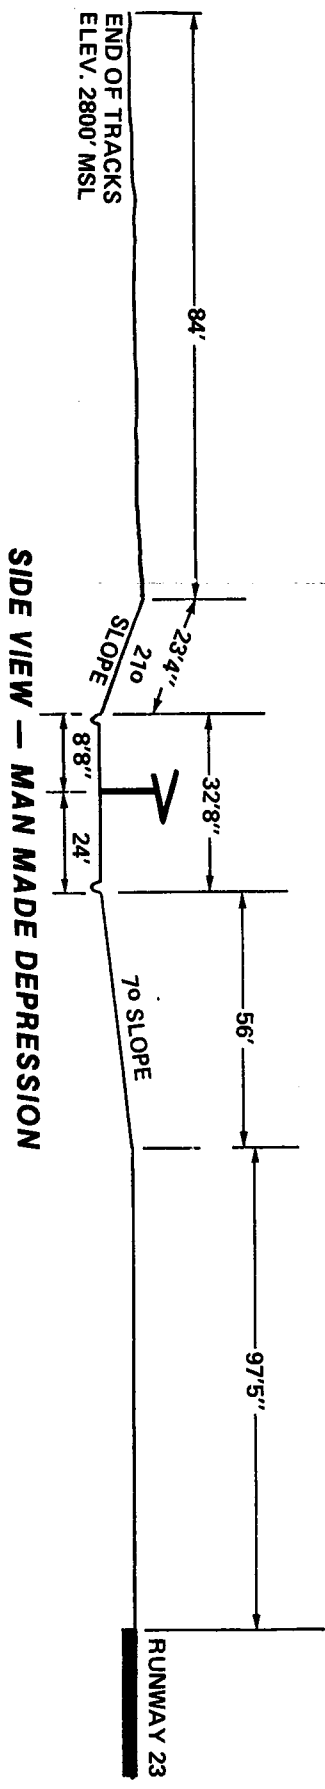
APPENDIX E

WRECKAGE DISTRIBUTION CHART
GEORGIA PACIFIC CORPORATION
CESSNA CITATION C/500, N501GP
MERCER COUNTY AIRPORT
BLUEFIELD, WEST VIRGINIA
JANUARY 21, 1981
