Air Accident Investigation Unit Ireland

FORMAL REPORT

**Cessna 208B, G-KNYS
Near Clonbullogue, Co. Offaly**

13 May 2018

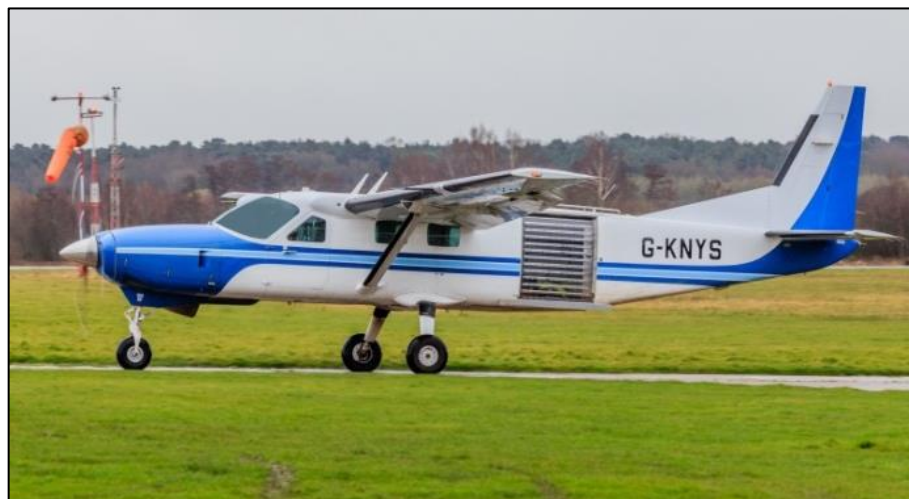
The Cessna 208B aircraft (**Photo No. 1**) took off from Runway (RWY) 27 at EICL at approximately 13.14 hrs. The occupants on board were the Pilot, who was seated in the left-hand cockpit seat, a Passenger (a child), who was seated in the right-hand cockpit seat, and 16 skydivers, who occupied two bench seats in the main cabin.

Photo No. 1: G-KNYS - Cessna 208B Grand Caravan (*David Reeves*)

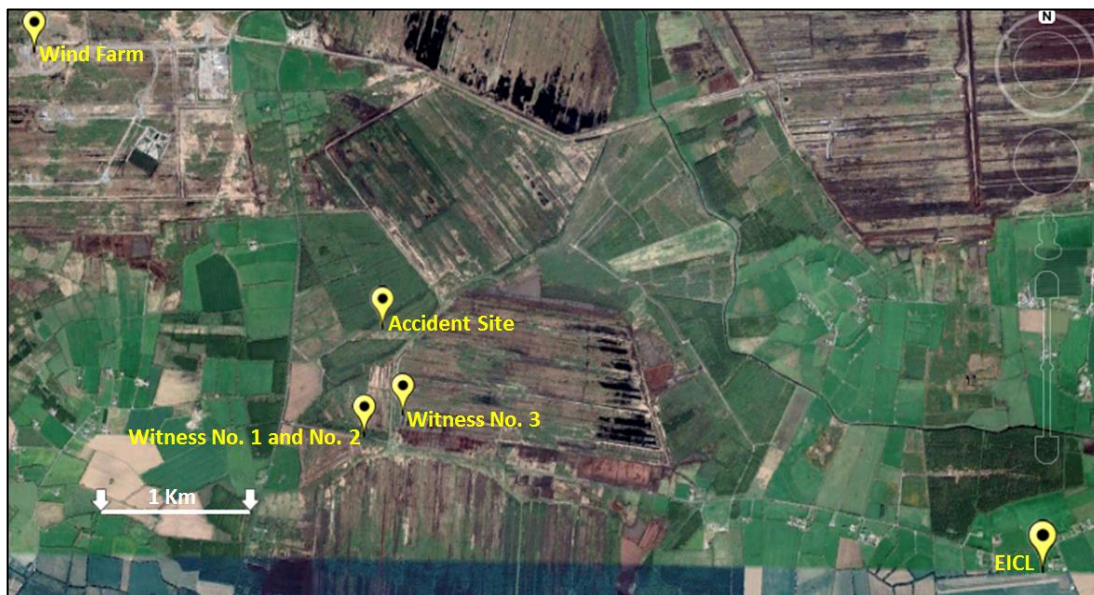
The Investigation interviewed three witnesses who were located close to the accident site at the time of the accident. Two witnesses (Witness No. 1 and Witness No. 2) were situated approximately 750 metres (m) to the south of the accident site (**Figure No. 1**). Witness No. 1 described hearing the aircraft pass overhead, before seeing it flying 'sideways' and that it was 'low down'. Witness No. 2 noted that a wing was 'sticking up'. Witness No. 1 indicated that the aircraft was on its left side and that it was travelling approximately northwards at the time (i.e. towards the area of the accident site). Witness No. 1 said that he and Witness No. 2 looked away momentarily and when they looked back, the aircraft was gone. He said that as he moved away from where they were standing, he met another person (Witness No. 3) who said that 'the plane's gone down'. Witness No. 2 then assisted Witness No. 3 with contacting the emergency services.

Figure No. 1: Location of witnesses relative to the accident site (*Google Earth*)

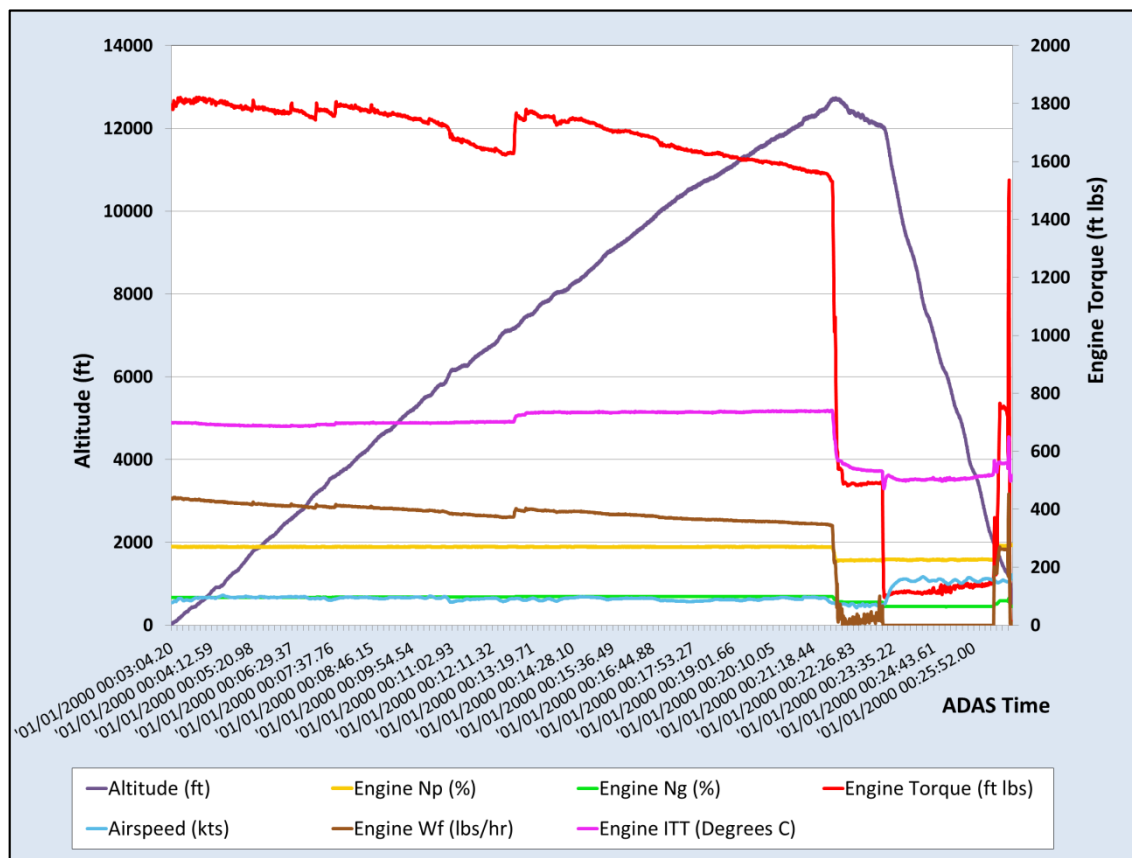
The engine and propeller parameters (fuel flow (Wf), Inter-Turbine Temperature (ITT) engine speed (Ng), torque, propeller speed (Np)), and the aircraft's altitude and airspeed from take-off until the end of the recording, with reference to the ADAS '*Time Actual*' are shown in graphical form in **Figure No. 3**.

Figure No. 3: ADAS data extract from take-off until end of recording

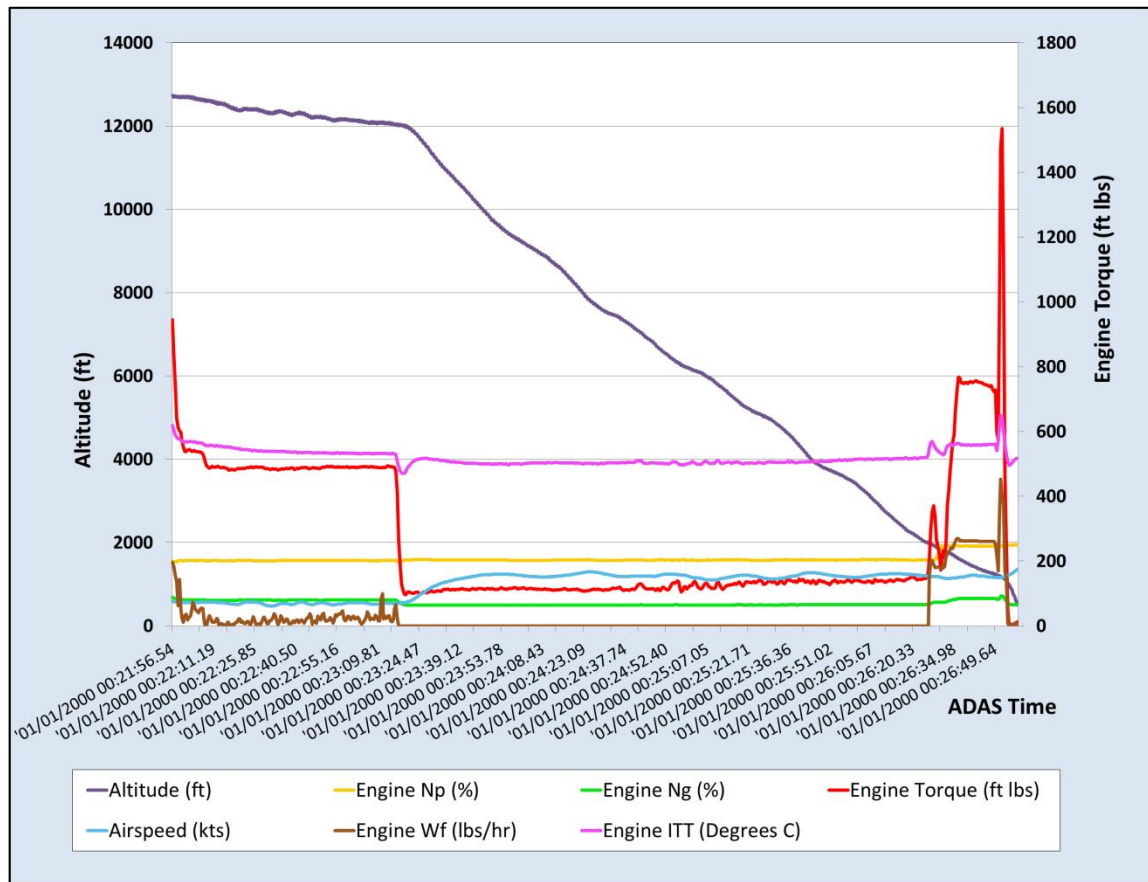
An extract of the parameters recorded during the descent phase of flight is shown in graphical form in **Figure No. 8**.

Figure No. 8: ADAS data extract from descent phase until end of recording

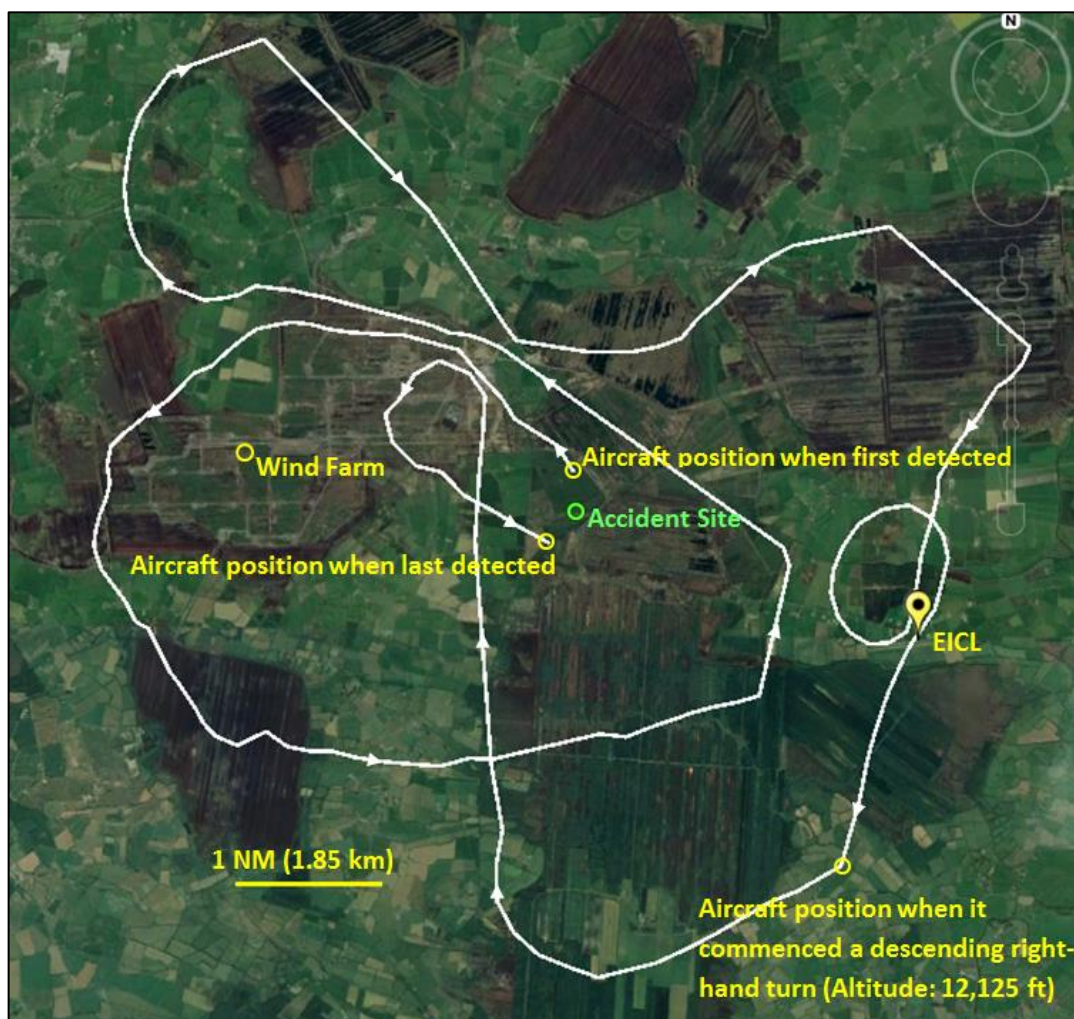
The flight path of the accident flight, as extracted from the combined radar data, is shown by the white line in **Figure No. 9**. ATC Radar first detected the aircraft just after 13.15 hrs, as it climbed to the north-west after take-off from EICL. The combined radar data indicates that the aircraft was at approximately 1,275 ft at this stage. The data indicates that the aircraft performed a series of turns while climbing until it reached overhead EICL, where it performed an orbital turn to the right while continuing to climb. The combined radar data indicates that the maximum altitude reached was 12,975 ft at time 13:32:37, when the aircraft was approximately 0.15 NM (0.28 km) north of the threshold of RWY 27 at EICL.

Figure No. 9: Aircraft track extracted from radar data (adapted from *Google Earth*)

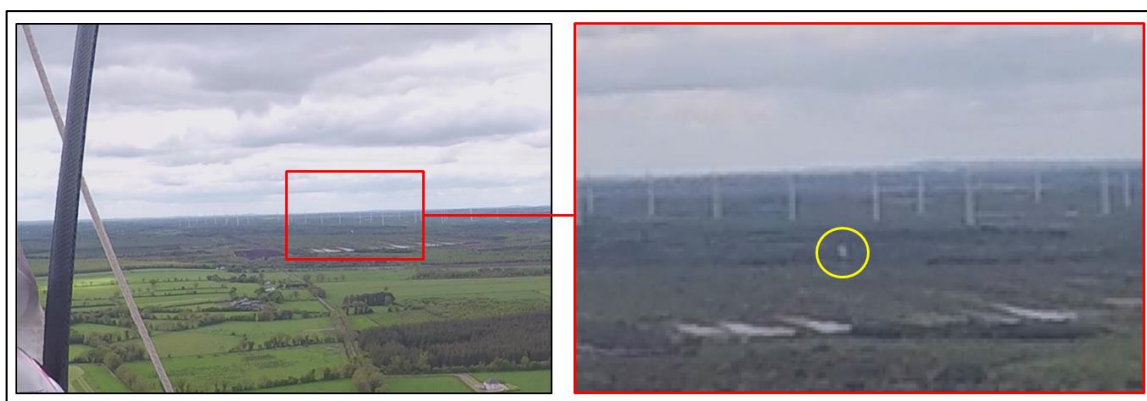
As the skydiver descended from the south, along a line approximately perpendicular to the runway, the skydiver's camera mainly pointed towards the landing zone at EICL. Approximately three minutes and 48 seconds after the skydiver exited the aircraft, which was approximately 30 seconds before the skydiver landed, the camera briefly pointed towards the north-west. At this time, the video recorded what appeared to be the aircraft for less than one second, as it descended into a line of trees in the distance at a location consistent with the accident location. The skydiver only became aware of this content some days after the accident and immediately contacted the Investigation. A still image extracted from this video is shown in **Figure No. 10**.

Figure No. 10: Still image (left) as extracted from Skydiver's video. The right-hand image was zoomed from this still image with what appears to be the aircraft circled in yellow

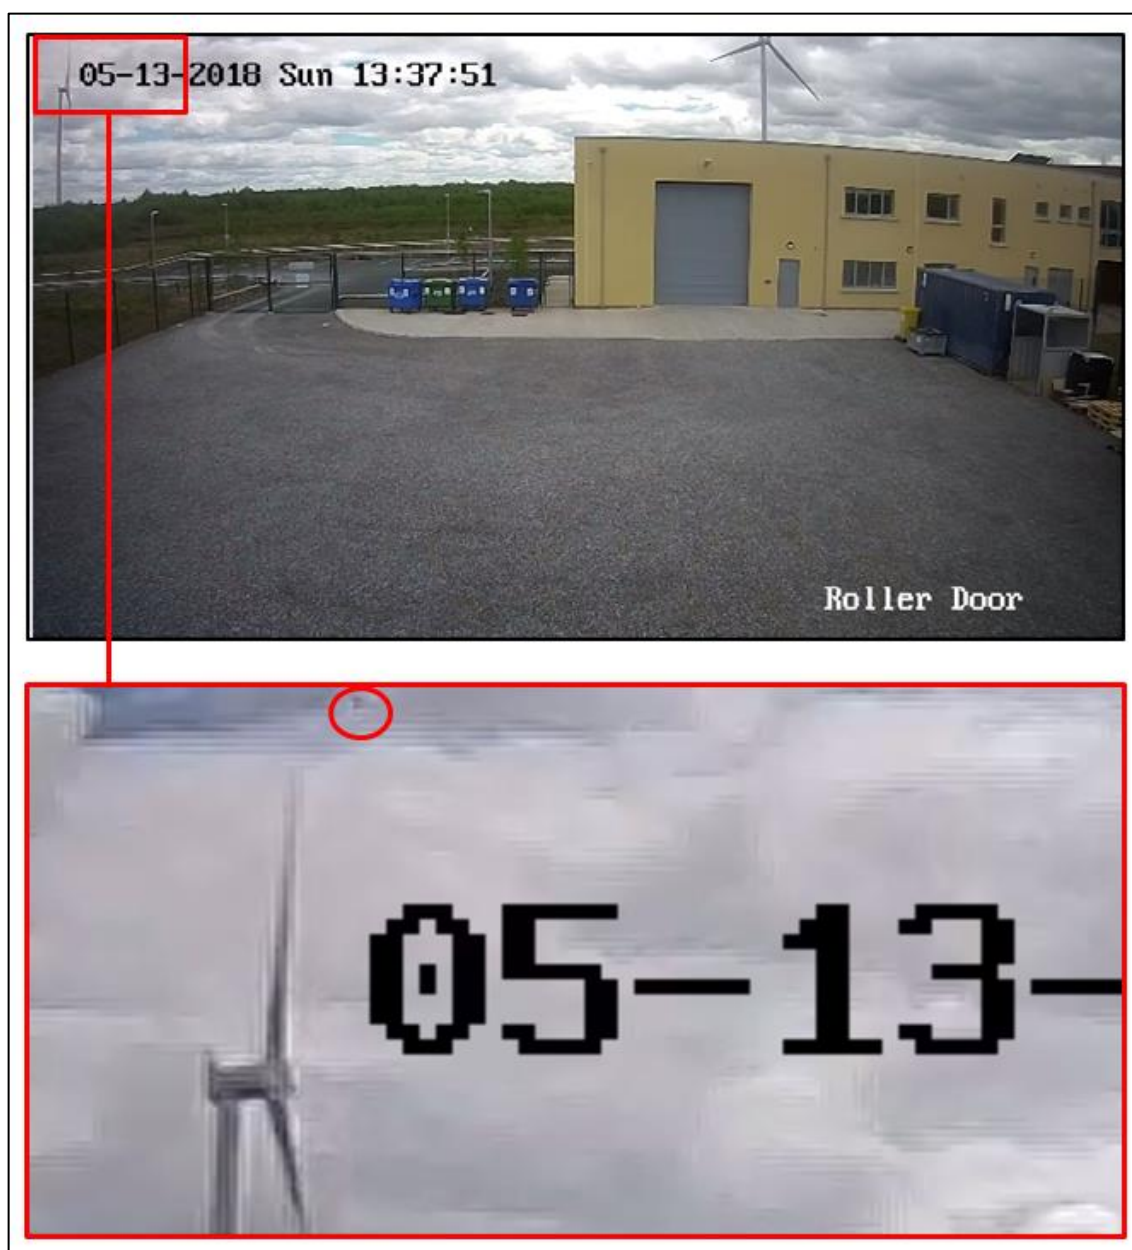
The CCTV system at the wind farm was similarly configured; however, two of the system's (fixed) cameras, which were pointing approximately to the south-east of the wind farm, showed the aircraft in flight. One of these cameras was located at the maintenance and administration buildings within the wind farm complex, and was pointing towards another building. The upper image in **Figure No. 12** shows the field of view of this camera, the upper third of which is of the sky. The lower image in the figure shows the upper left-hand section of the camera's field of view in greater magnification. The aircraft (circled in red) was visible in this section for approximately five seconds, travelling diagonally from the upper edge of the field of view towards its left-hand edge. The video did not contain sufficient detail to permit further analysis. **Note:** It was subsequently established that the camera system's clock was not displaying the correct time.

Figure No. 12: Field of view of camera located within wind farm complex (upper image). The lower image shows upper left-hand corner magnified, with the aircraft circled in red

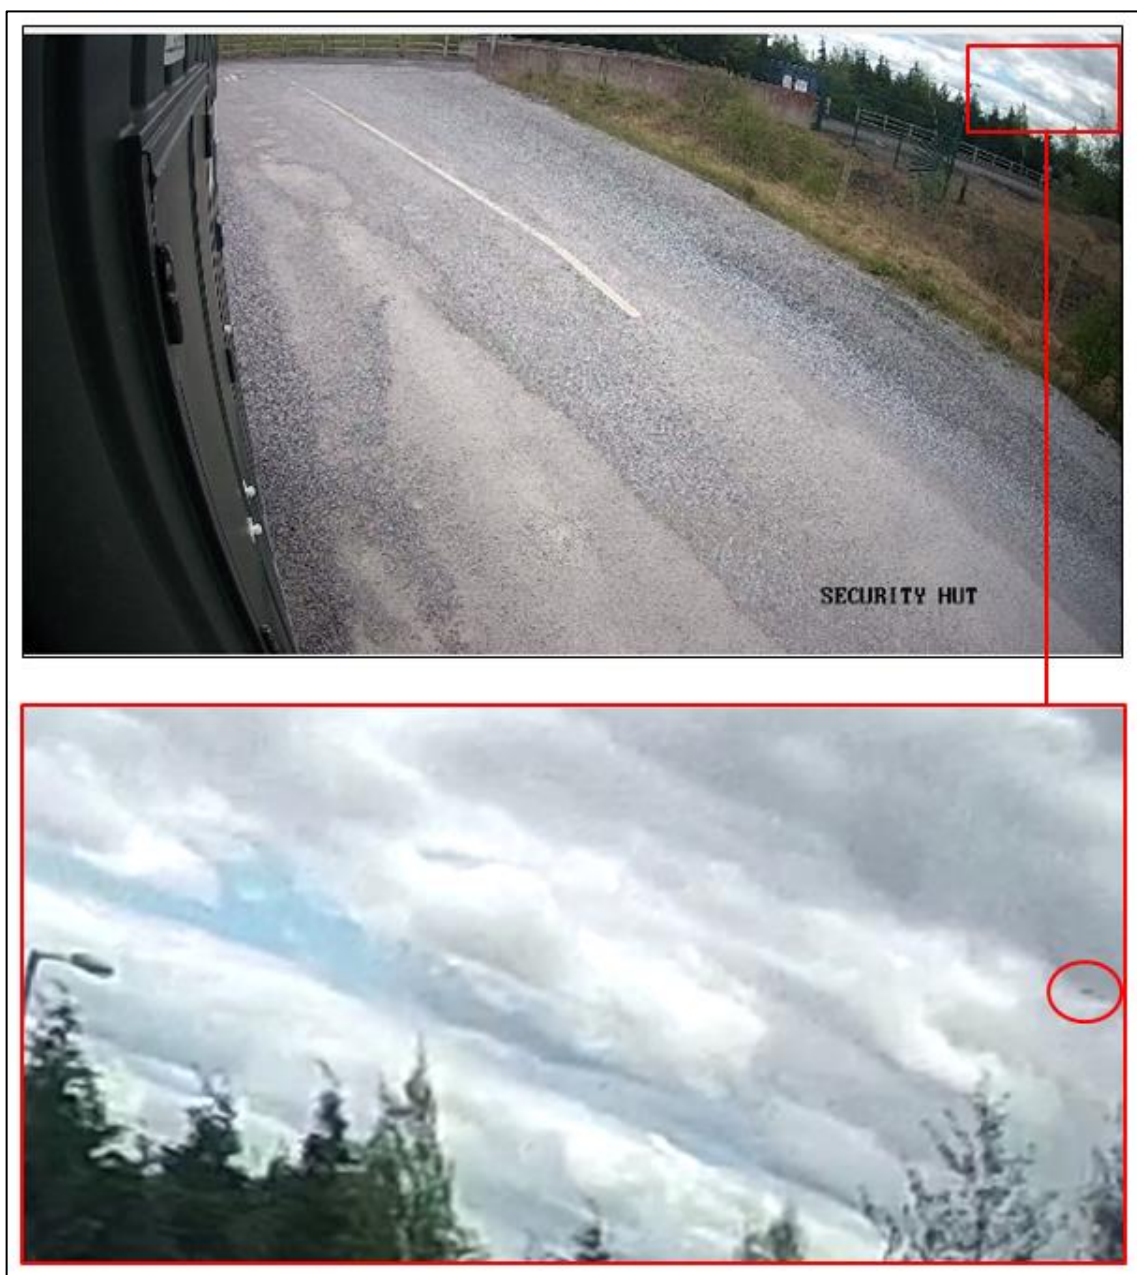
The other camera which recorded the aircraft was mounted on a security hut located just outside the wind farm complex. This camera was approximately 0.7 NM (1.3 km) to the north-east of the camera located within the complex and approximately 1.2 NM (2.2 km) north-west of the accident site. The upper image in **Figure No. 13** shows the field of view of this camera. The sky is visible in the upper right-hand corner; the lower image shows this section in greater magnification, just as the aircraft entered the camera's field of view. The aircraft (circled in red) was visible in this section for approximately 11 seconds. During the first 7.5 seconds approximately, the aircraft can be seen flying towards the upper edge of the field of view, following what appears to be a normal trajectory. In the final 3.5 seconds approximately, the aircraft can be seen rapidly losing altitude and travelling towards a line of trees in what appears to be a near-vertical (nose-down) attitude.

Figure No. 13: Field of view of camera located on security hut (upper image). The lower image shows upper right-hand corner magnified, with aircraft circled in red

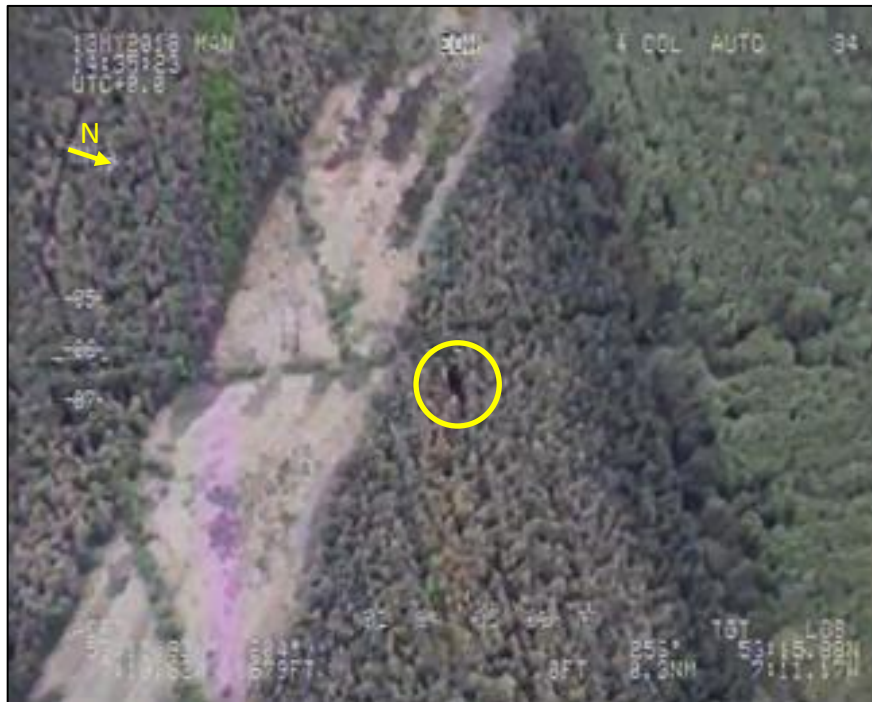
The accident site was compact. Only trees immediately adjacent to the aircraft wreckage were damaged. The compact nature of the site is apparent in video recorded from above the accident site by an Irish Coast Guard Search and Rescue helicopter, which was responding to the accident. A still image extracted from this video is shown in **Figure No. 15**. The accident site's height above sea level was approximately 230 ft.

Figure No. 15: Still image extracted from video recorded by a responding Search and Rescue helicopter. Accident site circled (*Irish Coast Guard*)

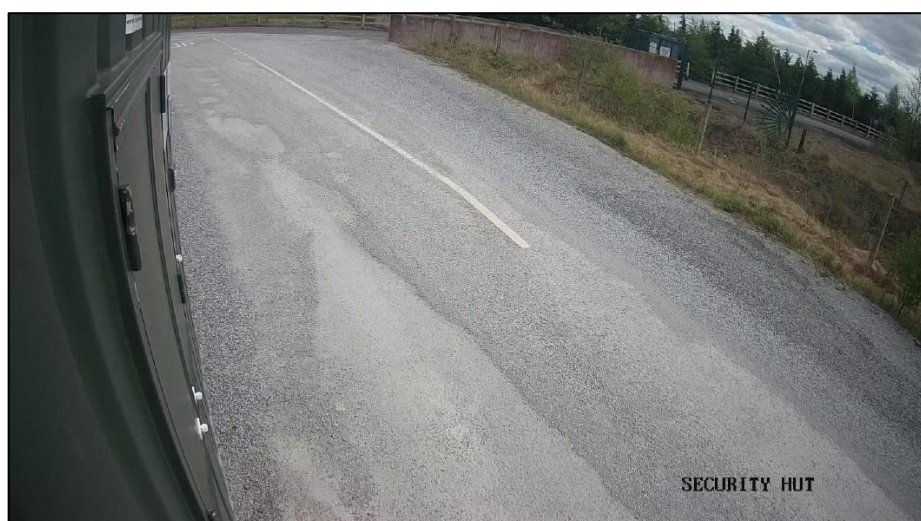
This camera's lens captured a wide field of view, which included the security hut itself and objects such as fences and roadways close to it, in addition to the sky in the distance (**Figure No. 18**). However, the wide angle lens resulted in severe '*barrel distortion*²²' that caused the fences and the edges of the security hut to appear curved. The distortion was greatest near the corners of the image; the aircraft was visible in the top right corner of the image. The distortion was removed mathematically before proceeding with further analysis.

Figure No. 18: Still image extracted from CCTV video from security hut camera

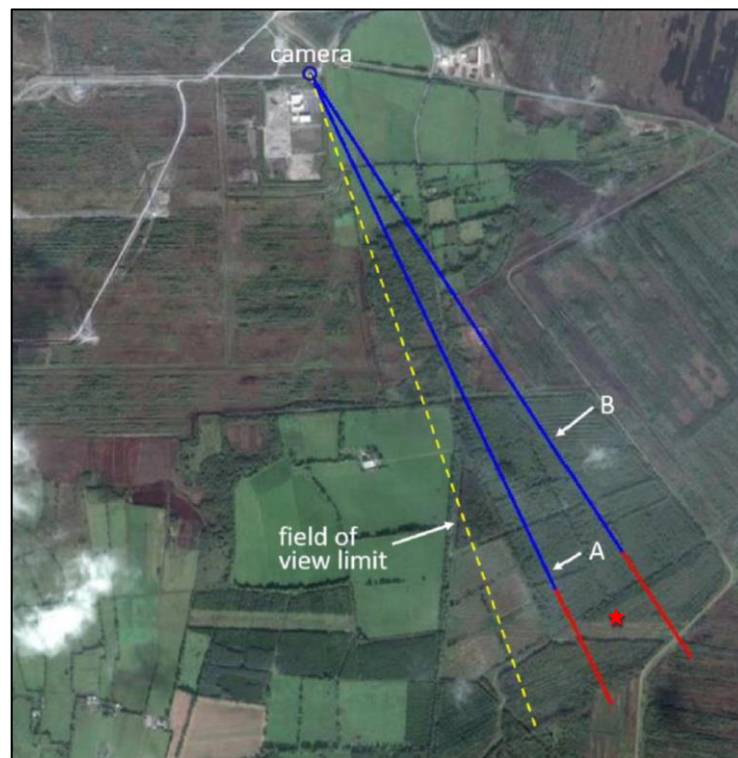
41 The report stated that there was a $\pm 10\%$ uncertainty on the estimated distance from the camera to the aircraft and also a $\pm 10\%$ uncertainty on the estimated heading and bank angle. The NTSB analysed the 11 seconds (approximately) of the recording that showed the aircraft, and identified six key frames for further analysis. The first 7.5 seconds (approximately) show the aircraft following what appears to be a normal trajectory. The analysis time was set to zero when the aircraft first became visible (dashed yellow line in **Figure No. 19**). The first frame analysed was recorded at time 3.3 seconds and before the wings of the aircraft became discernible. The direction from the camera at this point is shown in **Figure No. 19** by the blue line marked 'A'. The last analysed frame was recorded at time 10.8 seconds, when the aircraft was descending in what appeared to be a nose-down attitude just before it disappeared into a line of trees. The direction from the camera at this point is shown in **Figure No. 19** by the blue line marked 'B'.

The ends of the lines are coloured red to indicate the $\pm 10\%$ uncertainty range of the distances involved. The location of the accident site is indicated by a red star between the two red lines. According to the analysis, estimation of the angle of lines A and B was based on video frames after barrel distortion correction and had an estimated accuracy of $\pm 1^\circ$.

Figure No. 19: Satellite view showing directions from camera at time 3.3 seconds (Line A) and at time 10.8 seconds (Line B). Red star indicates the location of the accident site (NTSB)

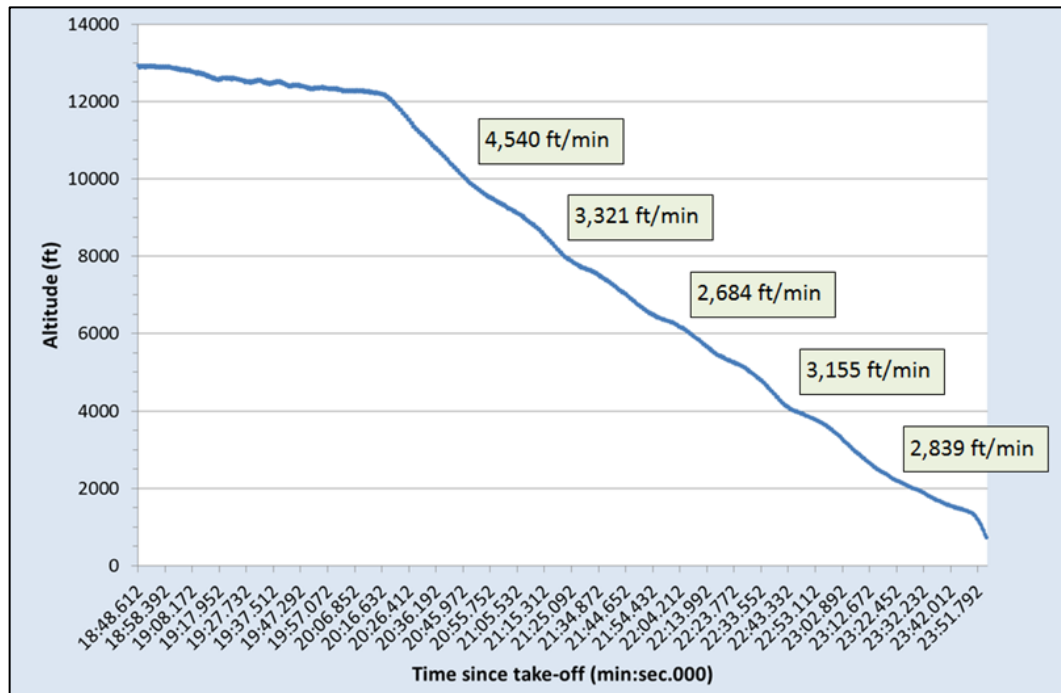
The overall descent rate from 12,000 ft to 2,000 ft was calculated as 3,196 ft/min. The airspeed recorded by the ADAS during this part of the descent was frequently above 155 kts (the aircraft's maximum operating speed with the cargo doors removed) and reached 166 kts at an altitude of approximately 7,900 ft (the degree of accuracy of the recorded airspeed is analysed in **Section 2.5.4**).

Figure No. 24: Altitude (adjusted) versus time. Overall descent rates also shown

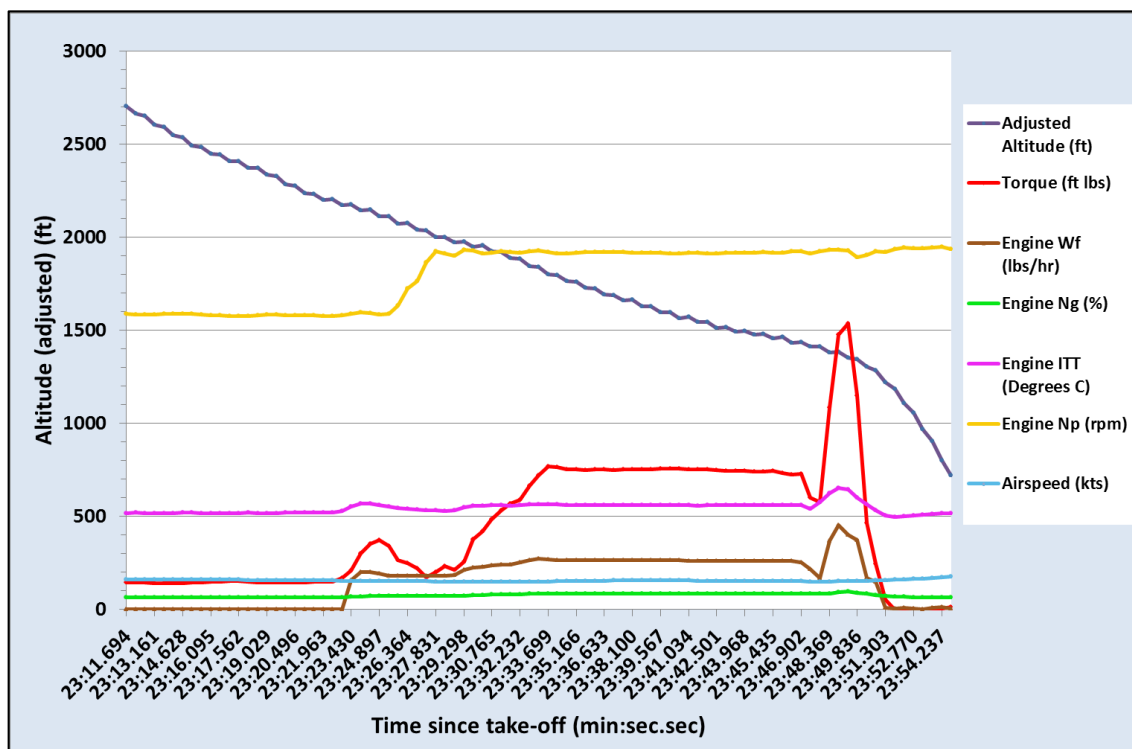
The engine parameters, airspeed and the (adjusted) altitude plotted against time for the final 2,500 ft of the aircraft's descent are shown in **Figure No. 25**. When the (adjusted) altitude reached 2,176 ft (elapsed time of 23:23.43), the fuel flow, having been at zero throughout the descent, increased. There was a corresponding increase in ITT, Ng, and engine torque. This was followed approximately three seconds later by an increase in Np, which continued to increase for the next two seconds. At an elapsed time of 23:27.34 (approximately 27 seconds from the end of the recording and at an adjusted altitude of 2,036 ft), the fuel flow and correspondingly, the ITT had reduced slightly. The torque had also reduced. The overall rate of descent in this period was 2,148 ft/min.

The fuel flow, ITT and Ng then reduced over the next 2.5 seconds approximately until an elapsed time of 23:51.30 was reached. The torque also reduced during this time. The (adjusted) altitude at the end of this period was 1,219 ft. The overall rate of descent from 1,437 ft (adjusted altitude) to 1,219 ft was 2,972 ft/min.

Figure No. 25: The final 2,500 ft of the aircraft's descent

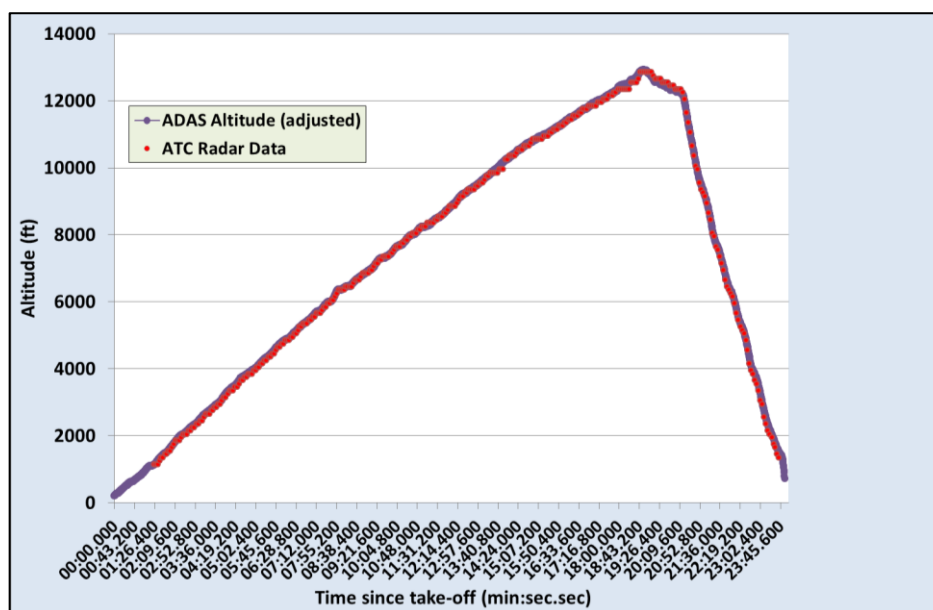
The altitude data from the Dublin-based radar head, as received by the Investigation, had not been corrected for the air pressure on the day. A 50 ft baro-correction was in use by ATC software systems that day. Therefore, the Investigation subtracted 50 ft from each Dublin-based radar head altitude value. The maximum altitude recorded by the Dublin-based radar head was 12,900 ft. The Investigation adjusted this to 12,850 ft and aligned it with the maximum (adjusted) ADAS altitude, which the Investigation deemed to be the most appropriate point to facilitate a comparison of all altitude values. The aligned ADAS and ATC altitude data were then graphed (**Figure No. 26**) and it was found that the (adjusted) ADAS altitude data was reasonably consistent with the ATC altitude data.

Figure No. 26: ADAS altitude (adjusted) versus data from Dublin-based radar head

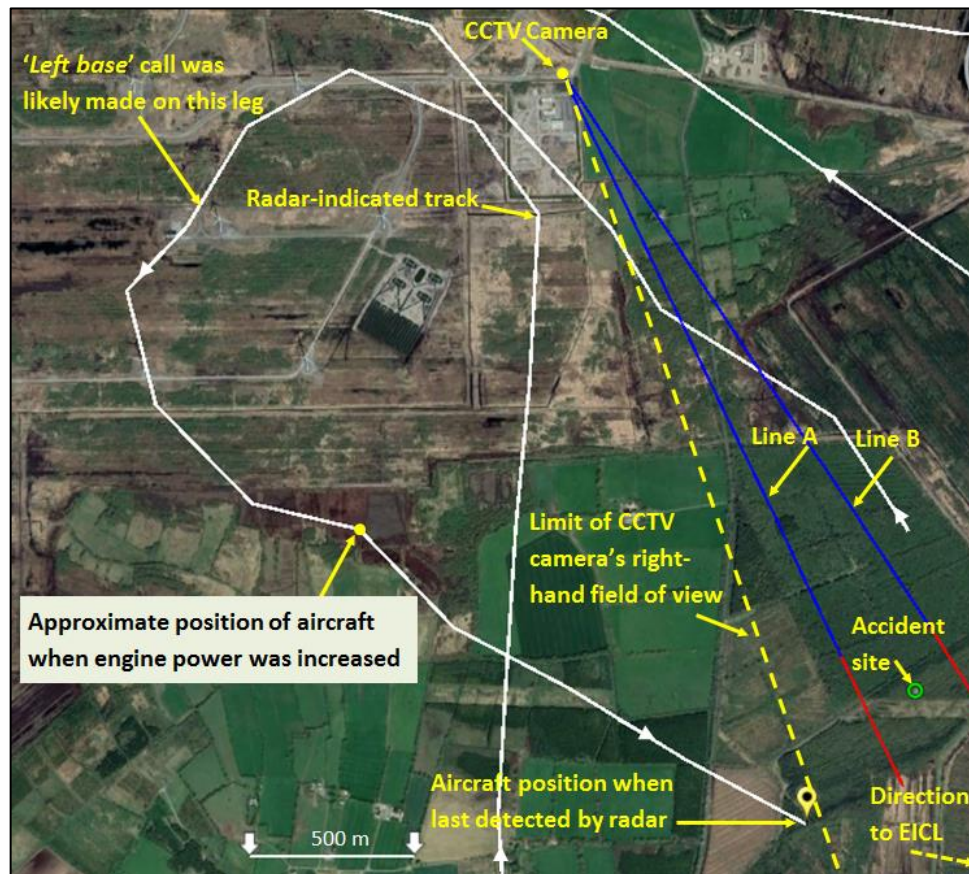
The Investigation examined the ADAS data in conjunction with the analysis of the CCTV recording. The ADAS data indicates that during the descent from approximately 12,000 ft until when the aircraft reached approximately 2,176 ft (adjusted altitude), the engine power was at a low level. A low power setting during the descent would be normal. To arrest an aircraft's descent, while maintaining airspeed, an increase in engine power would be one of the inputs required by a pilot. When the aircraft reached an (adjusted) altitude of 2,176 ft, which the alignment with the ATC data indicated was when the aircraft had just completed a left-hand turn and was on a straight south-easterly track, back in the general direction of EICL (**Figure No. 27**), the ADAS unit recorded an increase in fuel flow, with a corresponding increase in other engine parameters. Approximately 4.5 seconds later, the recorded propeller speed (Np) had increased to over 1,900 rpm, having been less than 1,600 rpm throughout the descent; this is consistent with the propeller lever being advanced in preparation for landing.

Figure No. 27: Approximate position of aircraft when power was first increased in descent

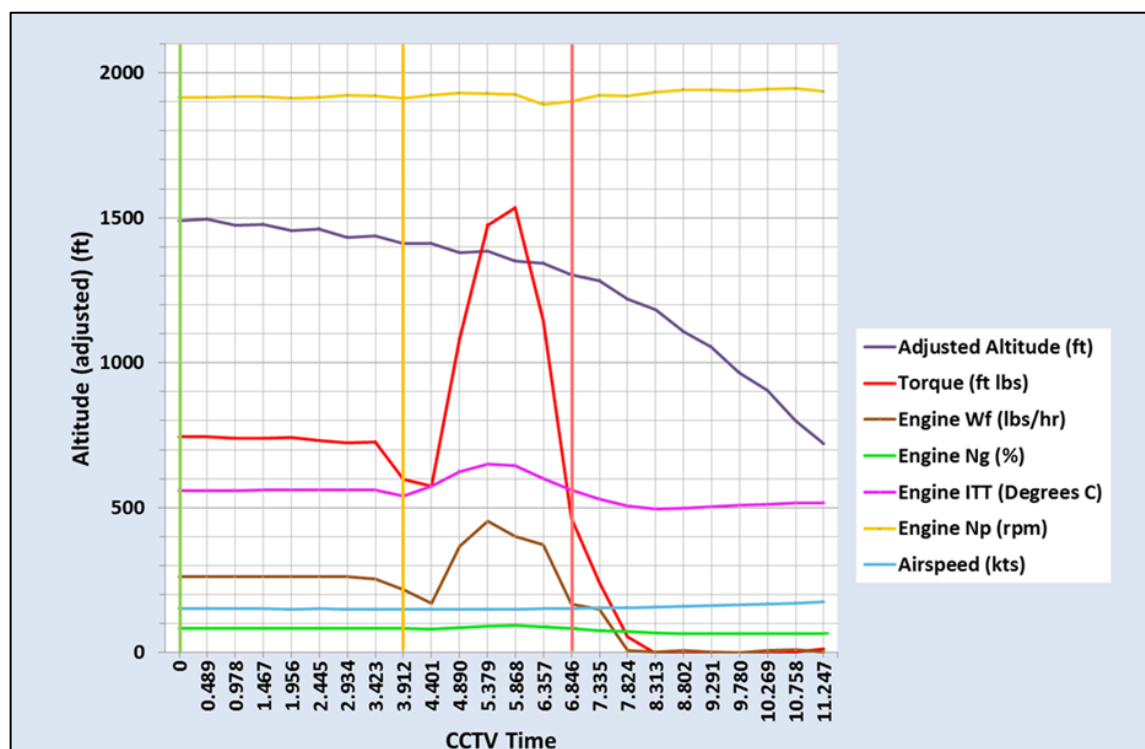
Figure No. 30: Final 11 seconds of ADAS data with reference to CCTV recording timings

The fuel flow figure of 261.292 lbs/hr recorded around the time that the aircraft was first visible in the CCTV recording (as contained in the row highlighted in green in **Figure No. 29** and indicated by the vertical green line in **Figure No. 30**) had remained constant at that figure (approximately) for the previous 10 seconds, as had other engine parameters, including torque. A review of the descent rates in further detail shows that the aircraft's rate of descent reduced to approximately 929 ft/min between 1,490 ft, which is the (adjusted) altitude corresponding to when the aircraft was first visible in the CCTV recording, and 1,437 ft, which is the (adjusted) altitude of the aircraft corresponding to when it was at Line A (3.3 seconds into the CCTV recording).

A reduction in fuel flow and other engine parameters can be observed in the row highlighted in amber in **Figure No. 29**, and at the matching vertical amber line in **Figure No. 30**. This is the ADAS data that corresponds with the CCTV frame analysed by the NTSB, which was 3.9 seconds after the aircraft was first visible in the recording. The fuel flow continued to decrease for another half second approximately.

In the subsequent one second approximately, the fuel flow rapidly increased, with an associated increase in other engine parameters. The recorded engine torque continued to increase to 1,535 ft lbs over the next half second approximately, before reducing over the course of the next two seconds approximately to 53.4 ft lbs, associated with a now decreasing fuel flow. The data from approximately one second before this (row highlighted in pink in **Figure No. 29** and vertical pink line in **Figure No. 30**) corresponds with the CCTV frame analysed by the NTSB, that was 6.8 seconds after the aircraft was first visible in the recording and just before the aircraft entered the steep descent observable in the CCTV recording, approximately 3.5 seconds before the end of the recording.

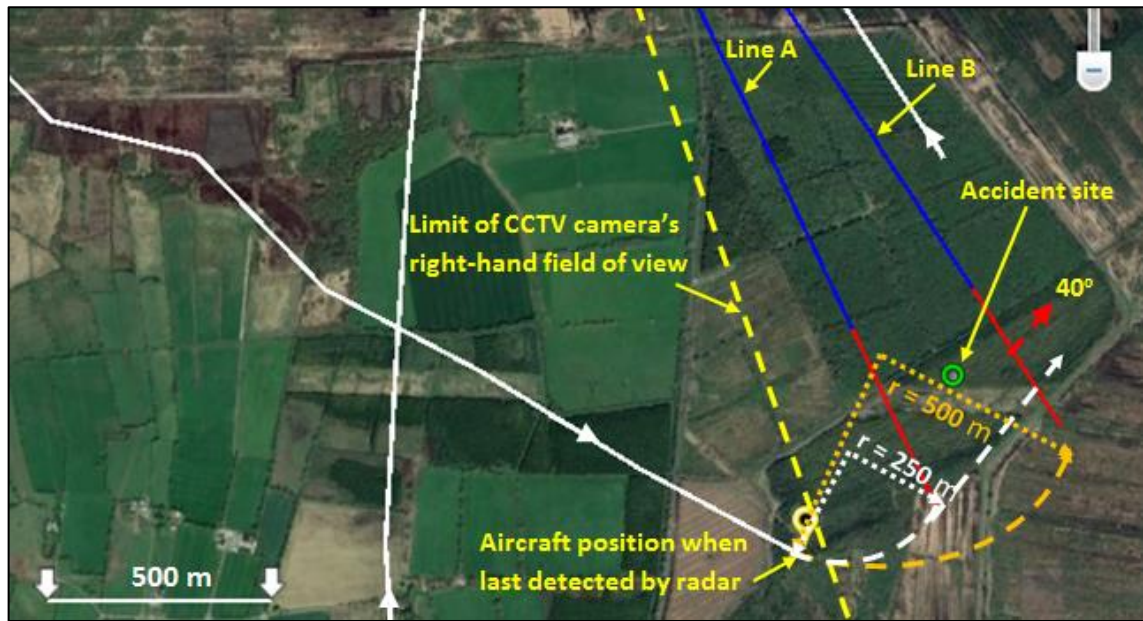
Figure No. 31: Possible turns performed (dashed amber and dashed white lines)

The Investigation estimated the radius (r) of the left-hand turn required to reach Line A and take up a heading of 040° to be between 250 m and 500 m (**Figure No. 31**). A turn with a radius of 250 m (dotted white line in **Figure No. 31**) would result in the track indicated by the dashed white line, and the aircraft remaining reasonably close to the accident site, prior to the aircraft's near-vertical descent and within the red-coloured $\pm 10\%$ lengths of Line A and Line B (the minimum and maximum distances of the aircraft to the CCTV camera as estimated in the video analysis). A turn with a radius of 500 m (dotted amber line) would result in the track indicated by the dashed amber line, and the aircraft being beyond the end of Line A, and also further from the accident site.

Using the formula below, which the Investigation acknowledges applies to coordinated turns, the Investigation estimated that a bank angle of approximately 46.6° would have been required to perform a turn of radius 500 m at a conservatively estimated airspeed of 140 kts (72 m/s):

Based on the foregoing calculations, the Investigation estimated that the bank angle in the earlier part of the manoeuvre (i.e. to reach Line A) was between 46° and 66° , with a bank angle in the upper part of the range considered more likely. A steep bank angle is consistent with what Witness No. 1 observed, who noted that the aircraft was flying '*sideways*' on its left side and Witness No. 2, who observed a wing '*sticking up*'. The Investigation similarly estimated the bank angle of the previous left-hand turn as approximately 45° . The airspeed recorded by the ADAS unit corresponding to when the aircraft first became visible in the CCTV recording and had likely commenced a left-hand turn, was 152 kts approximately, which at the aircraft's estimated weight, was well above V_A , the aircraft's maximum manoeuvring speed (the maximum speed at which full or abrupt control movements may be used without overstressing the airframe).

The Investigation estimated that a left-hand turn with a bank angle of between 46° and 66° would have been required for the aircraft to reach Line A (3.3 seconds after the aircraft was first visible in the CCTV recording) (**Figure No. 31** in **Section 2.6.1**), with a bank angle in the upper part of the range considered more likely. The accident aircraft was also descending during the turn. In descending turns, the inside wing travels down a steeper descent path and therefore has a greater angle of attack than the outside wing.
