AIRCRAFT ACCIDENT REPORT
OCCURRENCE NUMBER 03/3794
PACIFIC AEROSPACE CORPORATION 750XL
ZK-UAC
341 NM WSW OF SAN FRANCISCO
26 DECEMBER 2003

AIRCRAFT ACCIDENT REPORT

OCCURRENCE No 03/3794

Aircraft type, serial number and registration:	Pacific Aerospace Corporation 750XL, 103, ZK-UAC
Number and type of engines:	1 Pratt & Whitney Canada PT6A-34 turboprop
Year of manufacture:	2003
Date and time:	26 December 2003, 1701 ¹ hours
Location:	341 nm WSW of San Francisco VOR Latitude: N 35° 11.1' Longitude: W 128° 45.3'
Type of flight:	Ferry
Persons on board:	Crew: 1
Injuries:	Crew: 1 fatal
Nature of damage:	Substantial, but aircraft not recovered
Pilot's licence	Airline Transport Pilot Licence (Aeroplane)
Pilot's age	58 years
Pilot's total flying experience:	16564 hours, 180 on type
Information sources:	Civil Aviation Authority field investigation
Investigator in Charge:	Mr A J Buckingham

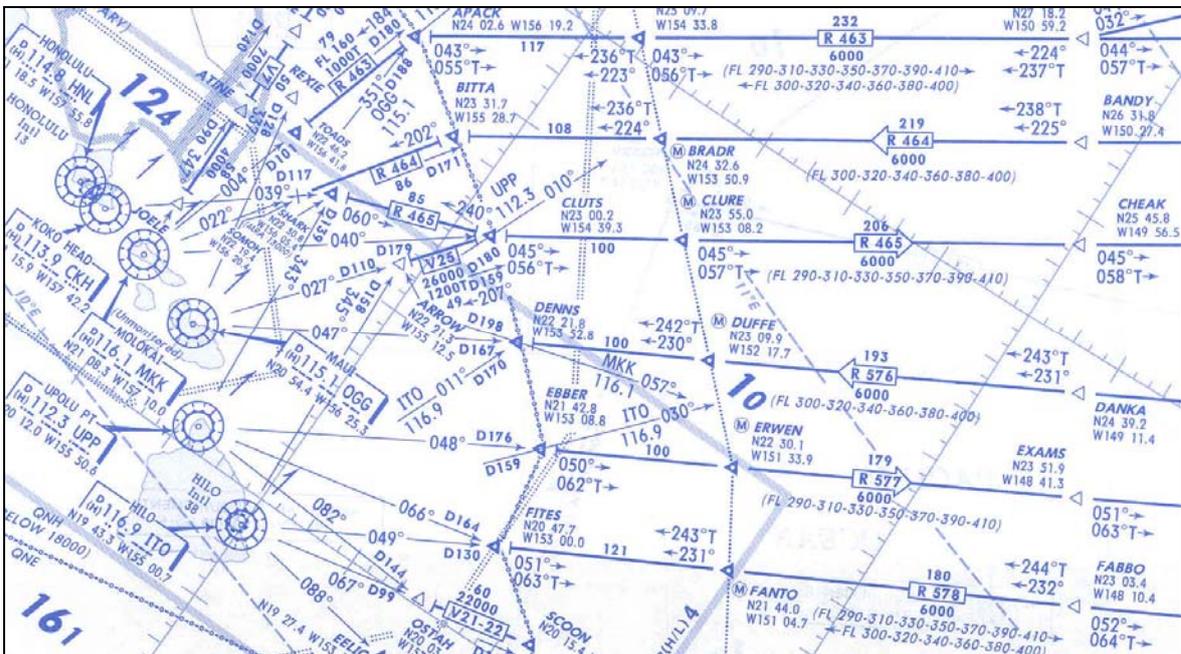
Figure 1: Extract from Jeppesen Enroute Chart P(H/L) 3

1.1.9 The aeroplane eventually departed at 260435 (251835 HAST), some 22 minutes after last light. First HF radio contact with San Francisco Communications Center (operated by ARINC⁸) was at 0505, reporting departure Hilo, climbing FL140 and estimating ERWEN at 0640. The reason for tracking via ERWEN, rather than the planned FITES is not known.
