NATIONAL TRANSPORTATION SAFETY BOARD

AIRCRAFT ACCIDENT REPORT

**BAR HARBOR AIRLINES FLIGHT 1808
BEECH BE-99, N300WP
AUBURN-LEWISTON MUNICIPAL AIRPORT
AUBURN, MAINE
AUGUST 25, 1985**

NTSB/AAR-86/06

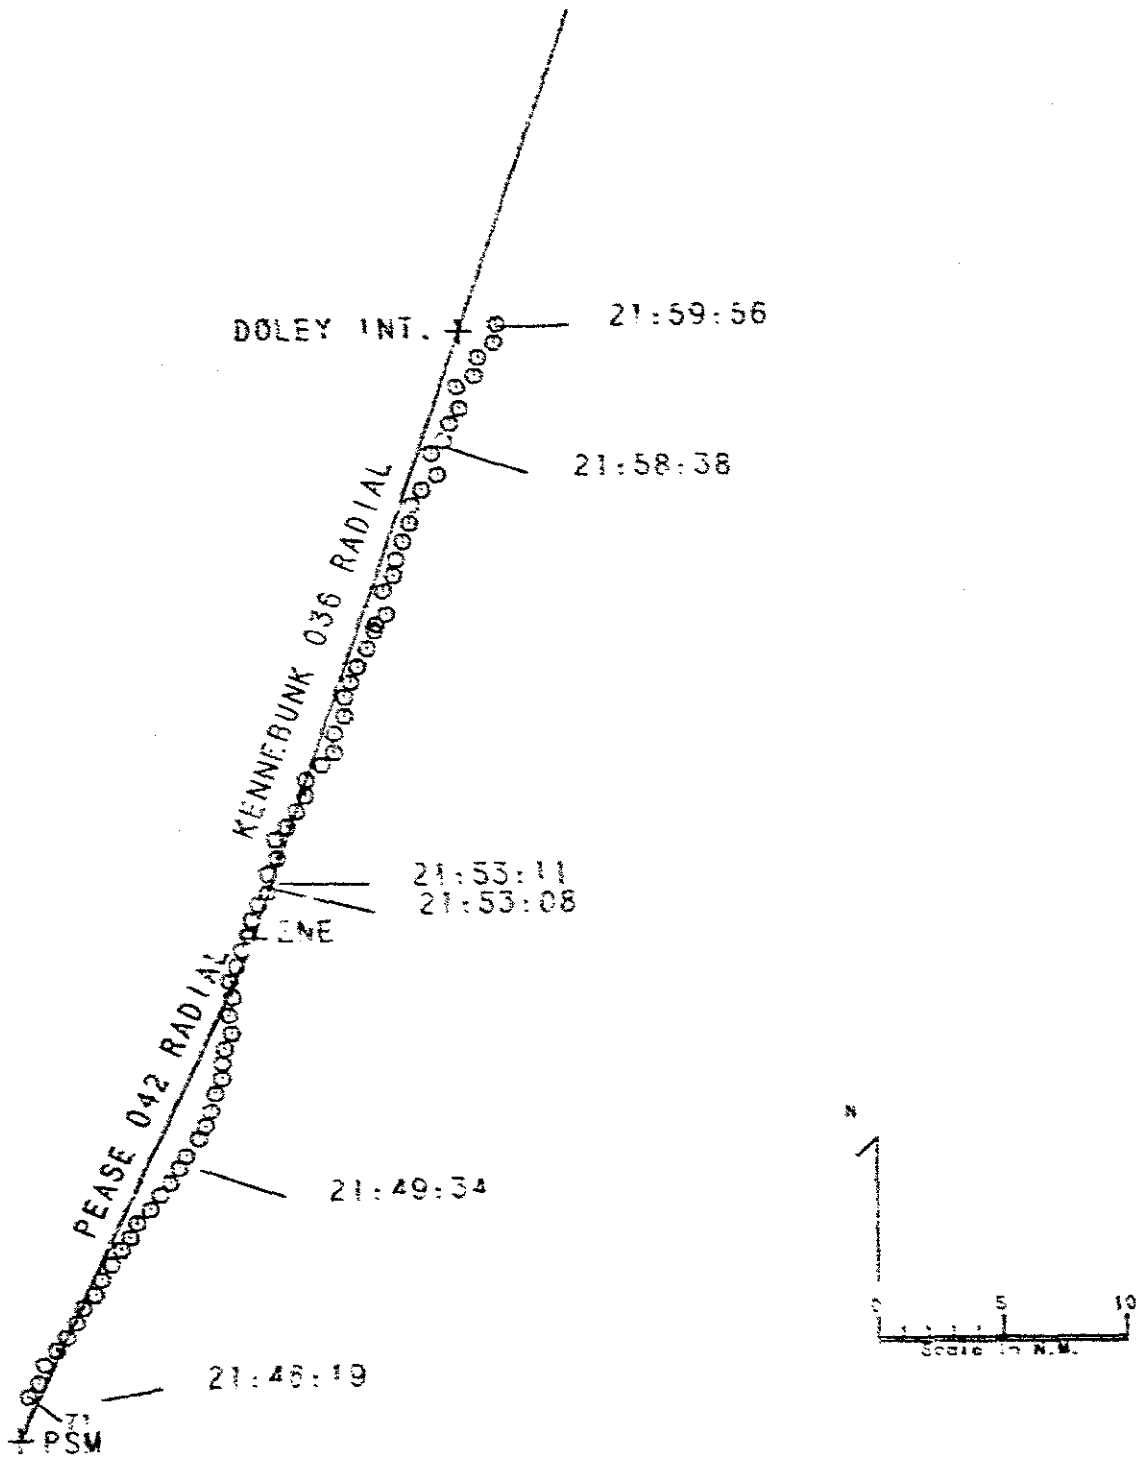
Figure 1.—Radar flight track.

At 2137:24, the first officer contacted Pease Approach Control while the airplane was passing through 5,500 feet and requested to go direct to the Kennebunk (ENE) VOR. The altimeter setting given was 30.21 inHg. Approach Control initially cleared the flight to Augusta, but the captain requested that his destination be changed to Auburn-Lewiston and requested ENE 036 radial transition to intercept the localizer to runway 4. About 2142, approach control cleared the flight to Auburn-Lewiston via direct Kennebunk at 7,000 feet and told the flight to contact Portland Approach Control. The captain acknowledged the transmission. (See figure 1.)

The Air Route Traffic Control Center (ARTCC) data were used to review the airplane's track from Boston to determine if there were any irregularities in navigation that might help explain why the airplane was slightly off course outside the Doley Intersection. (See figure 1.)

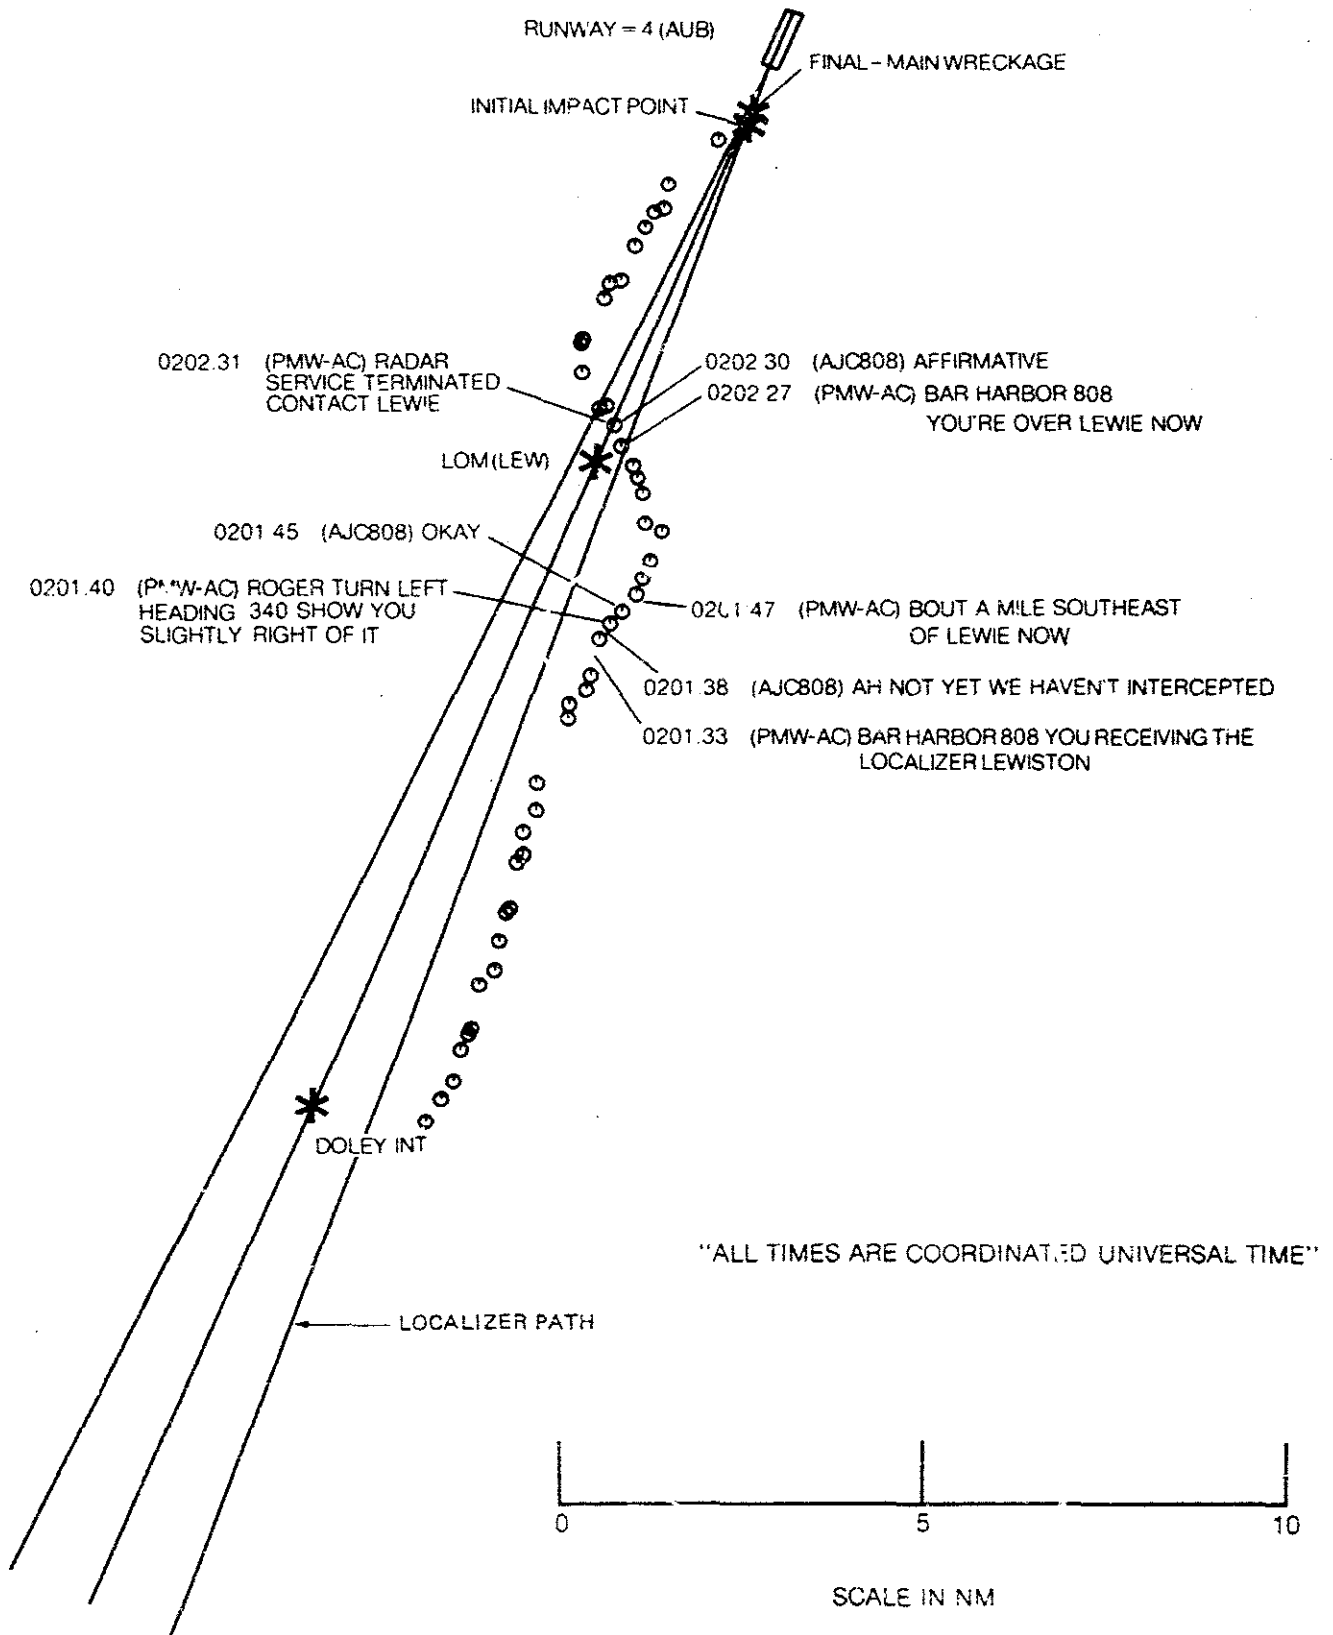
Figure 9.—Radar data reconstructed plan view of the flight track.

The TPX-42 radar data were used to review the airplane's track inside Doley. Measurements of the data were made from the video monitor and converted to nautical miles to align the ARTCC data with the TPX-42 data and to provide a complete radar flight track from Boston to Lewiston. Also, the raw and smoothed TPX-42 data were used for input into a National Aeronautics and Space Administration (NASA) program which estimates performance parameters, such as airspeed, ground speed, roll angles, and acceleration loads. It must be noted that the program calculates "long term" motion parameters of the airplane. "Short term" maneuvers, such as abrupt attitude changes cannot be derived using this program. However, in the following discussion, the "short term" maneuvers were defined more accurately by using the radar data in a manner similar to the computer program, but additional information, such as airplane performance limits and radar data limits, were incorporated into the calculations. The plan view and profile view of the airplane's flightpath are shown in figures 9 and 10.

Review of the radar data indicated that after departing Boston, the airplane turned north and then established itself on the 215° radial of the PSN VOR for 5 minutes before the flight was given a clearance to proceed direct to Augusta via the ENE VOR at

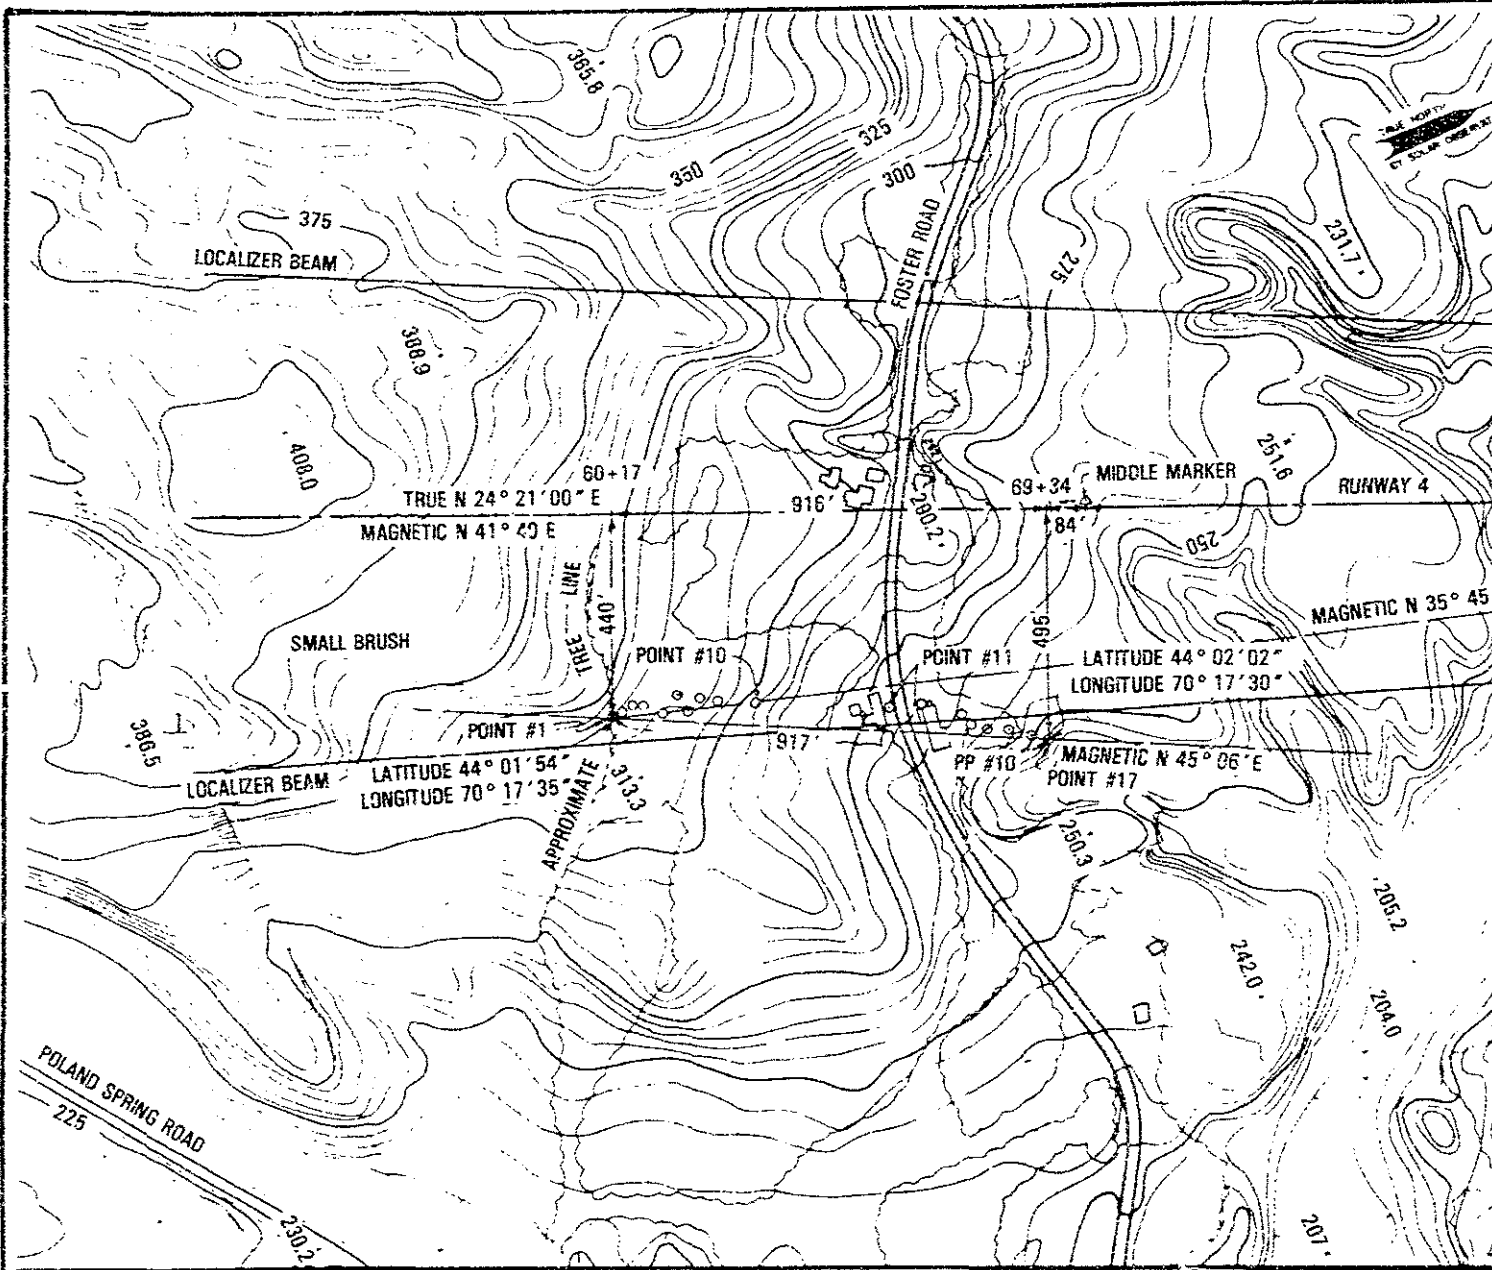
POINT DESCRIPTION	STATION	OFFSET	ELEV	REMARKS
1 INITIAL AIRBORNE COLLISION WITH 2" POPLAR	60-17	440'	313.0 348 363	GRADE POINT TREE WAS SEVERED CANOPY
2 INITIAL AIRBORNE COLLISION WITH 9" OAK	60-39	427'	314.6 342 357	GRADE POINT TREE WAS SEVERED CANOPY
3 RIGHT AILERON	60-53	414'	312.2	GRADE
4 RIGHT OUTBOARD WING PANEL AND TIP	60-84	415'	309.5	GRADE
5 LEFT AILERON OUTBOARD SECTION	61-25	433'	310.1	GRADE
6 LEFT OUTBOARD WING SECTION AND TIP	61-54	394'	311.9	GRADE
7 FUEL CAP	61-78	428'	312.6	GRADE
8 OIL COOLER SCOOP	62-02	398'	318.5 356	GRADE CANOPY
9 LEFT AILERON INBOARD SECTION	62-39	405'	307.9	GRADE
10 RIGHT INBOARD LEADING EDGE	63-23	411'	294.6 355	GRADE CANOPY
11 BROKEN LIMBS IN TOP OF 20" PINE TREE NEXT TO POSTER ROAD	66-02	419'	289.6 327 338	GRADE APPROXIMATE POINT OF IMPACT CANOPY
12 BROKEN LIMBS IN 14" MAPLE NEXT TO HOUSE	66-71	422'	288.8 297 312	GRADE APPROXIMATE POINT OF IMPACT CANOPY
13 INITIAL GROUND IMPACT	67-54	441'	286.3	GRADE
