Accident  
on 22 June 2003  
at Guipavas (21)  
to the Bombardier Canadair  
CL-600 2B 19  
registered F-GRJS  
operated by Brit Air

REPORT TRANSLATION  
[f-js030622a](#)

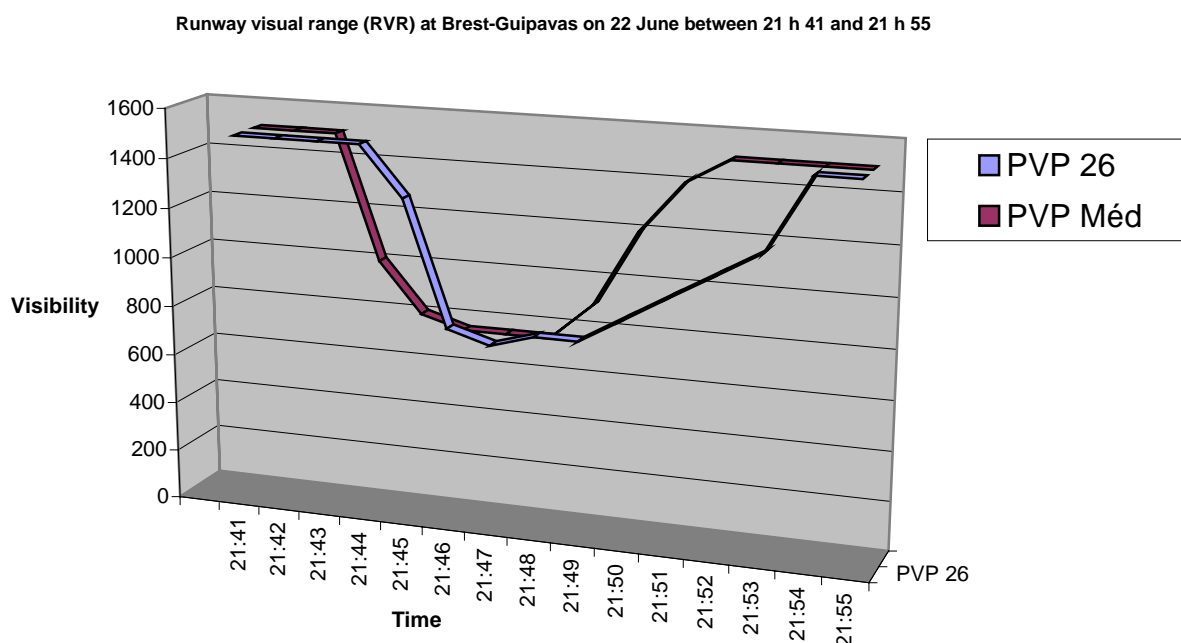
Threshold 26 = transmissometer through the threshold of Runway 26 Left.  
Median = second transmissometer through the runway centre point.

The rapid variation in the RVR's indicate the passage of fog banks. These indications nonetheless should be interpreted cautiously, since the location of the accident was over two kilometres from the runway threshold.

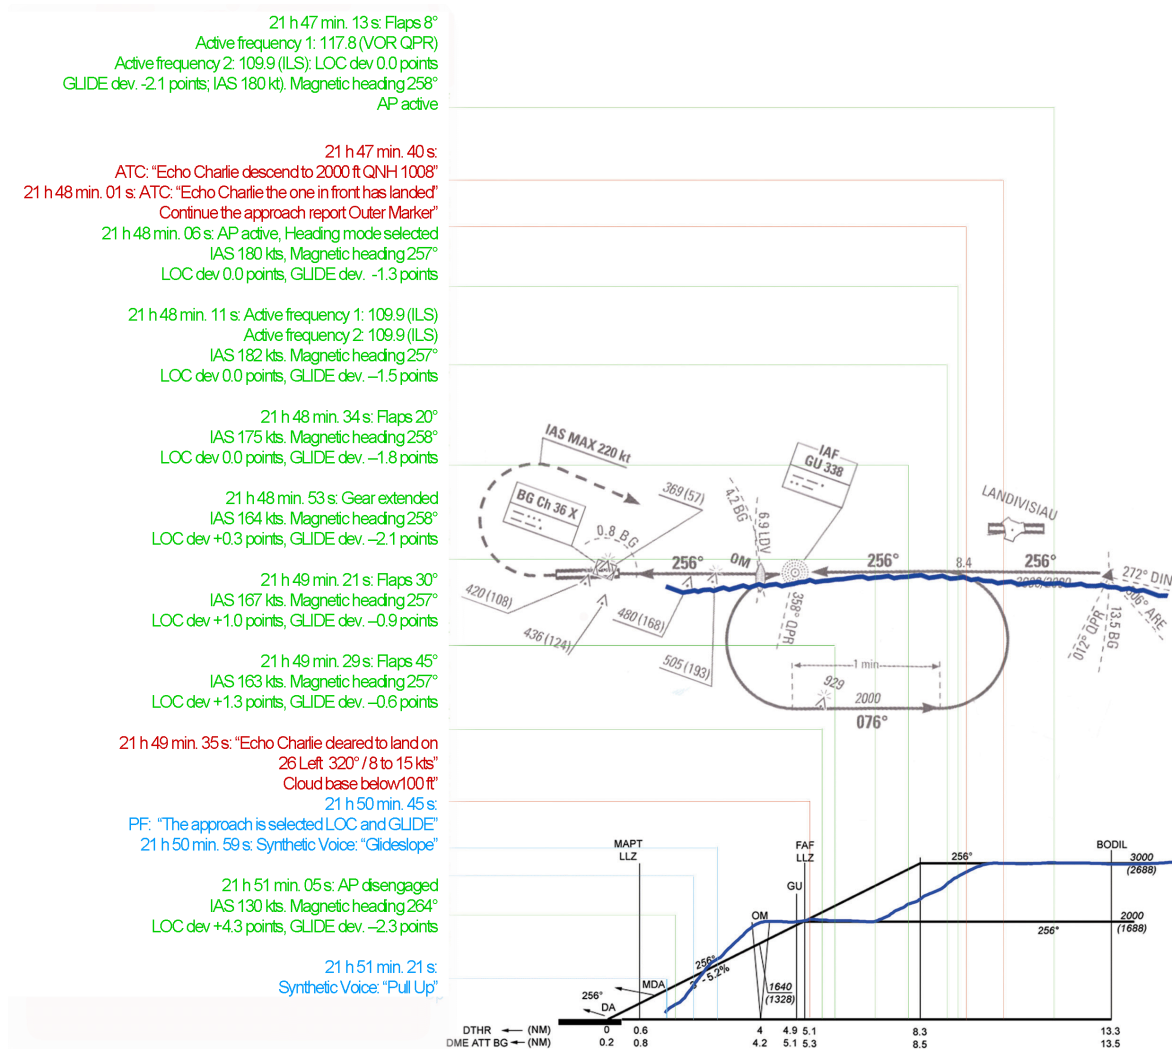
Note: The wind information presented in the preliminary report was obtained from the FDR and has been removed from the present diagram due to its lack of precision (see para. 1.16.1).

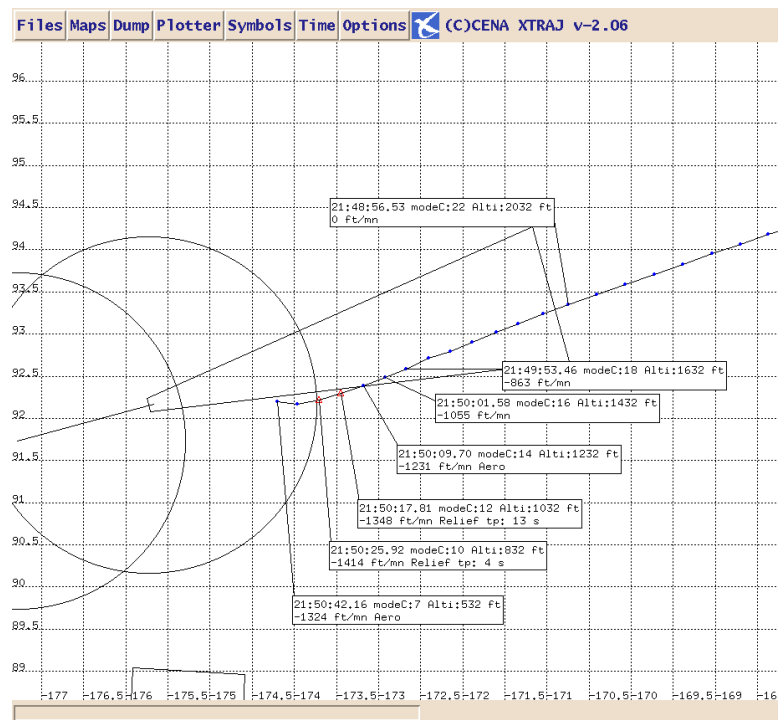
This simulation showed that the system would have detected that the aeroplane was outside its authorised envelope at 21 h 50 min 53 s. Since the display renewal rate of the radar processing system is asynchronous with the Regional Traffic Control Centre radar, a period of three to eleven seconds is required before the alarm is effectively transmitted to the controller. Thus, the latter would have had a MSAW alarm between 21 h 50 min 57 s and 21 h 51 min 05 s, that is sixteen to twenty-four seconds before the aeroplane touched the ground. It would then be necessary to allow for the controller's reaction time, transmission of the alert message to the crew, and the reaction times of the latter and the aeroplane.

Note: The radar time reference precedes that of the FDR by thirty-six seconds.

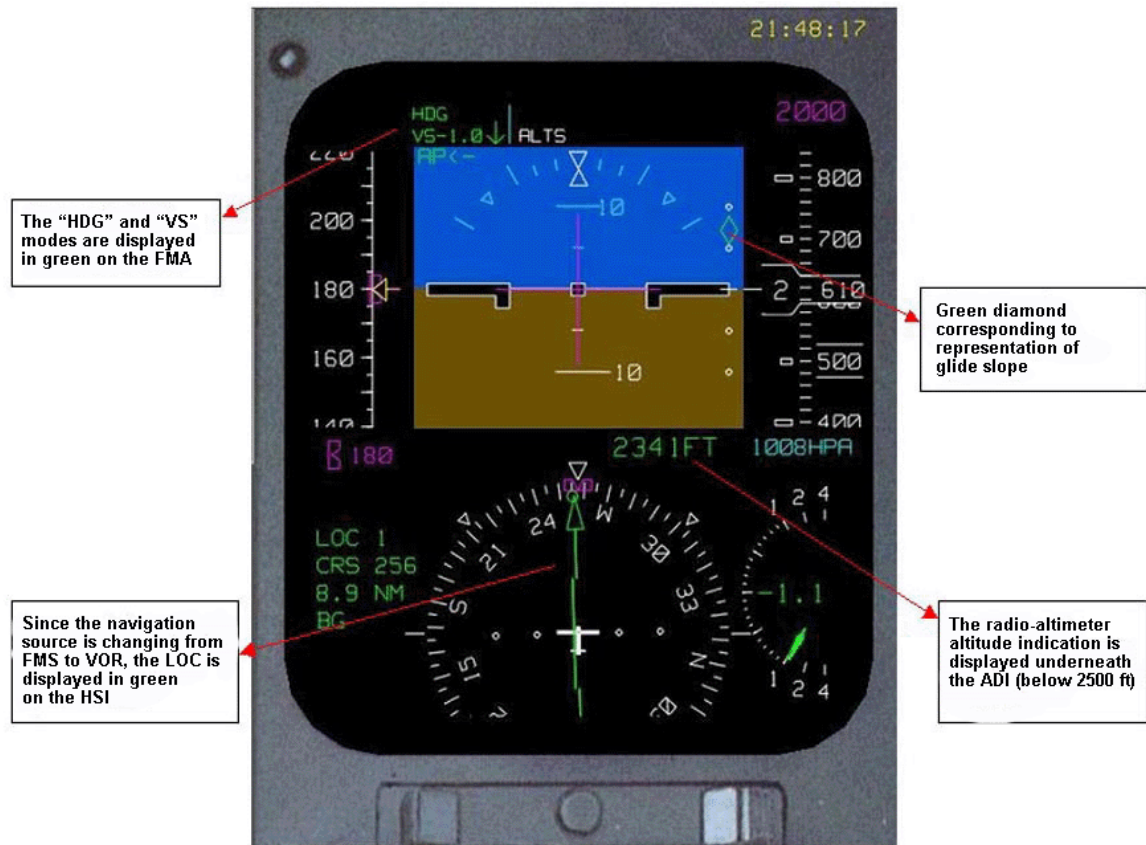
At that moment, the PFD was displaying the following information:

Note: The PFD images in this part of the report were created at the BEA, using data from the flight recorders.

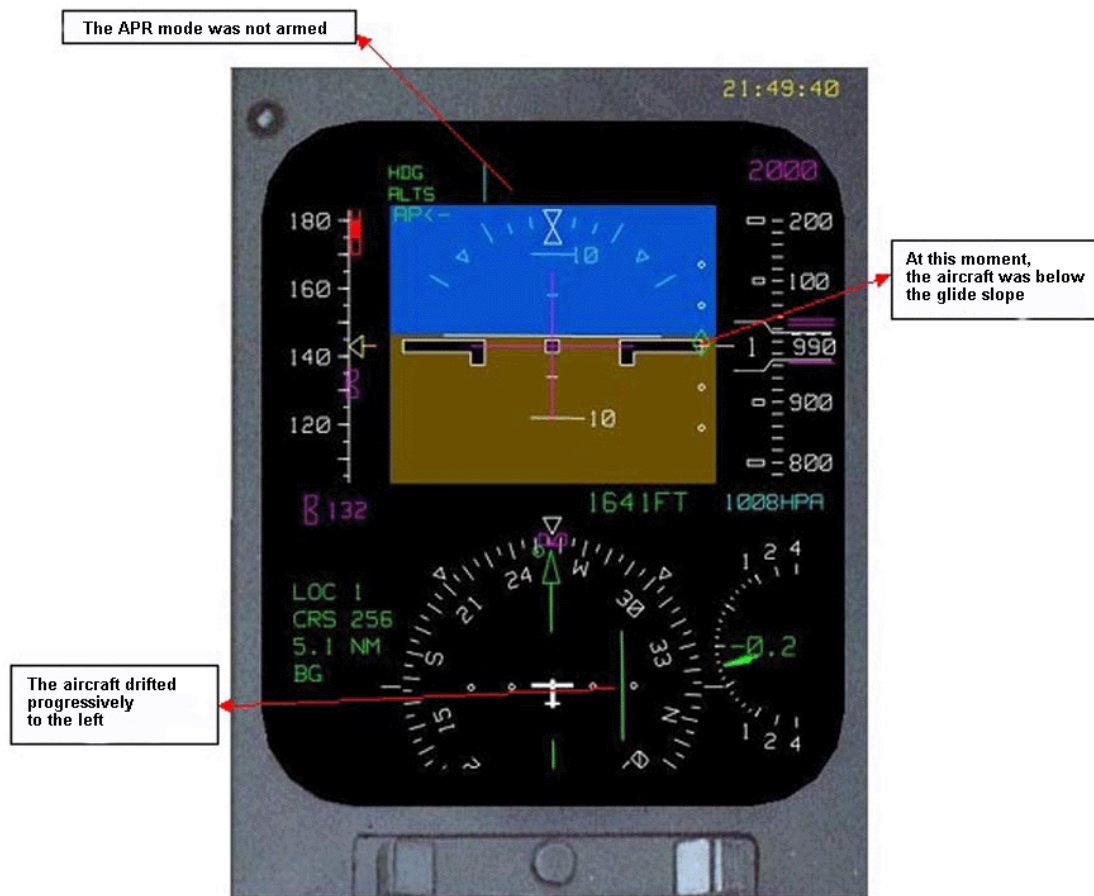
During these exchanges, the aeroplane passed down through the glide slope then passed back above. During this period, when the workload was very high, the crew did not detect the aeroplane's drift. For her part, the Controller indicated after the accident that she had looked repeatedly at the screen without seeing the aeroplane, probably because the latter was in an area where loss of radar contact was a known phenomenon.

Immediately after the end of these exchanges, sixteen seconds after the aeroplane passed through the glide slope, the Co-pilot said, "(...) we haven't got (\*) approach (\*)". These words are extremely difficult to hear and it has not been possible to reconstitute the whole sentence. The Co-pilot told the investigators that he had been out of the control loop while reading the checklist, configuring the aeroplane, and talking to Control. These words may mean that he was trying to analyze the situation, and the allusion to "approach" means that he was aware that the "APPR" mode was not armed. At that moment, the LOC display on the HSI attains right-hand stop. It will remain in this position until the ground impact.

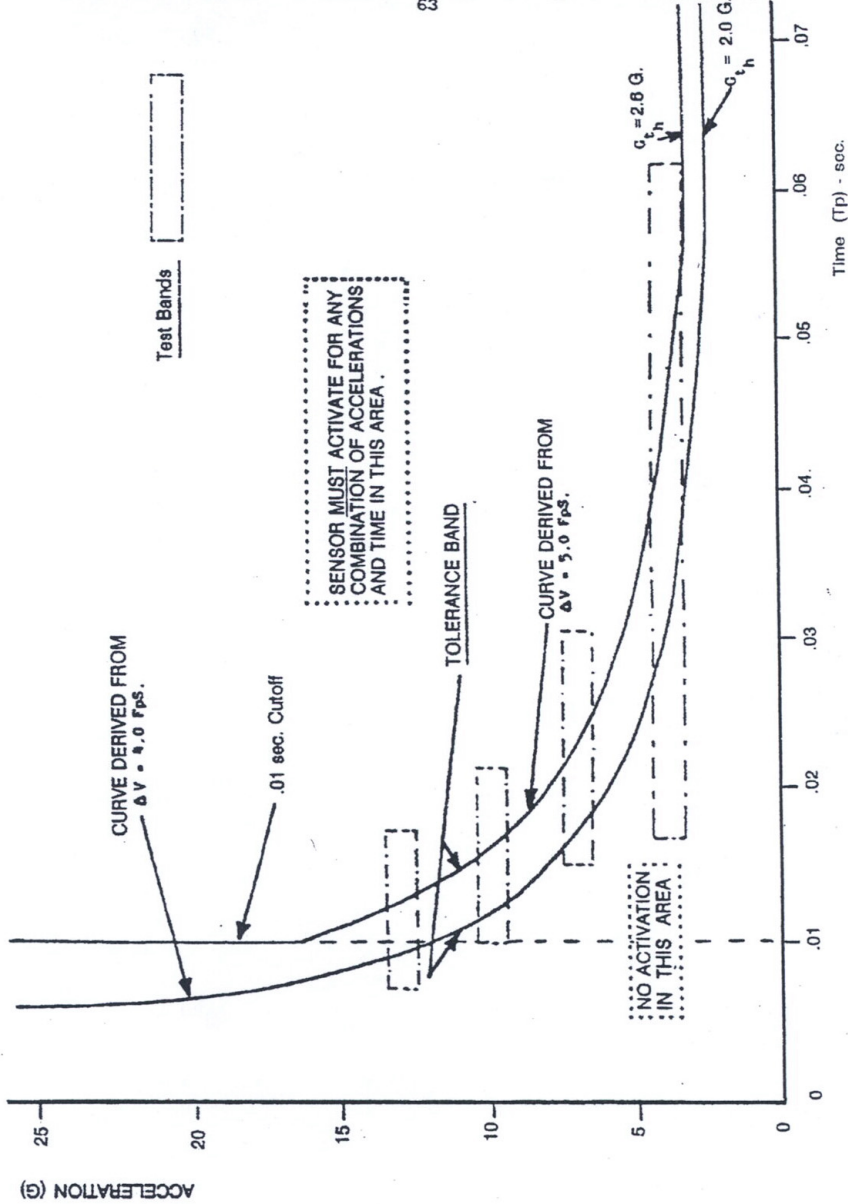
**Figure 5-7 : Crash Sensor Response Curve**

The crash response curve of ELT96, according to ED62 (page 63).
