ACCIDENT

Aircraft Type and Registration:	Britten Norman 2B-26 Islander, J8-VBI	
No & Type of Engines:	2 Lycoming 0-540-E4C5 piston engines	
Year of Manufacture:	1980 (Serial no: 2025)	
Date & Time (UTC):	29 September 2021 at 2133 hrs	
Location:	John A. Osborne Airport, Montserrat	
Type of Flight:	Commercial Air Transport (Passenger)	
Persons on Board:	Crew - 1	Passengers - 6
Injuries:	Crew - None	Passengers - 1 (Minor) 5 (None)
Nature of Damage:	Aircraft damaged beyond economic repair	
Commander's Licence:	Commercial Pilot's Licence	
Commander's Age:	42 years	
Commander's Flying Experience:	2,650 hours (of which 712 were on type) Last 90 days - 105 hours Last 28 days - 22 hours	
Information Source:	AAIB Field Investigation

Synopsis

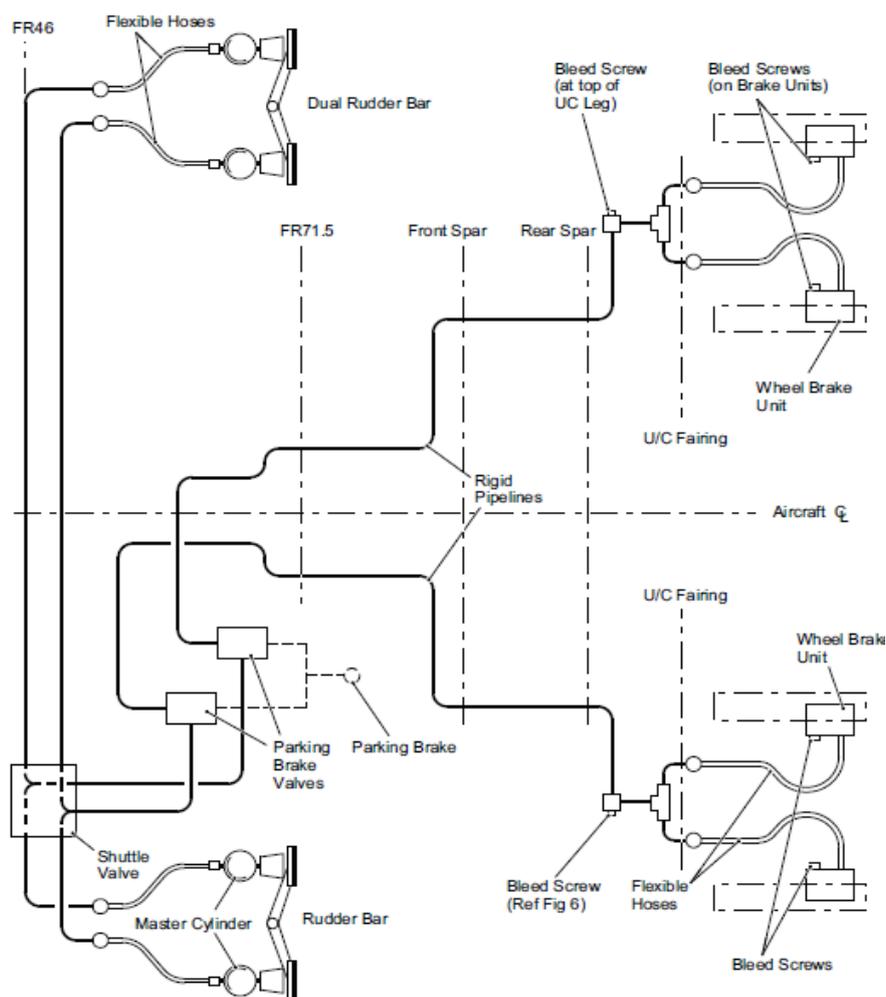
Figure 5

The brake system consists of master cylinders attached to each of the pilot's rudder pedals. Operation of the left brake pedal supplies brake fluid under pressure to the left brake calliper. Pistons in the calliper push friction pads against a brake disc in proportion to the pressure applied to provide braking. Likewise, operation of the right pedal supplies pressure to the right brakes to provide braking. The pilot operates the individual brake pedals to obtain the required braking action. During the landing roll, this would normally be both equally together to ensure the aircraft stops in a straight line. The co-pilot's rudder pedals are also fitted with master cylinders and operation of these pedals supplies pressure to the brakes in a similar way to the pilot's but through shuttle valves which allow the highest pressure applied to supply the brakes. In common with other similar aircraft, there is no anti-skid system and as a result, the pilot is required to adjust the brake pressure manually to ensure the braked wheels do not skid. A parking brake is available and when applied it maintains any pressure applied to the brakes (Figure 5).

Schematic diagram of braking system

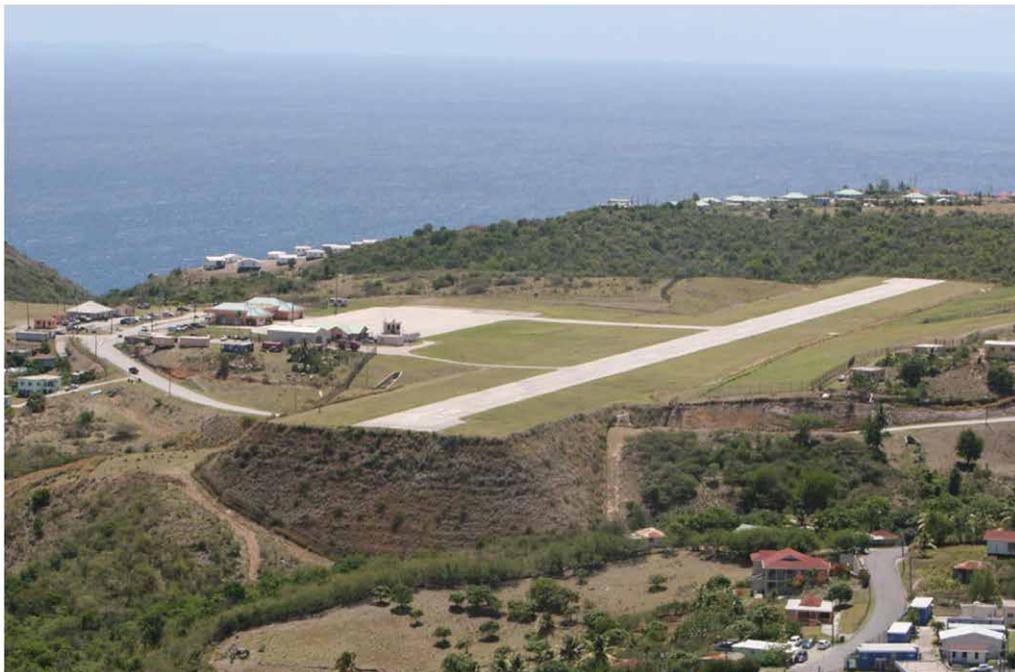
Figure 10
John A Osborne Airport

John A Osborne Airport has a single asphalt Runway 10/28 and sits at an elevation of 550 ft amsl. The runway was resurfaced in 2021 with grooves cut into the surface to improve runway friction in wet conditions. Both runways have a take-off run available (TORA) of 553 m / 1,814 ft and a LDA of 540 m / 1,771 ft, being constrained in length by a steep downhill gradient at either end. Recent improvements to the runway include renewed and re-positioned approach guidance lighting, and 'throw away' markings to help guide pilots judge when to go around.
