Investigation Report

Type of Occurrence: Accident

Type: Cessna 401A

State File Number: BFU20-0721-CX

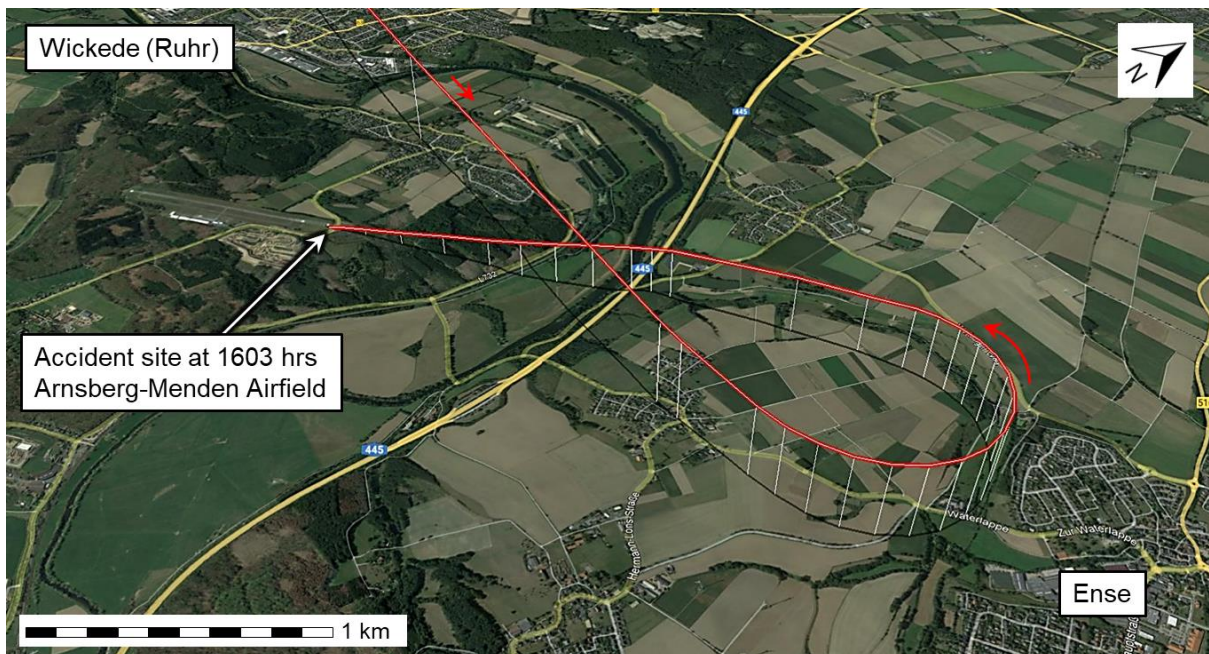
At 1600 hrs, about 2.5 NM west of the destination aerodrome, the airplane turned left in an easterly direction. About one minute later, the airplane crossed the extended runway centre line of runway 23, at a distance of 0.7 NM from the threshold at about 1,400 ft AAL with an eastern heading. At the time, ground speed was approximately 150 kt. At 1601:39 hrs, the airplane turned left towards the final approach of runway 23. During the turn, the airplane had a bank angle of 45°. After the pilot had finished the turn, at 1602:32 hrs, the airplane reached the extended runway centre line at about 1,500 ft AMSL (about 700 ft AAL), approximately 1 NM from the runway threshold (Fig. 1), and turned toward the landing direction. At the time, ground speed was approximately 100 kt.

During the last 30 s of the final approach, airspeed decreased continuously. At 1602:44 hrs, the airspeed undershot the Blue Line Speed² and 2 s later the minimum approach speed. At 1603:04 hrs, airspeed fell below the minimum control speed and at 1603:15 hrs, below the stall speed for flaps 30°. The airplane impacted a slope more than 200 m in front of the runway threshold.

Fig. 1: Approach based on GPS data

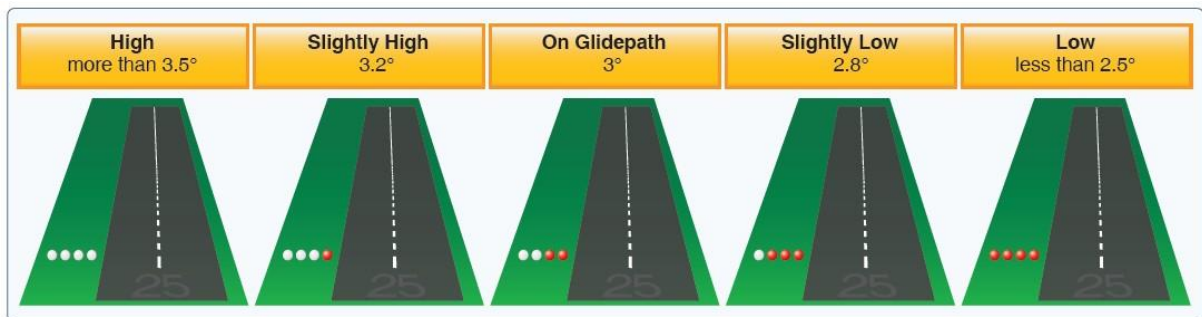
At Arnsberg-Menden Airfield, both landing directions were equipped with Precision Approach Path Indicators (PAPI, Fig. 2). They were set to a glideslope of 3°. According to the Flugleiter, the PAPI for runway 23 was active during the airplane's approach.

Fig. 2: PAPI indications of different approach angles

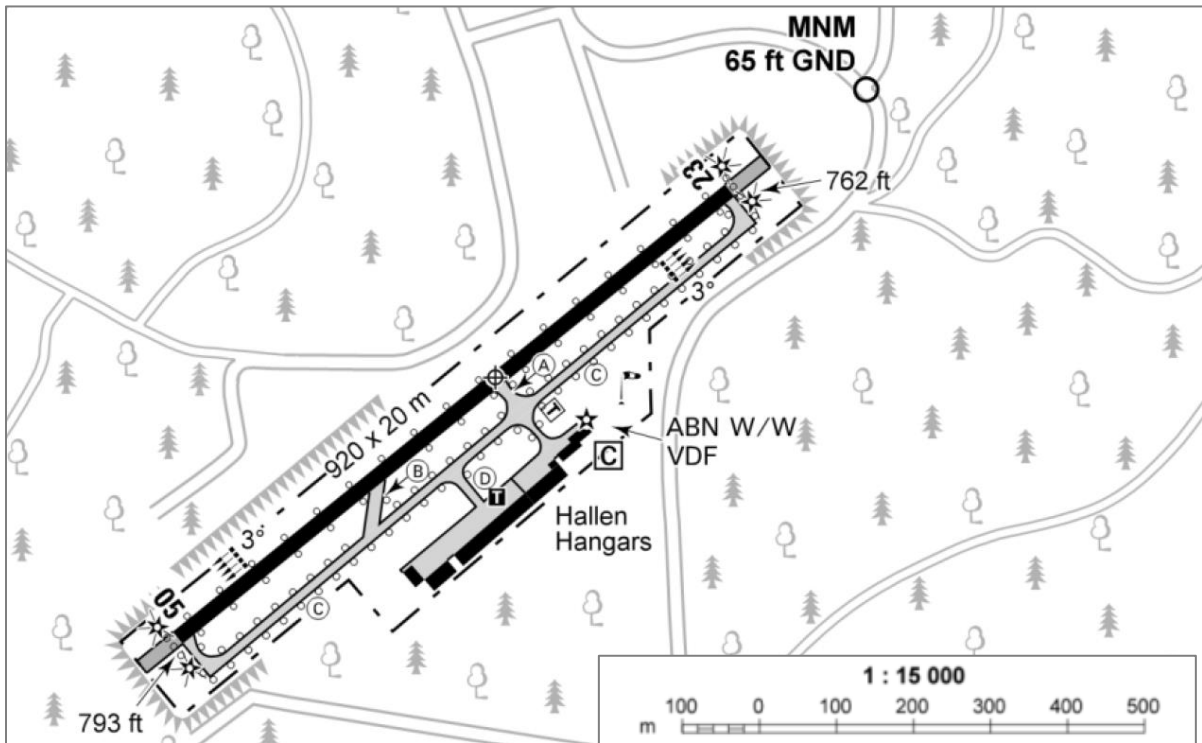
A traffic pattern had not been published for the airfield. According to the aerodrome chart published in the AIP (Fig. 3), at the time of the accident, it had one 920 m long and 20 m wide asphalt runway with the orientation 048°/228°. The elevation of the threshold of runway 23 was 762 ft AMSL. It increased within about 700 m to 794 ft AMSL and decreased again at the end of the runway to 793 ft AMSL. The aerodrome chart indicated the Landing Distance Available (LDA) with 920 m. At the time of the accident, runway 23 was in use.

Fig. 3: Excerpt of the aerodrome chart published at the time of the accident (as of 7 June 2018) Source: AIP

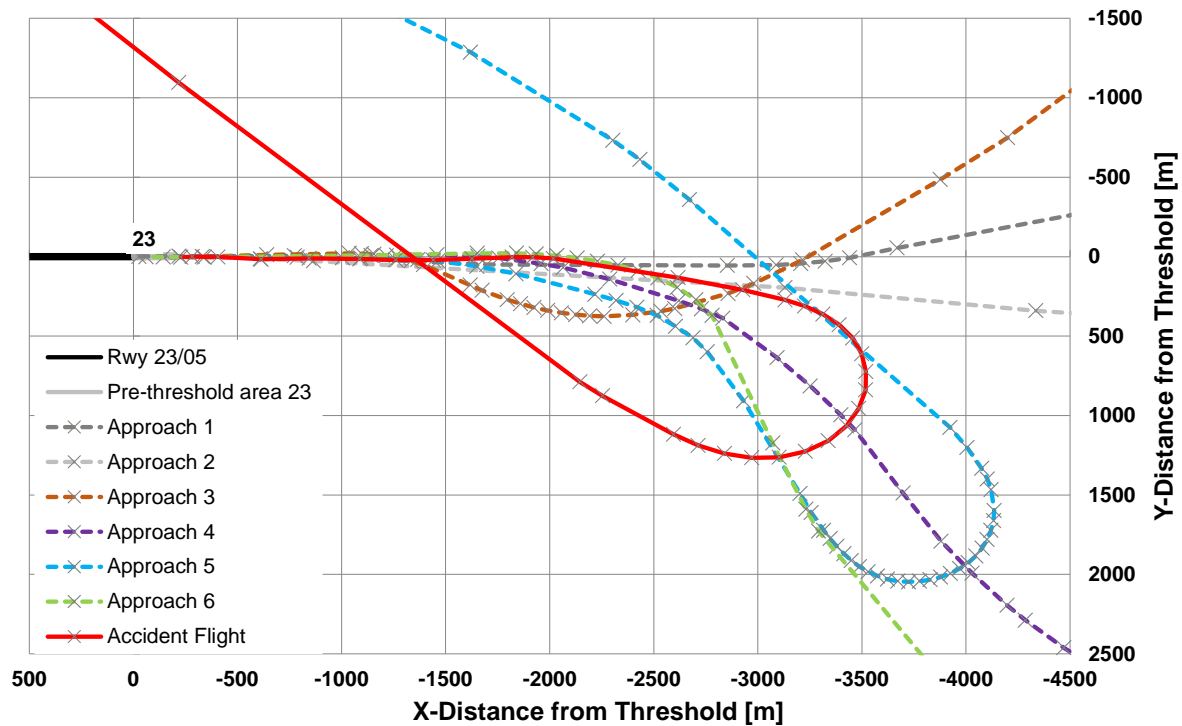
The accident flight and six other flights with landings on runway 23 of Arnsberg-Menden Airfield the pilot had conducted between April and August 2020 and which had also been recorded, showed that he had approached the airfield twice from a westerly direction, once from the north and twice each from a north-eastern and eastern direction (Fig. 8).

Fig. 8: Top view of the six approaches to runway 23 at Arnsberg-Menden Airfield (accident flight red)

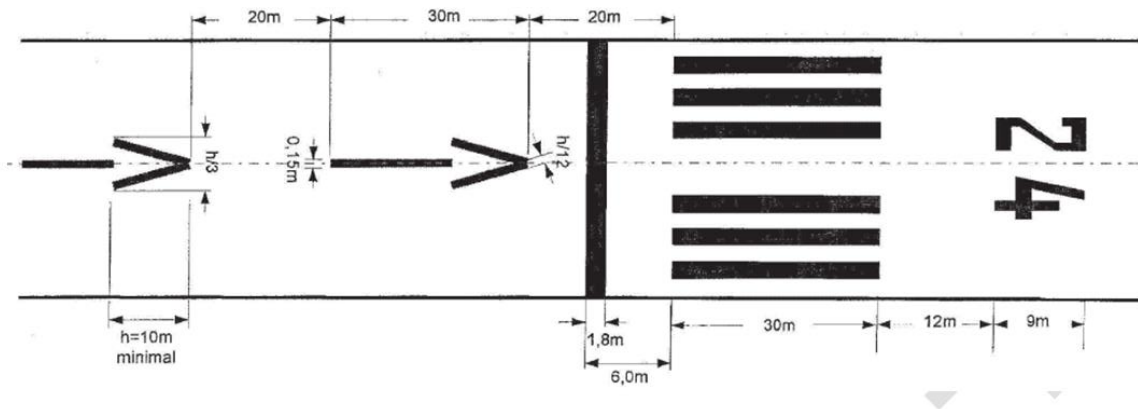
It stipulated and described in detail the markings for paved runways and pre-threshold areas (Fig. 13), among other things. Thus, a displaced threshold was to be marked with a white strip running across the runway and the area in front with arrows.

Fig. 13: Runway marking with displaced threshold in accordance with NFL I 94/03

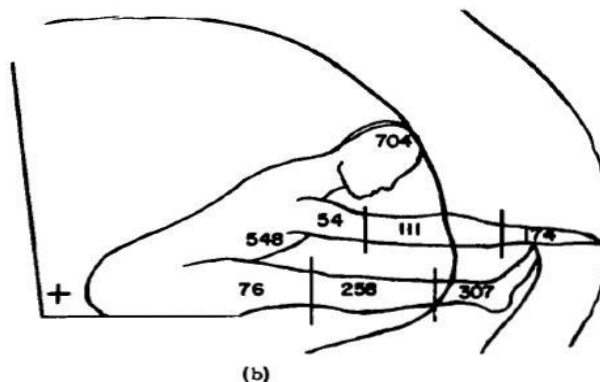
Fig. 14: Movement of an occupant secured with a lap belt during impact and number of occurring injuries per body area
Source: De Haven et al. (1952)

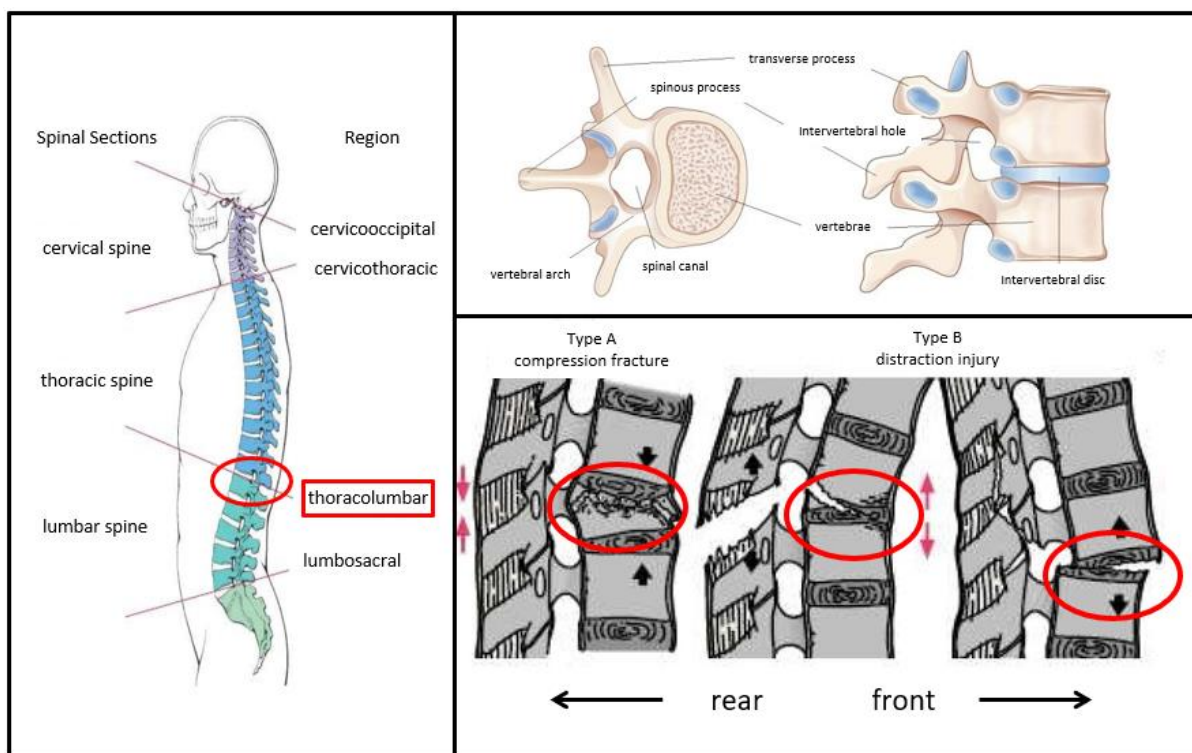
Already in 1952, De Haven and employees examined retrospectively the occurrence, the distribution and the injury severity of 800 General Aviation accidents survivors.³² They concluded that both the most life-threatening and the most frequent injuries occurred primarily in the area of the head and chest, which was caused by the fact that the occupants, who were only secured with lap belts, performed a jack-knife-like forward, backward movement with their upper bodies and the pelvis as the lateral axis of rotation, due to the forces occurring during the impact (Fig. 14). Thus, head and upper body collided with cockpit parts. The rotational movement overloaded individual vertebral bodies in the transition between the thoracic spine, which is relatively rigid due to the thorax, and the flexible lumbar spine causing these vertebral bodies to compress and fracture at the front or rear edges. If this fractured vertebral body widens geometrically this can lead to compression of the spinal cord located in the immediate vicinity of the spinal canal with neurological failure including paralysis (Fig. 15).

Fig. 15: Anatomy of the spine and vertebral bodies; compression and distraction fractures
Source: Niedhard und Pfeil (2003), Thieme Verlag; Eysel und Fürderer (2004), Thieme Verlag
