**AVIATION INVESTIGATION REPORT**  
**A09Q0203**

**CONTROLLED FLIGHT INTO TERRAIN**  
**EXACT AIR INC. BEECH A100 C-GPBA**  
**CHICOUTIMI/SAINT-HONORÉ AIRPORT, QUEBEC,**  
**3 NAUTICAL MILES NW**  
**09 DECEMBER 2009**

Report Number A09Q0203

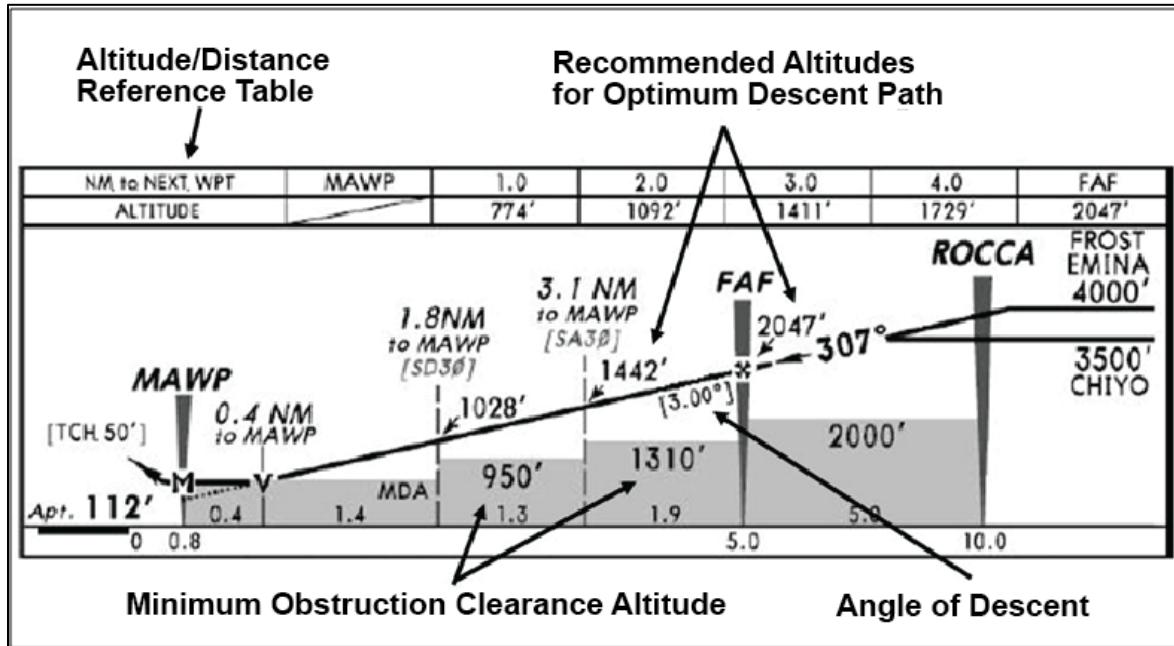
Figure 6. Descent profile used on European Union approach charts (Jeppesen).

The charts produced by Jeppesen incorporate non-precision approach profiles consistent with the standards and recommendations of Annex 4 (Figure 6). These charts will help European Union operators comply with the EU-OPS1 standards by clearly depicting the path to be followed (designed to be 3°). This 3° angle facilitates stabilized descents, similar to precision approaches. The recommended altitudes for flying this descent path, combined with an altitude/distance table and a rate of descent table, make it easier to monitor the descent on approach. Lastly, the shaded blocks indicate minimum obstacle clearance altitudes, providing awareness of the height of the path above terrain.

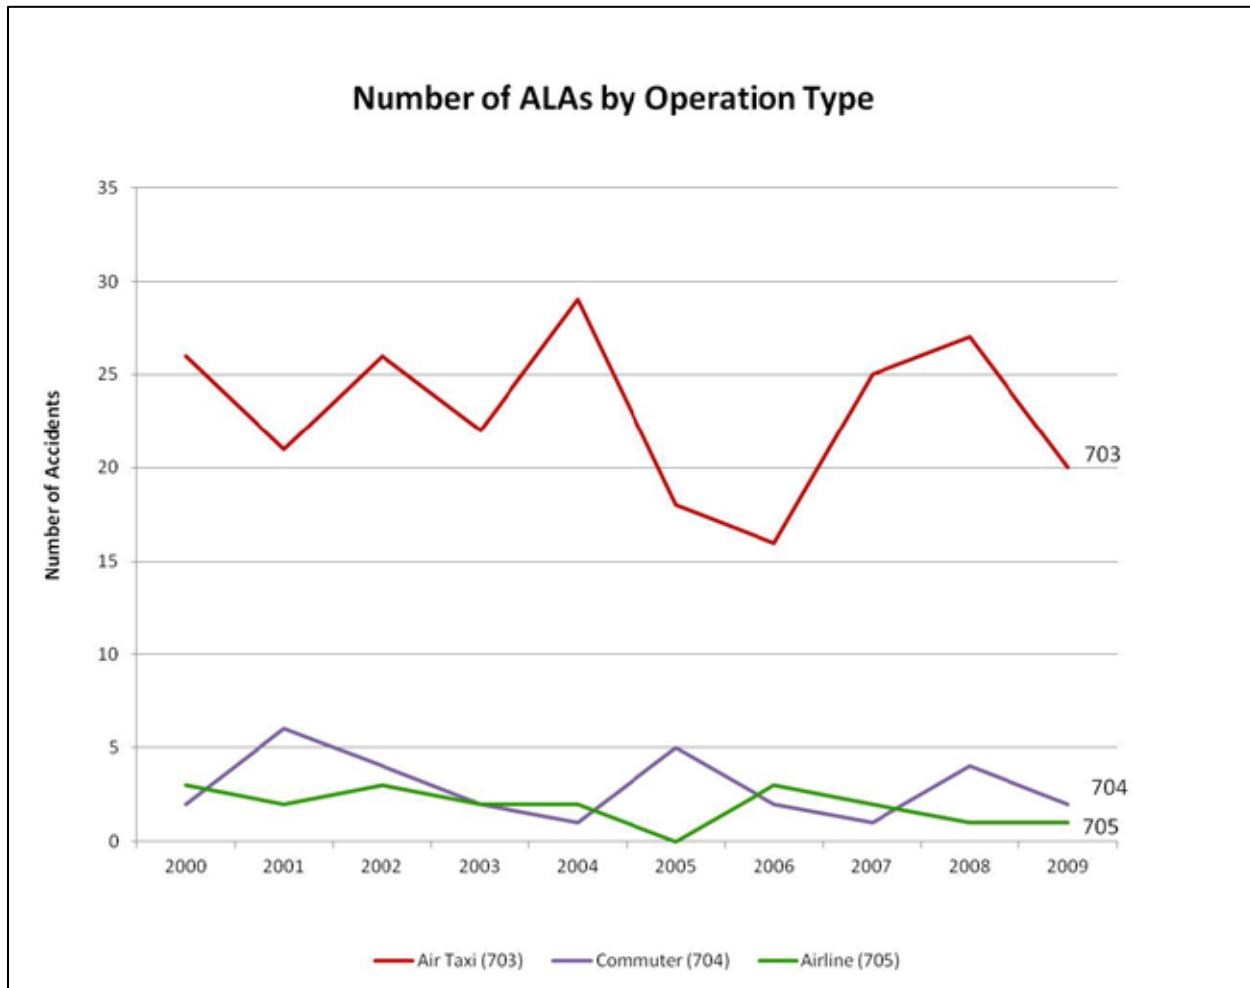
**Figure 7.** Number of commercial operation ALAs in Canada involving Canadian-registered aircraft

Approximately 80% of commercial operation ALAs have taken place at airports that are only equipped with non-precision instrument approaches. Regional airports, which are rarely equipped for precision instrument approaches, are generally those used by air taxi operators.
