# Collision with terrain, VH-FNM

## Wynella Station, Queensland

### 20 December 2010

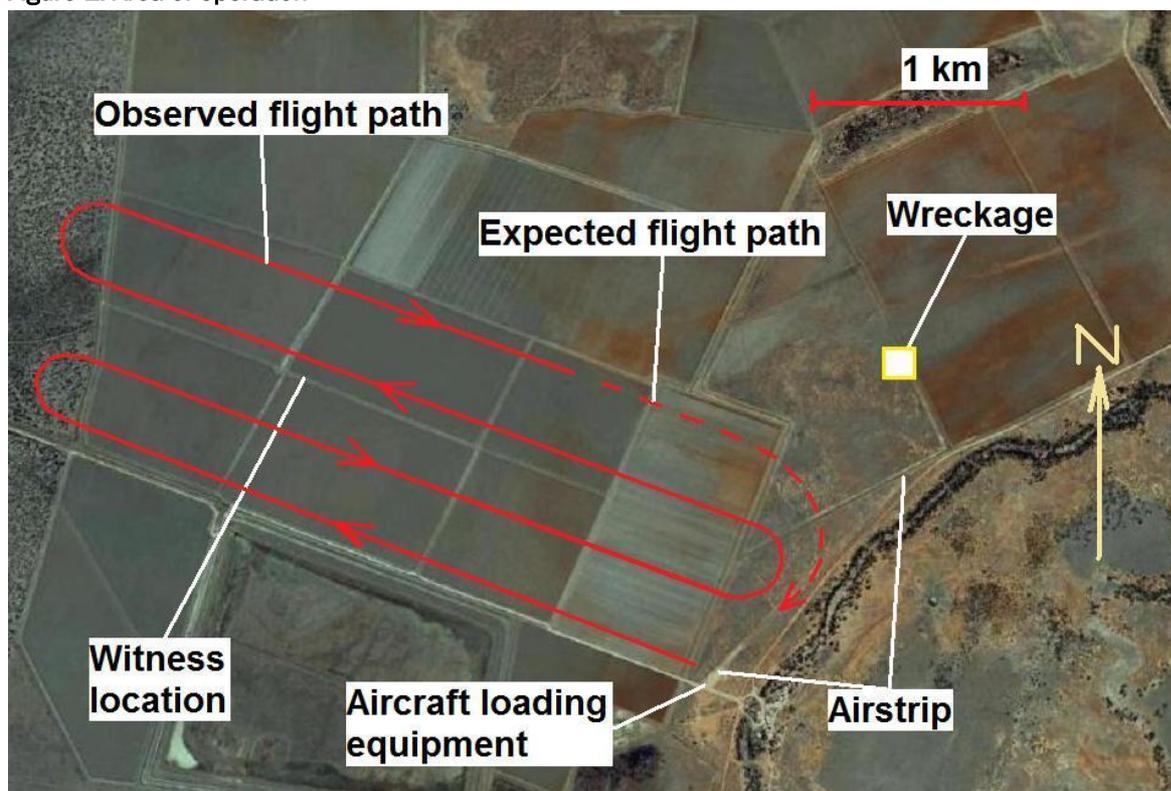
Figure 1: Area of operation

south-south-west of Dirranbandi, Queensland. The application area consisted of several paddocks adjacent to an airstrip that the pilot used for refuelling and replenishing the load (Figure 1).
