FINAL
KNKT.12.05.09.04

Aircraft Accident Investigation Report

**Sukhoi Civil Aircraft Company
Sukhoi RRJ-95B; 97004
Mount Salak, West Java
Republic of Indonesia
9 May 2012**

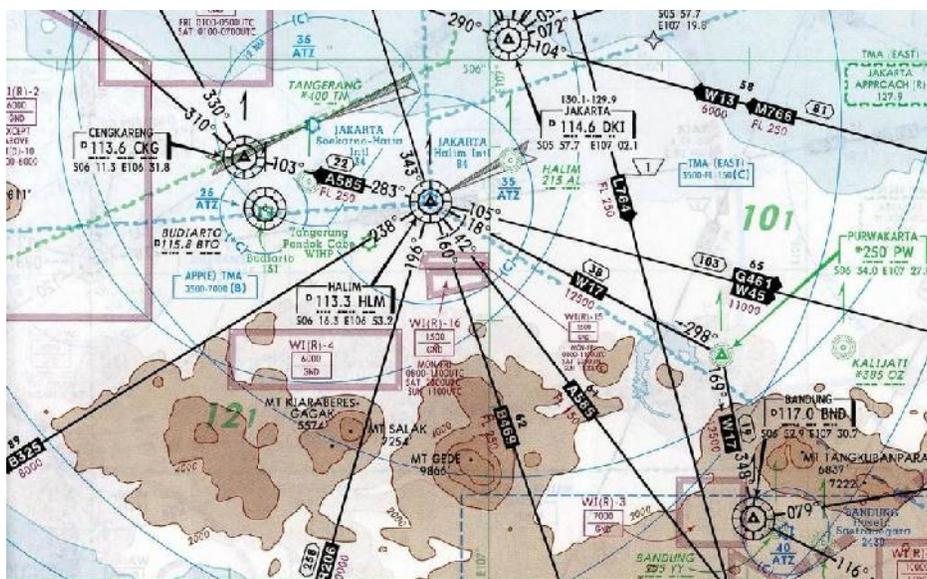
Figure 9: Navigation chart contains information of Atang Sanjaya Training Area and terrain contour

Figure 9 shows a sample of instrument navigation chart that provides information includes the Atang Sanjaya Training Area / WI(R)-4 and the terrain contour. This chart was not carried on the aircraft.

The instrument chart, shown as figure 9, contained terrain contour and "Bogor Area", and the visual chart, shown as figure 10, may have provided a better understanding to the pilot that the point they intended to fly to was close to a mountainous area. These charts were not carried on board the aircraft.

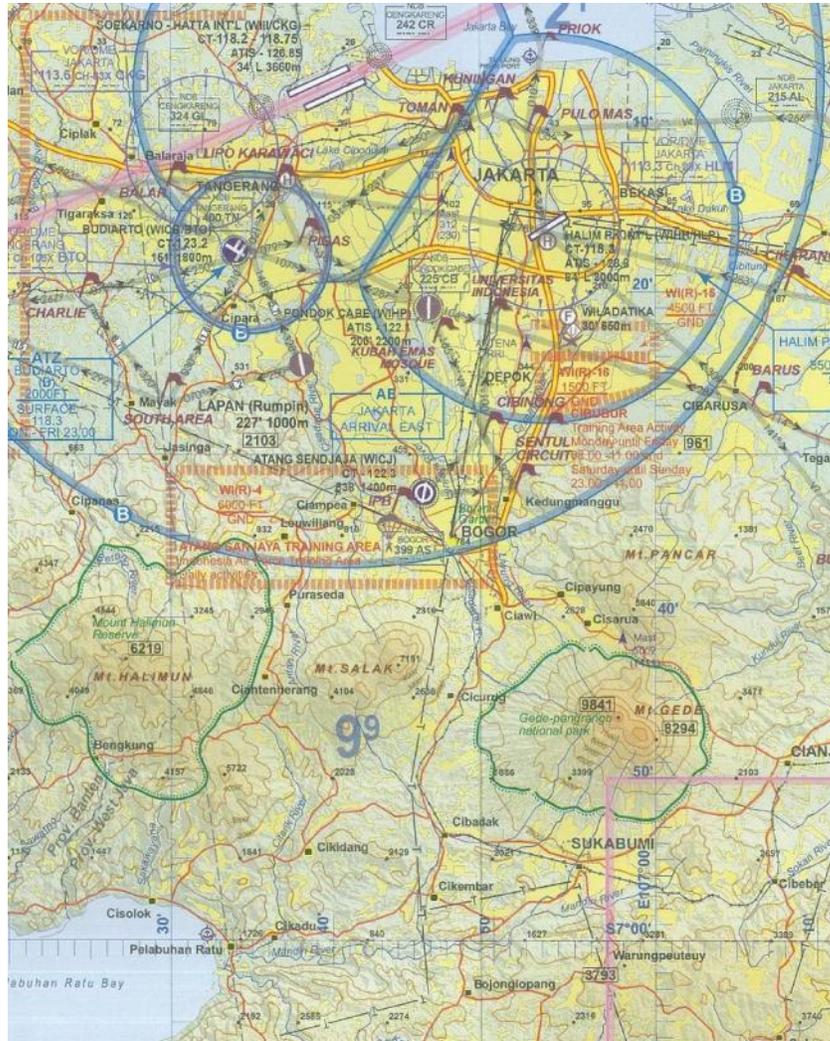
Figure 10: Visual chart

This typical visual chart (figure 10) contains information of the Atang Sanjaya Training Area / WI(R)-4 and the terrain contour which is normally provided by the local government. The investigation was unable to determine if this chart was carried on the aircraft.

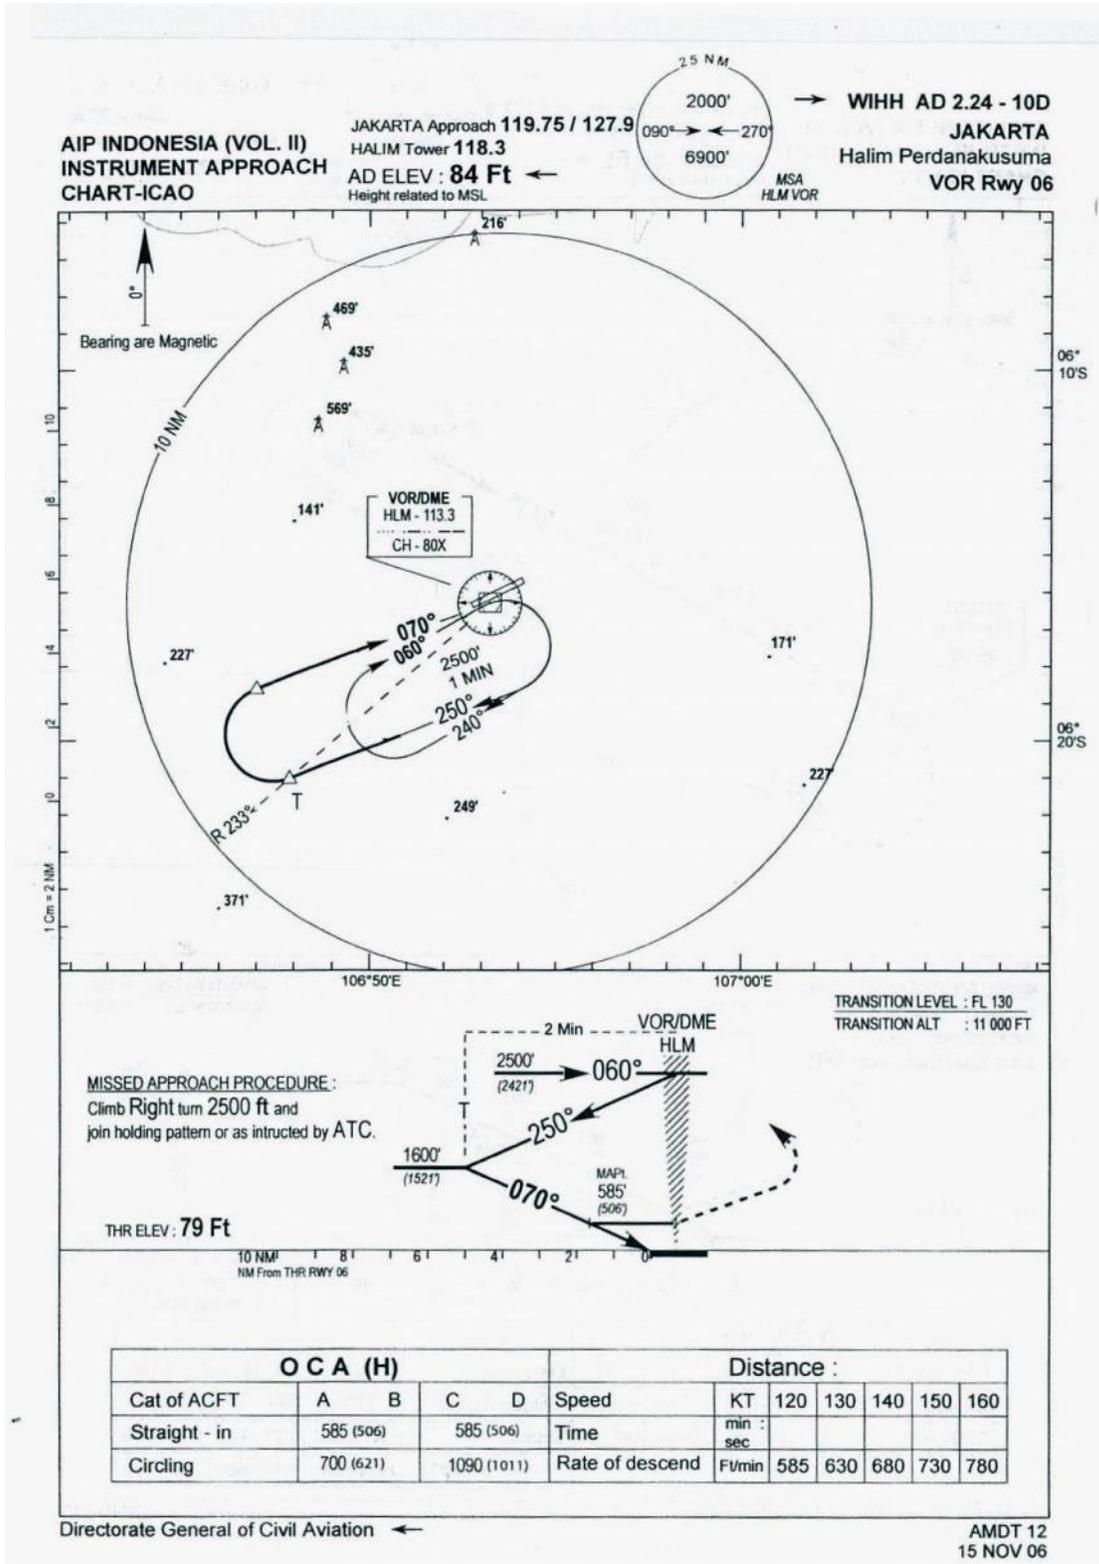
Figure 11: VOR approach procedure for runway 06 Halim

The VOR Approach procedure for runway 06 stated that the turn altitude was 1,600 feet and the Minimum Sector Altitude (MSA) in the area from 090 degrees clockwise to 270 degrees of HLM VOR was 6,900 feet.

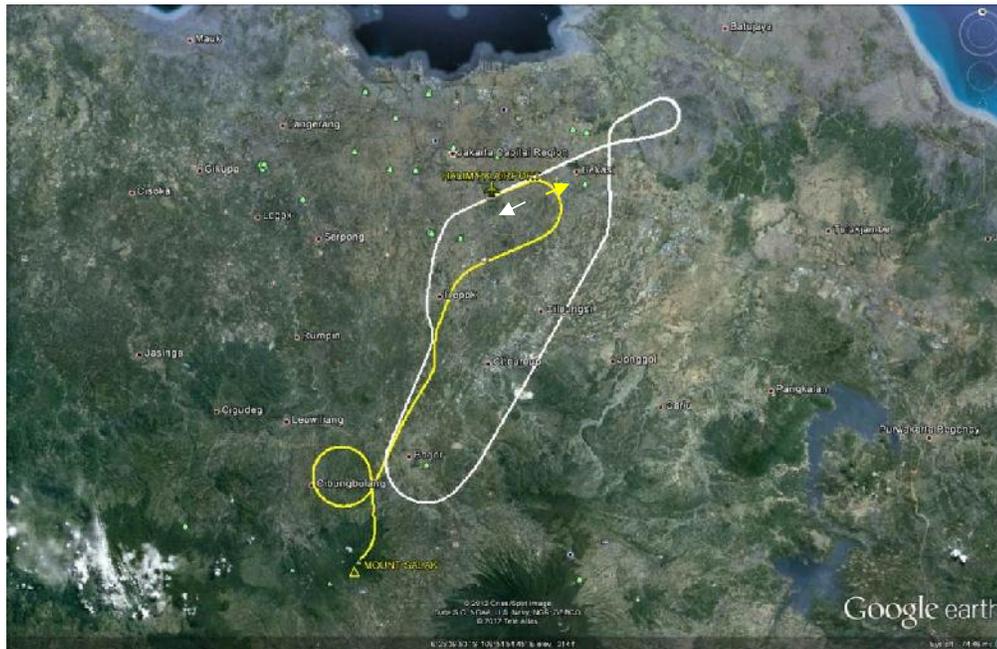
Figure 15: The first and second flight paths

The flight path of the first (white line) and second demonstration flight (yellow line) based on FDR data (figure 14).

This limited information may have given the pilot the understanding that the approved route was toward the point on the 200 radial at 20 Nm from HLM VOR and return to Halim. Evidence from the FDR data as shown on figure 14, showed that the first and the second demonstration flights reached this point. Understanding that the approved route was to a point instead of an area, may have contributed to the pilot's lack of awareness of the "Bogor" area.
