No. 9

British European Airways Corporation, Trident Series 1, G-ARPY,
accident 1 mile SSW of Felthorpe, near Norwich, Norfolk,
United Kingdom, on 3 June 1966. Civil Accident Report EW/C/0130,
dated June 1968, released by the Board of Trade, United Kingdom, C.A.P. 311

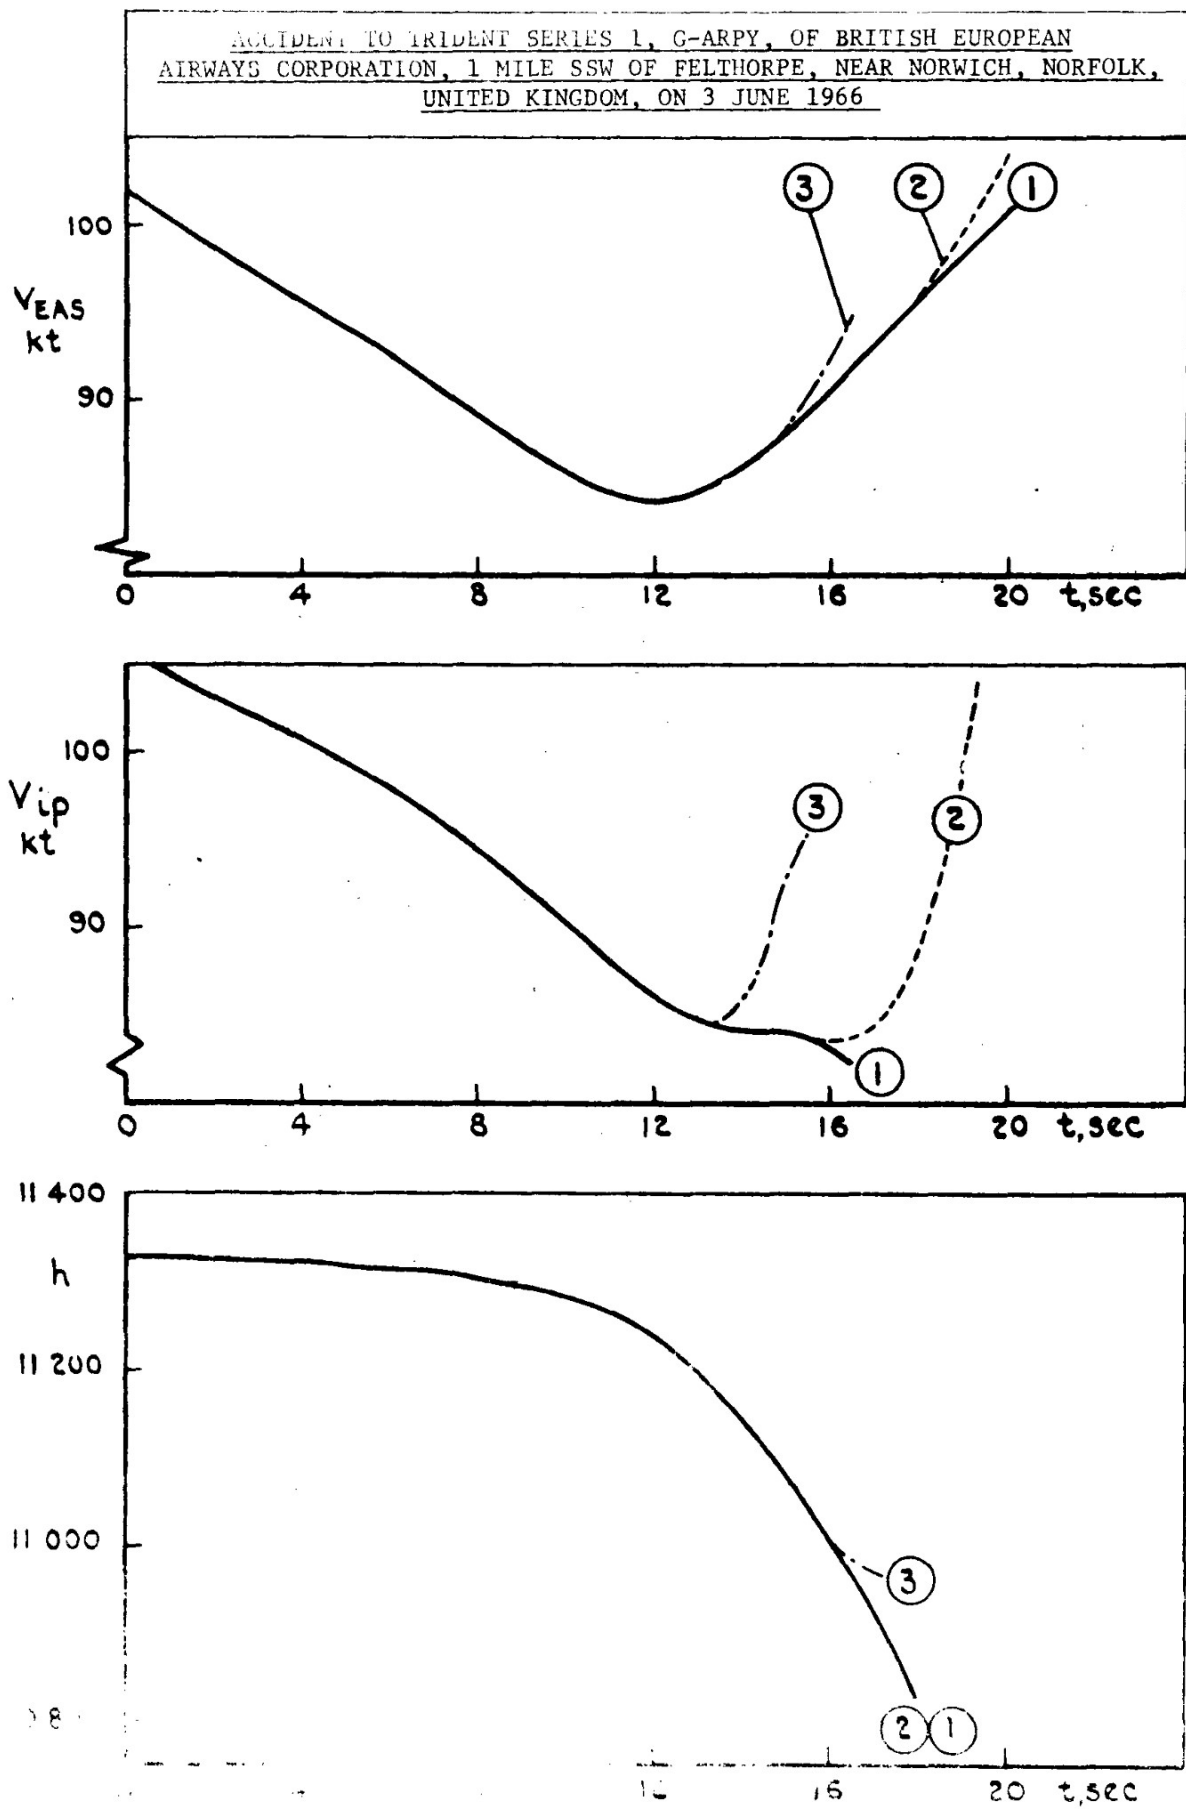
In the particular test under consideration it is of interest to see whether a situation could have arisen in which recovery would have proceeded without mishap and yet there would be little evidence immediately available to someone examining the recorded data, much less to the pilot, of how narrowly disaster had been avoided. From among a number of calculations made to test the sensitivity of the deteriorating situation to the pilot's action, as well as the sensitivity of the calculation process to the tightness of the correlation tolerance allowed between calculated and measured pitch attitude angle, one was chosen which illustrates this point well. In this calculation the pilot is assumed to start his final push forward of the stick half a second earlier than he seems to have done in reality.

Fig. 9-5 - Effect of different recovery action on pitch attitude (angle of inclination), H° and on normal acceleration factor, n
