PART ISUMMARIES OF AIRCRAFT ACCIDENT REPORTS AS PREPARED BY ICAONo. 1

British Midland Airways Limited, Argonaut, G-ALHG accident at Stockport, Cheshire, England, on 4 June 1967. Report, not dated, released by the Board of Trade, United Kingdom. C.A.P. 302 on 22 August 1968

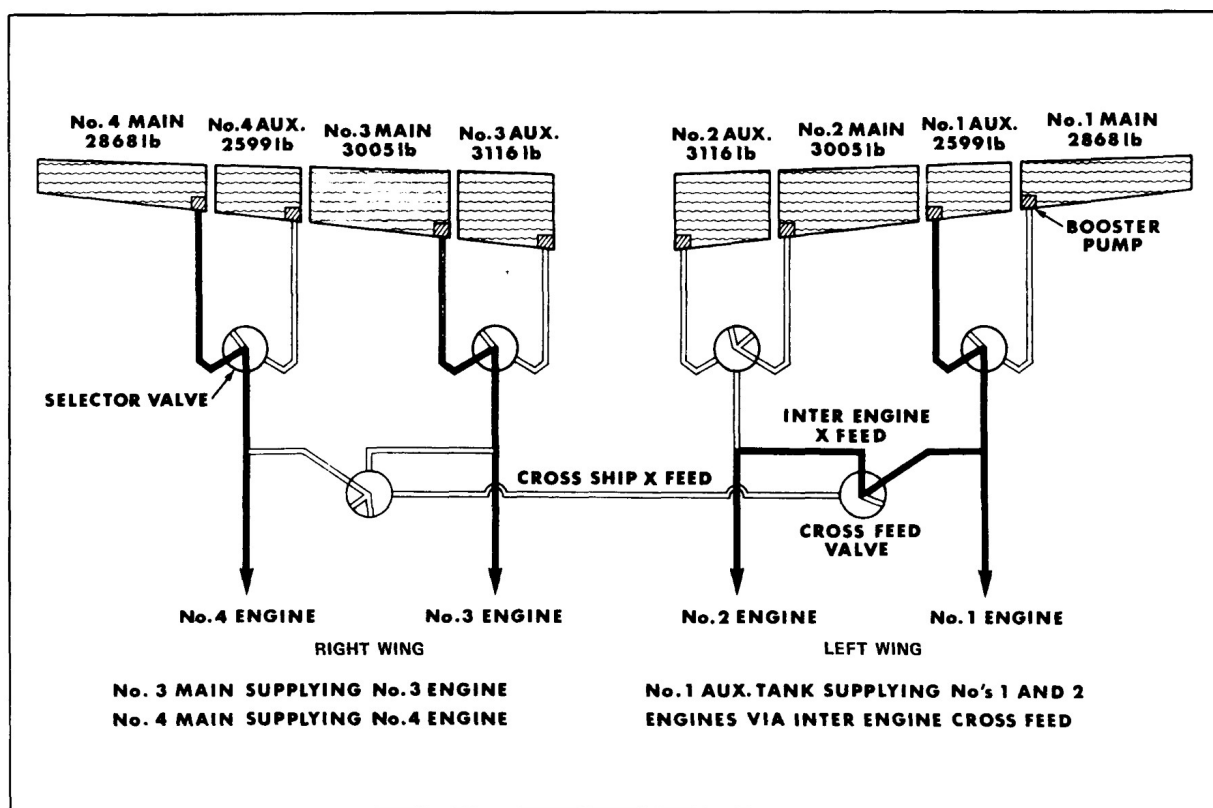
Figure 1-7. Fuel System Diagram

There are booster pumps in or at the outlet of each tank and cross feed lines are provided so that either engine of each pair can be fed from the tank supplying the other (inter-engine cross feed), or any tank in one wing can be used to supply engines on the other wing (cross-ship cross feed) (see Fig. 1-7). The tank selector valves and cross feed valves are similar in design. The four tank selector controls are located in front of and concealed by the throttle controls on the left side of the pedestal within reach of the pilot in the left hand seat. They have three positions: in the fully forward and down position the respective main tank is "ON" and the auxiliary tank is "OFF", in the midway position the main tank is "OFF" and the auxiliary tank is "ON". In the fully aft and up position both tanks are "OFF". The two cross feed controls are located in front of and concealed by throttle controls on the right side of the pedestal within reach of the pilot in the right-hand seat. They have also three positions: in the fully forward and down position the cross feed system is "OFF", in the midway position it provides "inter-engine cross feed" between both engines on the same wing, in the fully aft and up position it provides "cross-ship cross feed".

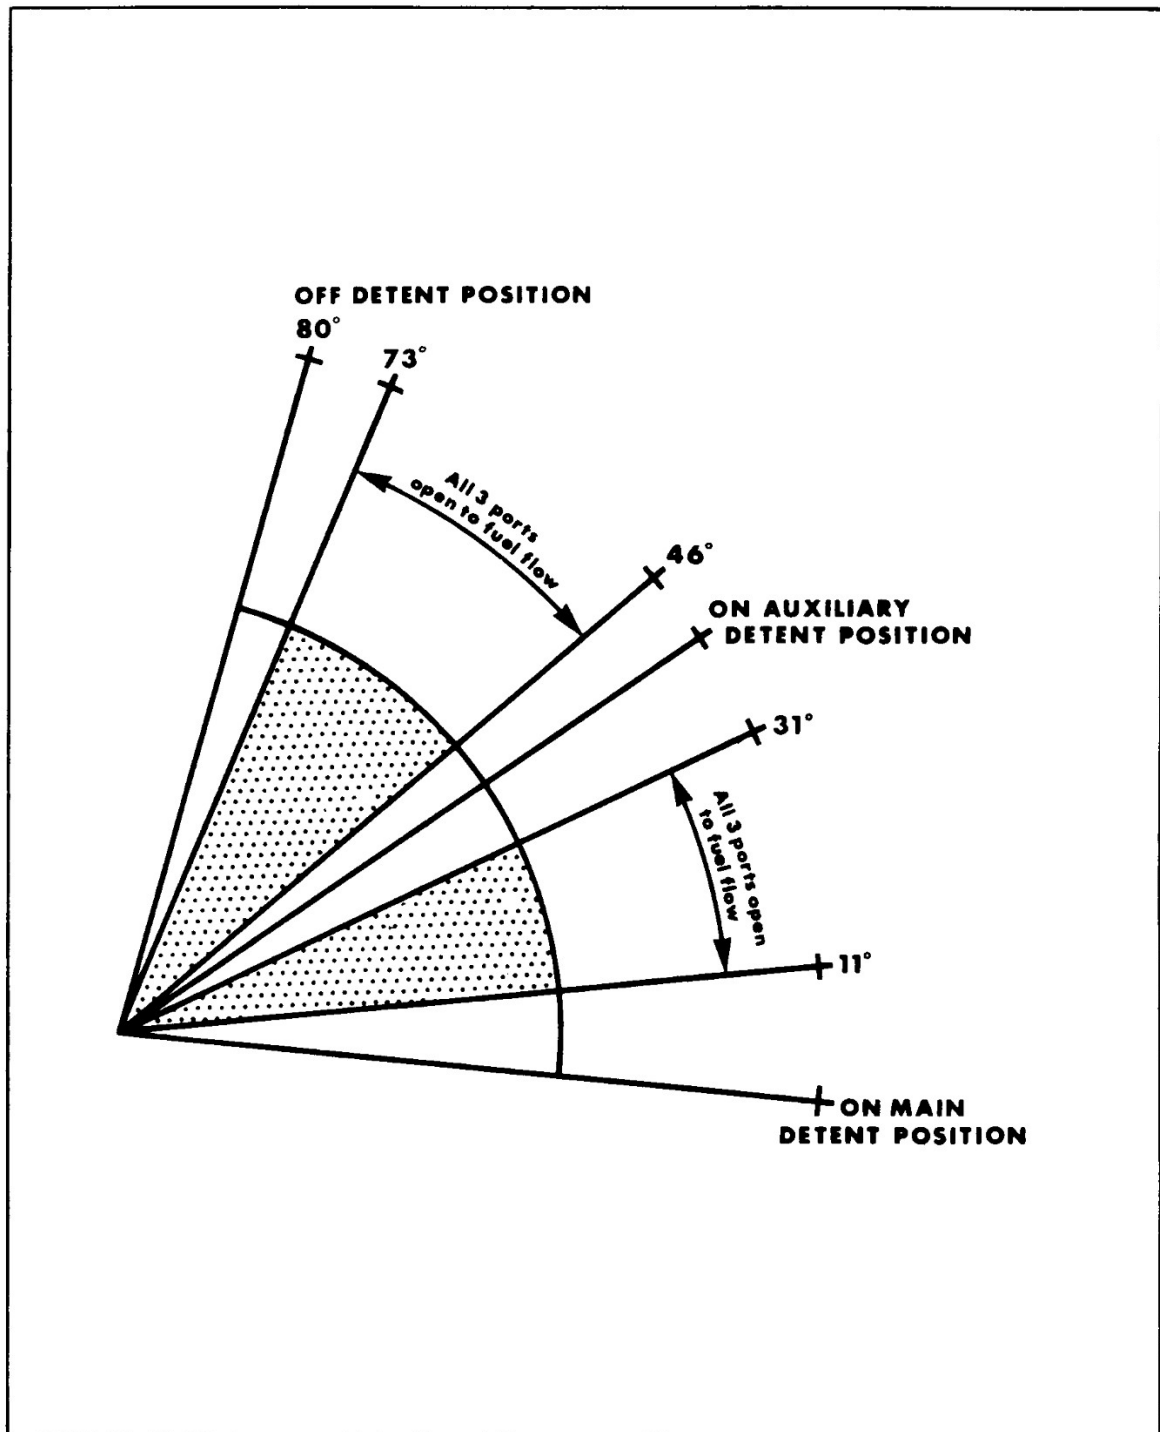
Figure 1-9. Tank Selector Cock Handle

- (b) Failure of those responsible for the design of the fuel system or the fuel valves to warn users that failure by a small amount to place the actuating levers in the proper position would result in inadvertent fuel transfer on a scale involving this risk after a long flight.

The only recommendation made was that express warning should be given by the Air Registration Board to all operators of Argonauts and other aircraft with similar fuel systems and valves with design characteristics similar to the Parker valves of the consequences of the cracking of the fuel valves either as a result of faulty rigging or of the failure of the pilot to ensure that the selector lever is in the correct position. The warning should be contained in flight and maintenance manuals, and should be the subject of prompt action.
