No. 24

British European Airways Corporation, de Havilland Comet 4B, G-ARCO, accident about 100 miles east of Rhodes, on 12 October 1967. Civil Accident Report No. EW/A/0102, dated April 1968, released by the Board of Trade, United Kingdom, C.A.P. 305

ACCIDENT TO DE HAVILLAND COMET 4B, G-ARCO, OF BRITISH EUROPEAN AIRWAYS
CORPORATION ABOUT 100 MILES EAST OF RHODES, ON 12 OCTOBER 1967

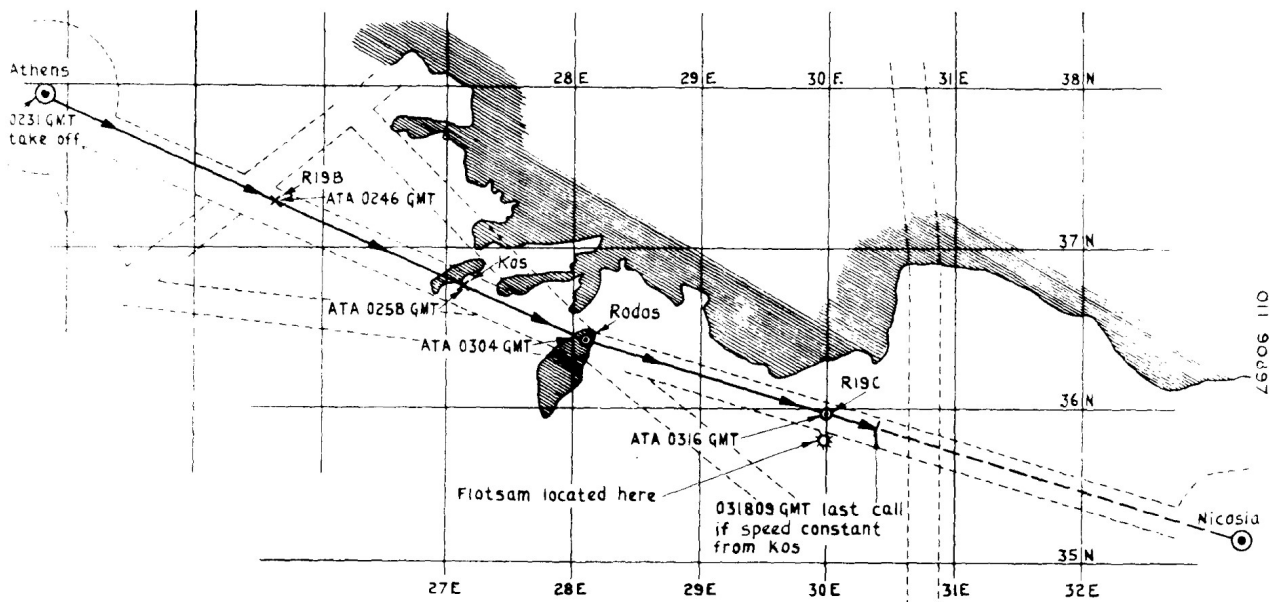
Fig. 24-1 - Times and positions of aircraft along track.

The recording of the R/T communications with Nicosia shows that G-ARCO called them to establish contact; the time of this call was 0318 hours + 9 seconds and it is estimated that the aircraft would then have been at a position 35°51'N, 30°17'E, approximately 15 NM to the east of R19C. Nicosia replied to the aircraft with an instruction to go ahead with its message but no further transmission was heard. Nicosia continued to try to contact the aircraft but without result and overdue action was therefore taken. At 0440 hours R.A.F. Search and Rescue aircraft took off from Akrotiri; at 0625 hours wreckage from G-ARCO was sighted in the vicinity of R19C, the last reported position. The aircraft's estimated track from Athens to the crash position is shown in Fig. 24-1.
