# National Transportation Safety Board Aviation Accident Final Report

<b>Location:</b>	Fort Lauderdale, FL	<b>Accident Number:</b>	DCA17MA022
<b>Date &amp; Time:</b>	10/28/2016, 1751 EDT	<b>Registration:</b>	N370FE
<b>Aircraft:</b>	MCDONNELL DOUGLAS MD 10-10F	<b>Aircraft Damage:</b>	Substantial
<b>Defining Event:</b>	Landing gear collapse	<b>Injuries:</b>	2 None
<b>Flight Conducted Under:</b>	Part 121: Air Carrier - Non-scheduled

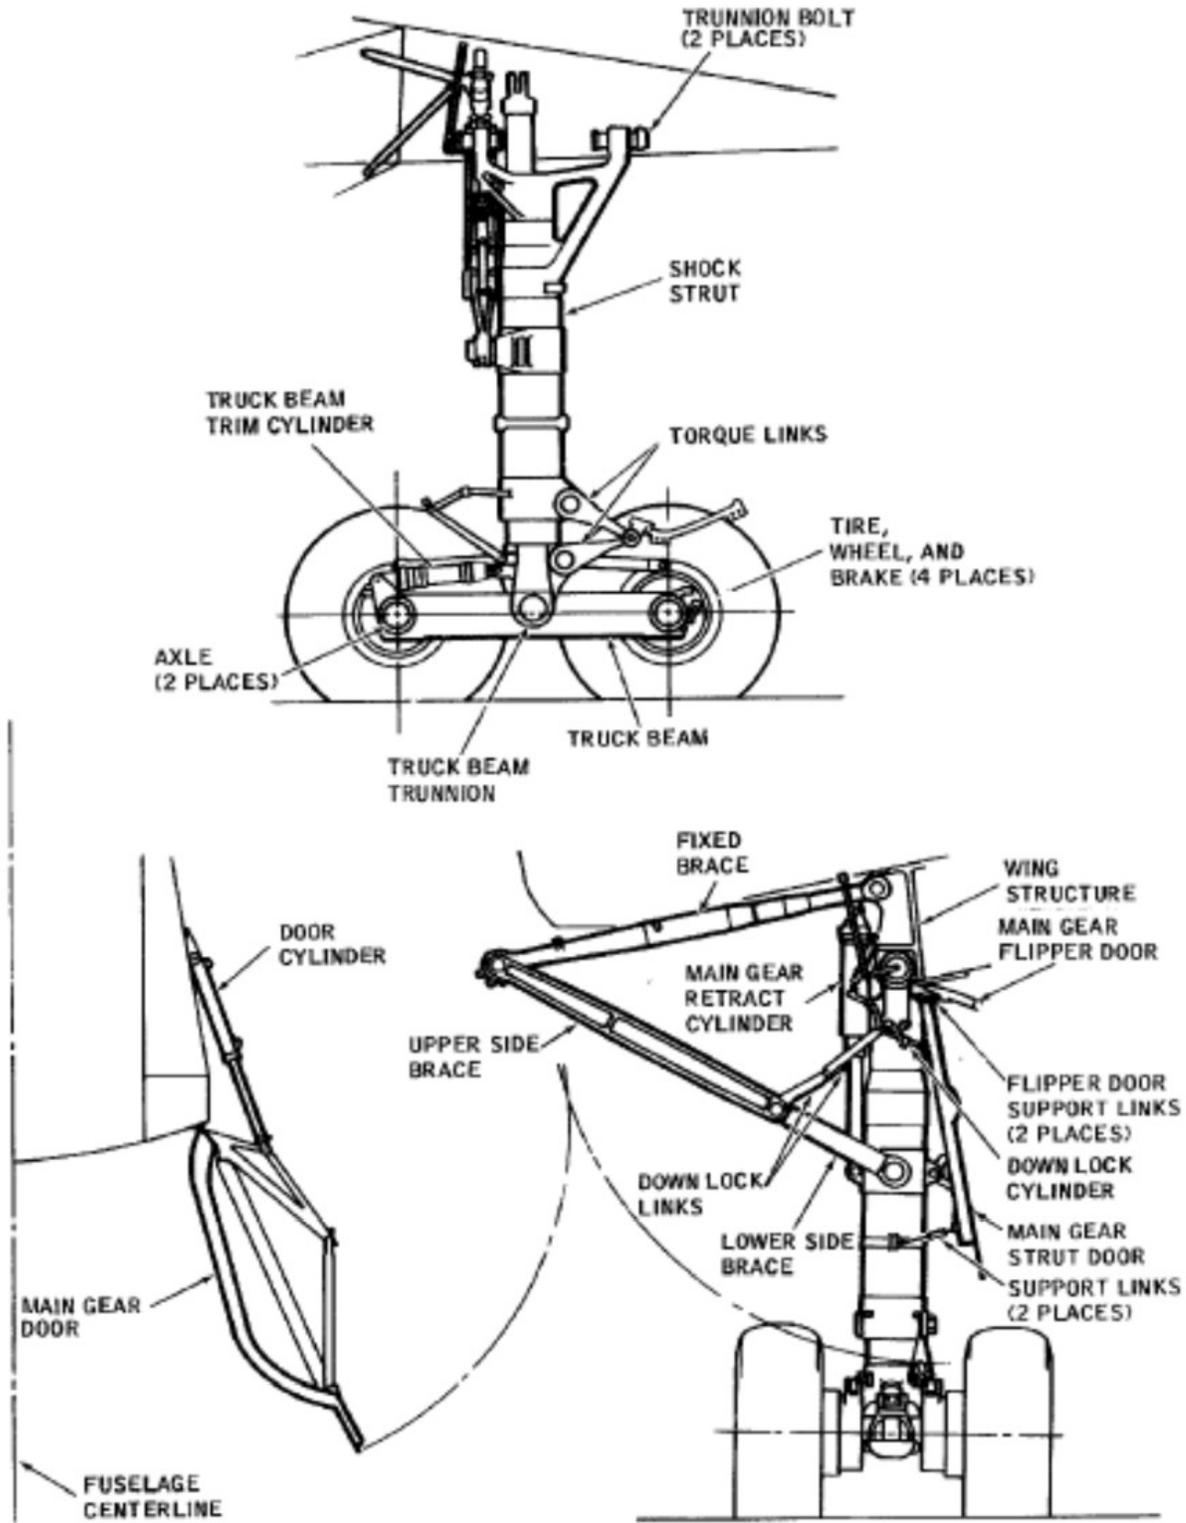
Figure 1. Diagram of MD-10-10F MLG (right shown)

The airplane came to rest off the left side of runway 10L near the A4 taxiway. The outer cylinder of the left MLG was fractured midway through the air filler valve bore on the aft side. The outer cylinder of the left MLG shock strut fractured around its entire circumference; the upper portion of the cylinder remained intact and attached to the airplane at the forward and aft trunnion lugs (figure 1 shows a diagram of an MD-10-10F MLG and figure 2 shows the upper portion of the accident MLG). No anomalies were noted with the trunnion lugs or trunnion bolt attachment points.

The lower segment of the landing gear was folded aft into the left side inboard flap. The lower portion of the gear remained attached to the MLG side brace assembly. The left MLG truck beam remained attached to the lower portion of the cylinder and shock strut at the pivot pin. The truck beam exhibited a crack running aft from the No. 1 wheel position axle to a 3-inch-long by 2-inch-wide hole on the top side near the pivot area (see MLG diagram in figure 3).
