1. Report No. NTSB-AAR-76-19		2. Government Accession No.		3. Recipient's Catalog No.	
4. Title and Subtitle Aircraft Accident Report -- Overseas National Airways, Inc., Douglas DC-10-30, N1032F, John F. Kennedy International Airport, Jamaica, New York, November 12, 1975				5. Report Date December 16, 1976

AIRCRAFT ACCIDENT REPORT

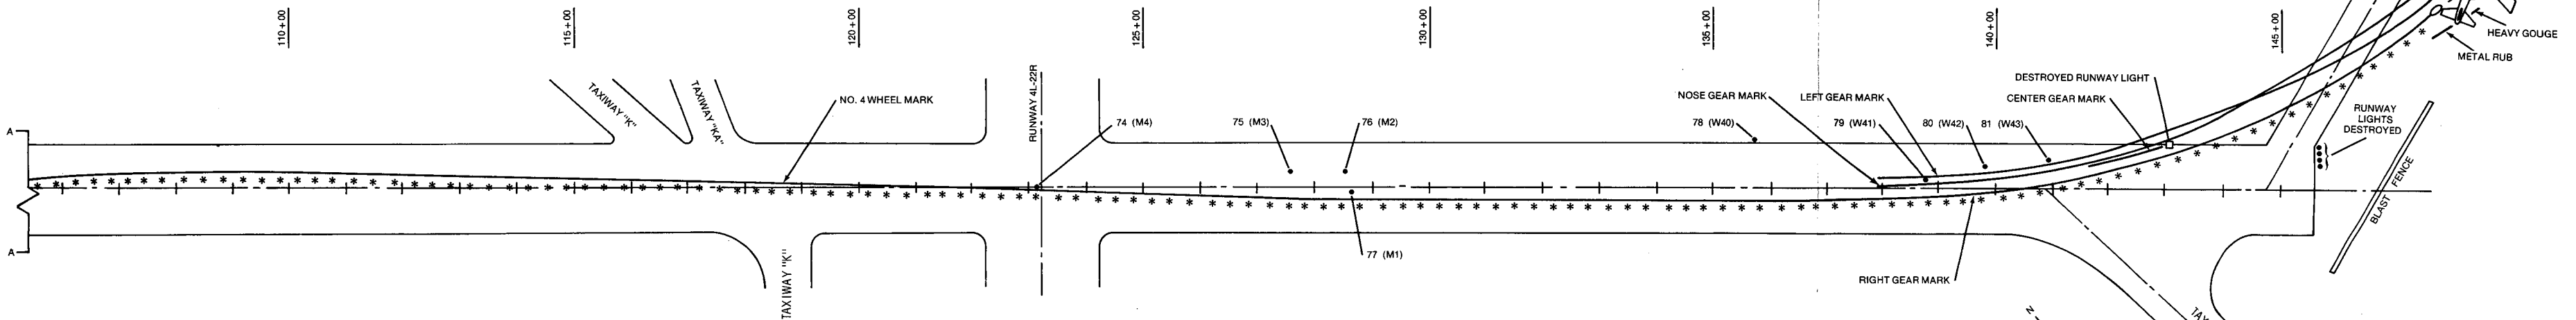
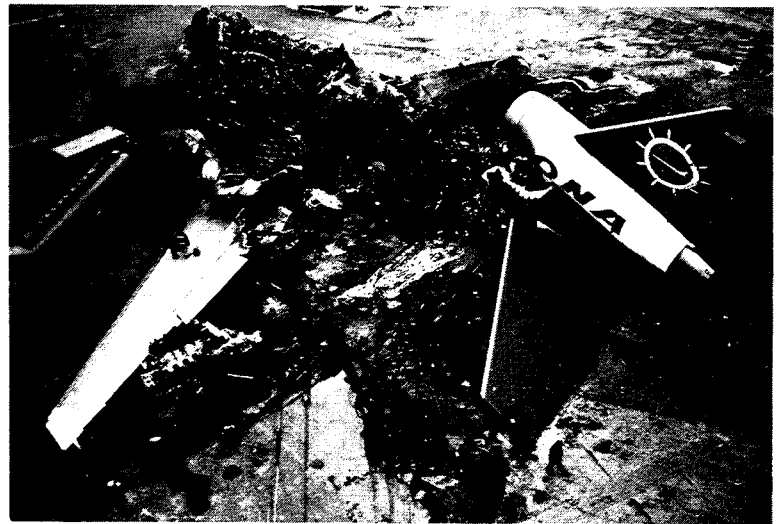
NOTE: THE WIDTH OF RUNWAY 13R HAS ACTUALLY BEEN EXTENDED FROM 150 FT. (AS SHOWN ON THIS CHART) TO 300 FT. THIS WIDTH EXTENSION WAS MADE TO ACCOMMODATE WIDE-BODIED JETS.
