# NATIONAL TRANSPORTATION SAFETY BOARD

## AIRCRAFT ACCIDENT REPORT

MIDWEST EXPRESS AIRLINES, INC.,  
DC-9-14, N100ME  
GENERAL BILLY MITCHELL FIELD  
MILWAUKEE, WISCONSIN  
SEPTEMBER 6, 1985

NTSB/AAR-87/01

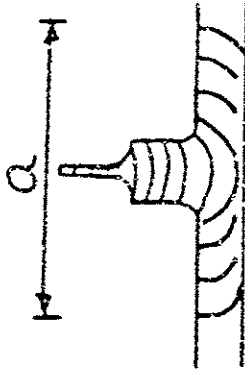
o CYCLES FROM A THROUGH CRACK TO RUPTURE - 1000 CYCLES (TYP)

TOTAL CYCLES TO RUPTURE - 21,000 CYCLES (TYP)

CYLINDER CRACK

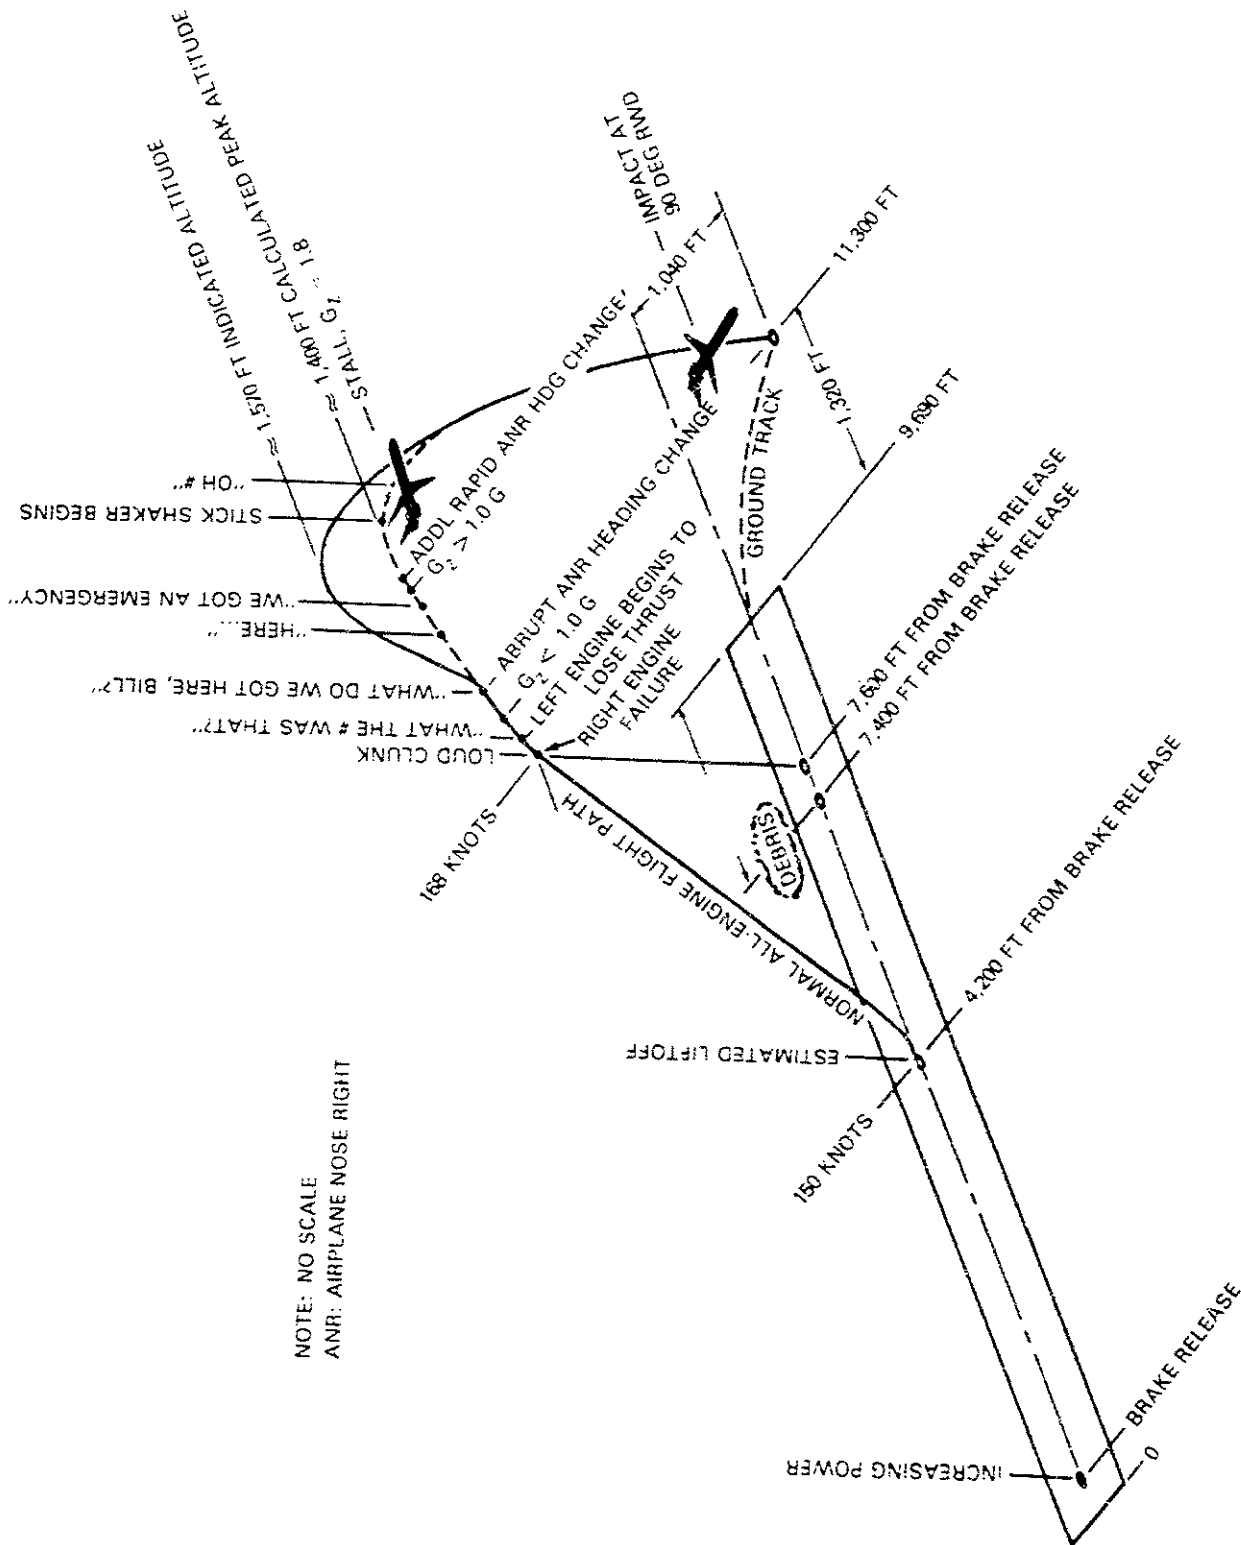
Figure 5.—Representation of the estimated flightpath and sequence of events.

The Safety Board determined that the sideslip angle reached about 15° and that the total yaw reached 20° during this interval. The airplane heading deviated even farther to the right and at a more rapid rate from the eighth to the ninth second, indicating that a large roll angle was developing. As the airplane started to descend, the normal acceleration forces increased rapidly. About 1 second later, 9.6 seconds after the right engine failure, the stall warning stickshaker activated when the normal acceleration indication was 1.5 G. Normal acceleration increased to about 1.8 G while the descending right turn continued, indicating that the airplane entered an accelerated stall at about 148 knots. The airplane crashed about 5 seconds later. (See figure 5.)
