# **NATIONAL TRANSPORTATION SAFETY BOARD**

## **AIRCRAFT ACCIDENT REPORT**

**MIDAIR COLLISION OF  
NABISCO BRANDS, INC.,  
DASSAULT FALCON, DA50, N784B AND  
AIR PEGASUS CORPORATION  
PIPER ARCHER, PA28-181, N1977H  
FAIRVIEW, NEW JERSEY  
NOVEMBER 10, 1985**

**NTSB/AAR-87/05**

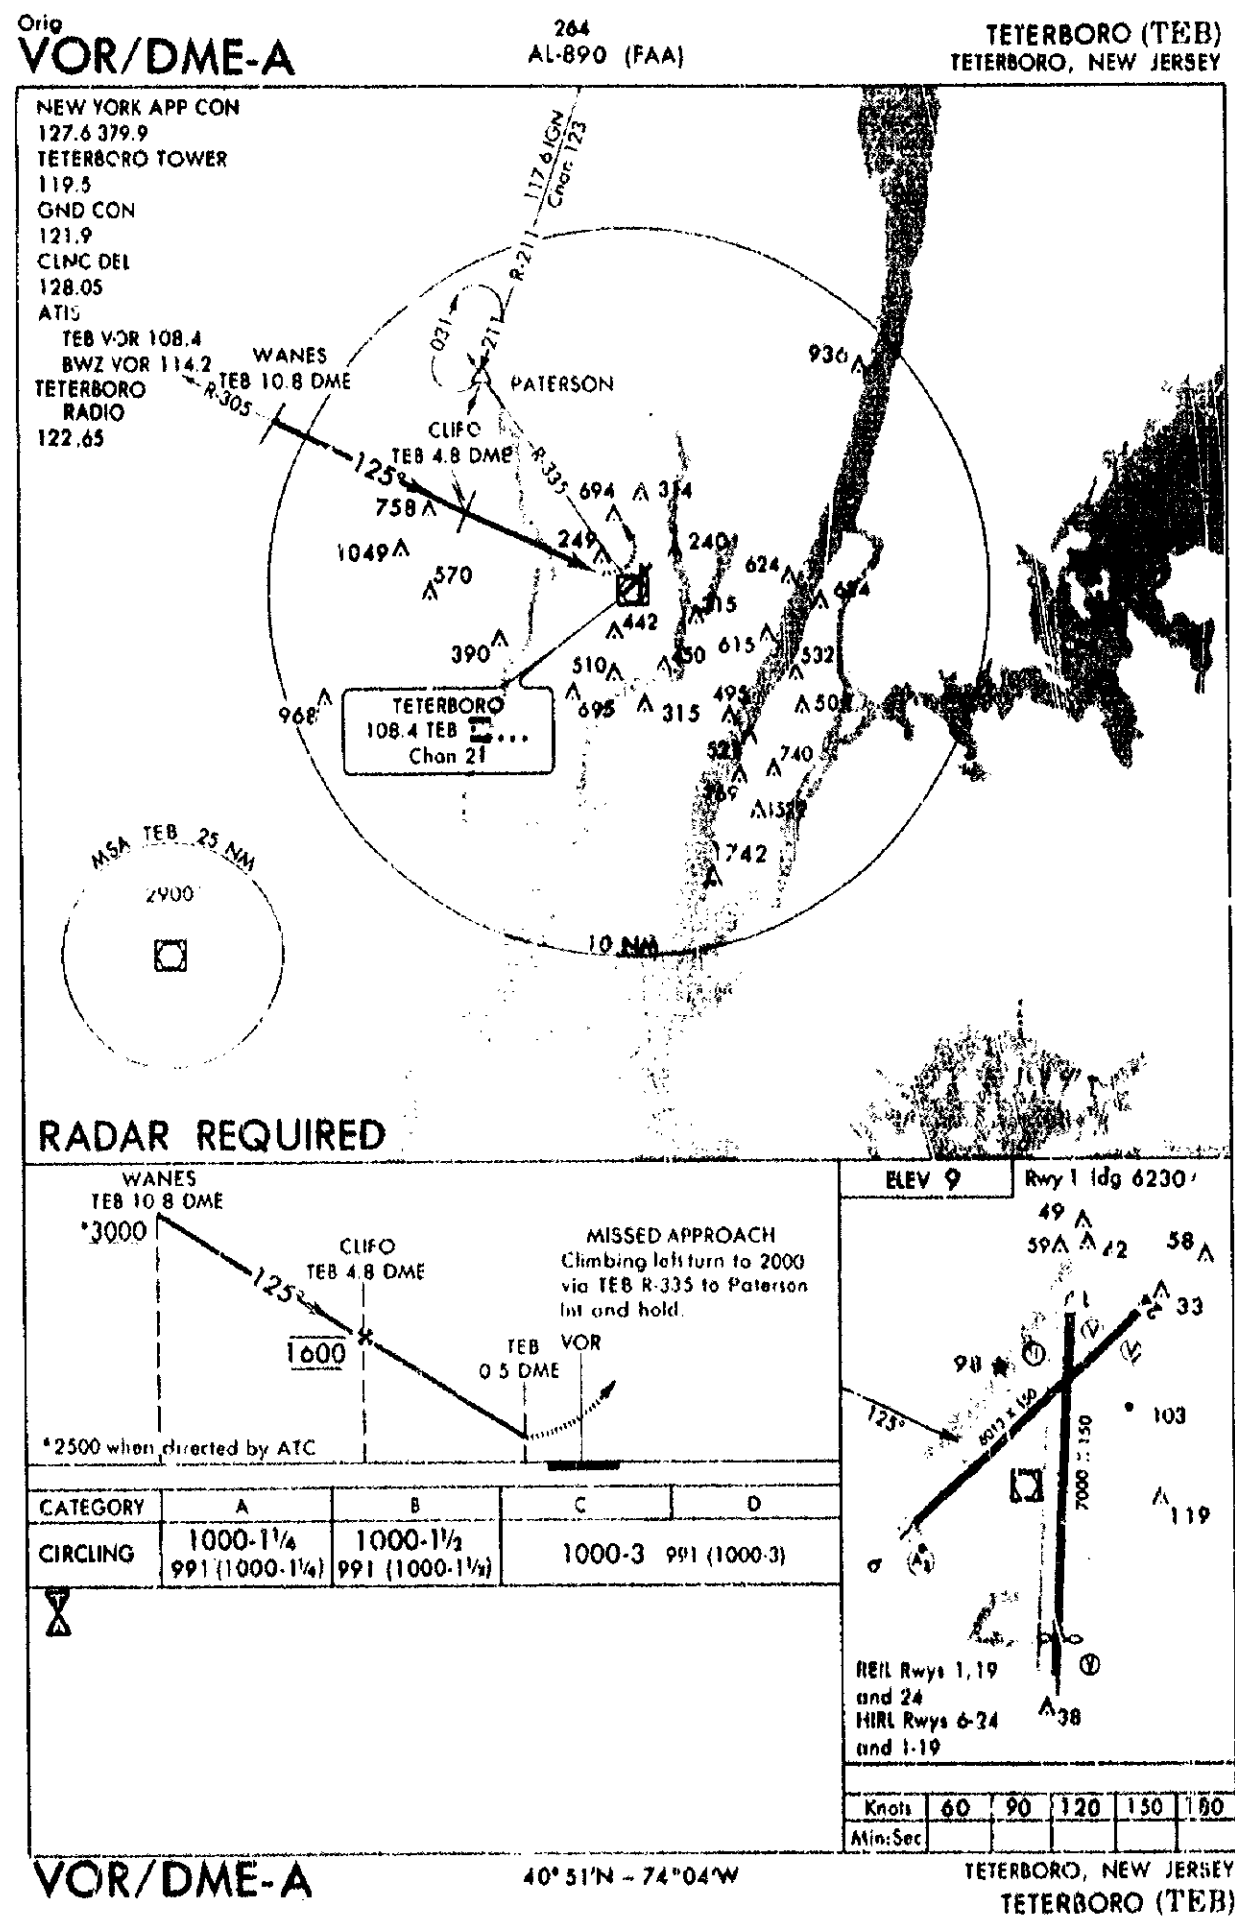
Figure 1.—TEB VOR/DME-A instrument approach procedure chart.

At 1716:55 the departure controller transmitted, "Falcon seven eight four bravo is three miles west of CLIFO, turn right heading zero, niner zero two thousand until on the TEB three zero five radial cleared VOR DME alpha approach." (See figure 1.) The captain correctly read back the clearance. At 1717:29, he stated, "They're everywhere. . . ." Twelve seconds later, the controller stated, "... that was obviously not

The VOR distance measuring equipment (DME) located on the TEB airport was operating at the time of the accident. There were no reported problems with the navigation aid. The standard instrument approach procedure used by the DA50 was the VOR/DME-A. It begins at WANES, 10.3 DME fix on the 305° radial of the TEB VOR at or above 3,000 feet, and continues inbound to the CLIFO final approach fix, 4.8 DME from TEB. There is a mandatory crossing altitude of 1,600 feet at CLIFO. The procedure is completed by making a left or right circling turn from overhead the airport. The minimum descent altitude for all categories of aircraft is 1,000 feet msl. (See figure 1.)

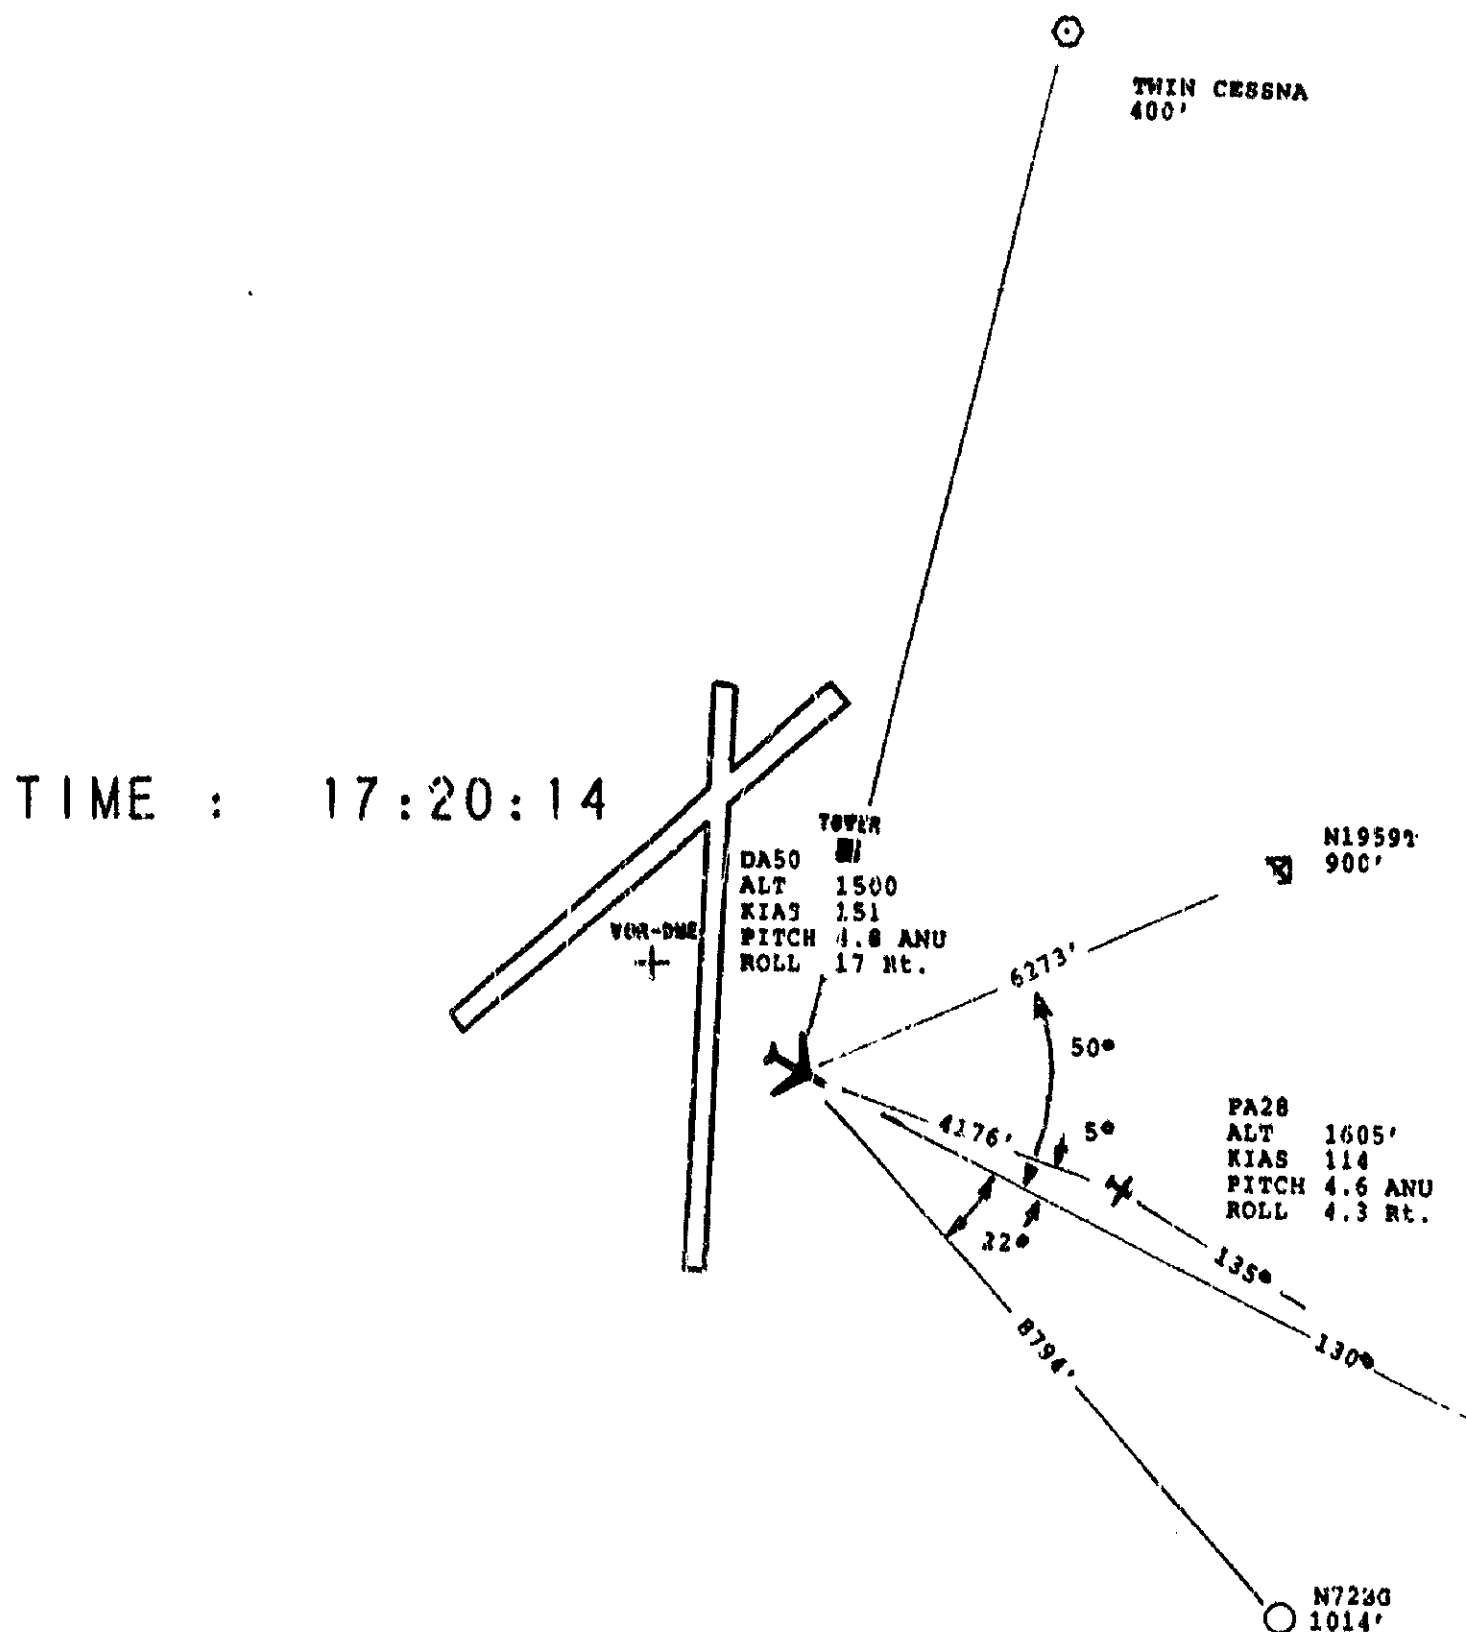
Figure 4.—Radar positions of aircraft at 1720:14.

Because the local controller was not aware of the DA50, he was surprised when the captain reported over the airport, but he managed to identify the DA50, sequence it with the other landing traffic, and issue traffic advisories. He sequenced the DA50 to be number three behind N1959T and correctly described N1959T's location as turning downwind abeam the tower. However, the local controller did not provide the proper description for N1959T, a Twin Bonanza, to the flightcrew. Furthermore, the controller erroneously reported the PA28 traffic as "westbound" in two instances 9 seconds apart -- at 1720:05 and at 1720:14 and did not say that it was an overflight. (See figure 19.) At this time, N1959T was in view at about the 10 o'clock position slightly below the horizon about 1.2 miles away. The PA28 was in view just under a mile directly ahead. N72BG was about 30° to the right of the captain's viewing angle about 1.7 miles ahead and moving closer to a 1 o'clock position than the PA28. Actually, both N1959T and N72BG were turning to the downwind direction at this time. Also, at 1720:14, the DA50 made about a 15° right bank.

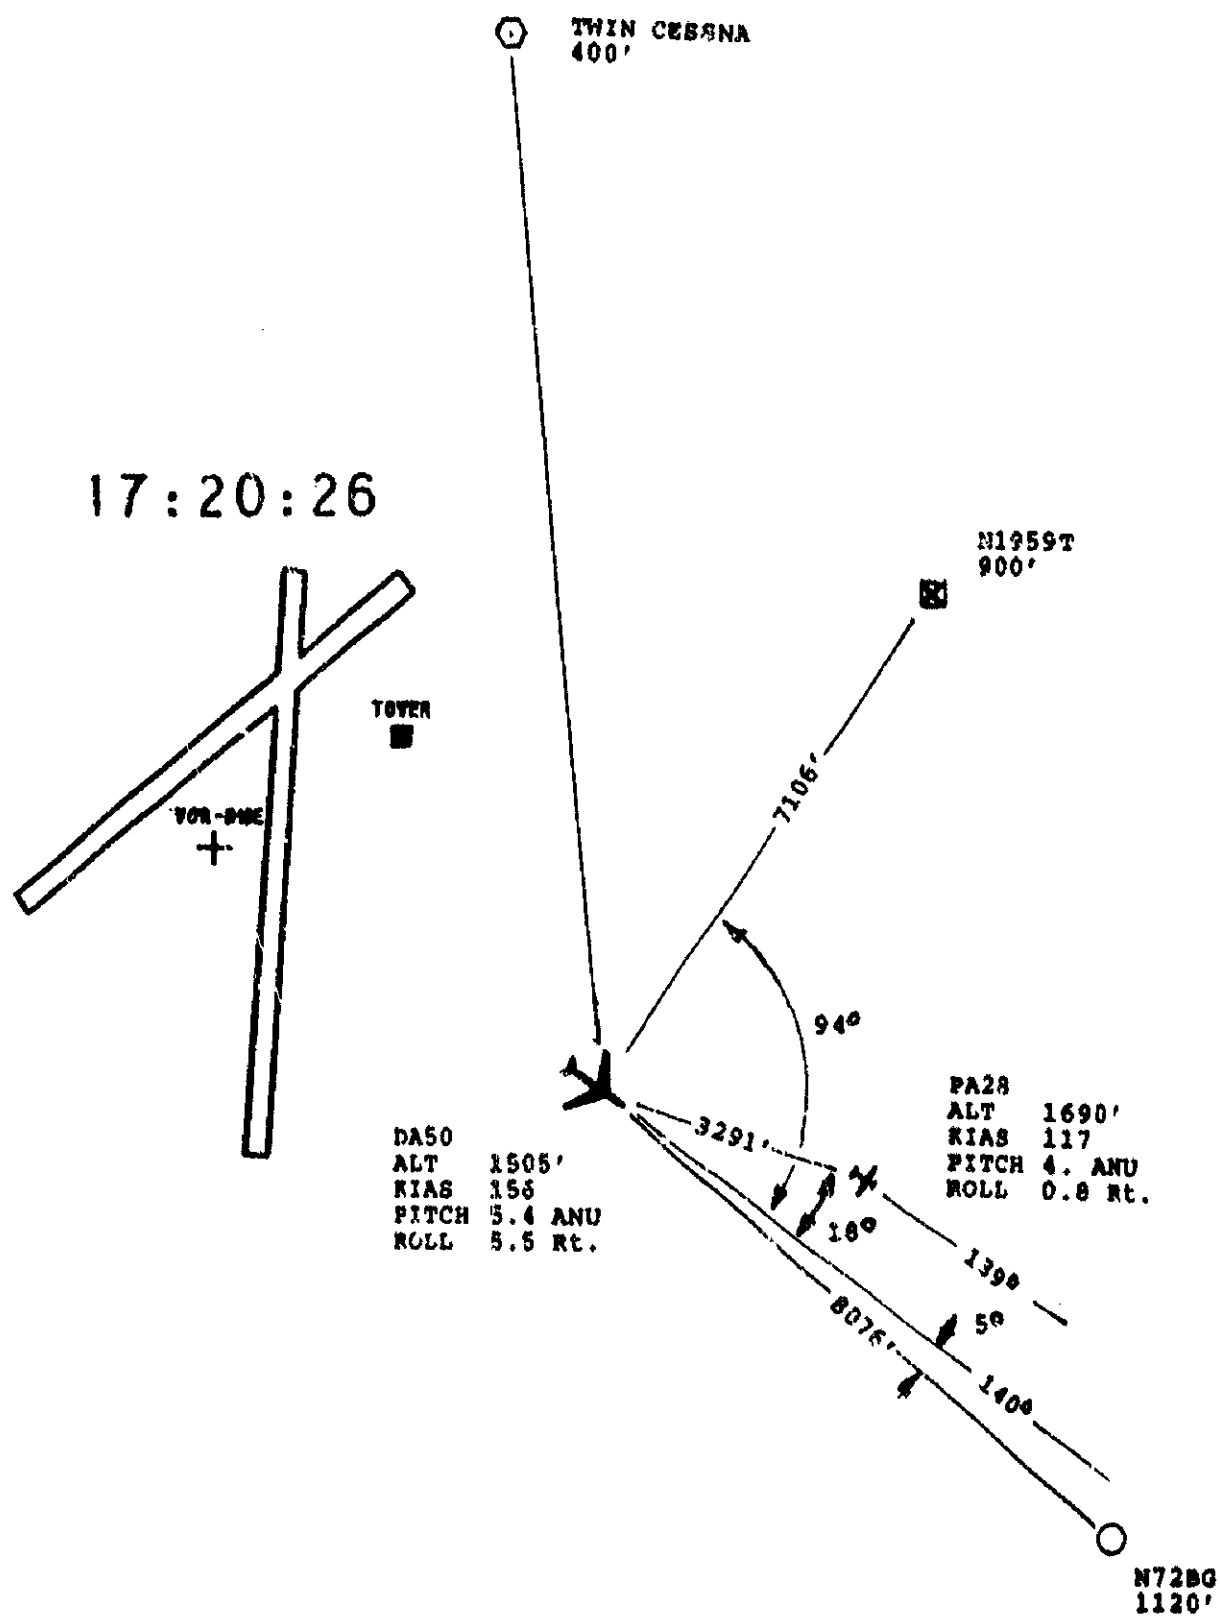
Figure 5.--Radar positions of aircraft at 1720:26.

One second later, another airplane called the controller for takeoff, but the local controller transmitted, "Seven seven hotel, traffic is a Falcon jet overtaking you from your, ah, six o'clock, ah [unintelligible]." (See figure 5.) An immediate response came from another airplane north of the airport that stated, "Uh, roger sir, ABC towers." (According to the CVR, at 1720:39, the captain stated, "Another one down low." The first officer responded with a word that was unintelligible, and then the captain stated, "Beneath him," and the first officer said, "I see him" which ended at 1720:42.) At 1720:41, the controller said, "Eight four bravo, you have the traffic sir," and the captain replied, "Affirmative." The controller then stated, "Okay, sir, maintain visual." (See figure 6.) The crew did not acknowledge the instruction.

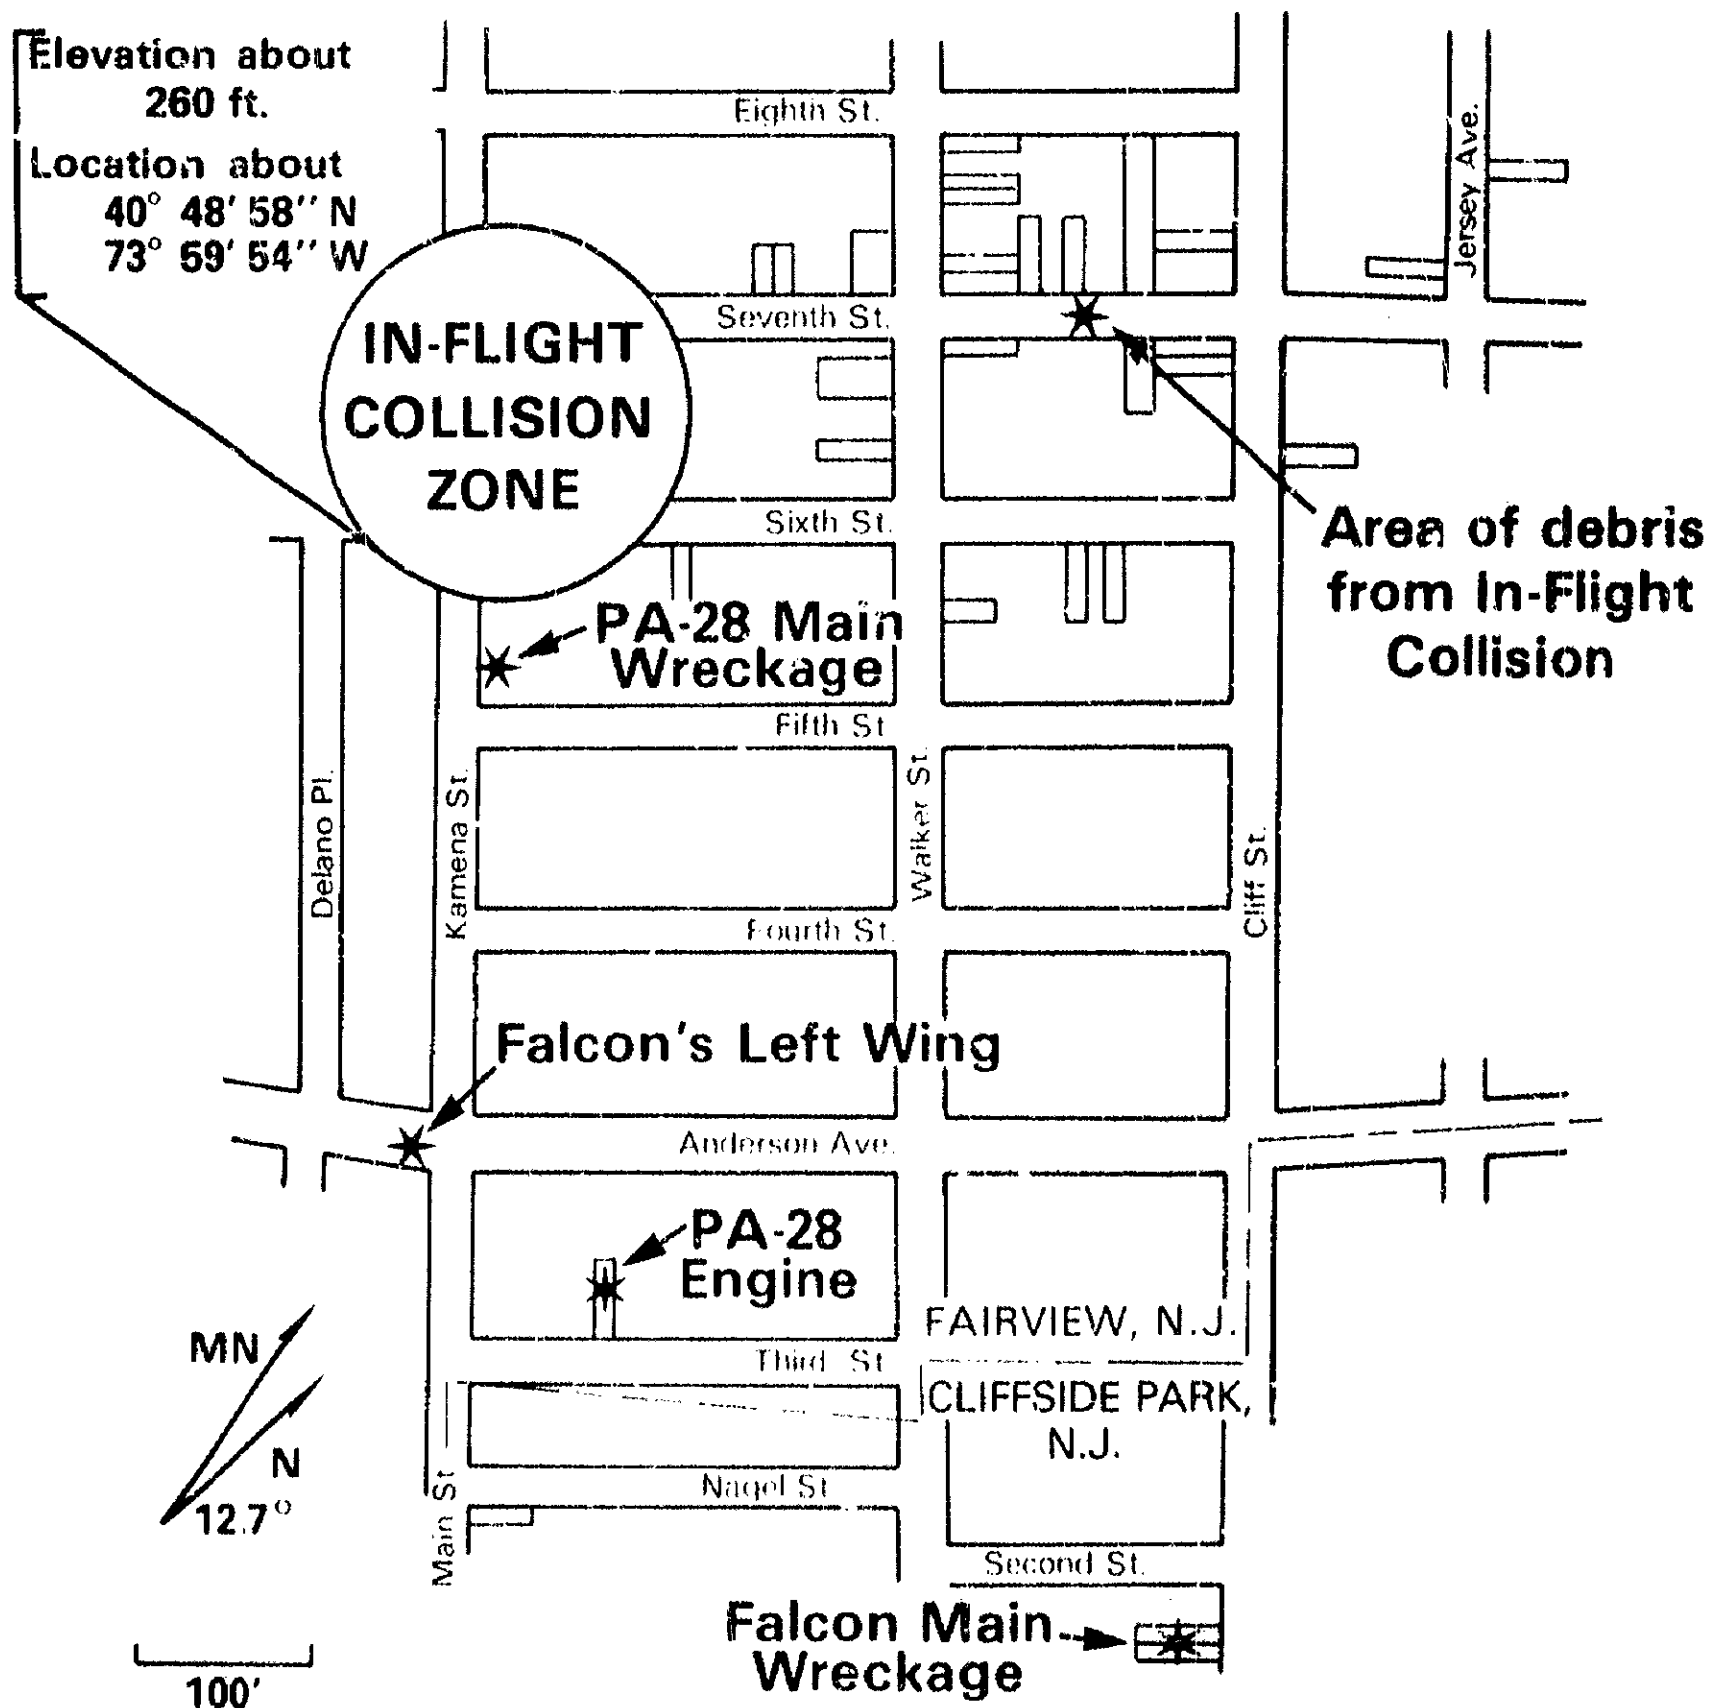
Figure 10.—Accident site location chart.

The main wreckage sites of the airplanes were about 700 feet apart. (See figure 10.) The wreckage was distributed over a four by eight city block area. Most of the wreckage scatter was concentrated in a six block area around the intersections of Walker Street and Sixth and Seventh Streets in Fairview.

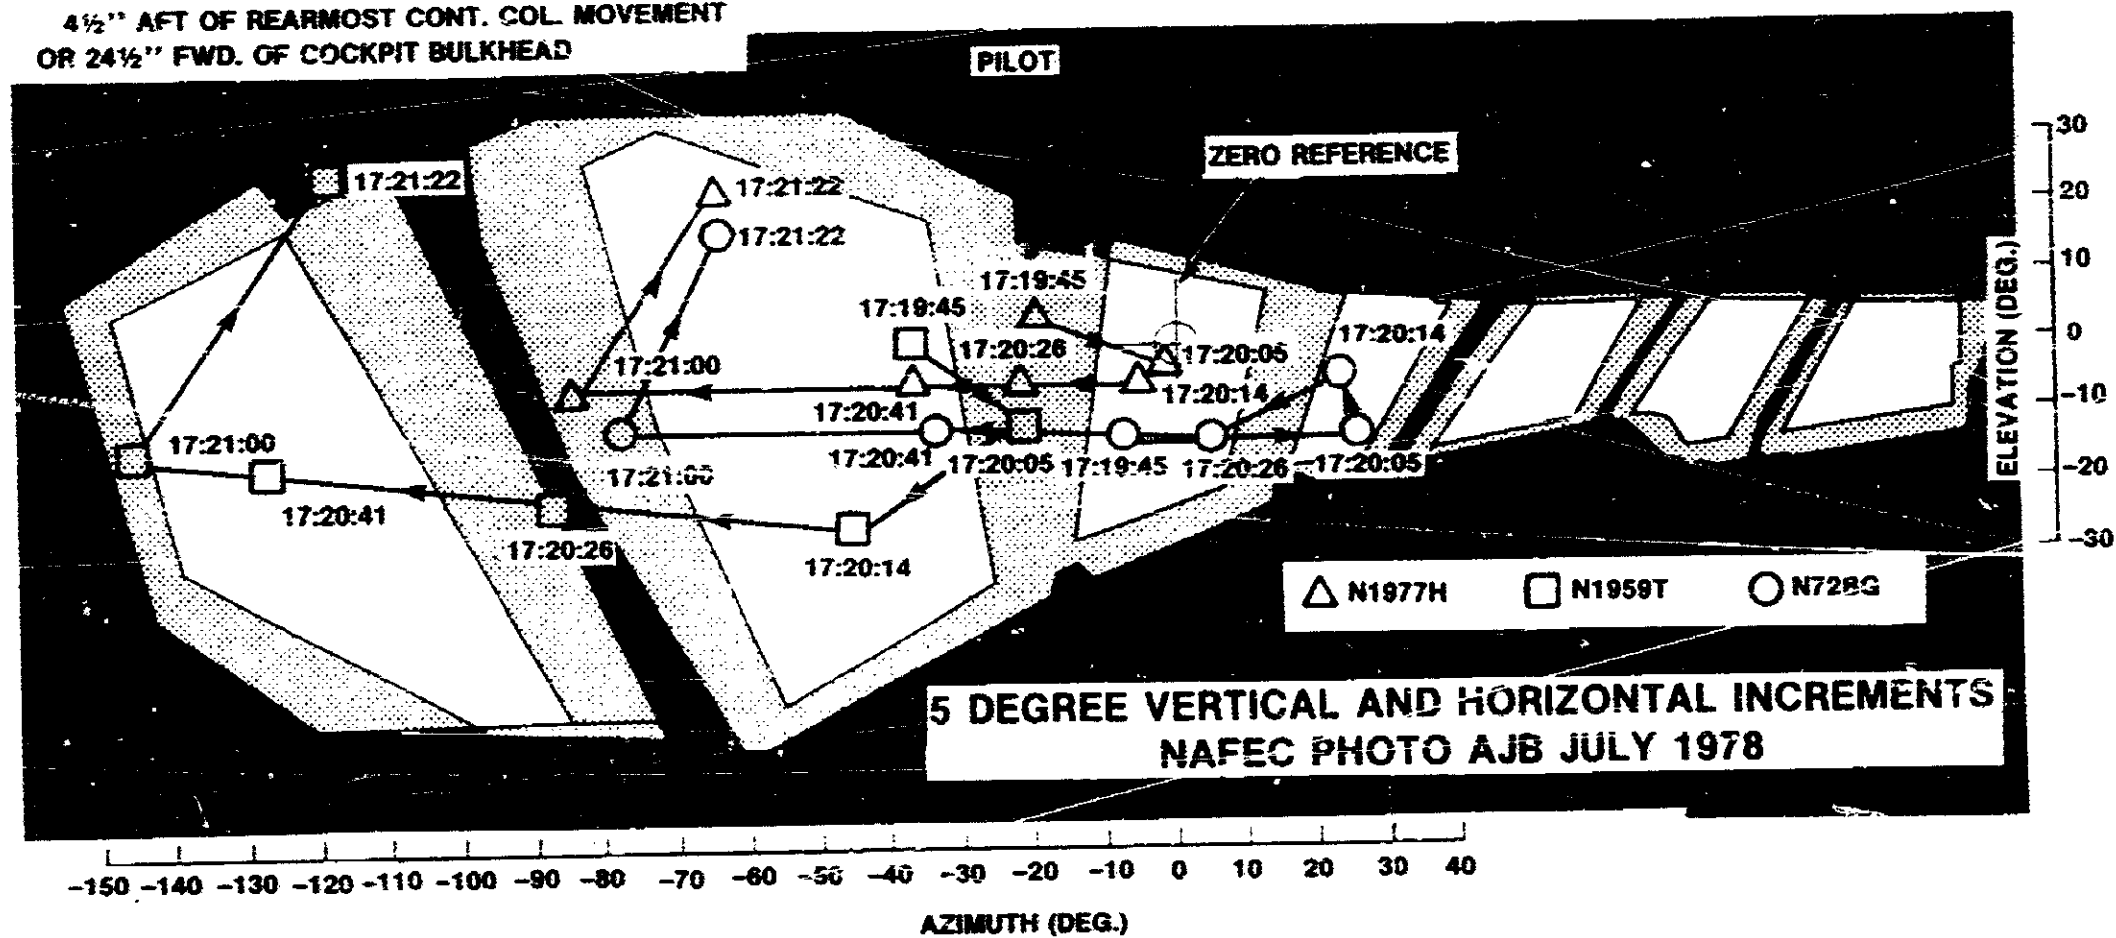
Figure 13.—Cockpit visibility study for the DA50 captain.

windshields, they are based only on a single-fixed eye position. Many potentially critical factors such as movement of the pilot's head, darkness, background clutter from ground and skyline lights, and airplane lighting were not addressed in these studies. (See figures 13, 14, and 15.)

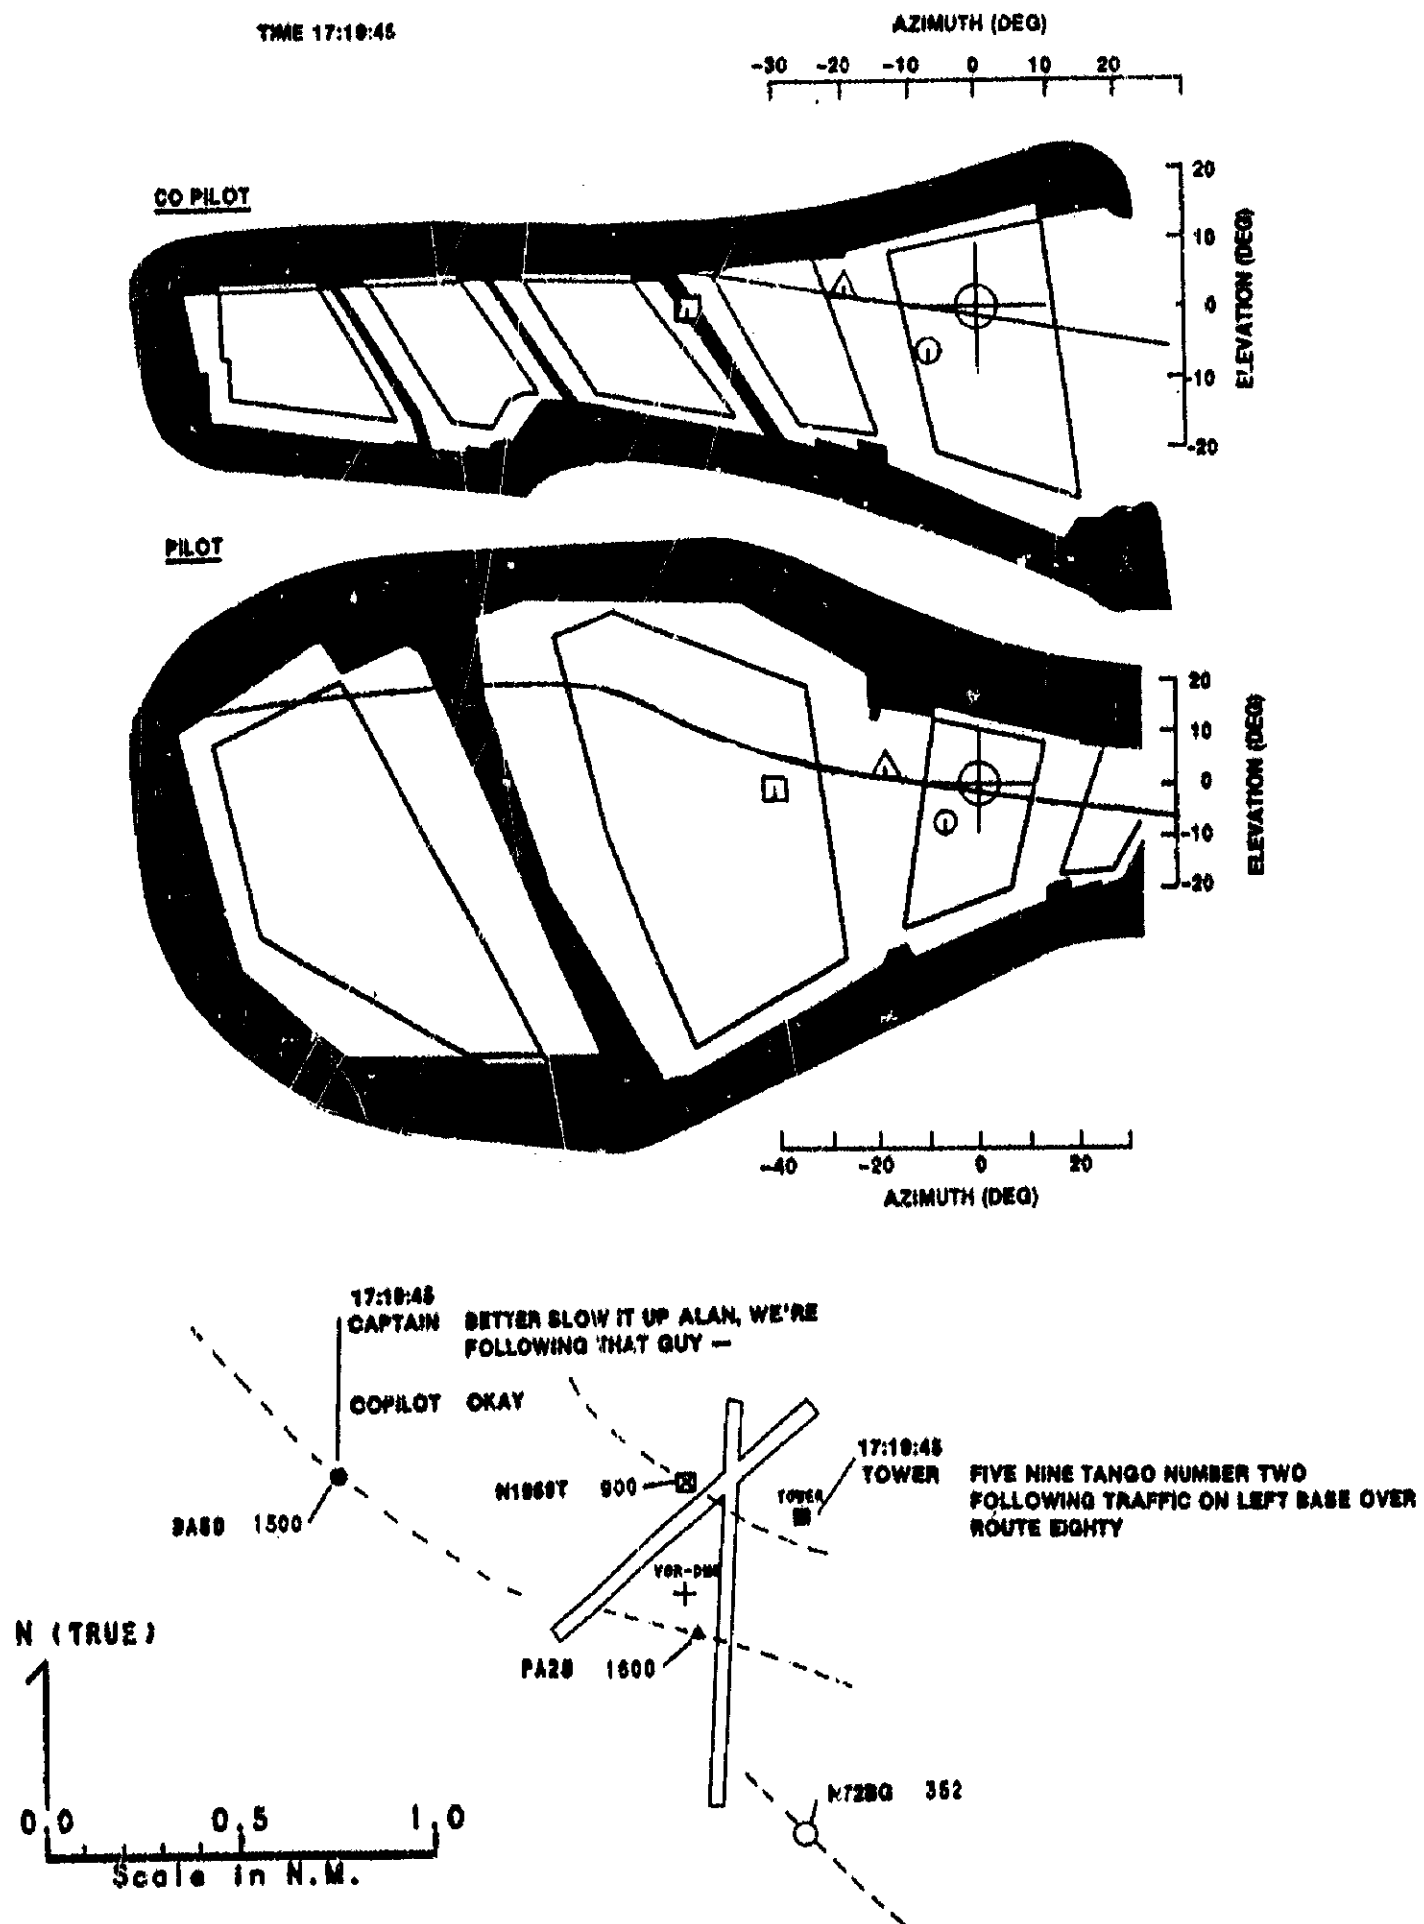
Figure 17.—Composite radar positions and cockpit visibility plot of aircraft at 1719:45.

Based on the radar data and cockpit visibility study at 1719:45, when the DA50 was about a mile west of the airport, the Twin Bonanza, N1959T, and the PA28 were passing over the airport in front of and in the DA50 flightcrew's view. (See figure 17.) N1959T was about 40° to the left at 900 feet and the PA28 was about 20° to the left of the crew's DER at 1,600 feet on the horizon. The Beech Baron, N72BG, which had departed to the east after takeoff from runway 19, was located slightly to the left of the crew's DER, and to the right of the PA28 and slightly below the horizon at 350 feet. At 1720:05, when the local controller told the DA50 flightcrew that they were to plan to be number three and there was additional traffic at the one o'clock position westbound at 1,500 feet, N1959T was about 20° to the left of the crew's DER, the PA28 was directly ahead at the 12 o'clock position, and N72BG was 1.5 miles ahead at 873 feet, 25° to 30° to the right of the DA50 crew's DER or in about a 1 to 2 o'clock position. (See figure 18.)

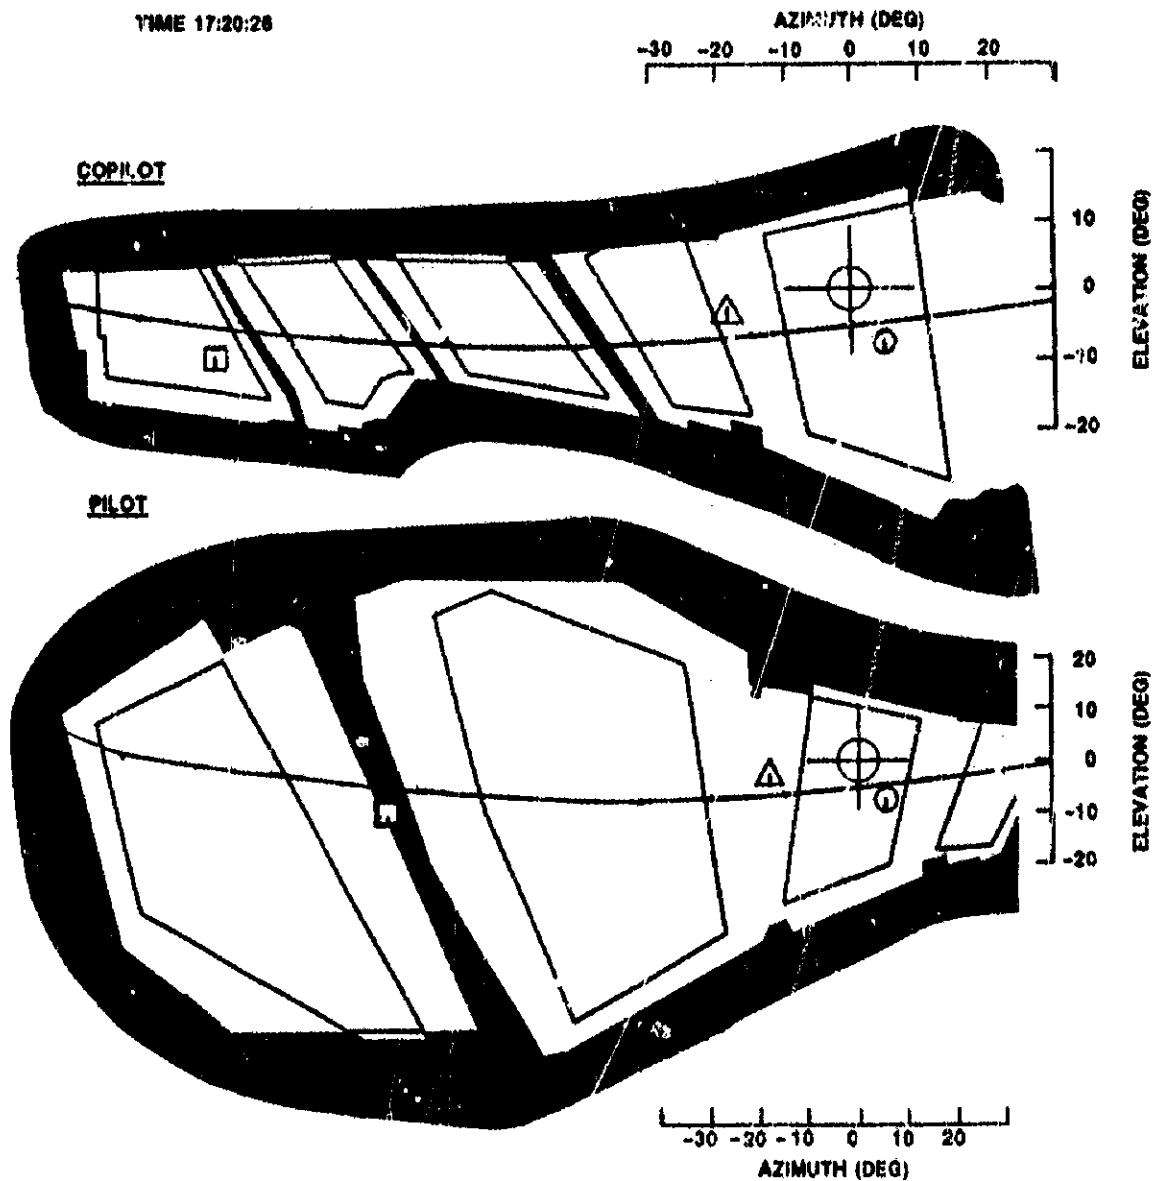
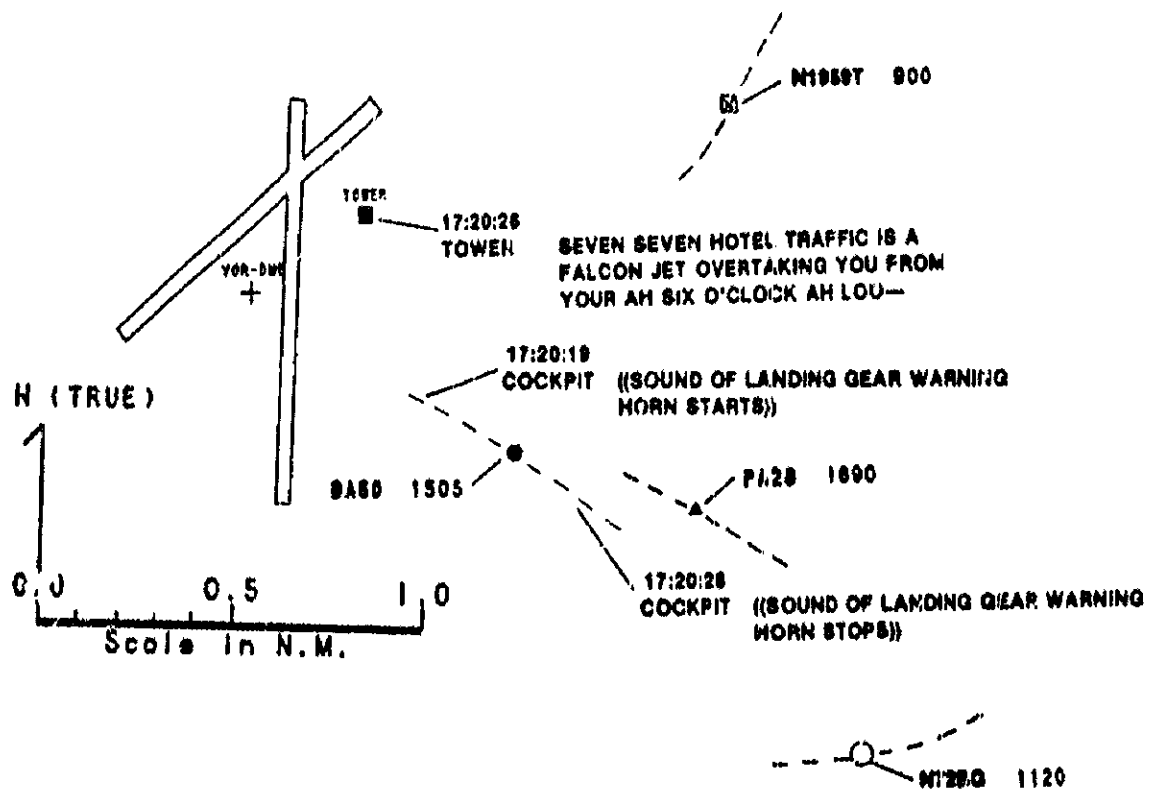
Figure 20.—Cockpit radar positions and cockpit visibility plot of aircraft at 1720:26.

At 1720:26, when the local controller advised the pilot of the PA28 about the DA50 at his 6 o'clock position, all three airplanes were in view of the DA50 flightcrew. (See figure 20.) At 1720:41, when the local controller asked the DA50 flightcrew if they saw the traffic, N1959T was in view about 124° to their left almost 4 miles away traveling northbound on the downwind leg of the traffic pattern, the PA28 and N72BG appeared close together and in view about 40° to the left of their DER points. The PA28 was about 3/4 mile ahead just above the horizon and N72BG was slightly below the horizon about 1.3 miles away, and to the right of the PA28. (See figure 21.) About this time, when the captain acknowledged sighting what is believed he thought to be the "westbound" traffic, all three airplanes were in his view, and only N1959T was far to the left, out of the first officer's view. Twenty seconds later, both the PA28 and N72BG maintained their approximate positions relative to one another and moved to the left horizontally about 46°. N1959T moved horizontally to the left and out of the first officer's view. (See figure 22.)

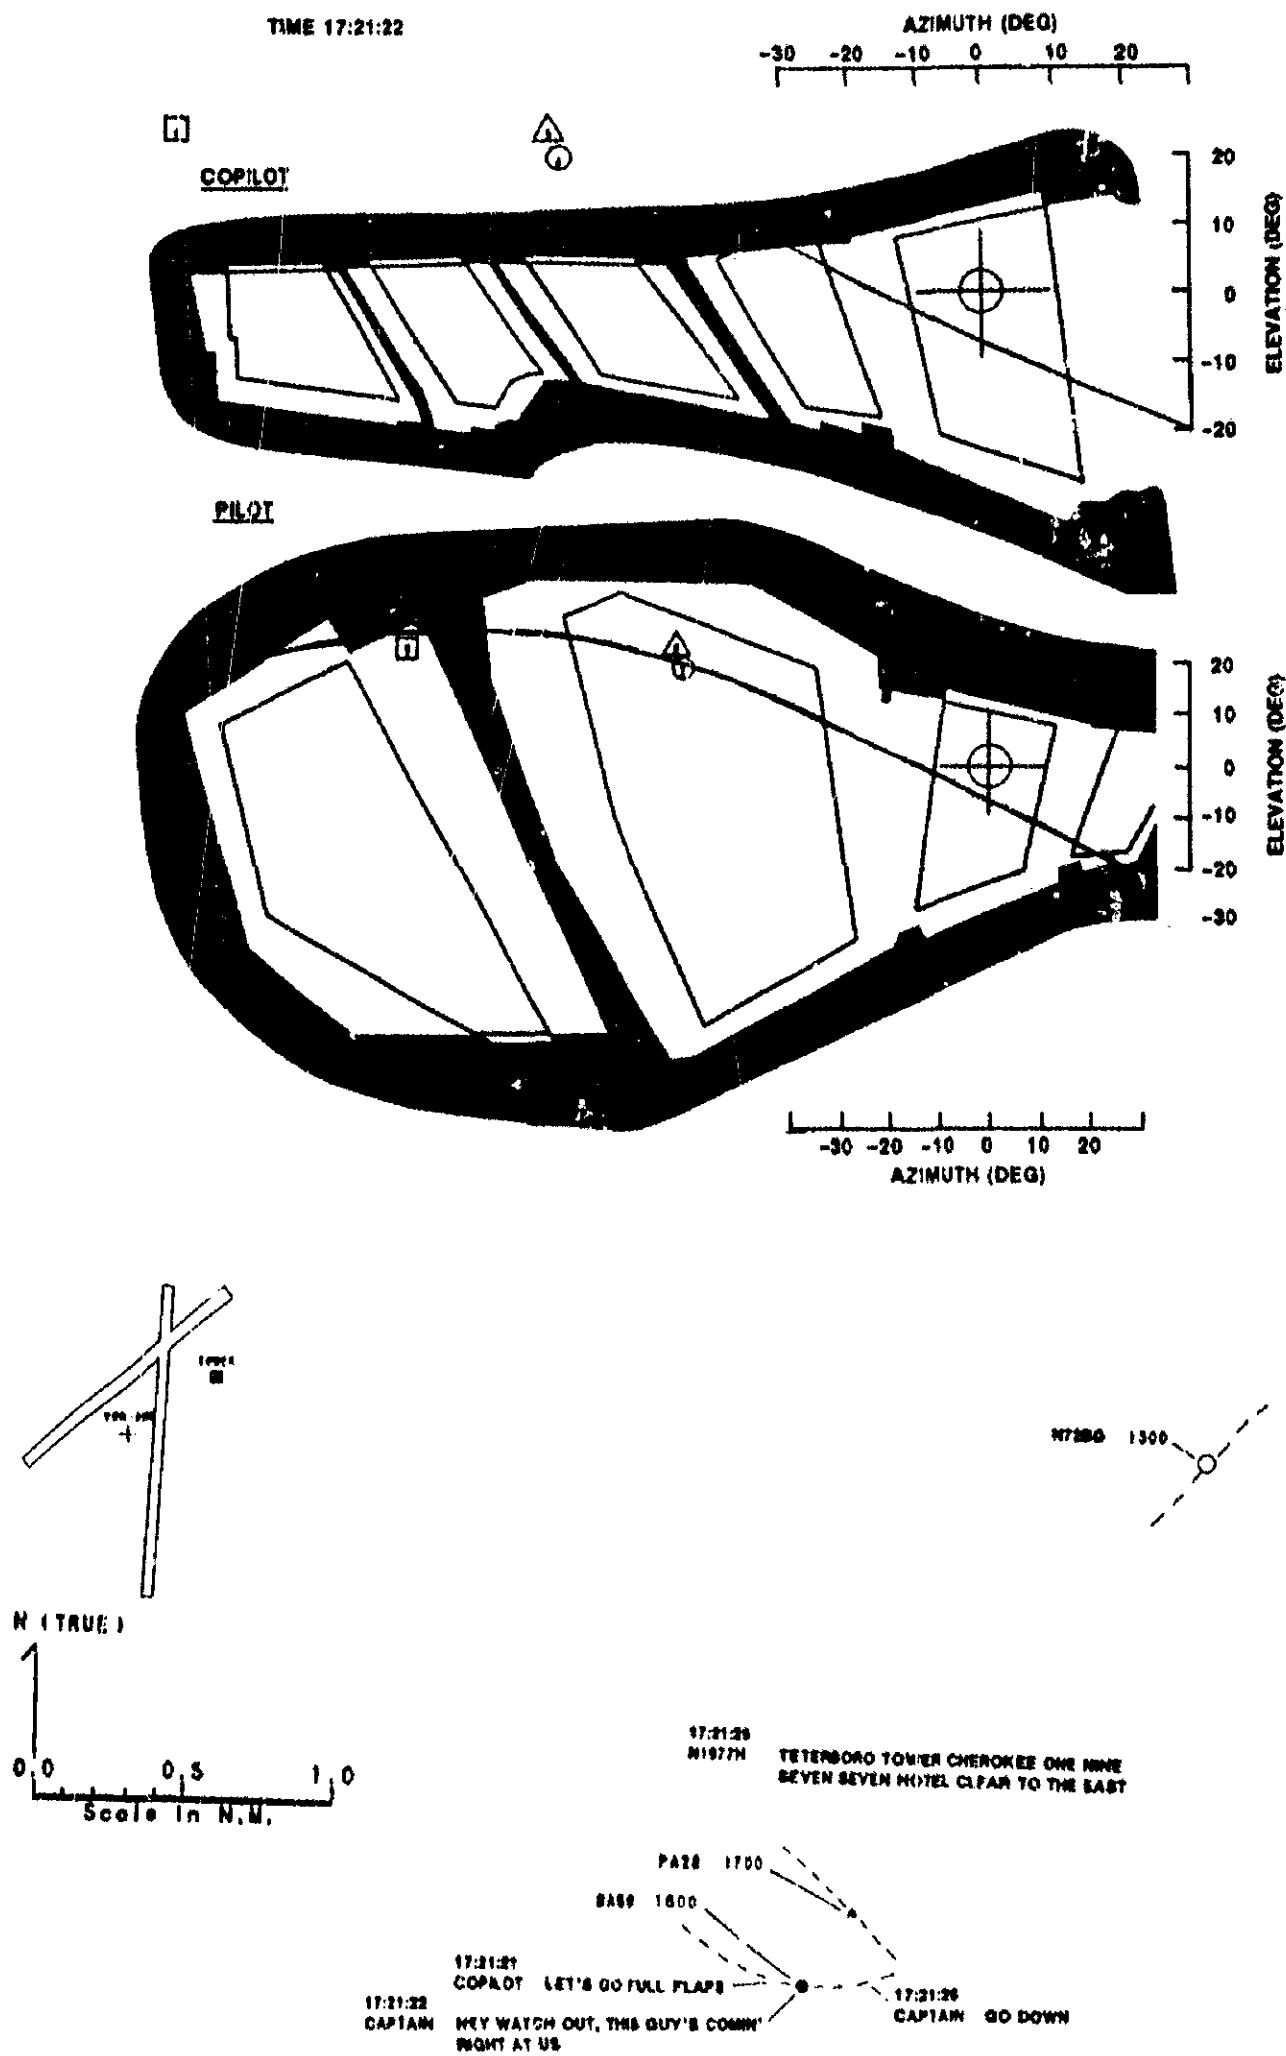
Figure 23.—Cockpit radar positions and cockpit visibility plot of aircraft at 1721:22.

At 1721:00, when the first officer asked "What kind of Cessna is that?" the PA28 and N72BG remained in view in about their same relative positions about 80° to the left of the crew's DER, but the PA28 was about 1/2 mile away and N72BG was about 1.6 miles away. Eight seconds before the collision when the captain said, "Hey, watch out, this guy's comin' right at us," the DA50 was in about a 30° left bank and the PA28 and N72BG were about 63° to the left and about 20° above the DER for the captain. They were not in the first officer's view. The PA28 was just above the horizon and N72BG was directly below the PA28 which was about 1/3 mile away or about 2,006 feet from the DA50. N1959T was out of the view of both pilots. (See figure 23.)
