ACCIDENT INVESTIGATION REPORT

BASI REPORT B/911/1012

Gulfstream Aerospace AC 681 VH-NYG
Tamworth NSW
14 February 1991

Incorporating
Australian Aviation Occurrences Involving Fuel
Starvation and Exhaustion 1969-86 (Reprint and Update)

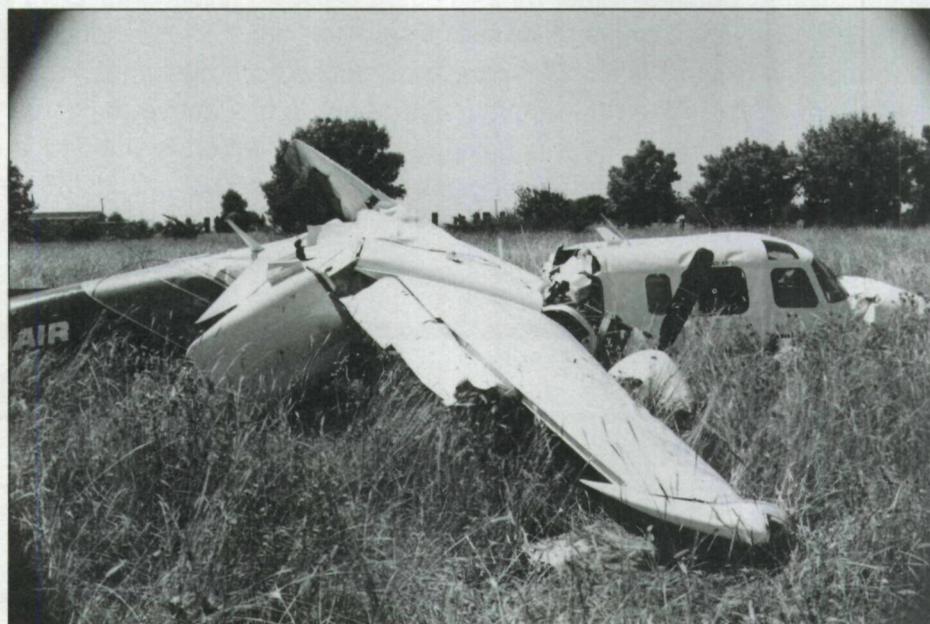
1.3 Damage to Aircraft

The aircraft was destroyed by impact forces.

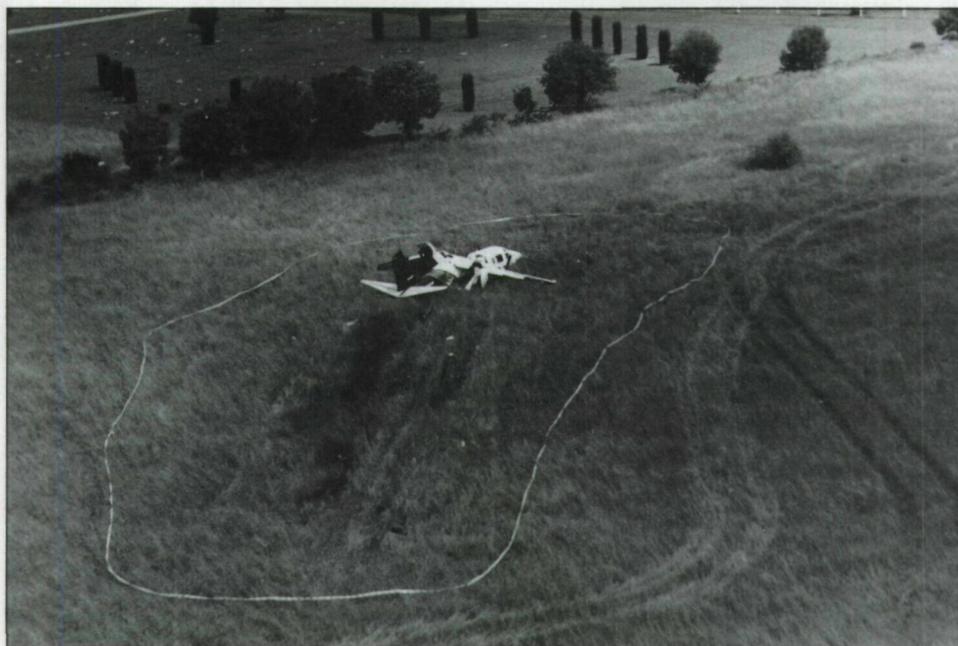
Impact deceleration forces were in the order of 40 to 45 times gravity (g) with peak loadings of about 90g. The landing gear was down and the flaps fully extended at impact.

The aircraft slid for 53 m before coming to rest, largely intact, heading 185°.

Damage to the aircraft structure was severe. All three landing-gear legs were broken and the fuselage suffered extensive compression damage. Both engines were ruptured with sections torn from the aircraft. The wing centre section had rotated forward and breached the cabin at the second and third row of seats.

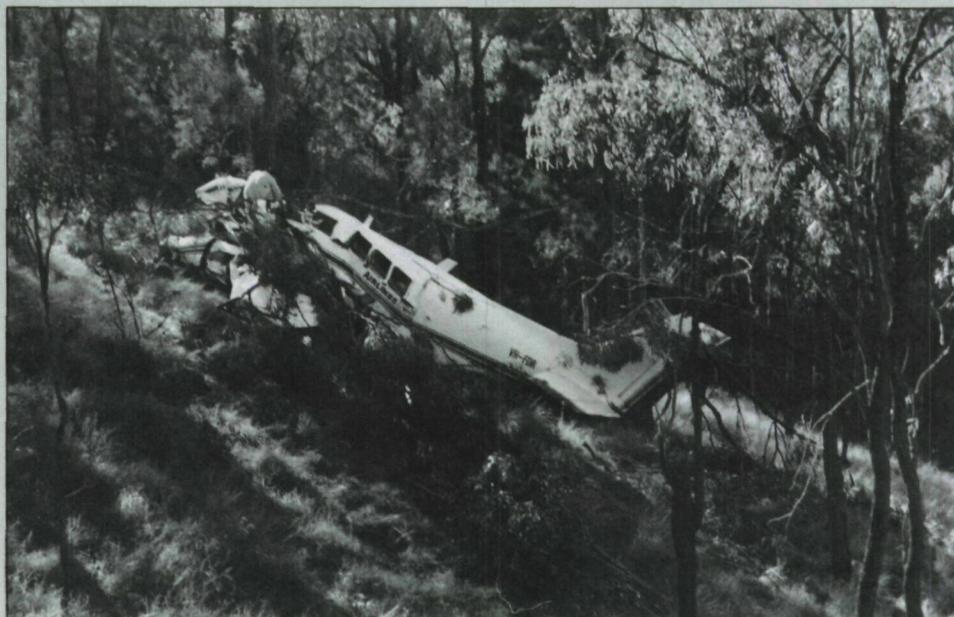
In August 1985, a Beech Queen Air departed Brisbane on a night freight run for Mackay. The aircraft differed from other Queen Airs operated by the company in terms of its fuel system, which required the pilot to select between inboard and outboard tanks, instead of there being an automatic selection of those tanks. This flight was the first in that particular aircraft for the pilot, who held a Senior Commercial Licence with a Class 1 Instrument Rating. He had been briefed on the fuel system on the previous morning, but had not actually received a cockpit demonstration.

The aircraft departed with full fuel. Approximately 2 hrs later, the pilot reported the failure of both engines, adding shortly afterwards that he was experiencing difficulty in drawing fuel from the outboard tanks. No further communications were received. The aircraft wreckage was discovered later and investigation revealed that the inboard tanks were exhausted but that fuel remained in the outboard tanks. The fuel selector was found positioned mid-way between the inboard and outboard tanks. No pre-existing mechanical

defects were evident, but the placard which described fuel selector settings was found to be obscured.

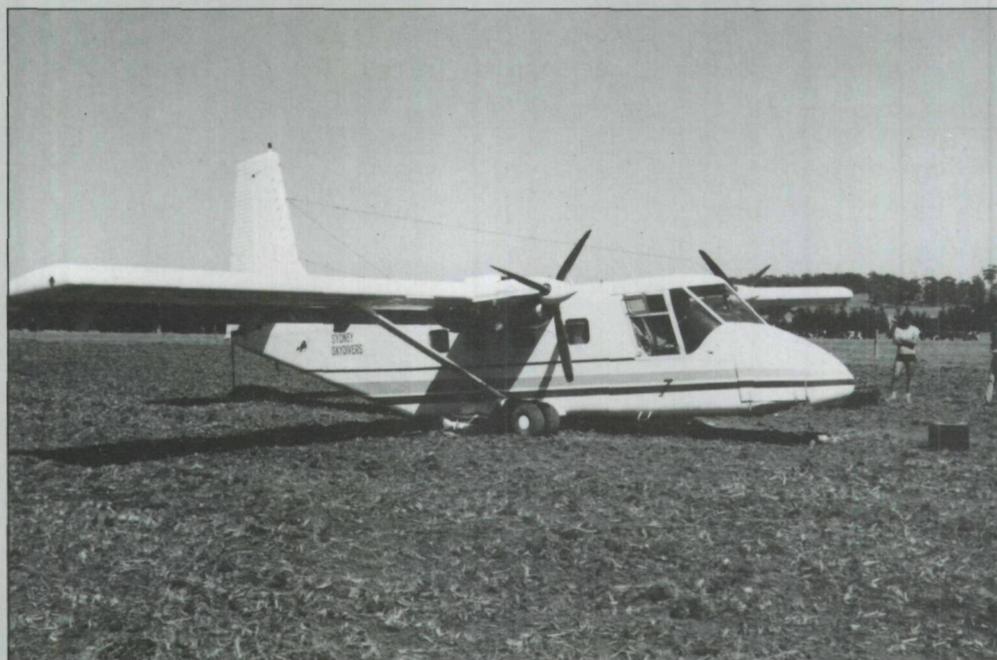
minimise sortie time, minimum fuel was carried. The pilot and the operator considered that the regulations relating to fuel reserve requirements did not apply to parachuting operations. The planned fuel for the flight was therefore substantially less than statutory requirements. A complete fuel drain and quantity check revealed only 19.5 lb (11 L) of fuel remained in the left tanks and 231 lb (130 L) in the right. The amount of fuel burned since the last refuel was 24 lb (13.5 L). The inspection of the aircraft fuel system revealed that the fuel quantity indication system was defective. The left outer fuel quantity sender unit was unserviceable and showed a reading on the left outer fuel gauge of 100 lb and empty on the left inboard gauge when both the inboard and outboard fuel tanks were completely empty. The pilot was unaware of the significance of this fuel gauge indication anomaly.

All fuel pumps were serviceable and both engines were found to be capable of operating throughout the design power range.
