**BUREAU OF AIR SAFETY INVESTIGATION
REPORT**

Investigation Report 9302851

**Piper PA-31-350 Chieftain VH-WGI
Launceston Tasmania
17 September 1993**

November 1995

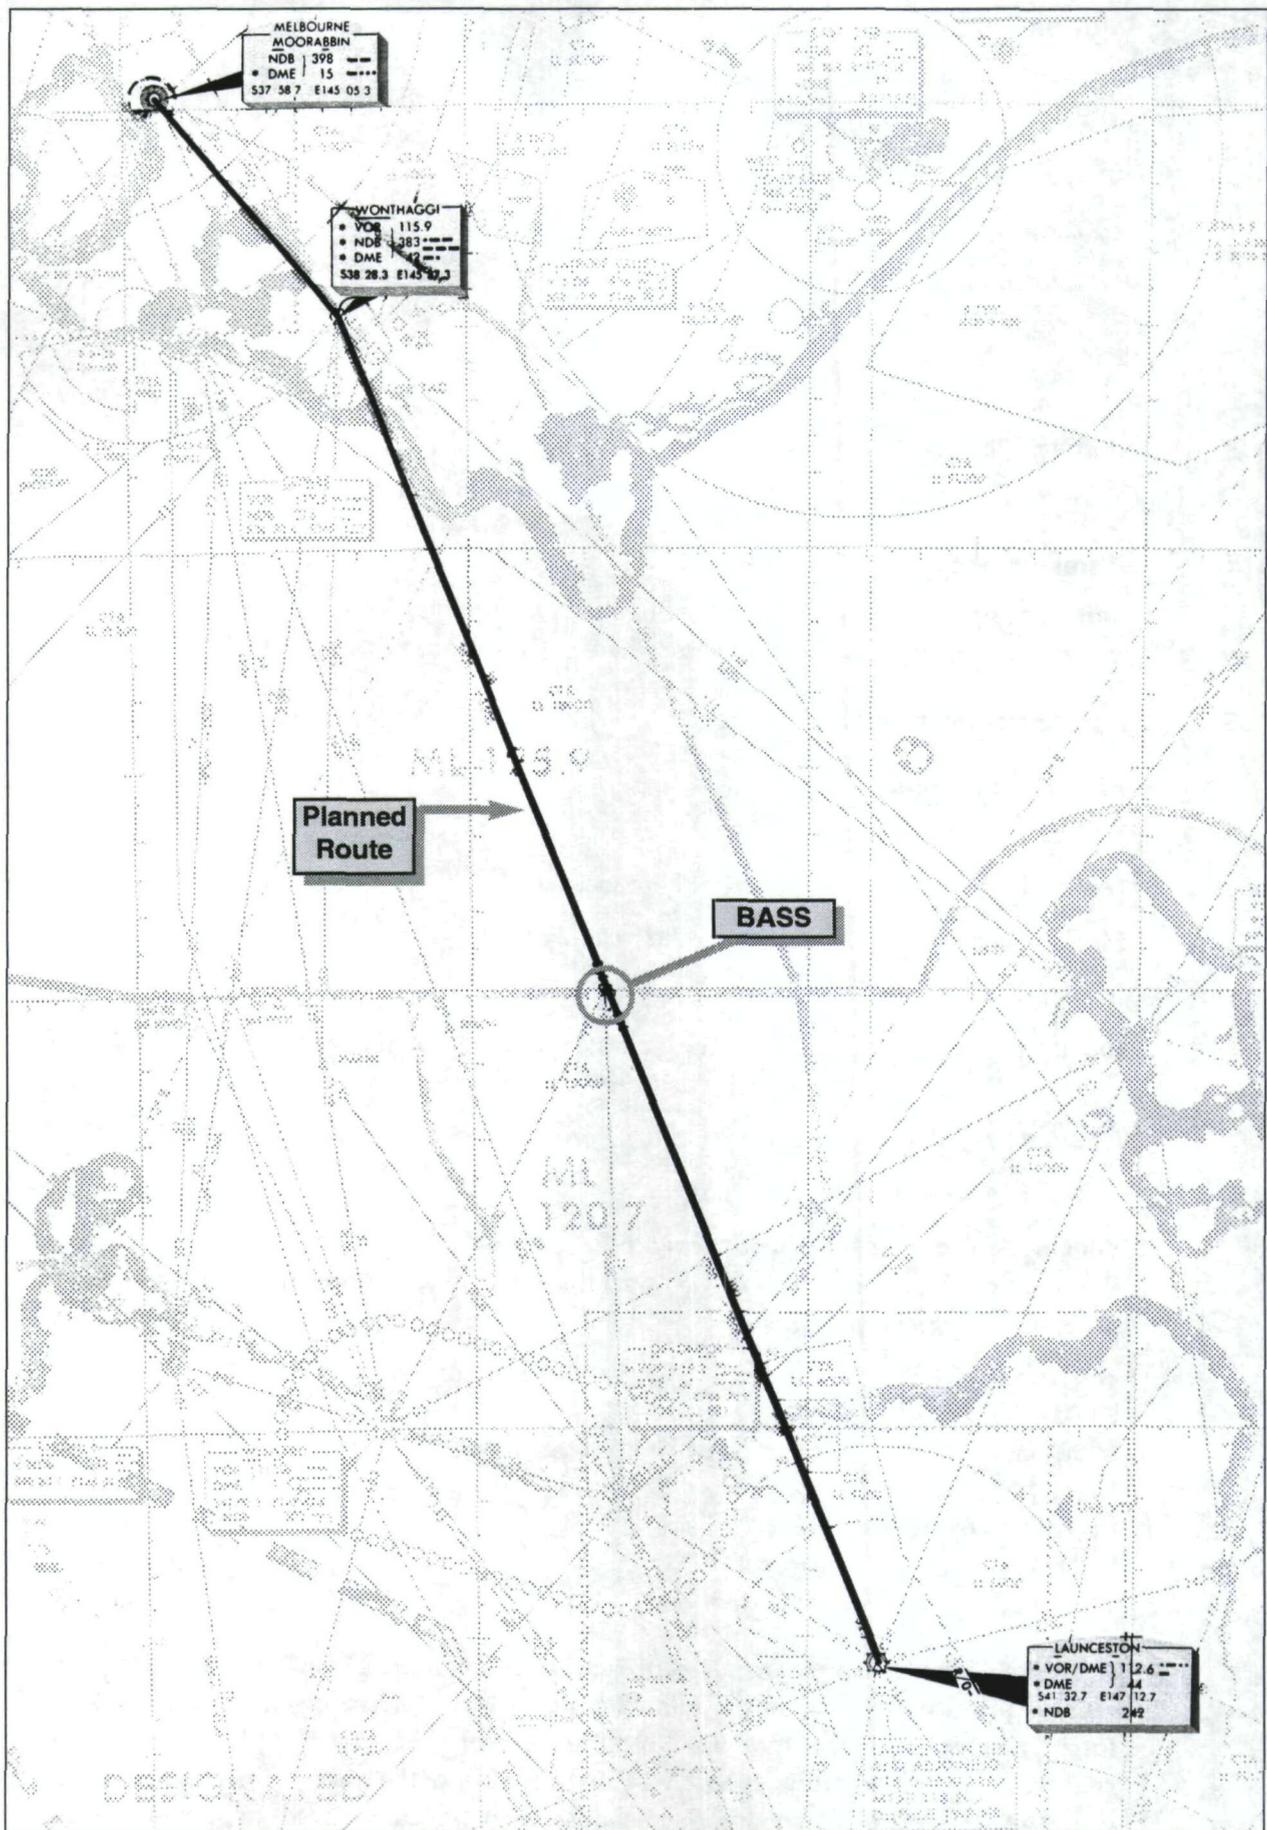
Figure 2 Flight planned route of VH-WGI.

The flight plan for VH-WGI (see fig. 2) indicated that the aircraft would track Moorabbin-Wonthaggi-Bass-Launceston and cruise at an altitude of 9,000 ft. A cruise TAS of 160 kts, total plan flight time of 90 minutes, endurance 155 minutes and Type of Operation 'G' (private category flight) were specified. No alternate aerodrome was nominated and none was required. The estimated time of departure was 1730. The flight plan was submitted to the CAA by facsimile at 1529. Last light at Launceston was 1919.

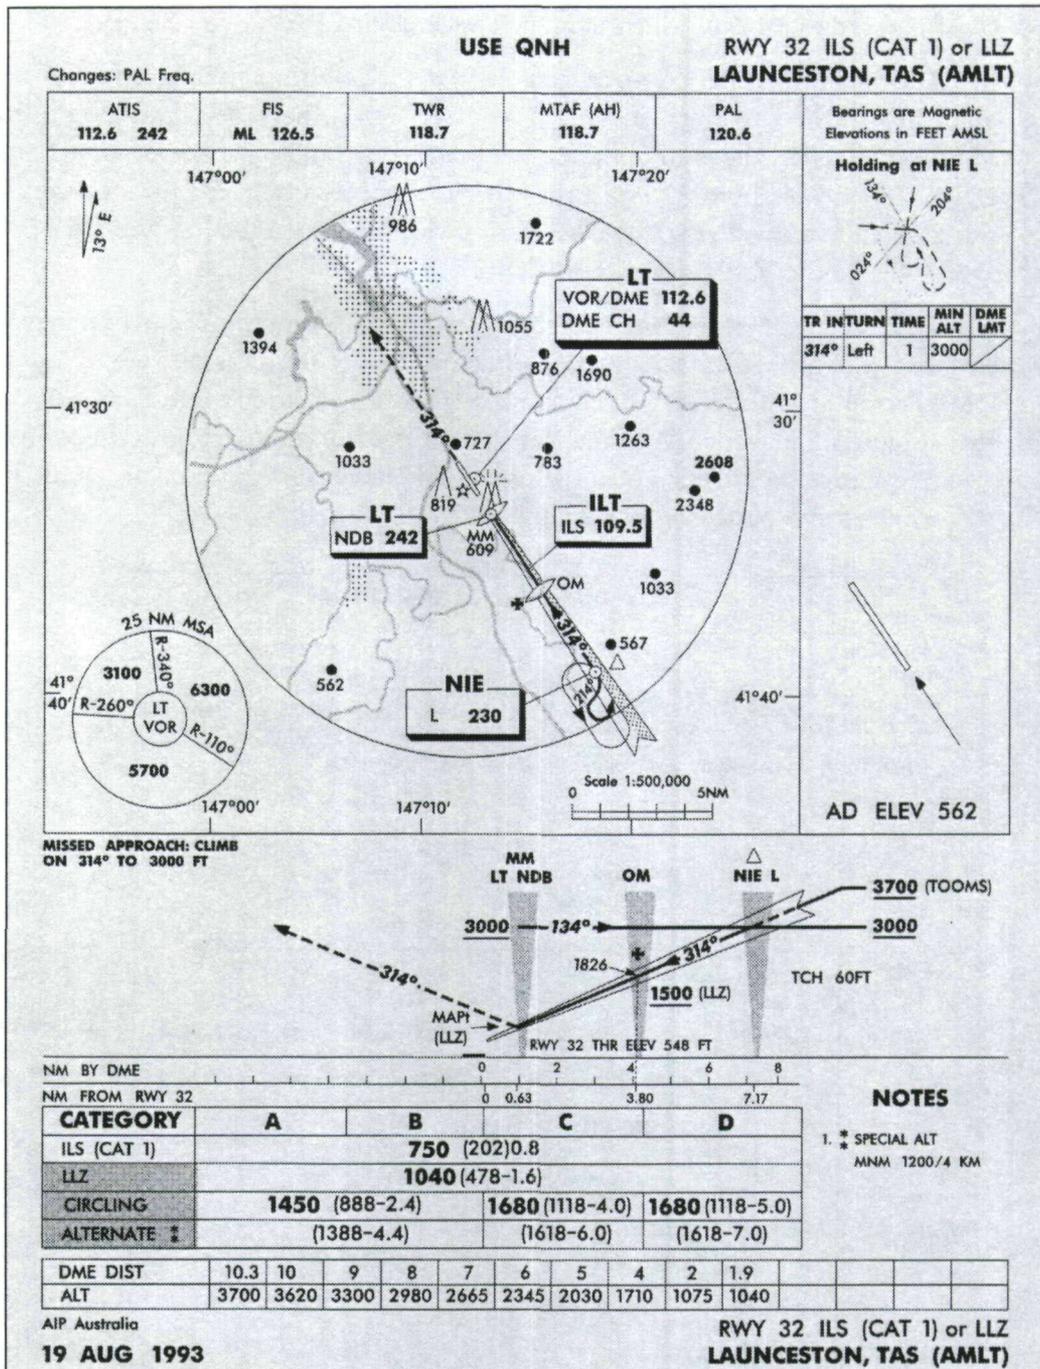
Figure 3 Launceston ILS approach chart.

Instrument approach procedures are published in AIP DAPS. At Launceston, instrument approaches are published for runway 14 VOR or VOR/DME, runway 32 ILS (fig. 3) or LLZ, runway 32 VOR/DME, and runway 32 NDB/L. These procedures enable pilots to descend in a prescribed pattern to the MDA/DA for each type of approach at the airport. The DA for the ILS was lower than for the other approach options.

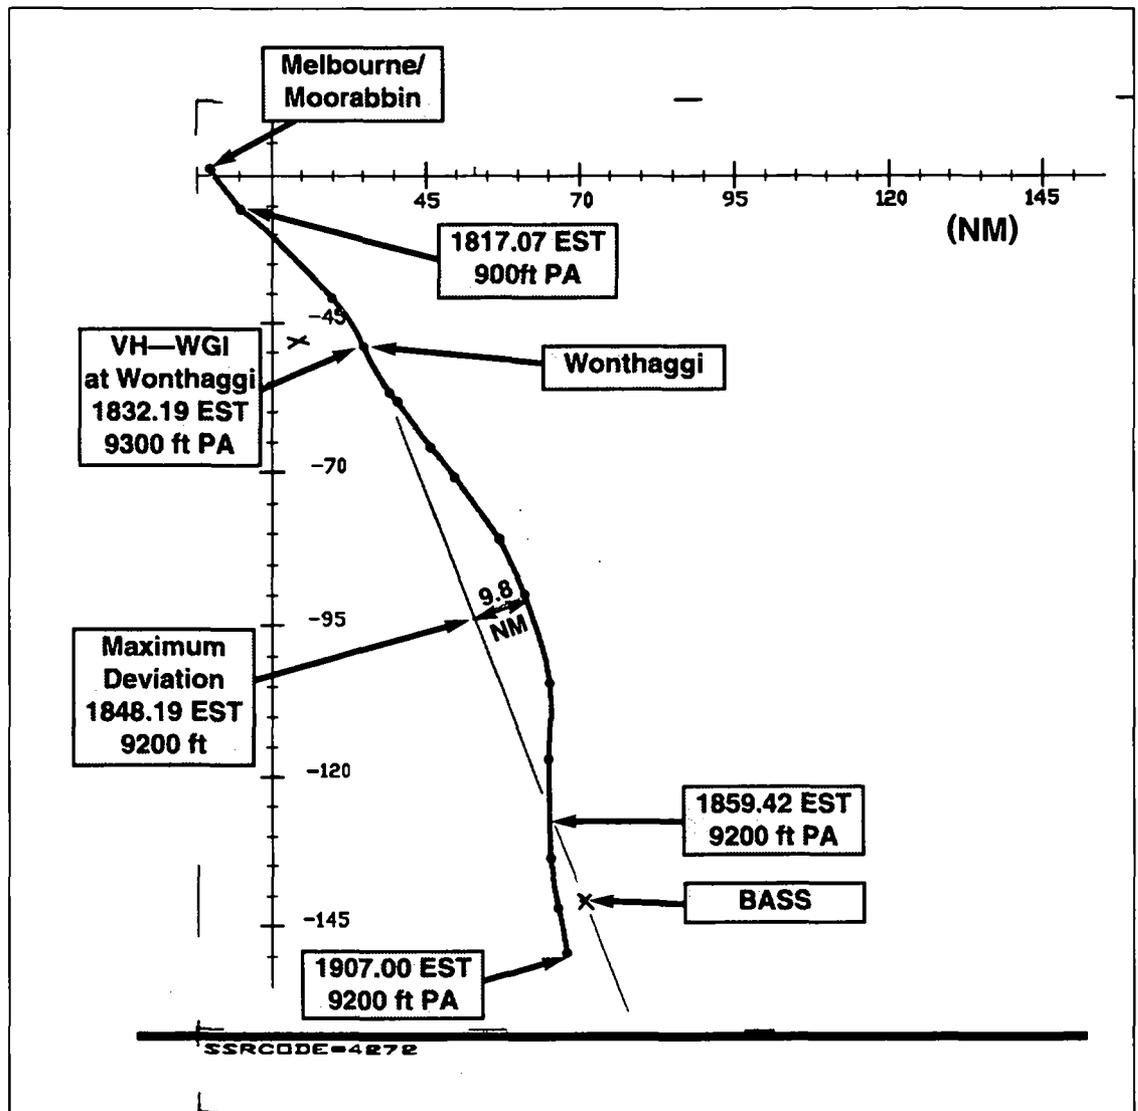
Launceston is not equipped with radar. On departure from Moorabbin the aircraft was within range of radar sensors used to supply data to Melbourne ATC. A readout of the data showed that after departing Wonthaggi the aircraft deviated left of track for some time. The radar coverage was lost near reporting position Bass (see fig. 9).

Figure 9 Readout of radar data for VH-WGI, showing the track of the aircraft until it left radar coverage just beyond Bass.
