## **AIRCRAFT ACCIDENT INVESTIGATION REPORT**

**ETHIOPIAN AIRLINES B767 (ET-AIZ) AIRCRAFT ACCIDENT  
IN THE FEDERAL ISLAMIC REPUBLIC OF THE COMOROS,  
IN THE INDIAN OCEAN ON NOVEMBER 23, 1996**

**ETHIOPIAN CIVIL AVIATION AUTHORITY  
FLIGHT SAFETY DEPARTMENT  
P.O.Box 978  
ADDIS ABABA - ETHIOPIA**

**ETHIOPIAN AIRLINES B767-260ER, ET-AIZ AIRCRAFT ACCIDENT IN THE  
FEDERAL ISLAMIC REPUBLIC OF THE COMOROS, IN THE INDIAN OCEAN  
ON NOVEMBER 23, 1996. REPORT NO. AI-3/96 RELEASED  
BY CIVIL AVIATION AUTHORITY, ETHIOPIA**

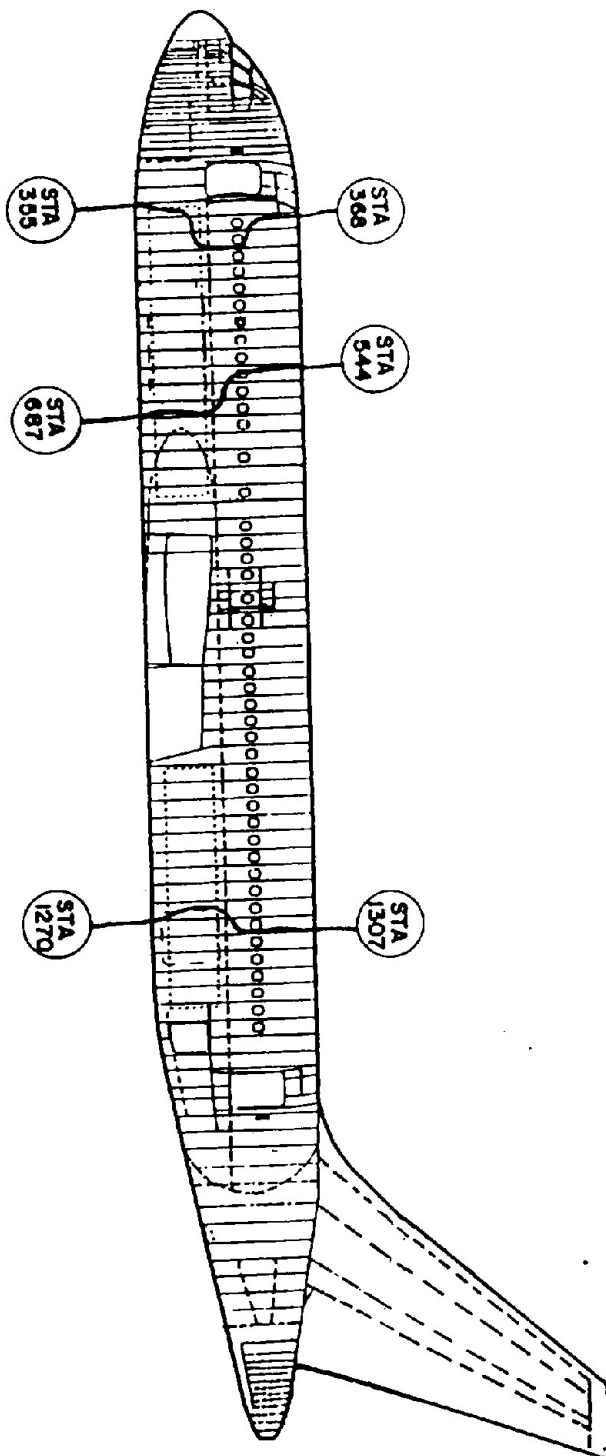
FIGURE - 2

QTY PER ASSY		DASH No.	DESCRIPTION		ETH. STOCK No.	PARTS LIST	MFR. P/N	STOCK SIZE	MATL. SPEC.	FINISH	HEAT	ZONE
UNLESS OTHERWISE SPECIFIED			NAME			DATE	TITLE			ETH. DWG. No.: 5307-001		
Dimensions are in			D W N			31/01/97	LOCATION OF BREAKAGE FOR ET-AIZ (767-200 ER)			DWG. SIZE:		
TOLERANCE ON			PROL. ENGR							REF.:		
FRA DEC. DEG.			EXPERT							SCALE: ~		
BREAK SHARP EDGES			MGR. ENGR							SHEET 2 OF 2		
<b>ETHIOPIAN AIRLINES</b> P.O. BOX 1753, ADDIS ABABA, ETHIOPIA

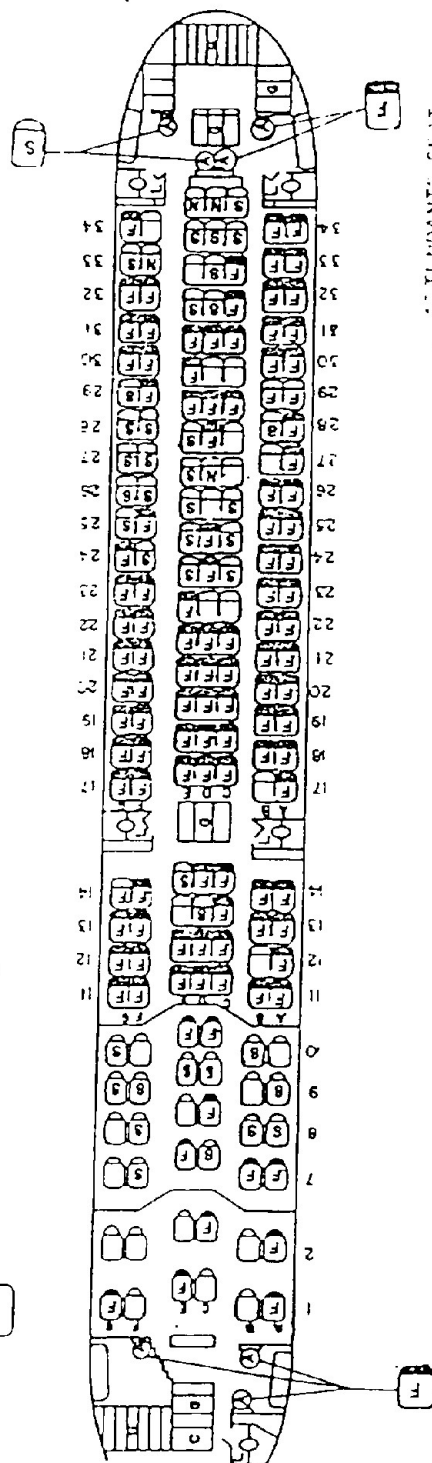
Occupation des sièges par  
des passagers

siège un occupé
