NATIONAL TRANSPORTATION SAFETY BOARD

AIRCRAFT ACCIDENT REPORT

**RUNWAY COLLISION
UNITED EXPRESS FLIGHT 5925
AND BEECHCRAFT KING AIR A90
QUINCY MUNICIPAL AIRPORT
QUINCY, ILLINOIS
NOVEMBER 19,1996**

Abstract: This report explains the accident involving United Express flight 5925, a Beechcraft 1900C, and a Beechcraft King Air A90 that collided at the intersection of runway 13 and runway 04 at Quincy Municipal Airport, near Quincy, Illinois, on November 19, 1996. Safety issues in the report include the importance of emphasizing careful scanning techniques during flight training, Beech 1900C certification standards and compliance with requirements on door jamming, the certification of small airports used by scheduled commuter airlines, and aircraft rescue and fire fighting protection on scheduled commuter aircraft having 10 seats or more. Safety recommendations concerning these issues were made to the Federal Aviation Administration.

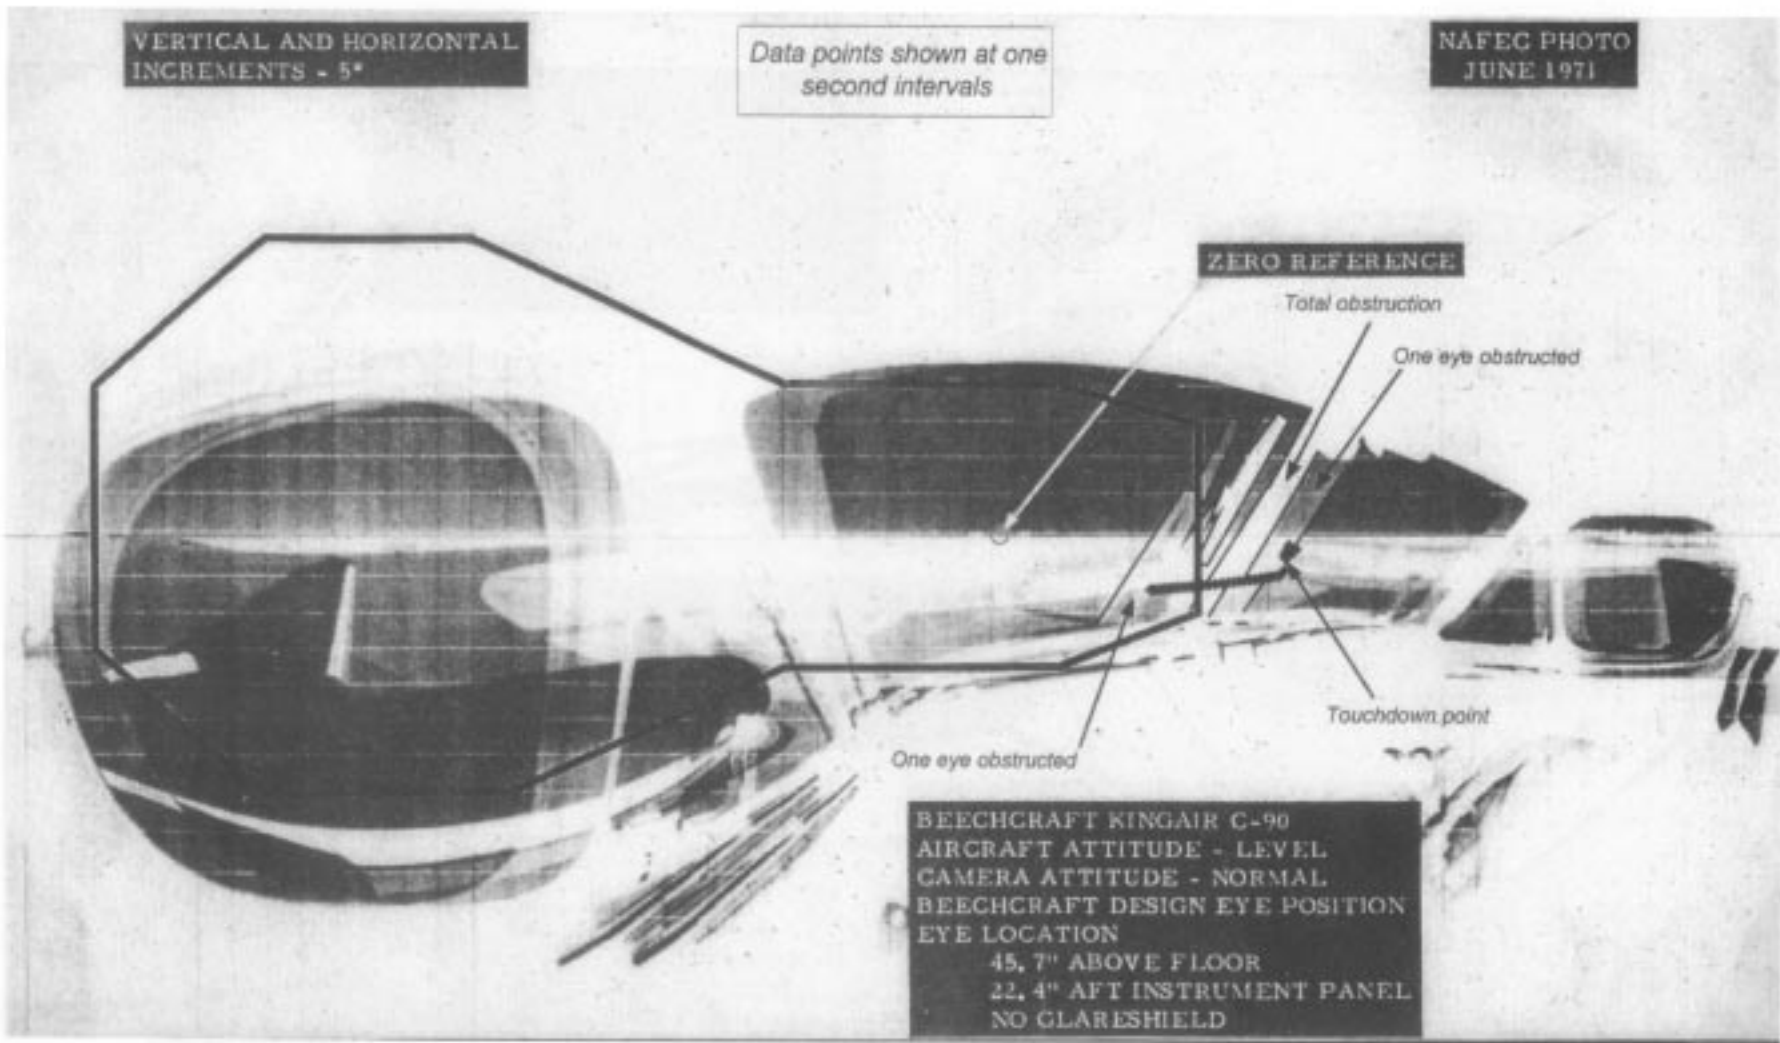
As shown in figure 6, the Safety Board's study using its VIZPC computer program indicated that the view of the King Air from the Beech 1900C captain's position would have been partially obstructed by the center post and windshield wipers during the airplane's final approach and would have been totally obscured by the center post for 6 seconds, starting about 17:00:43. Approximately 10 seconds before touchdown,³⁶ at 1700:49, until the time of the

Figure 6.—Beech 1900C captain's view of King Air.

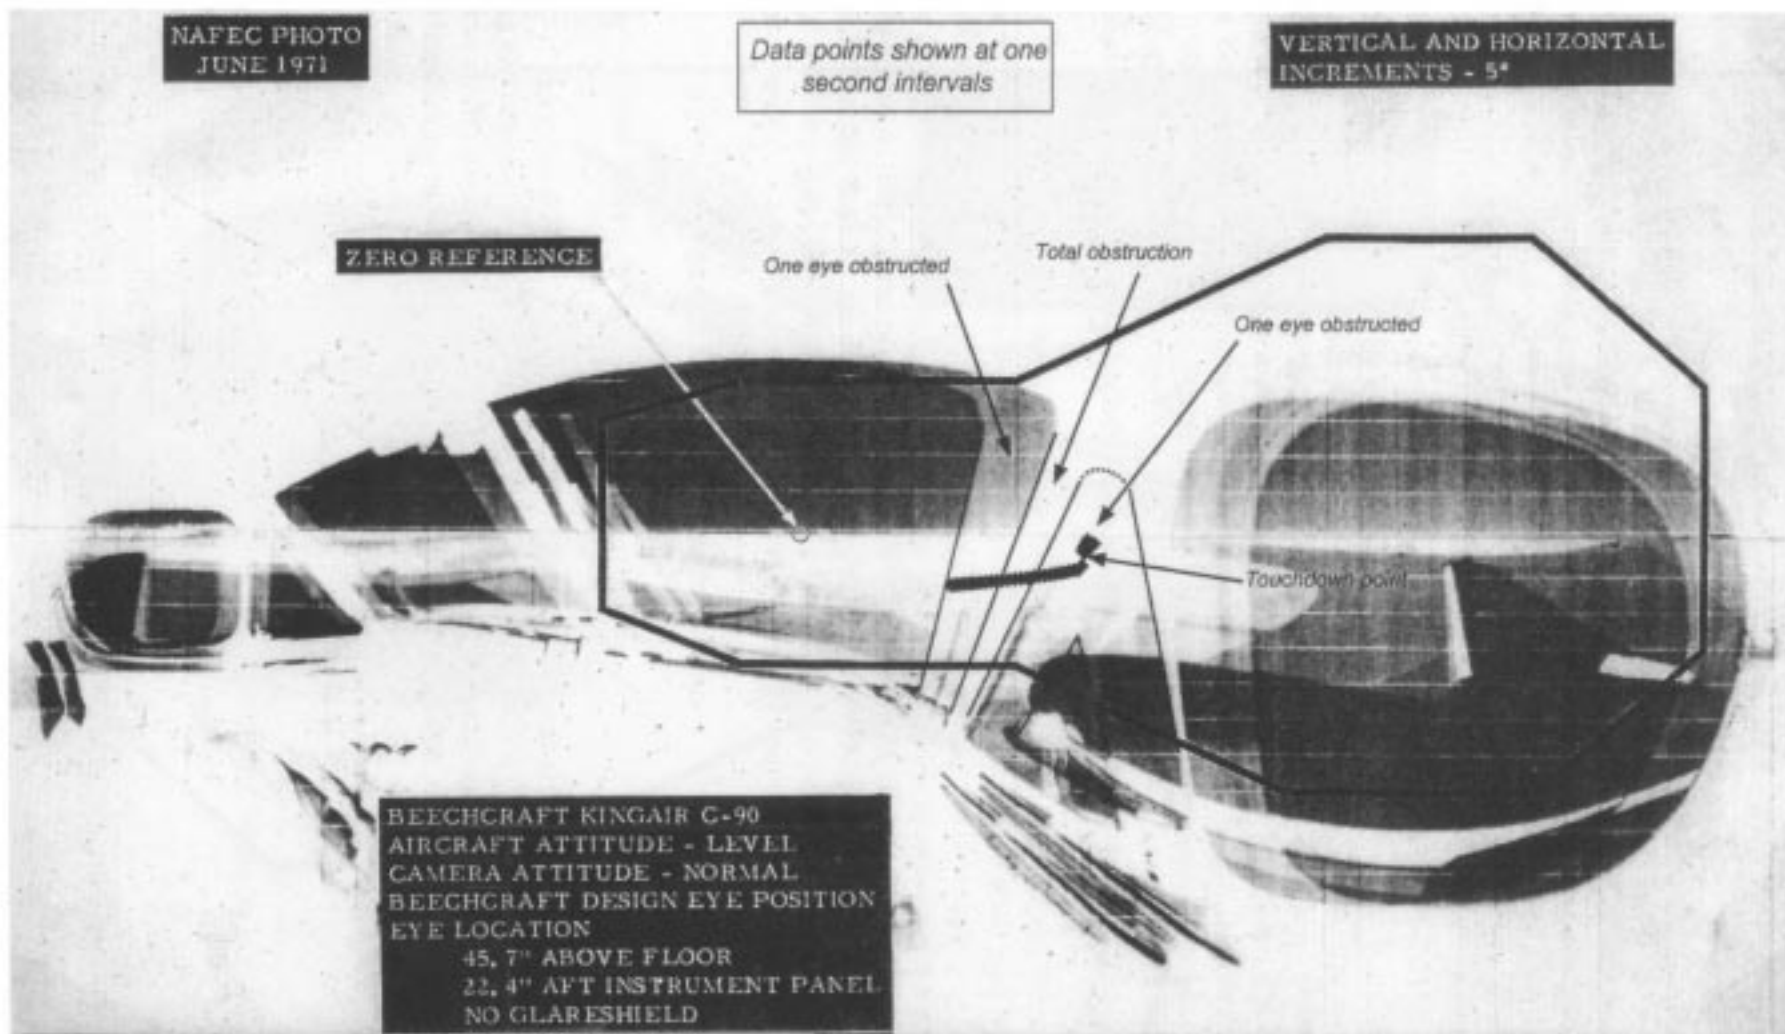
As shown in figure 7, the view from the Beech 1900C first officer's position would have been partially obstructed by the first officer's side posts for nearly 30 seconds before touchdown until impact, including 6 seconds starting at 17:00:42 when the first officer's view of the King Air would have been totally obstructed by the front windshield side post.

Figure 7.—Beech 1900C first officer's view of King Air.
