*Accident
on 25 May 2000
at Paris Charles de Gaulle (95)
to aircraft
F-GHED operated by Air Liberté
and
G-SSWN operated by Streamline Aviation*

REPORT

This report presents the technical conclusions reached by the Bureau Enquêtes-Accidents on the circumstances and causes of this accident.

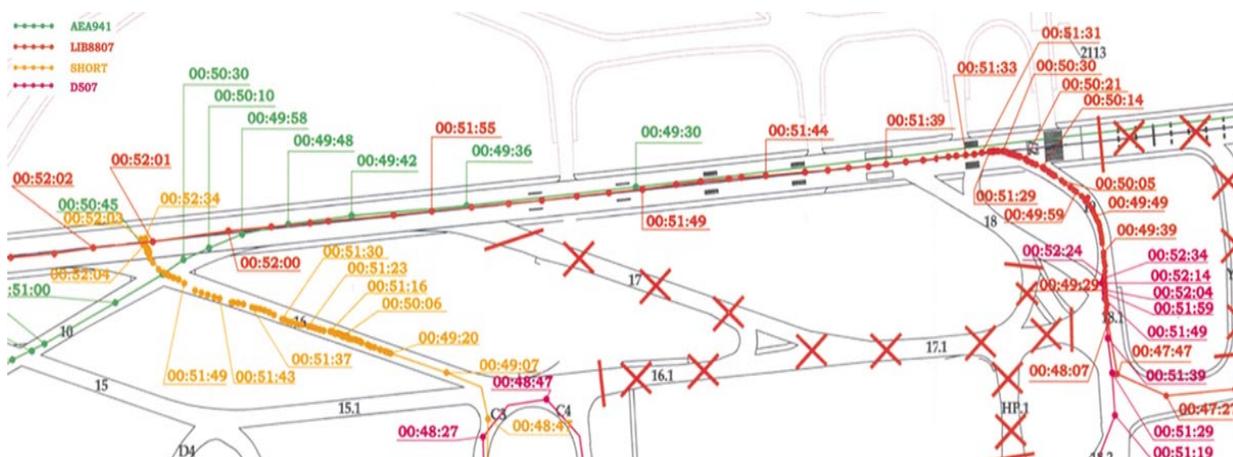
1.16.1 Trajectories of the Aircraft

The marks found on the right-hand side of the Shorts 330 indicate that the relative angle of the two aircraft at the time of the impact was approximately 50°.
