Aviation Safety Council

Accident Investigation Report

ASC-AAR-00-11-001

MD-90-30 cabin explosion and fire

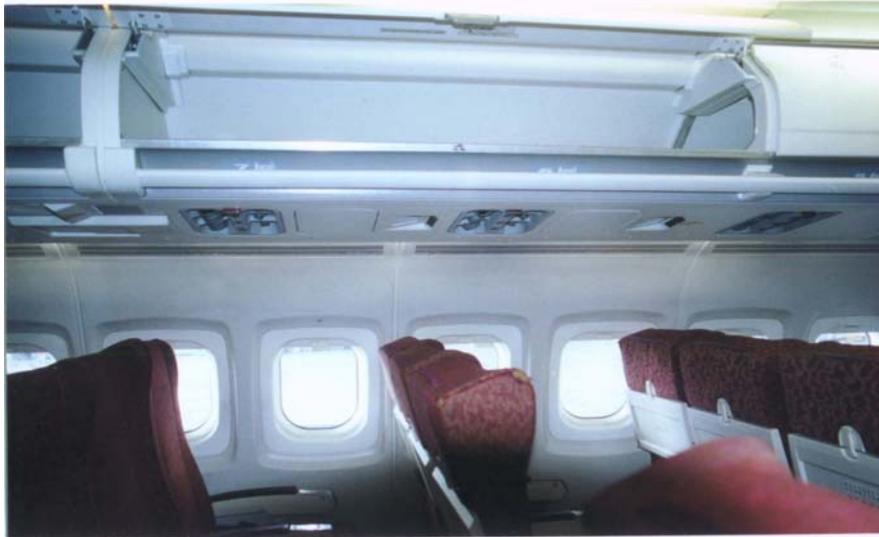
Fig. 1.12-6 Picture of the passenger cabin and stowage bin of an aircraft of identical model.

By comparing a picture of the damaged aircraft to an image of an undamaged aircraft of the exact same type (Fig. 1.12-6), we can deduce that the rupture is located in the stowage bin above rows 3~7 (there is no row 4). The stowage bin is constructed of reinforced fiberglass and measures 577.2cm in length, 57.4cm in width and 37.0cm in height. Its lugs are attached in suspension to the rack that stretches along the fuselage. Above it are electric wire clusters. The larger wires are for carrying a larger load for the galley. Two environmental control tubes can be seen along side the wires. The one of larger diameter is an air duct that provides exhaustion from the wall of the fuselage. The thinner one is for cold and feeds air from the gasper in the Passenger Service Unit (PSU), contained inside the bottom wall of the stowage bin. The entire stowage bin and its suspension system were destroyed by the explosion. Fig.

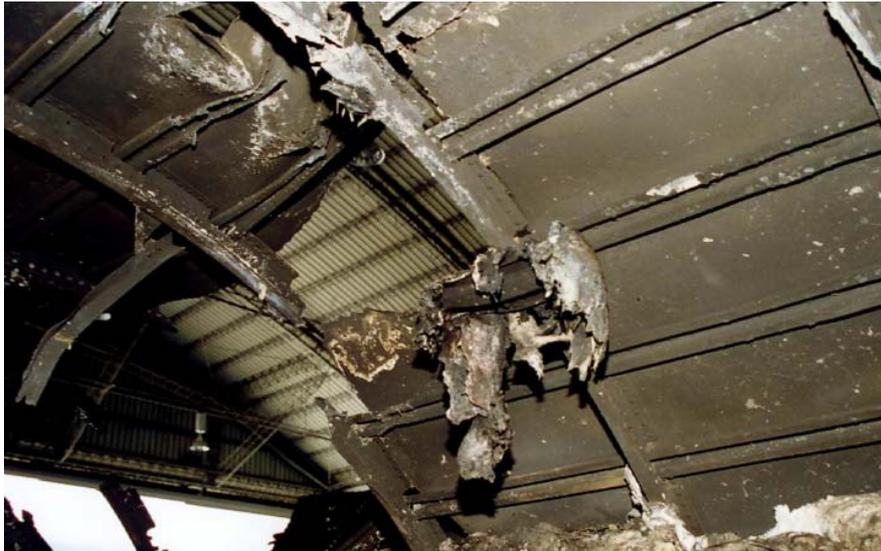
Fig. 1.12-10 Bin support and the tie rod

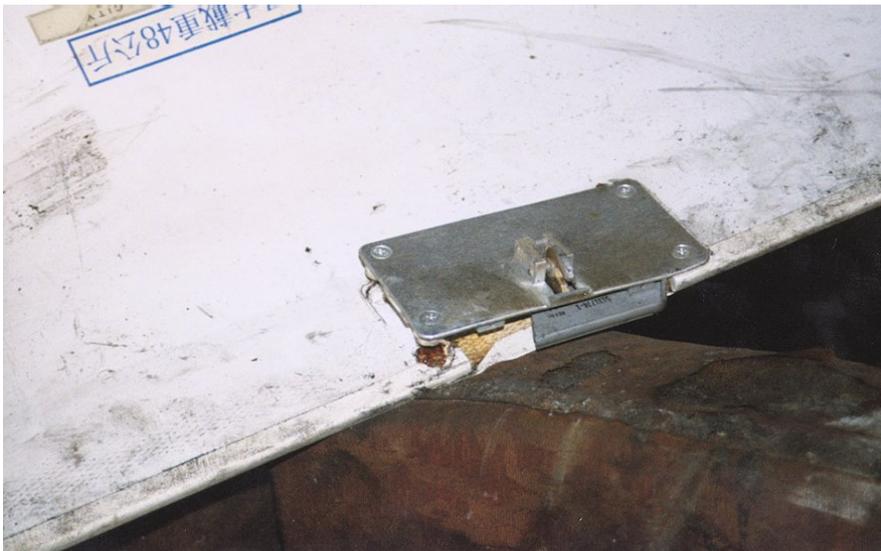
Fig. 1.12-11 The bin lid latch

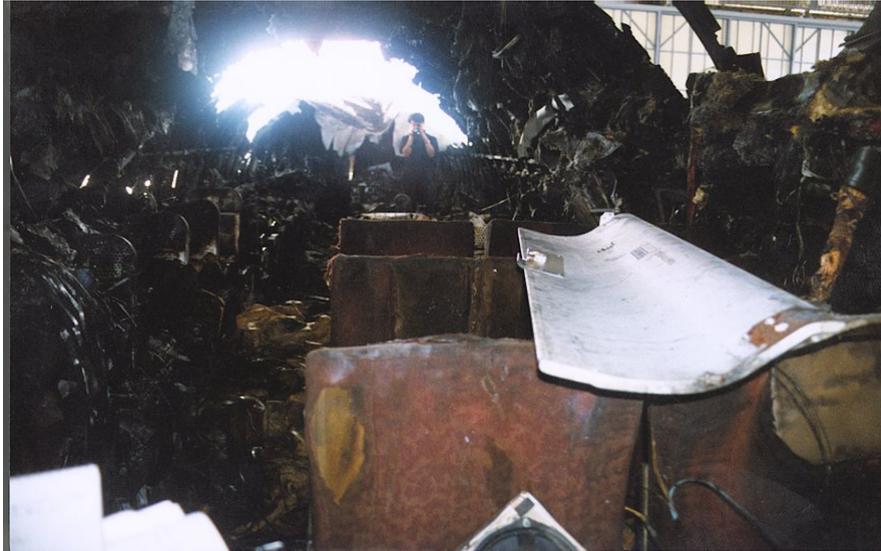
Fig. 1.12-12 FS253~FS1156

consumed the interior material, from the sidewall through the air return in the lower part of the seats. After having been consumed by flames, the cabin partition panel was found on top of the doghouse. Aside from the carbon-fiber wire clusters on the back of the stowage bin, most of this area is now just ashes.

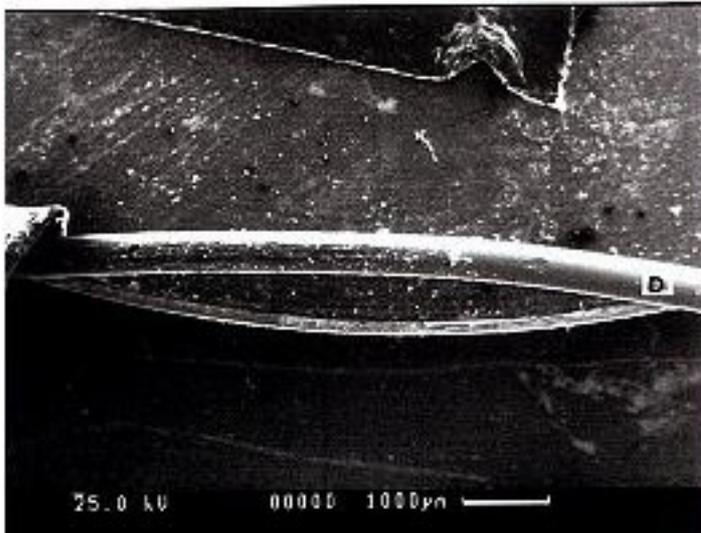
Figure 2. SEM image of segments C, D of the #1 wire. The C segment is scratch. The segment D remains unmarked.

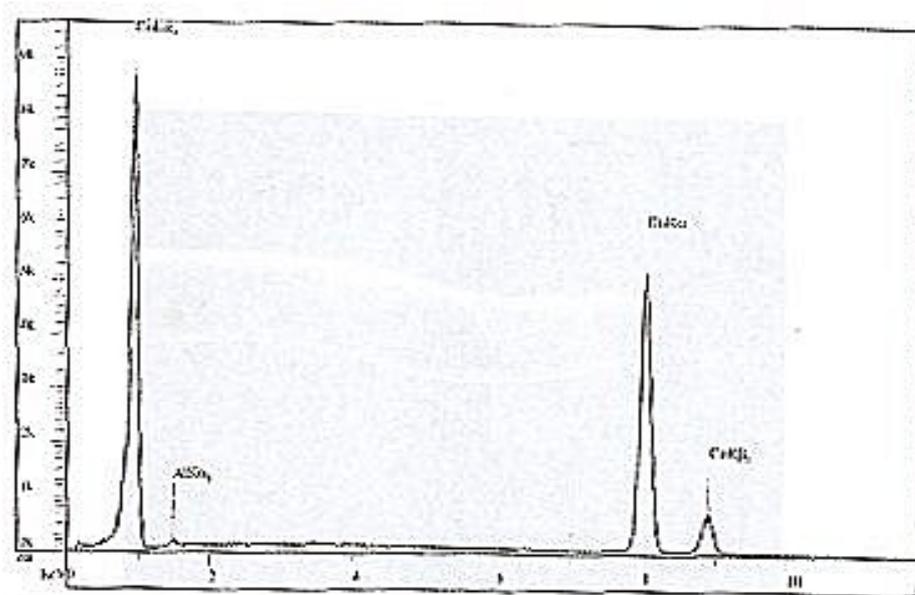
Figure 3. EDS spectrum of C in figure 2. It shows the #1 wire substrate of copper with aluminum coming from the environment reactant.

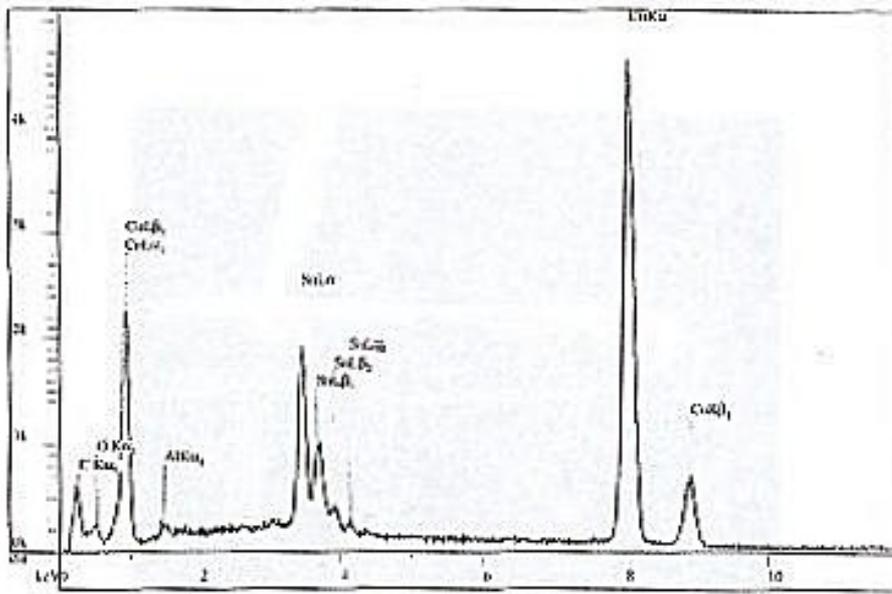
Figure 4. EDS spectrum of D in figure 2. It shows that except the #1 wire substrate of copper and tin-plated surface, the other elements come from the environment reactant.

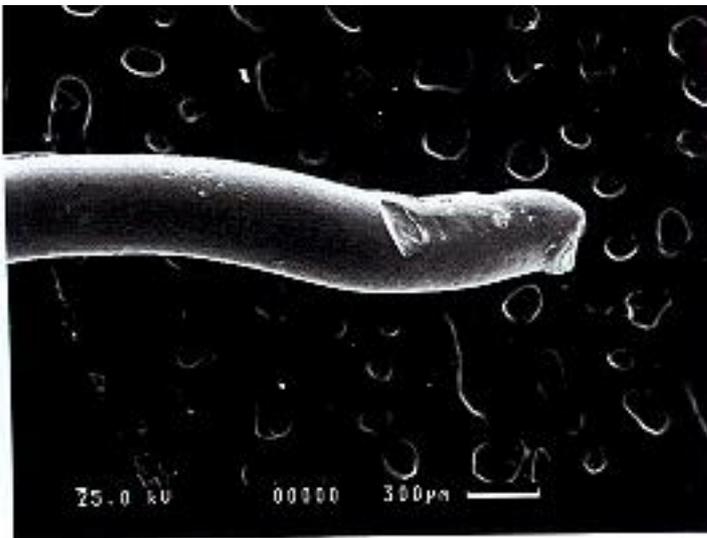
Figure 5. The SEM image of A of the #1 wire. The lead has visible necking and the surface shows scratches.

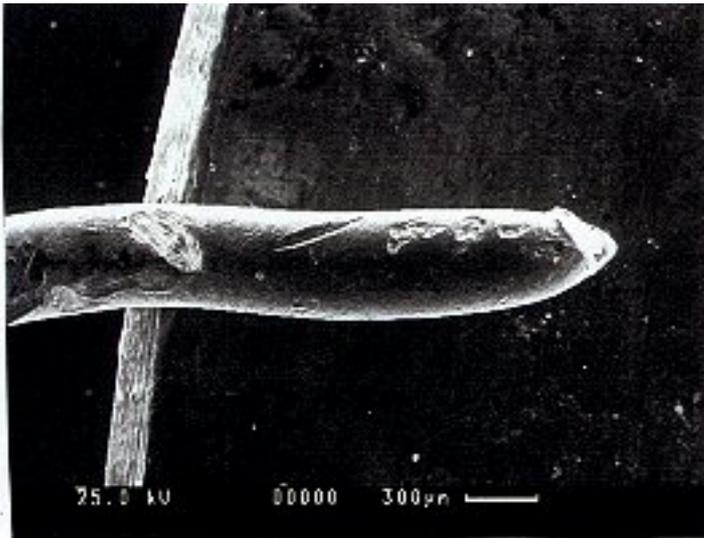
Figure 6 The SEM image shows B of the #1 wire. The lead has visible necking and the surface is faded with scratches.

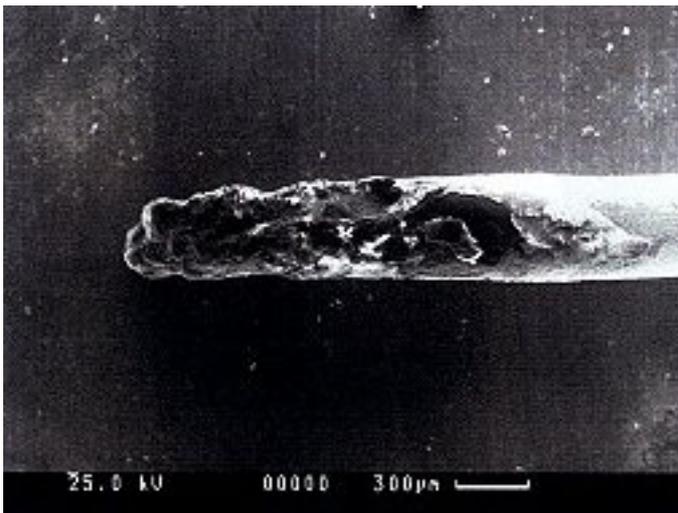
Figure 7. The SEM image shows the P of the positive wire. The lead has necking and the broken surface is a dark brown color, with broken plating and uneven on the substrate.

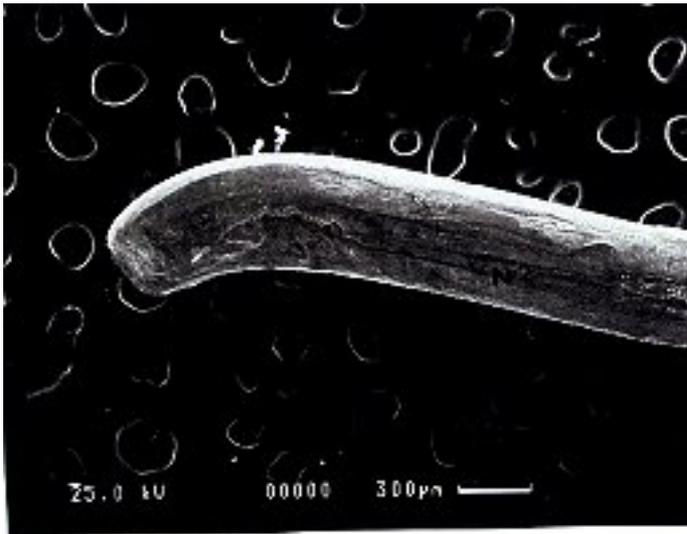
Figure 8. The SEM image shows N side of the negative wire. The broken surface shows necking and squeeze marks.

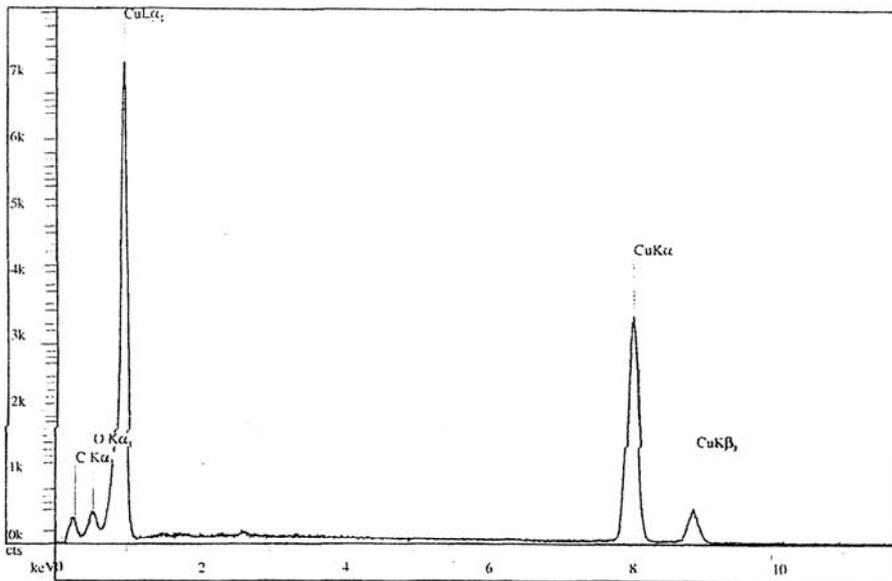
Figure 11. EDS spectrum of the fracture surface in Figure 10. The primary element of the #1 wire substrate is copper, with carbon and oxygen resulted from the environment reactants.

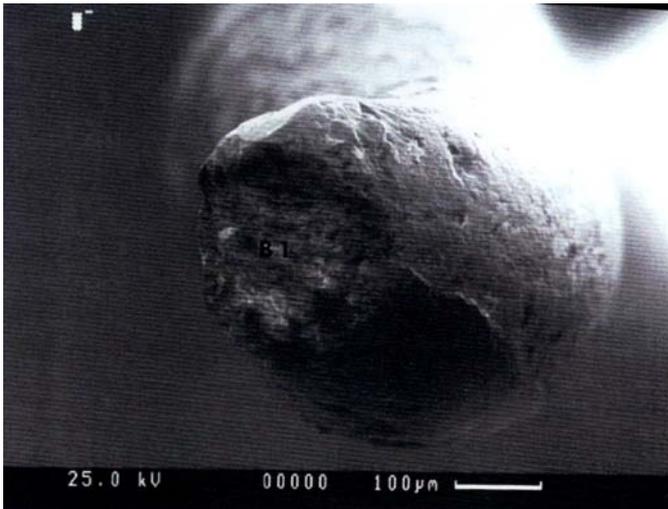
Figure 12. The SEM image shows B fracture surface of the #1 wire. The fracture surface is round and shows clear necking.

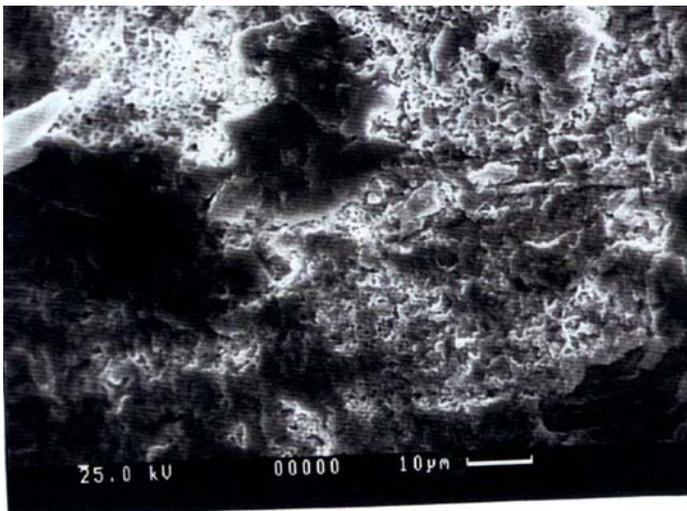
Figure 13. The SEM image shows B1 (figure 12) fracture surface of the #1 wire. The fracture surface has deposited and minor 1~3 μm diameter dimples.

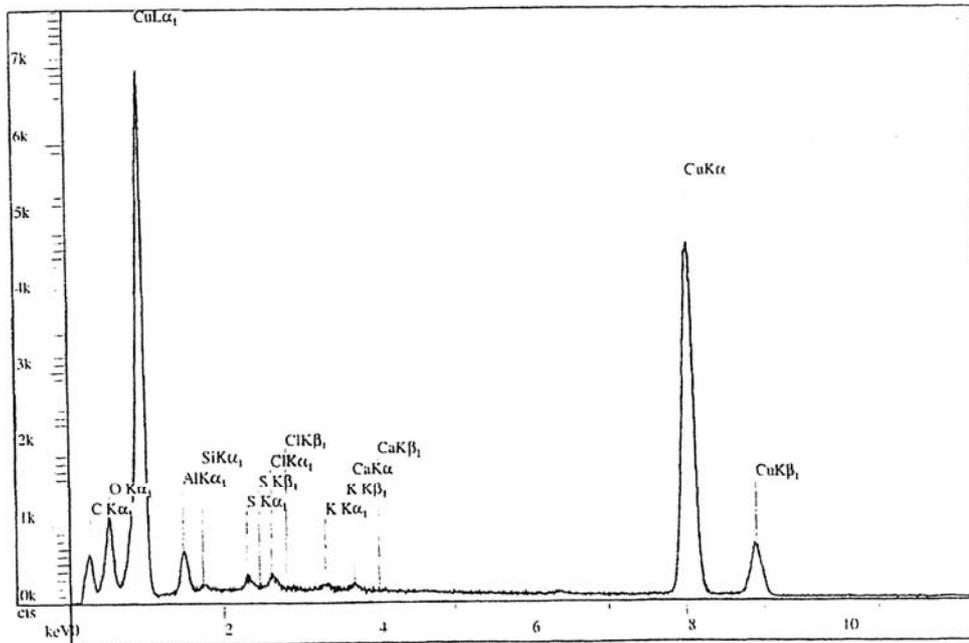
Figure 14. The EDS spectrum of the fracture surface in figure 13. The copper is the substrate of #1 wire. Aluminum, silicon, chlorine, potassium, calcium, sulfur, carbon and oxygen resulted from the environment reactants.

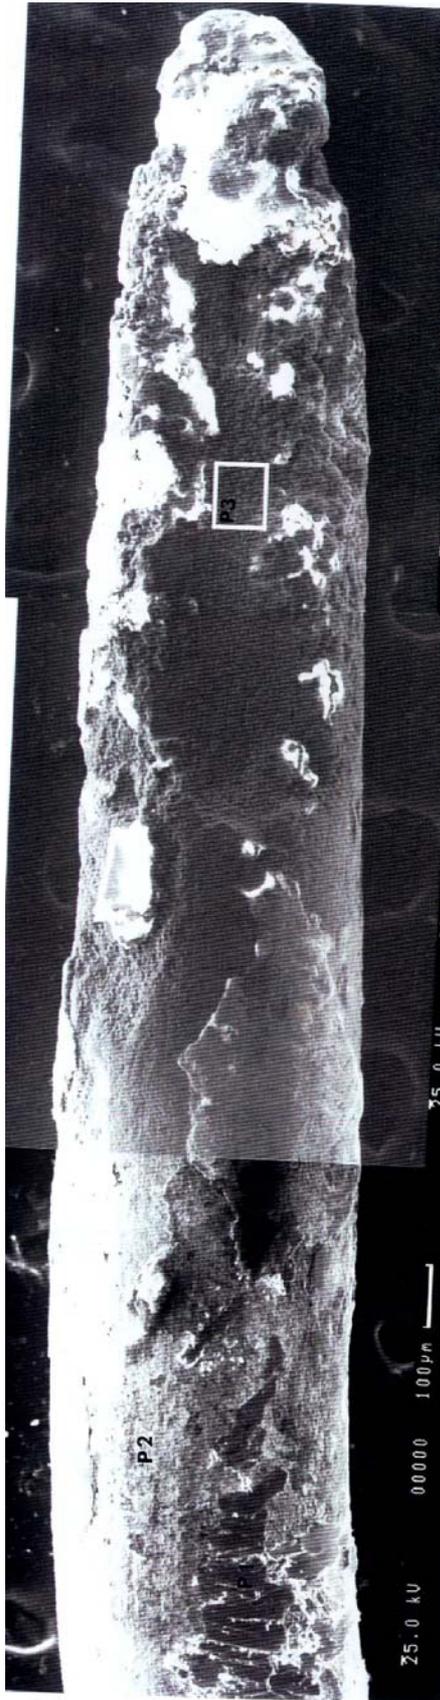
Figure 15. The SEM image shows P

fracture surface of the #1 wire, showing necking. Within 1.7 mm from the fracture, it is dark brown with broken plating and dimples. In 1.7 mm~2.2 mm from the fracture, it is silver color with peeled plating. The fracture surface was overheated and melted, and the fracture surface deposit environment reactant and contaminants.

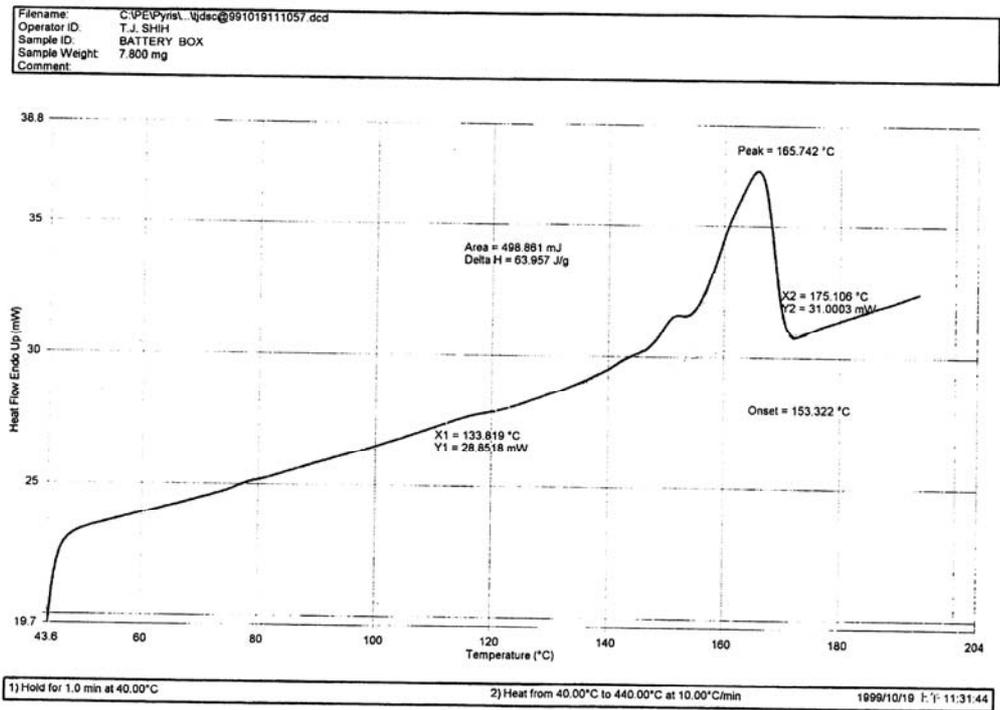
Figure 16. Thermal analysis curve of the battery casing.

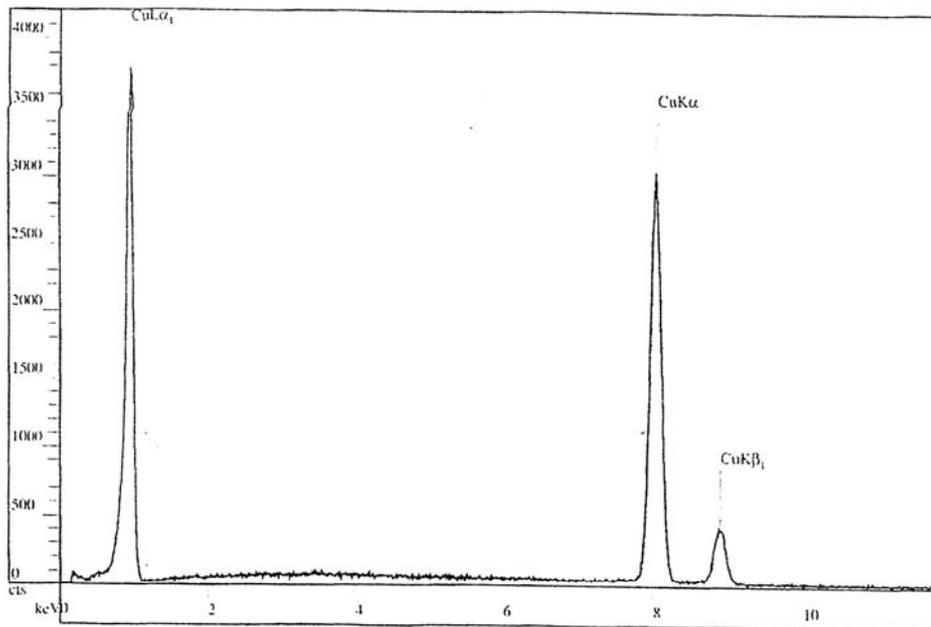
Figure 17. The EDS spectrum of fracture surface of P1 in Figure 15, demonstrating that the substrate is copper.

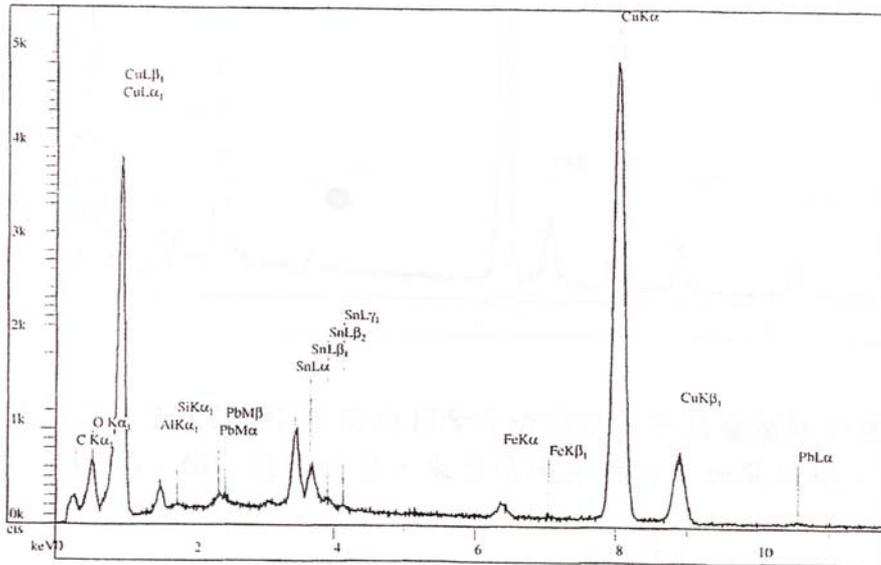
amount shown as figure 18. The copper is the substrate element of the positive wire and the tin is plating. The lead and iron were resulted from the polarity components. The oxygen, carbon, aluminum and silicon probably were resulted from the environment reactants. The EDS analysis given in P1, P2 indicate that the positive wire was copper wire with tin-plating, which is the same as the #1 wire. EDS analysis of the P3 dimpled surface (shown in figure 15), the spectrum shows the elements of iron, copper, oxygen and lead, plus trace amounts of carbon, aluminum, silicon and calcium shown as figure19. The copper is the substrate element of the positive wire. The iron, aluminum, silicon, lead, calcium and oxygen probably resulted from the oxides and carbides, which were come from the environment reactant and the deposited contaminant. The dimpled surface at P3 may be resulted from the high temperature, above 1083°C (the melting points of tin and copper are 232°C and 1083°C, respectively), generated by the arc of the short circuit. The completely burned pure copper substrate formed the crater and later deposited the contaminant (oxides and carbon buildup).

Figure 18. The EDS spectrum of fracture surface of P2 in Figure 15, revealed that the substrate is copper with tin-plating, and aluminum, silicon, chlorine, potassium, calcium, sulfur, carbon and oxygen resulted from the environment reactant.

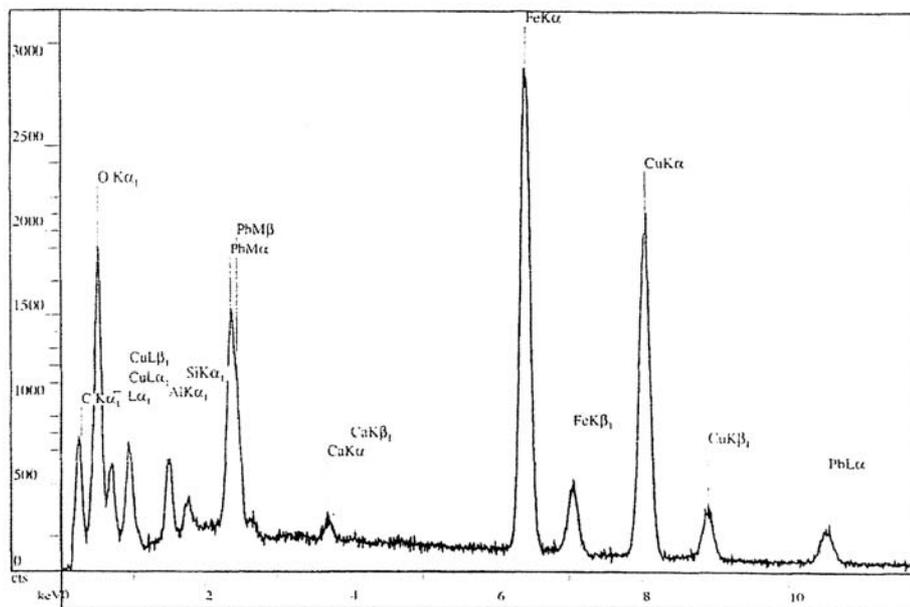
Figure 19. The EDS spectrum of fracture surface of P3 in Figure 15, showing that the substrate is copper, and aluminum, calcium, iron, oxygen and carbon come from the environment reactant.

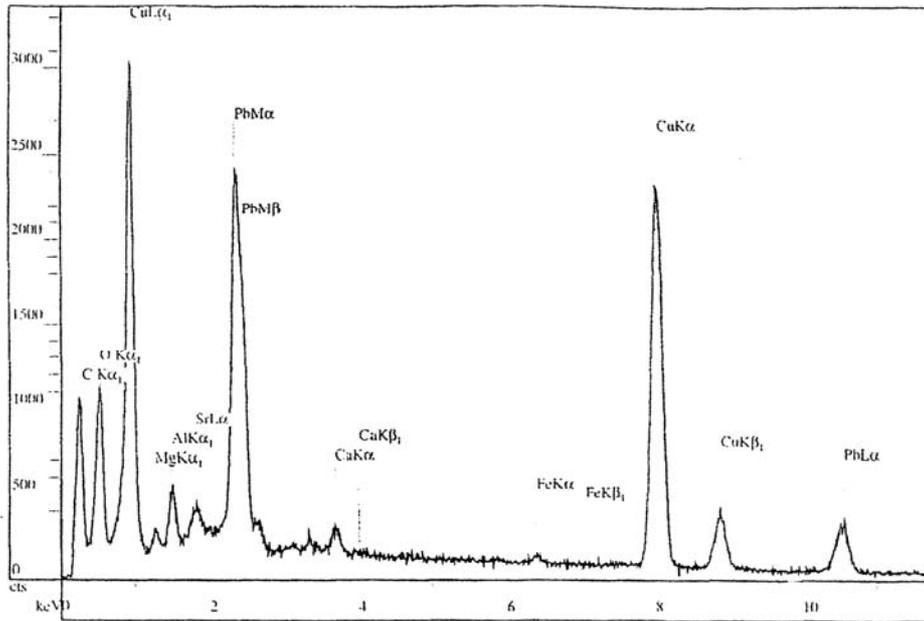
The SEM image shows that the fracture N of the negative wire was squeezed to form a triangle of 200 μm (0.2 mm) in height and 100 μm (0.1 mm) in width shown as figure 20. A magnified image of the N1 fracture surface (shown in figure 20) shows a large number of dimples of 5~10 μm in size shown as figure 21. The N1 fracture surface is resulted by overstress destruction. EDS analysis of the fracture surface (shown in figure 21) that the spectrum reveals the primary elements of copper and lead, the minor element of oxygen, and the magnesium, aluminum, silicon, calcium and iron in

Figure 22. The EDS spectrum of surface of figure 21, showing that the substrate of the negative wire is copper, with magnesium, aluminum, silicone, calcium, iron, oxygen and carbon coming from the environment reactant.

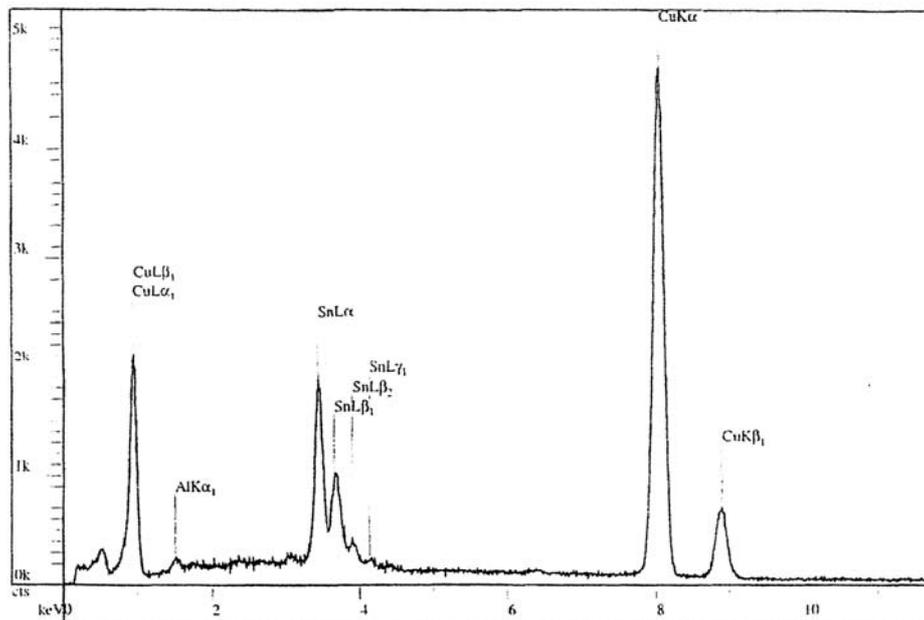
minimal amount shown as figure 22. The negative wire substrate was copper with lead coming from the lead polarity rod. The magnesium, aluminum, silicon, calcium, iron, oxygen and carbon were resulted from the environment reactant. EDS analysis of the N2 negative wire surface (shown in figure 8) that the spectrum reveals its primary components are copper with tin, oxygen and aluminum in minimal amount shown as figure 23. Copper is the substrate element of the negative wire and with tin-plating. The aluminum and oxygen were probably resulted from the environment reactant.

Figure 23. The EDS spectrum of N₂ surface in figure 8, showing that the substrate of the negative wire is copper with tin plating, while aluminum and oxygen came from the environment reactant.

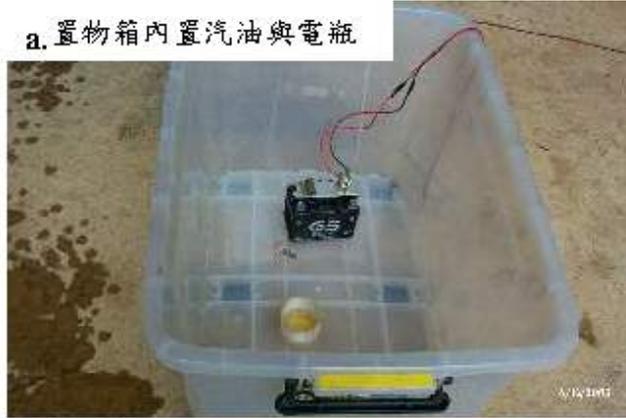
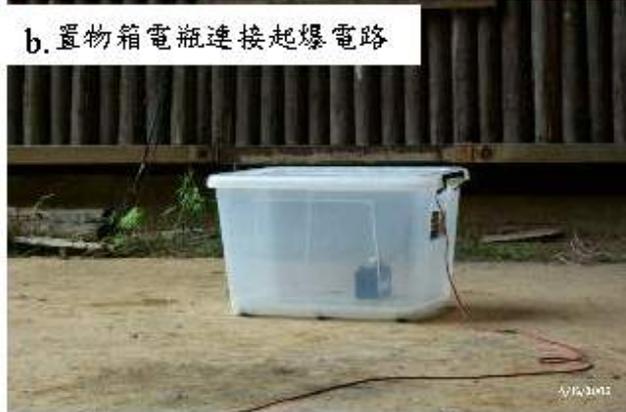
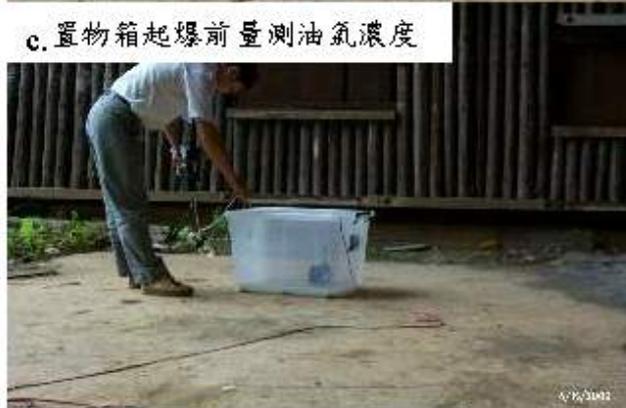
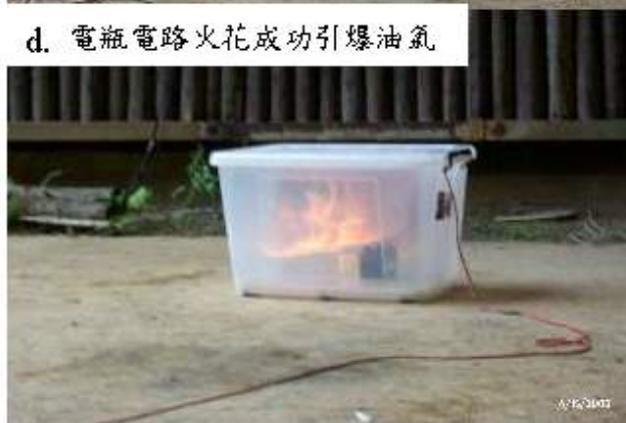
- 8) Plastic cup
 - 9) Pressure gauge
 - 10) High-speed cameras
- 2) On June 15, a 96-liter simulated bin vapor ignition test was conducted to determine if a spark from the 12v battery would ignite the vapor inside the bin, as shown in Picture 1 (a)~(d).

照片一. 96 公升模擬置物箱先期試驗(一), 汽油濃度高於爆炸下限兩倍, 有氣爆現象, 產生大火團, 但無法持續燃燒

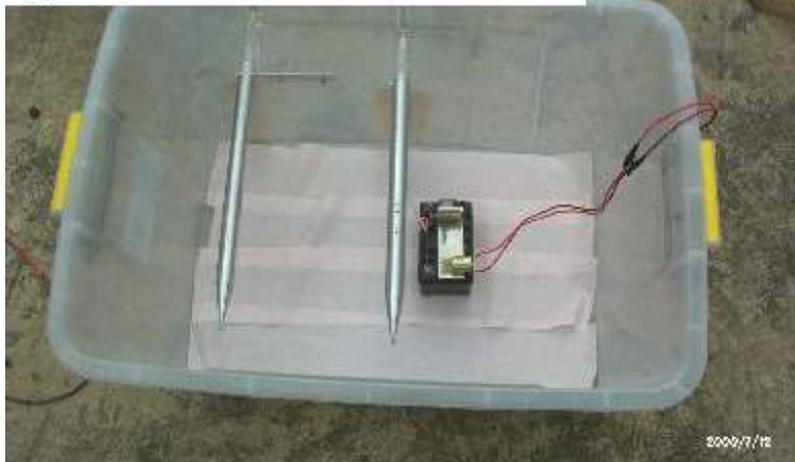
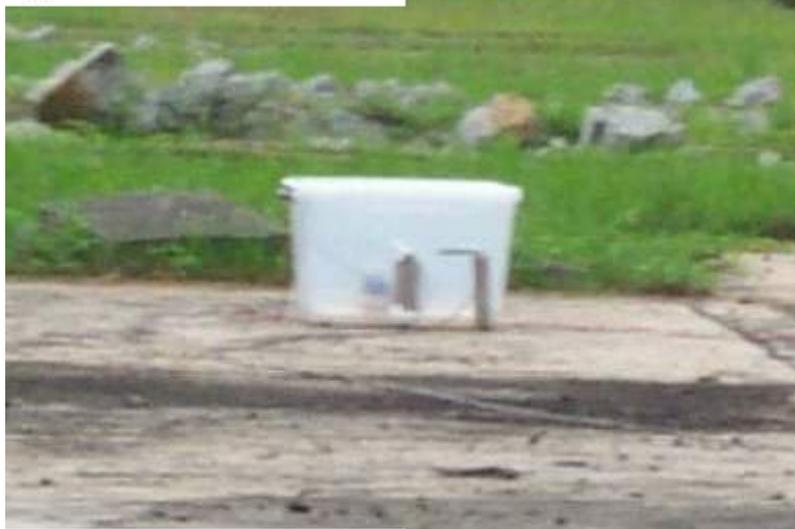
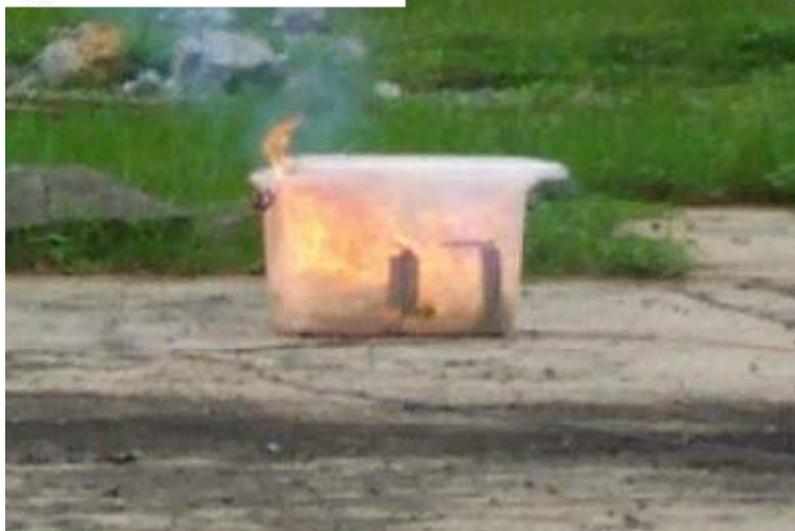
- 3) On July 12, 96-liter and a 400-liter simulated bin vapor ignition tests were conducted using a high-speed camera to record the ignition process. The results indicated that the 96-liter bin ignition was successful, as shown in Picture 2 (a)~(c). Boost was detected too, as shown in Fig. 2. The 400-liter simulated bin ignition was also successful, as shown in Picture 3 (a)~(c). However, there is no reliable data as the instant peak value exceeded the upper limit. Both sensors were damaged in the 400-liter simulated bin test.

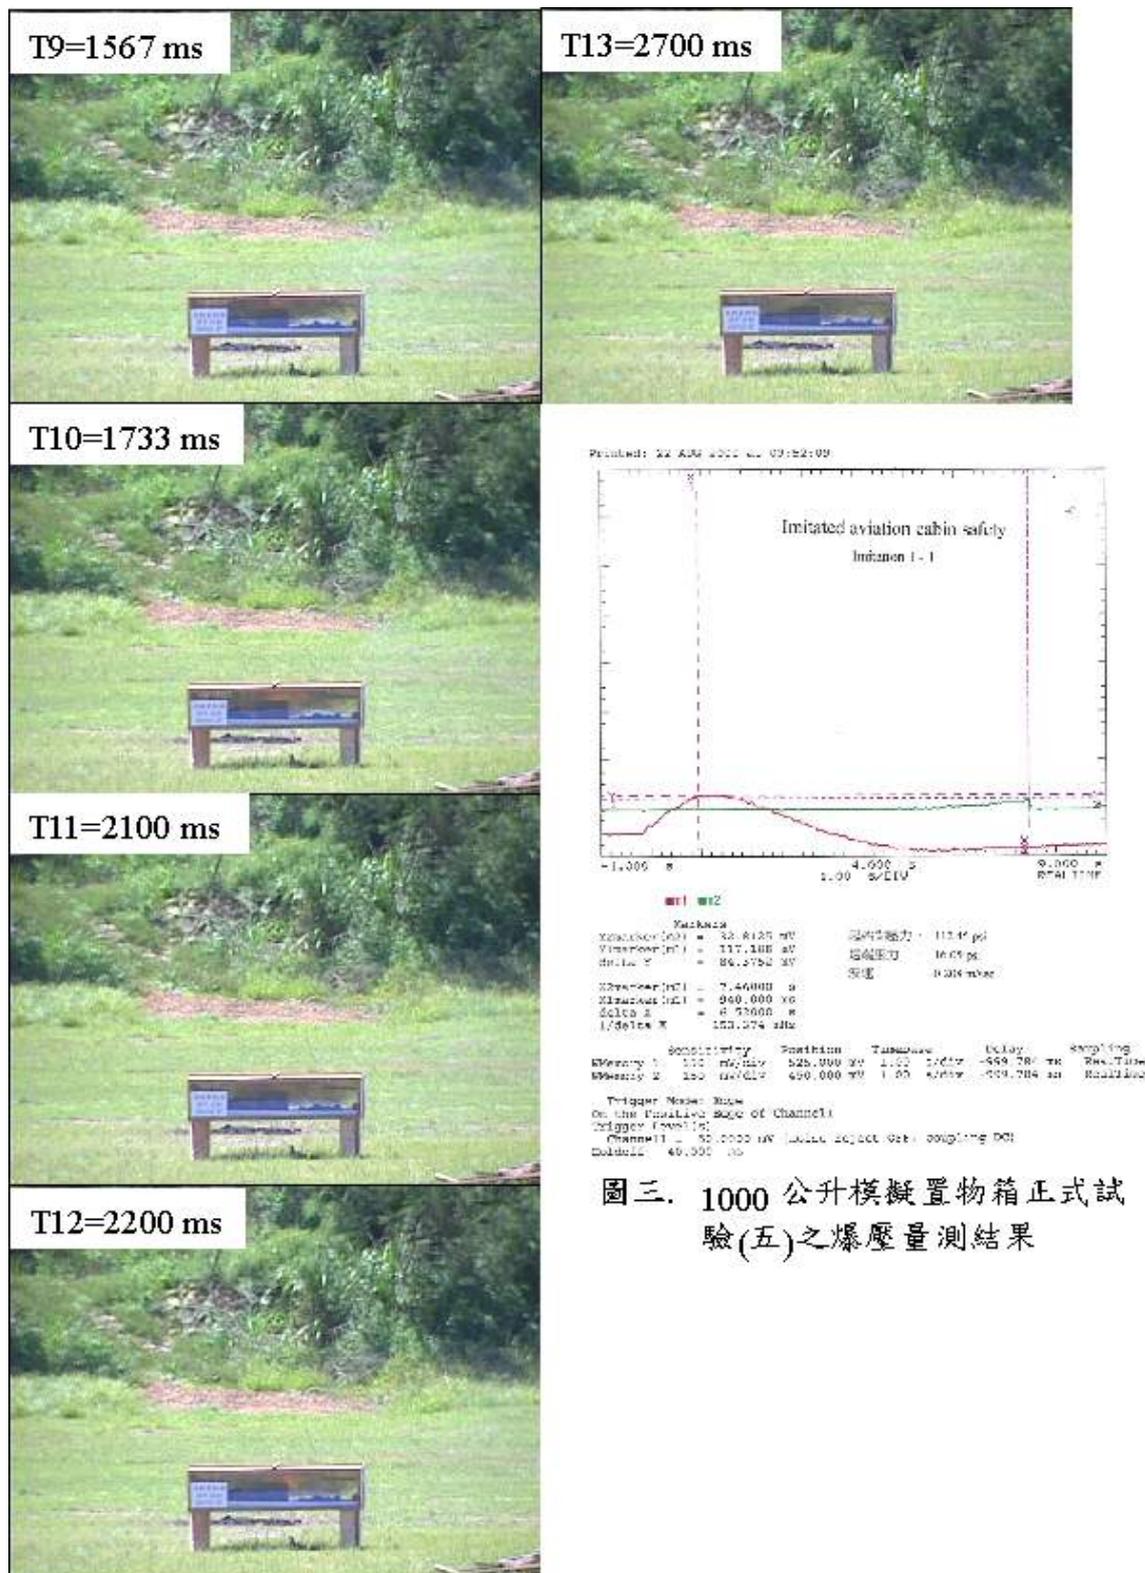
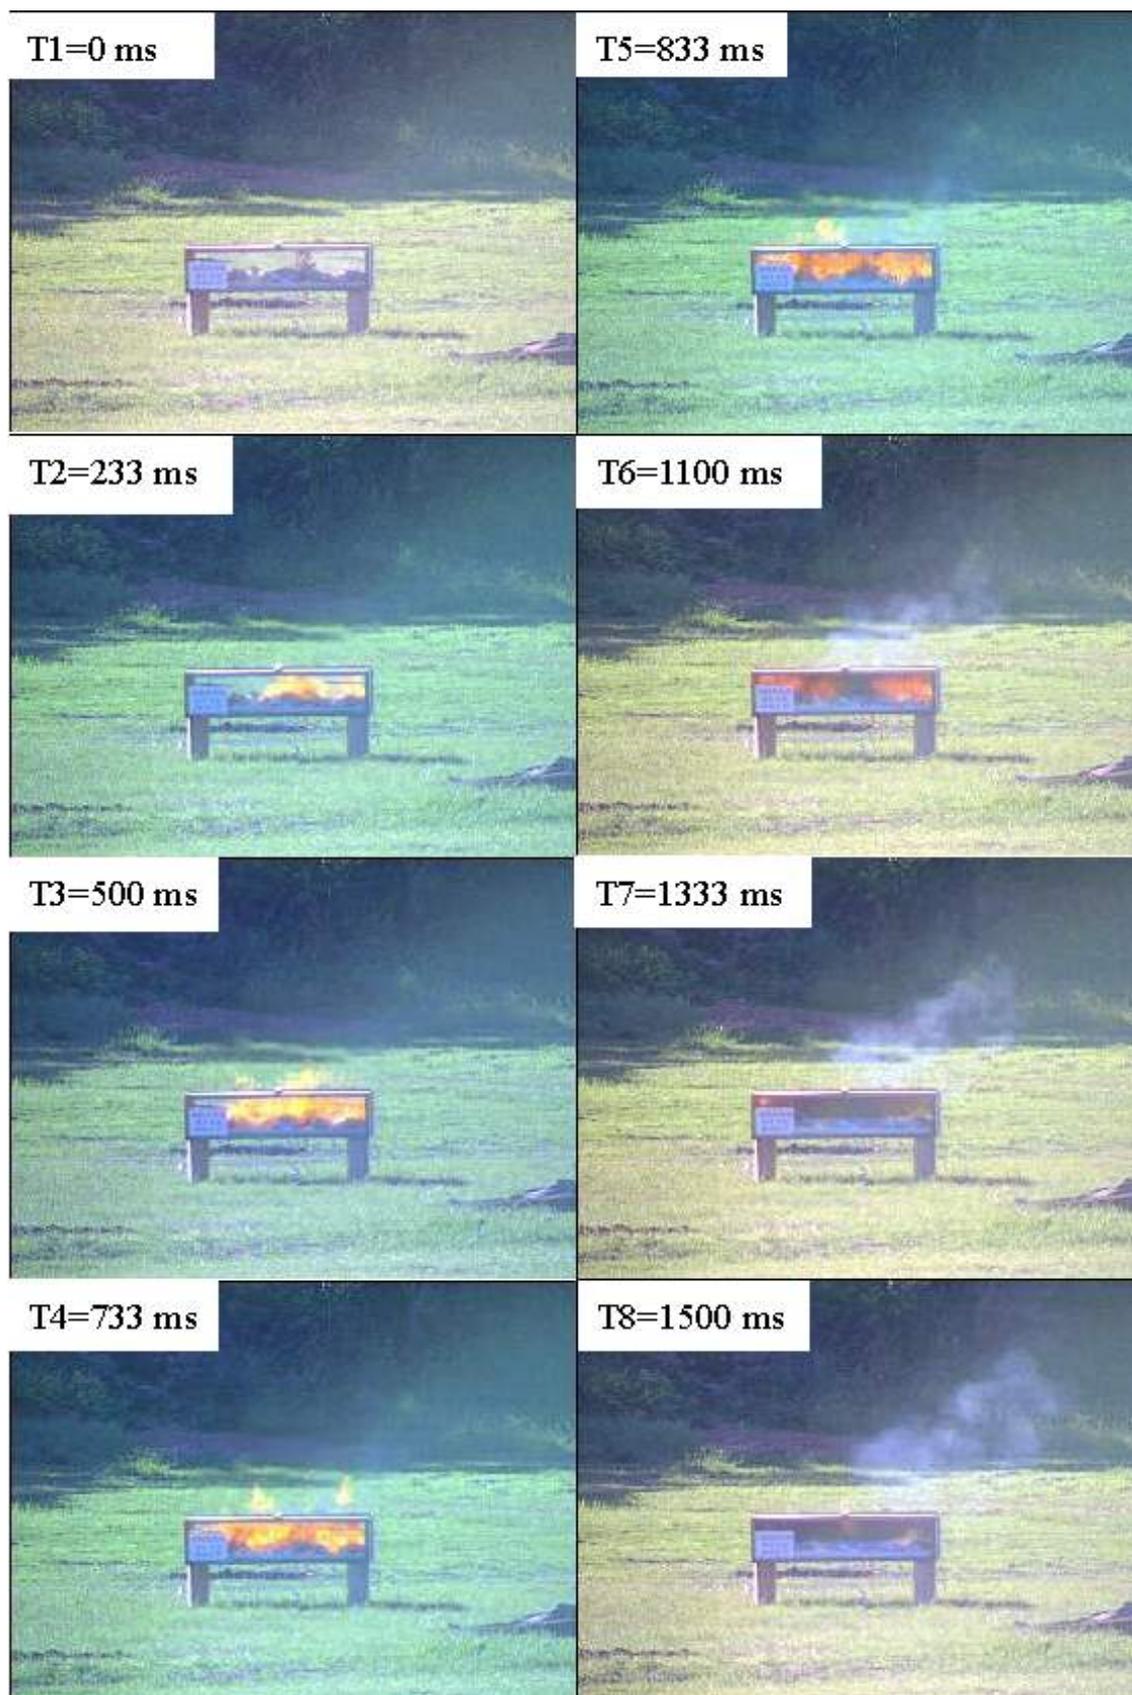
照片五. 1000 公升模擬置物箱正式試驗(五)

The vapor inside the carton ignited although the outside of the carton showed no damage. No exterior flash was evident on the high-speed camera.

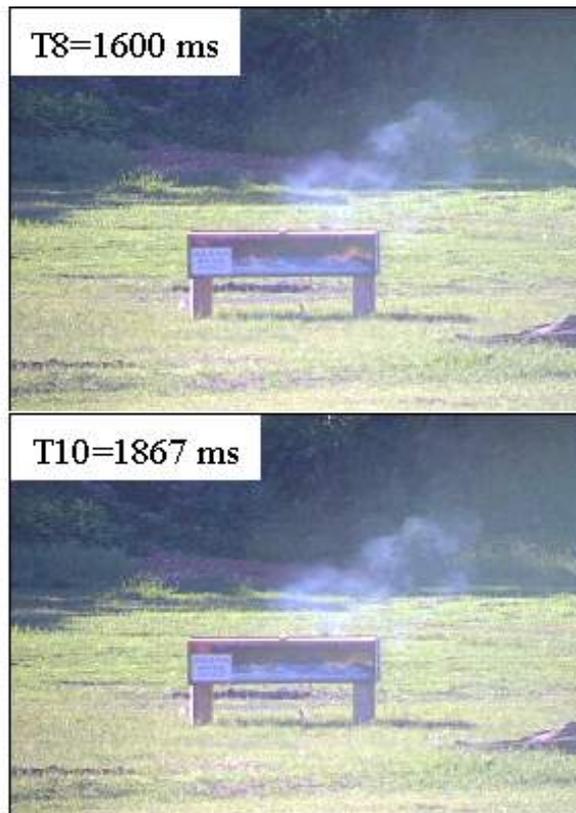
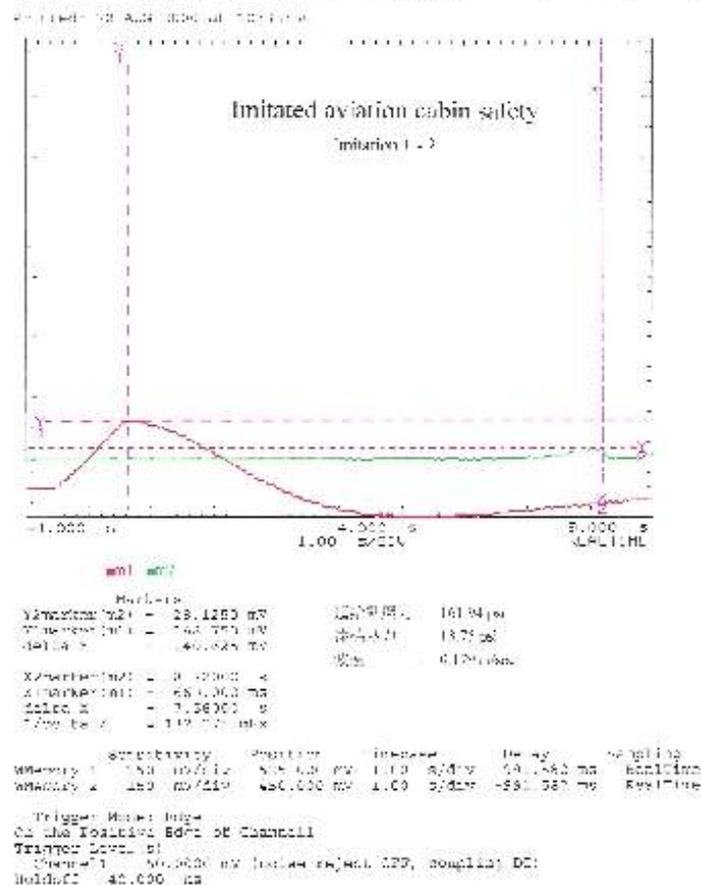
照片六. 1000 公升模擬置物箱正式試驗(六)

The 6th test result: The upper part of the rag shows no signs of burns, but has dried. The gray tape is unbroken but shows blistering from the high temperature. The 12V-battery power cord is severely damaged. We believe that the sudden fire and oxygen deprivation caused this damage. The explosion sequence is shown in Picture 6 and the boost test is shown in Fig. 4.
