Aviation Safety Council

Accident Investigation Report

ASC-AAR-00-11-001

MD-90-30 cabin explosion and fire

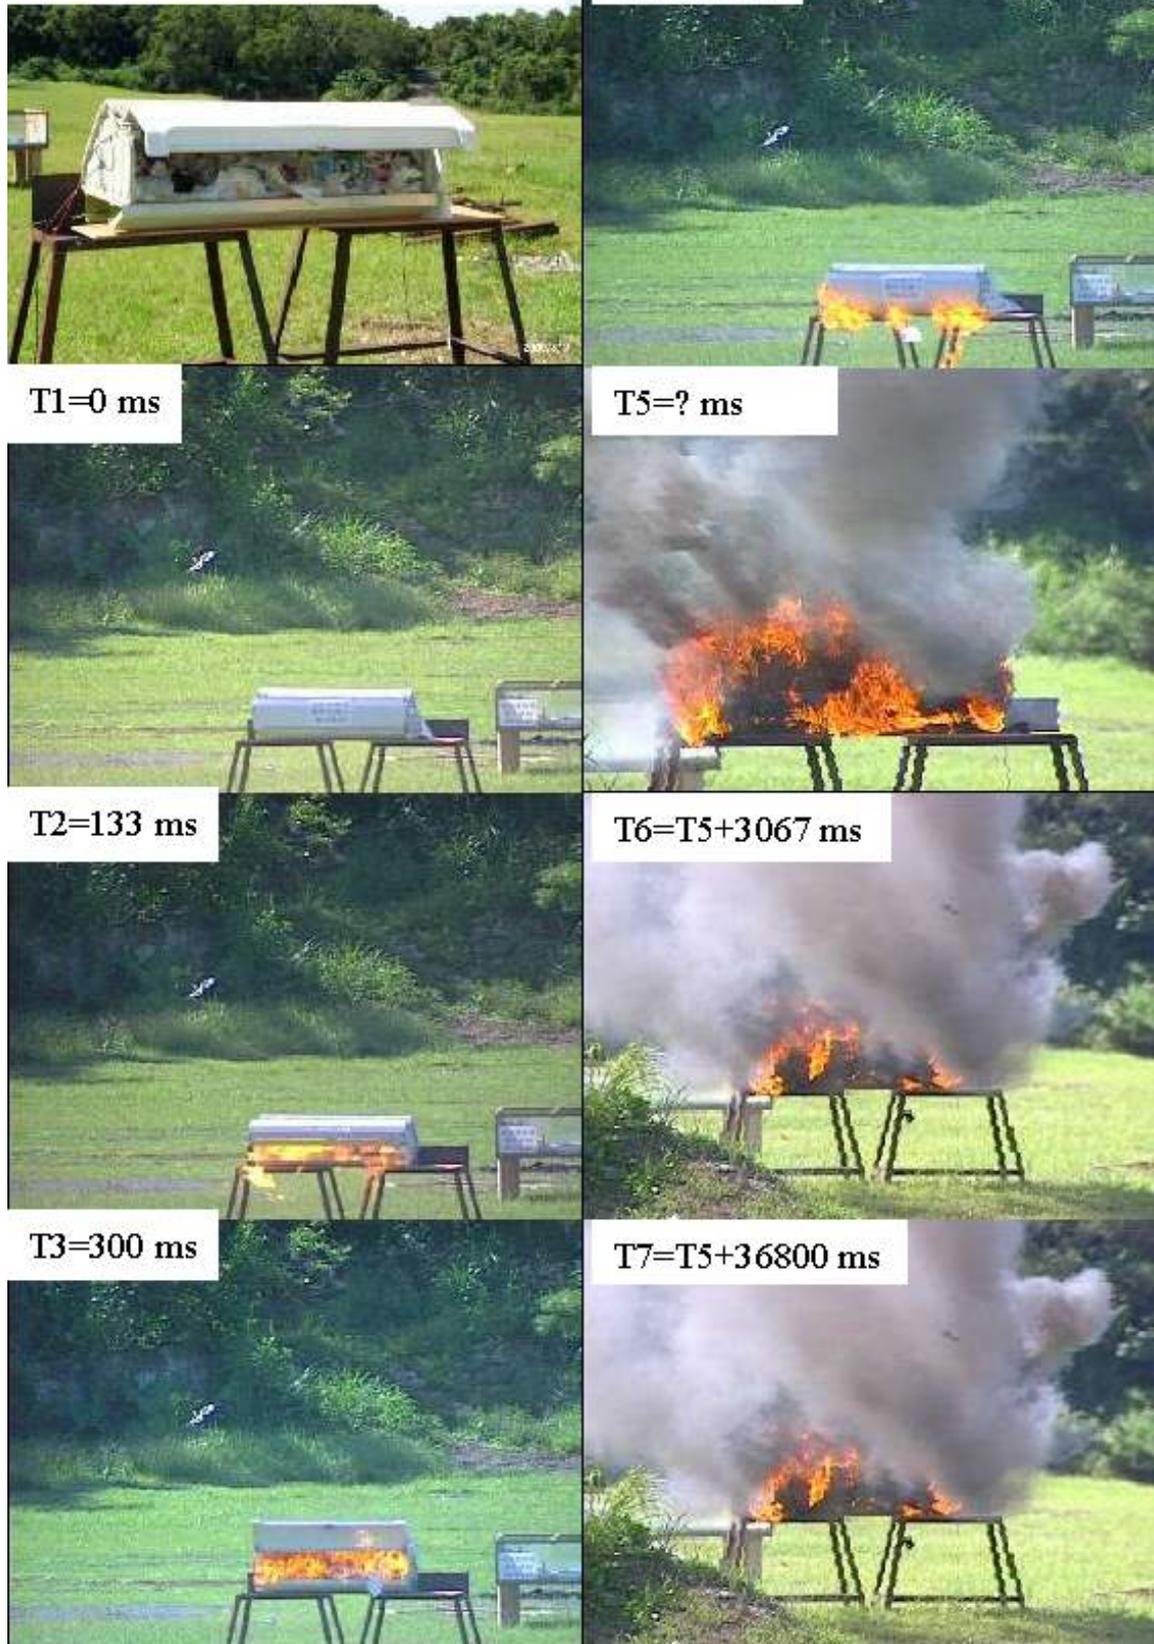
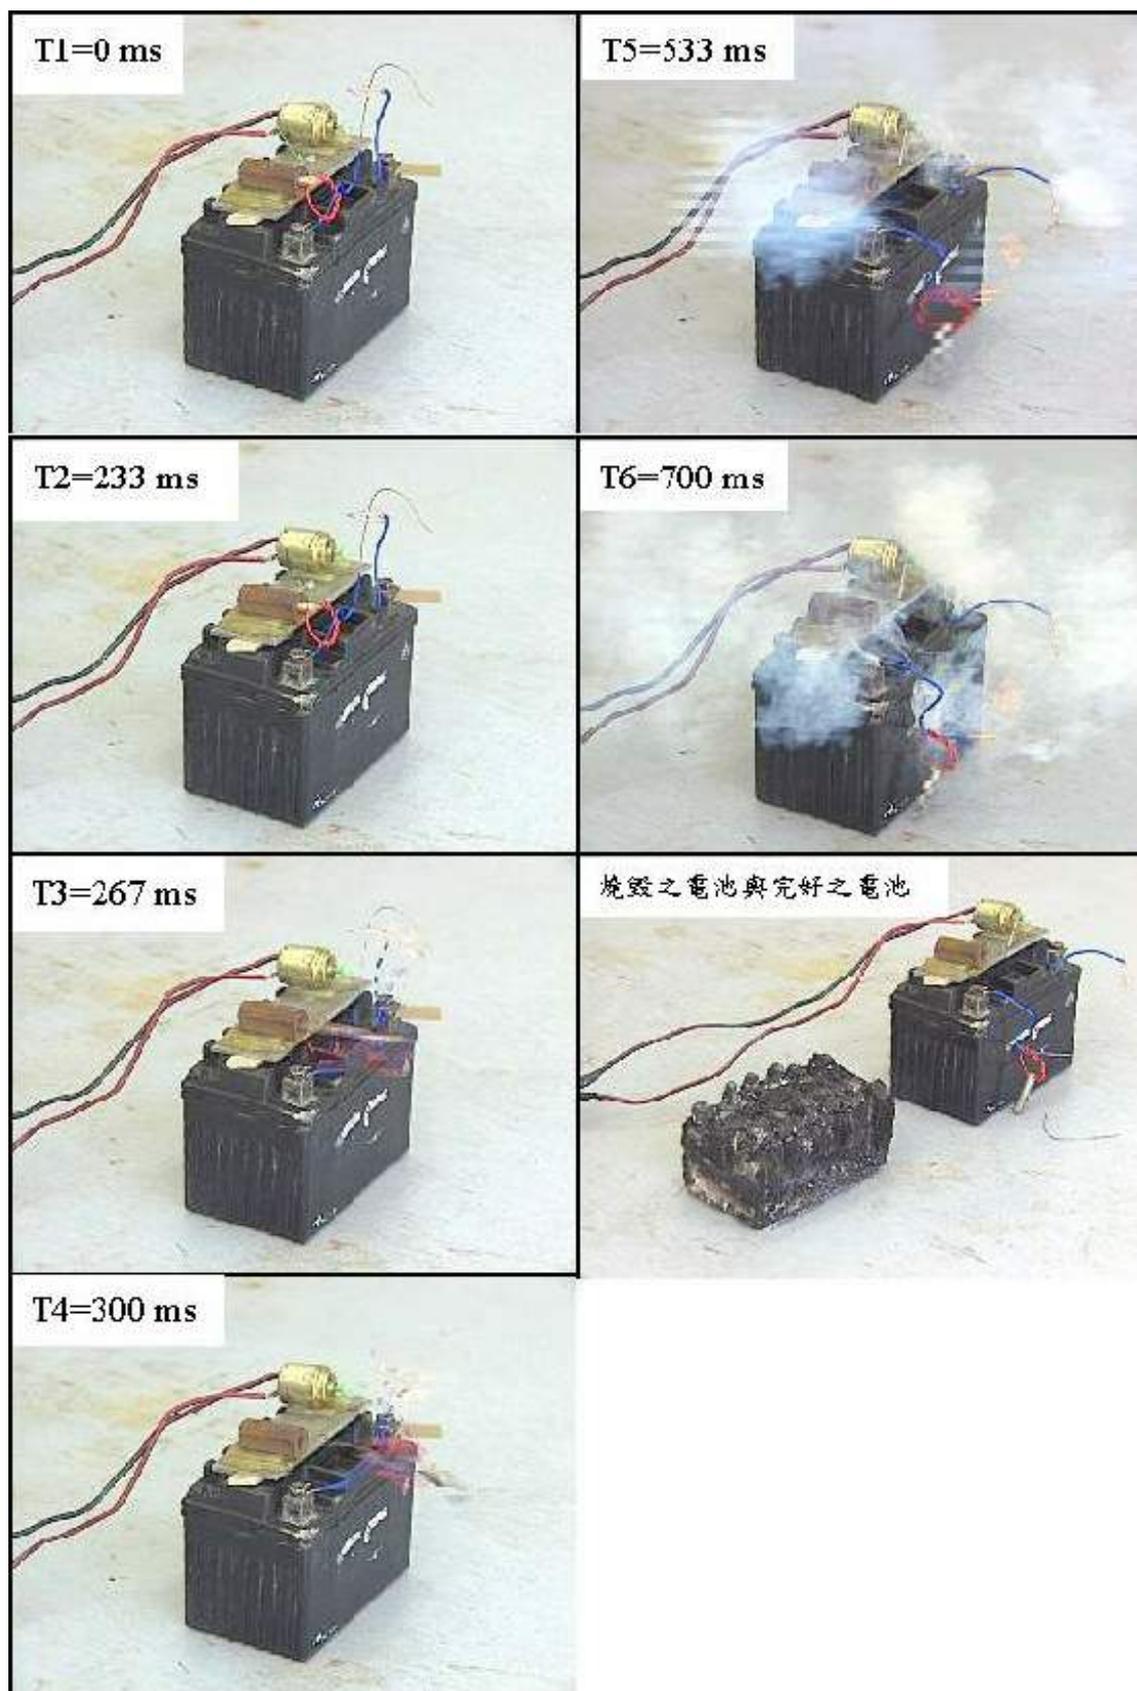
照片九. 350 公升模擬置物箱正式試驗

A Boeing 727 storage bin has a capacity of 350 liters and has a 10cm-wide opening above the lid and a 3cm-wide opening to its left. The lid is secured by a mechanical spring located in the center. To keep vapor from leaking, both openings were sealed with gray tape. This bin was not sealed as tightly as the wooden bin because the tape used was too narrow. The battery was placed in the bin along with newspapers, and then sprayed with approximately three liters of gasoline. Finally, a liquid bleach bottle half filled with gasoline was placed in the bin, as shown in Fig. 9.

The upper part of the newspaper is completely burned. The gray tape shows burn signs but did not break. We believe that the bin lacked oxygen necessary to sustain the fire.
