**NATIONAL
TRANSPORTATION
SAFETY
COMMITTEE**

AIRCRAFT ACCIDENT REPORT

AN-72-100 ES-NOP

21 APRIL 2002

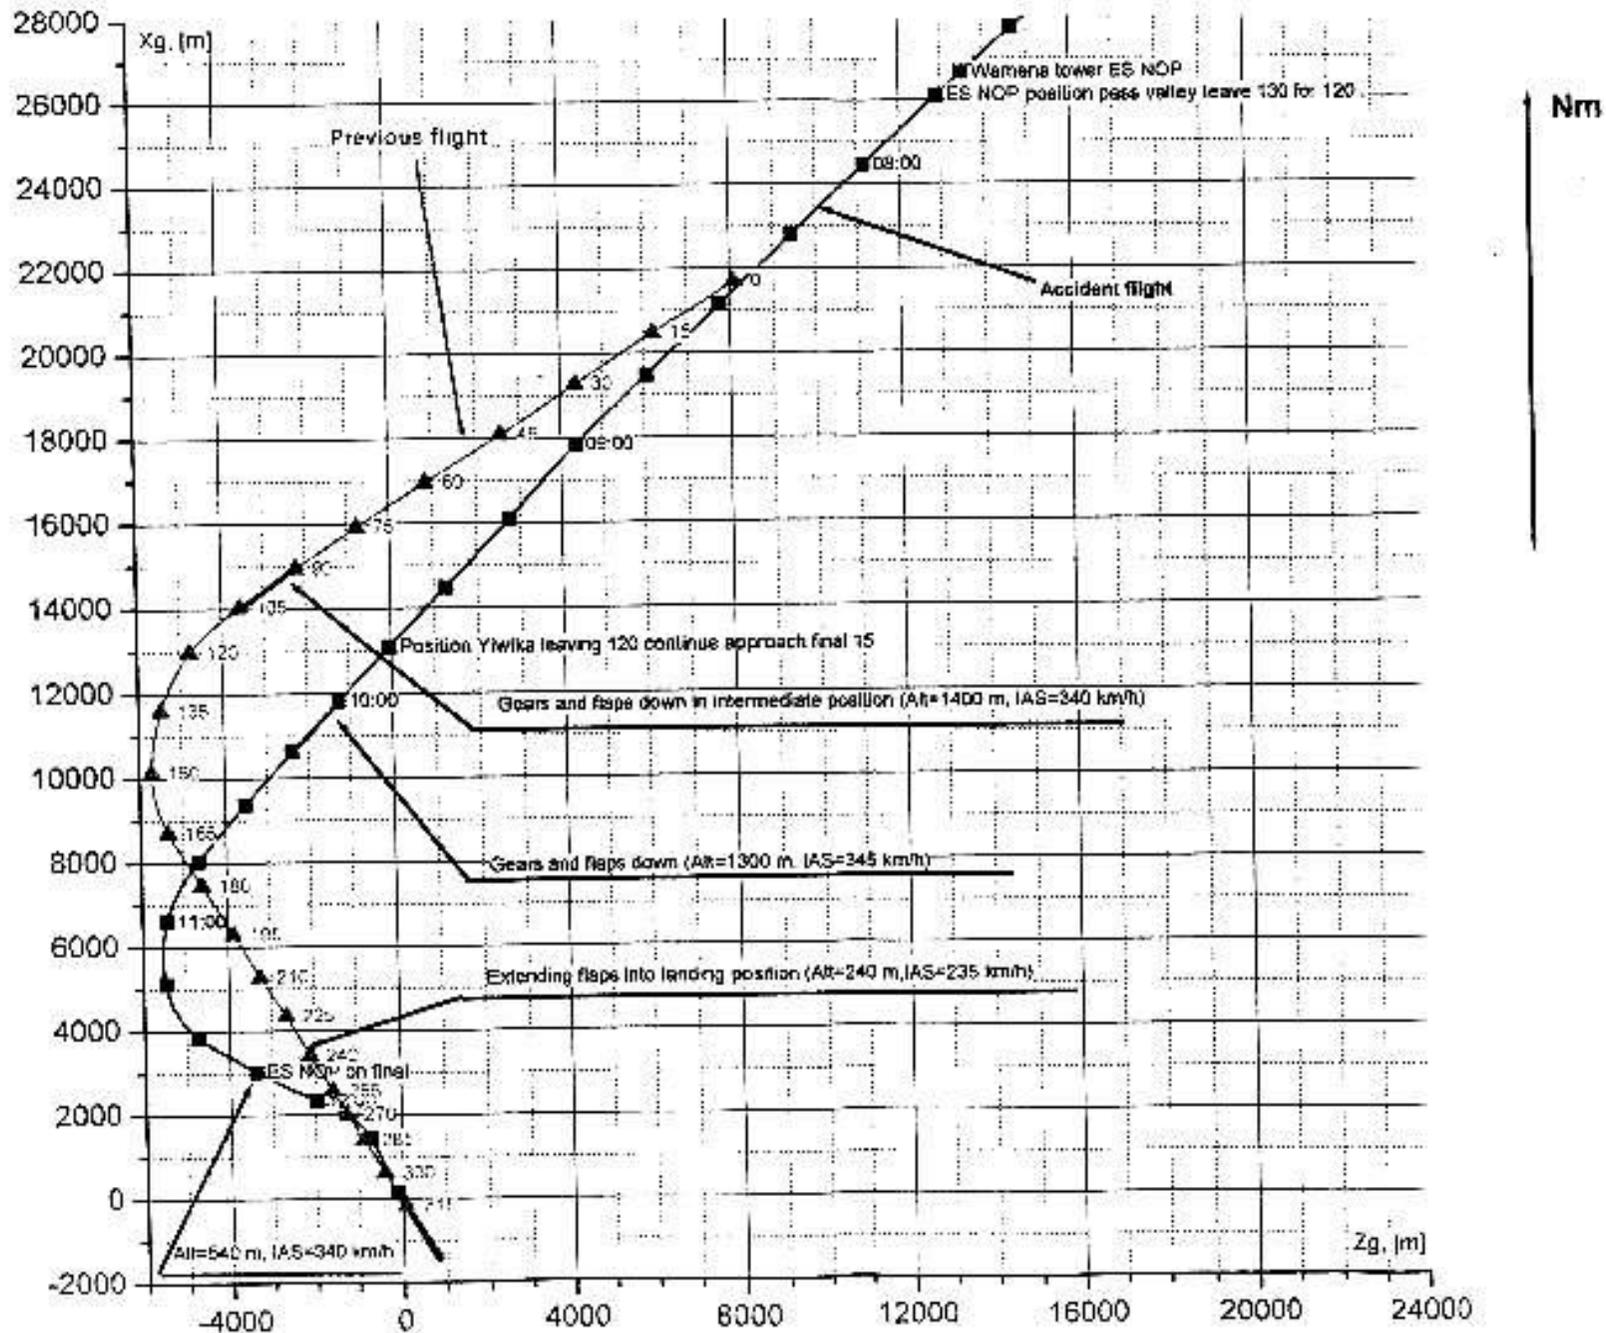
Pic. 4 Flight path of the Antonov 72 aircraft on April 21, 2002 while landing in Wamena airport

Therefore, it can be concluded that the aircraft was over speed upon the accident landing. The FDR analysis also noted that the aircraft never fully deploy its flap due to over speed on final (see 0).
