AIRCRAFT ACCIDENT REPORT

Controlled Flight into Terrain

Ilyushin IL-76 TD, RDPL-34141

Baucau, Timor-Leste

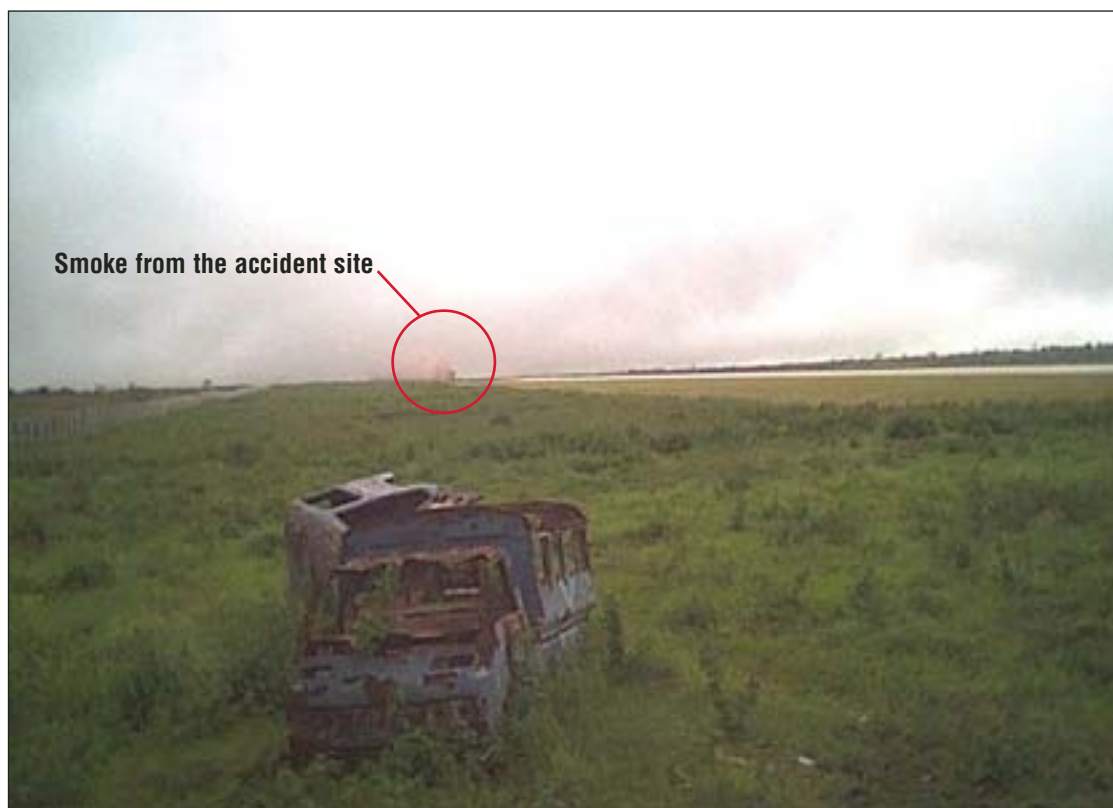
FIGURE 5:
Smoke seen to the northwest of the aerodrome

- the aircraft landing gear was not extended as it overflew the aerodrome on the first occasion (see Figure 3)
- the aircraft landing gear was extended during the first landing approach (see Figure 4), but the aircraft appeared too high to be able to land, and discontinued the landing approach
- the weather at the time was overcast with a low cloud base
- a few minutes after the discontinued first landing approach, they heard an explosion to the northwest of the aerodrome, and saw flames and smoke in that vicinity (see Figure 5).

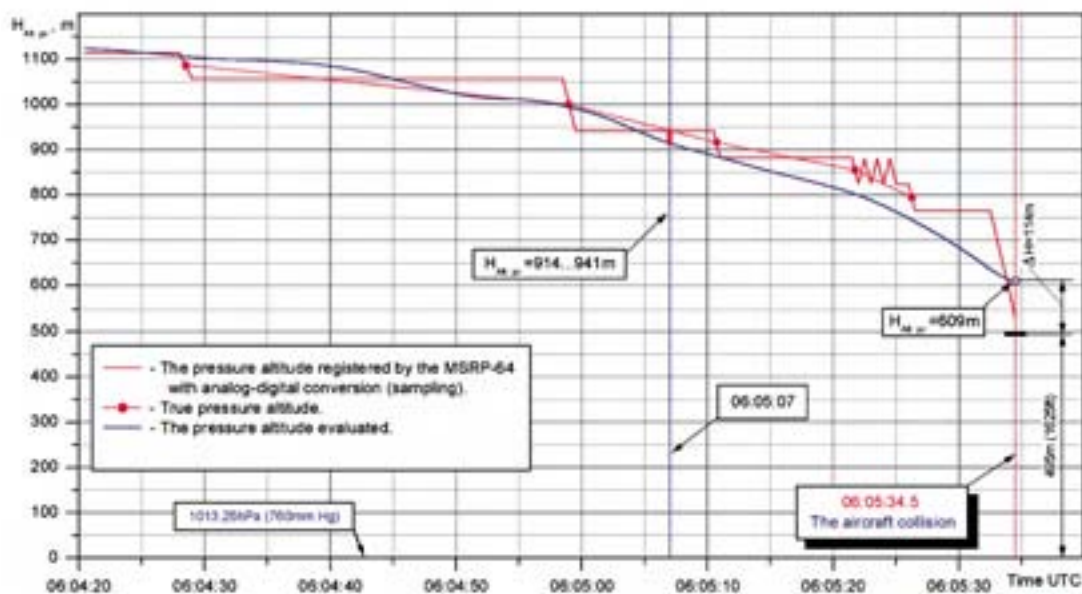
FIGURE 14:
Evaluated aircraft barometric altitude

The IAC reported that the FDR recorded barometric altitude in 60 m increments, and that it was possible there could be as much as a 120 m error in the barometric altitude plot. The IAC ‘smoothed’ the recorded barometric altitude data to take into account the variable quality of the recorded data and to derive true pressure altitude. It then applied recorded vertical acceleration (‘g’) to the derived true pressure altitude data to provide an evaluation of the actual aircraft barometric altitude (see Figure 14).

The evaluated pressure altitude varied slightly from the 'smoothed' true pressure altitude derived from the variable recorded barometric altitude data. The impact point was 495 m (1,625 ft) above the 760 mm Hg (1,013.2 hPa) datum. The evaluated pressure altitude at impact was 609 m (1,998 ft), indicating a discrepancy of 114 m (374 ft) between the recorded barometric data and the evaluated pressure data.

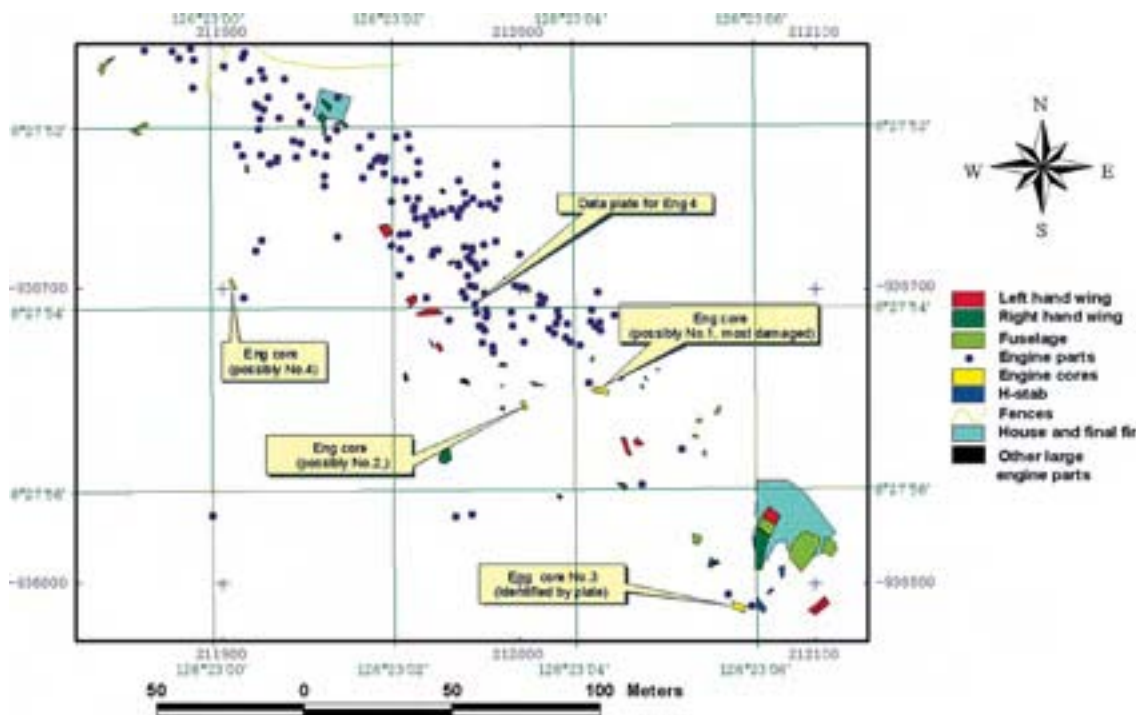
FIGURE 16:
Location of engines

The engine cores and accessories were mostly intact, however each engine fan assembly had separated from its respective engine, and fan blades were spread throughout the accident site (see Figure 16).

The post-occurrence technical examination of the engine fan blades found in the wreckage did not display any evidence of bird strike or blending repairs.³⁰ It was not possible to determine whether the engines had sustained any foreign object damage before impact because of the significant damage resulting during from the impact sequence. The FDR EGT and N2 plots are depicted at Figures A.8 and A.9 in Appendix A. The plots revealed no apparent aircraft engine anomalies during the descent into Baucau or during the approach sequences. The extent of the typical resultant engine damage is depicted at Figures 17 and 18.

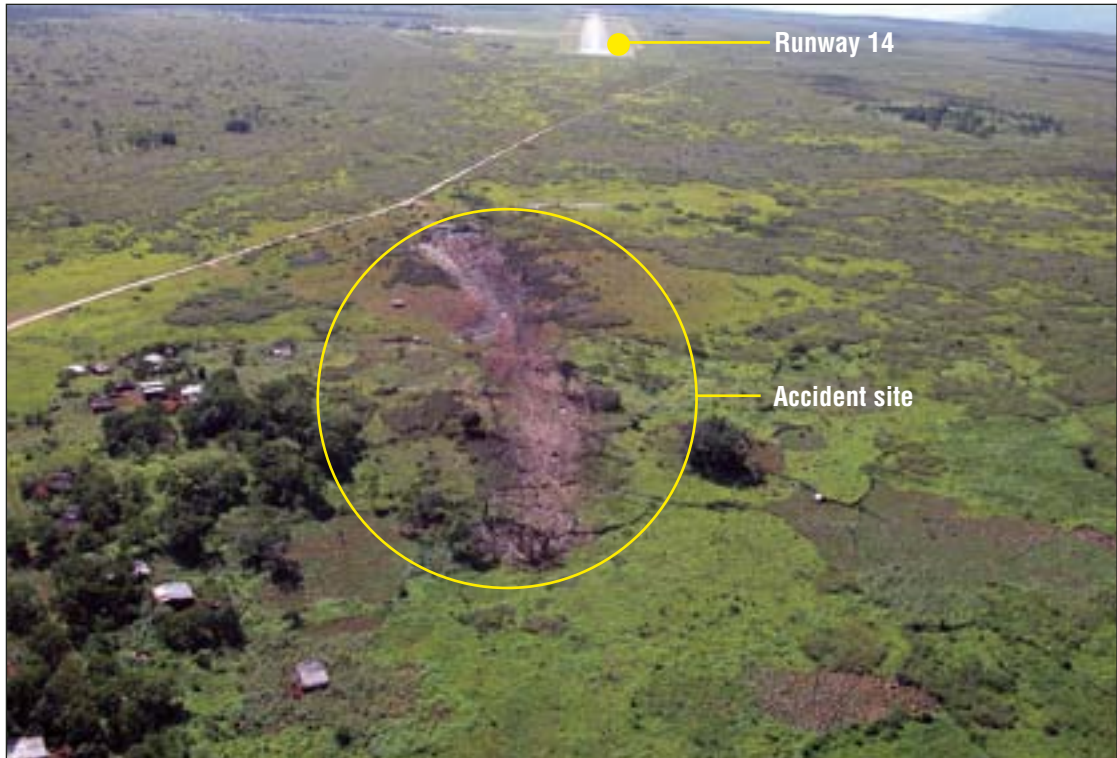
FIGURE 19:
Accident site in relation to Baucau runway 14

The aircraft impacted terrain about 1 NM (2 km) to the north-northwest of Baucau aerodrome. The accident site is depicted at Figures 19 and 20.

The terrain between the impacted trees and the aerodrome contained no other significant groups of trees of similar height to those impacted (see Figures 19 and 20). The investigation concluded that had the correct QNH had been used to establish QFE, impact with the trees may have been avoided. The investigation also concluded, however, that the likelihood of impact with terrain at a point closer to the runway would probably have remained almost certain. Under those circumstances, even though the aircraft would probably have sustained severe damage by impact forces, the consequences of the CFIT event may not have been as catastrophic.

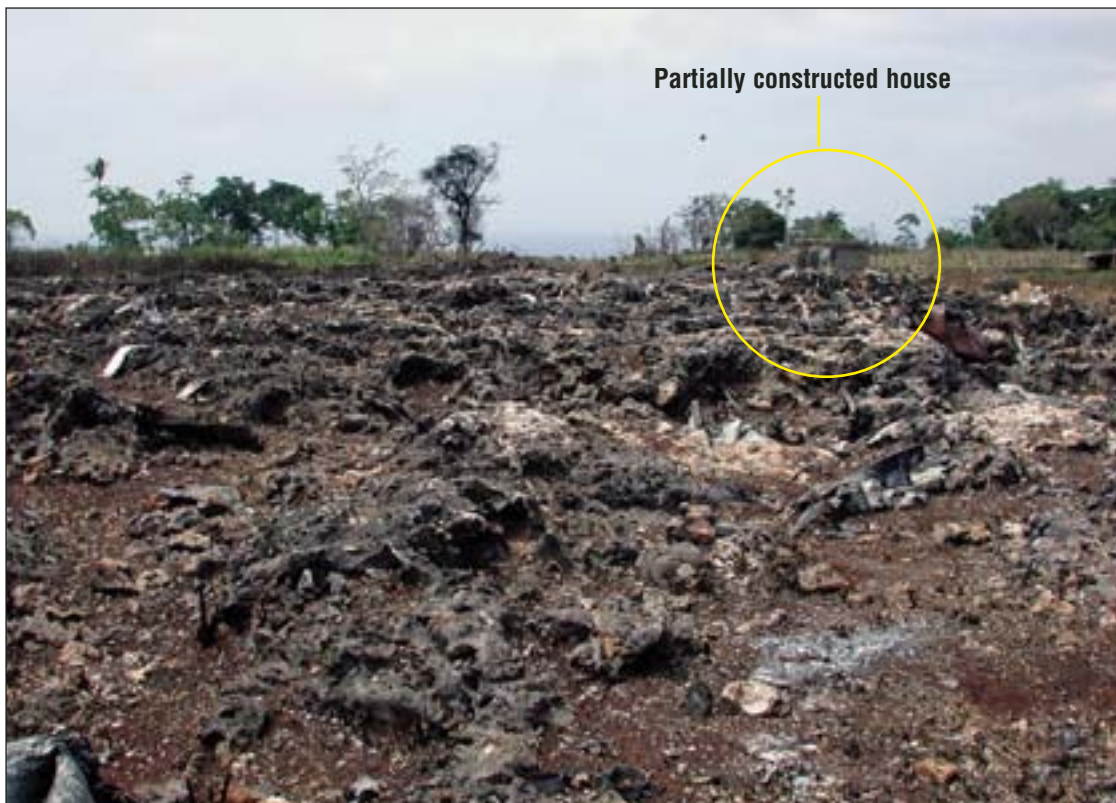
FIGURE 22:
Terrain within the wreckage area

A serrated area of rising ground consisting of coral outcrops up to a metre (3.3 ft) high was located just past the partially constructed house that was struck by the aircraft during the impact sequence. The area was difficult to traverse on foot, and the Australian investigation team likened it to an 'enormous cheese-grater' (see Figure 22).

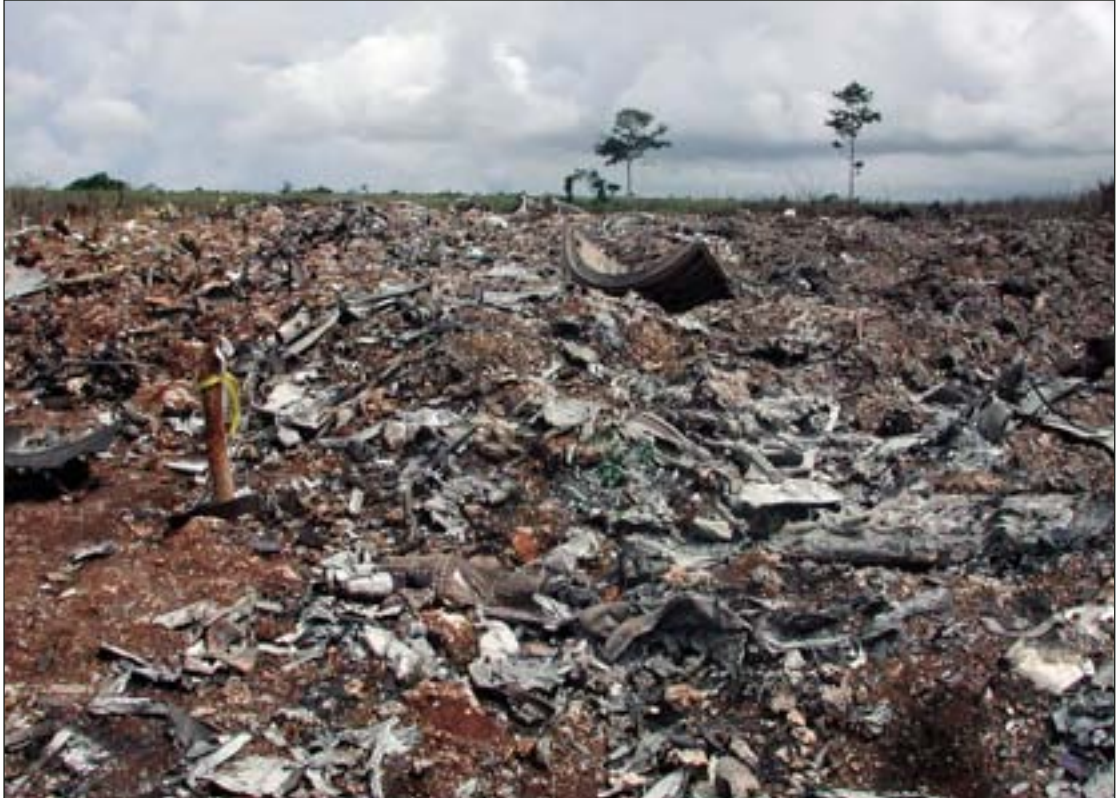
FIGURE 23:
Commencement of the cockpit wreckage area

Many small parts of the forward fuselage section, wing sections, and engine fan blades were found to the left of the wreckage trail, starting from the beginning of that serrated portion of ground. Several of the cockpit instruments, controls, the quick access recorder, the remains of most of the occupants, and large sections of the cockpit windows were also found to the left of and beyond that area (see Figure 23). The area also displayed evidence of an intense short-duration fire.

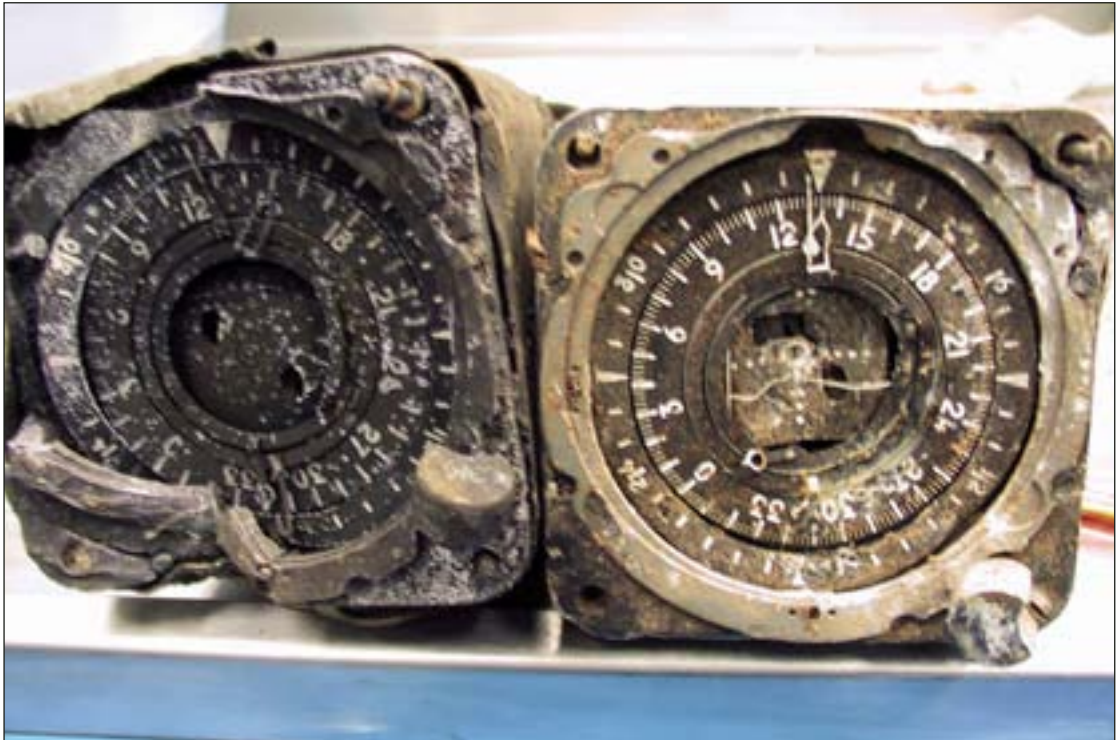
FIGURE 24:
Course Indicators recovered from the wreckage

Two CIs were recovered from the wreckage (see Figure 24).

The impact forces had substantially damaged both the CIs. One was badly sooted from exposure to the post-impact fire around where it lay after being dislodged from the instrument panel. The 3K desired heading pointer on the less-damaged CI was aligned to a magnetic heading of about 134 degrees. The 3K desired heading pointer of the more-damaged CI had been bent during the impact sequence.

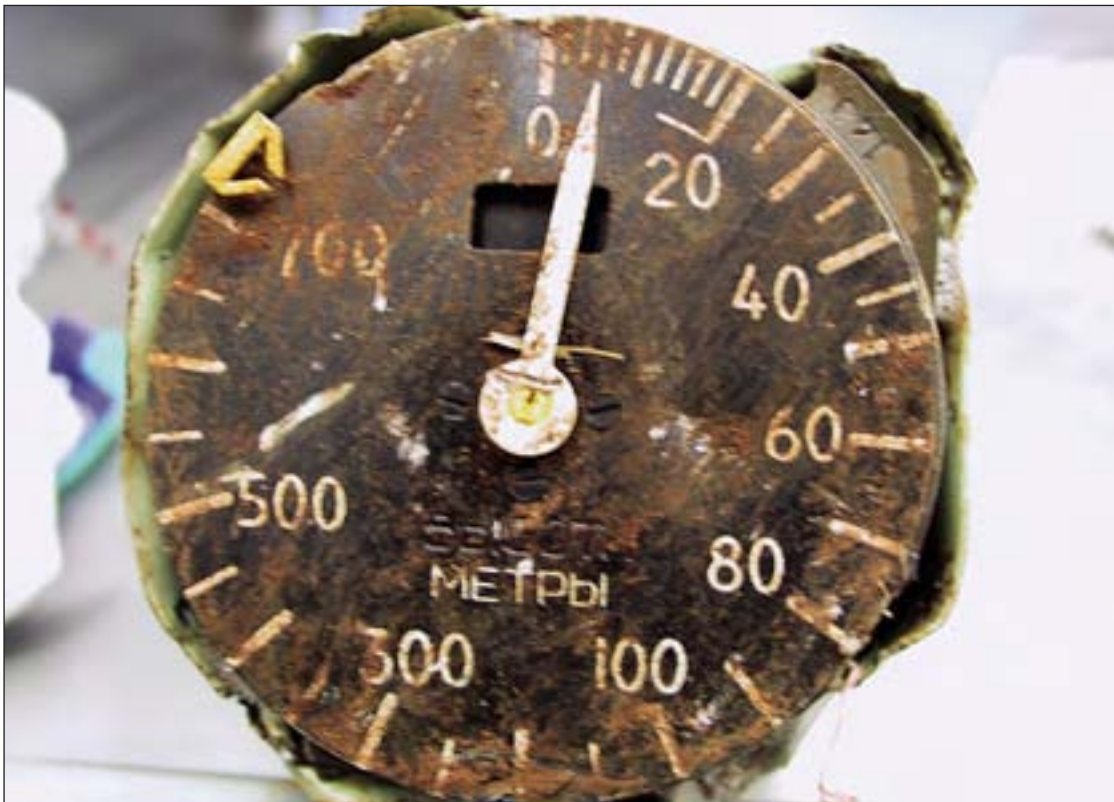
FIGURE 26:
The PB-750 radio altimeter indicator located in the aircraft wreckage

The more-damaged indicator was a PB-750 m scale unit (see Figure 26). The reference bug on that indicator was set to 750 m.

A number of other instruments were also found in the cockpit wreckage area. The casings of many of those instruments were badly distorted from impact forces, and some of the instruments were damaged to such an extent that they provided no reliable information.

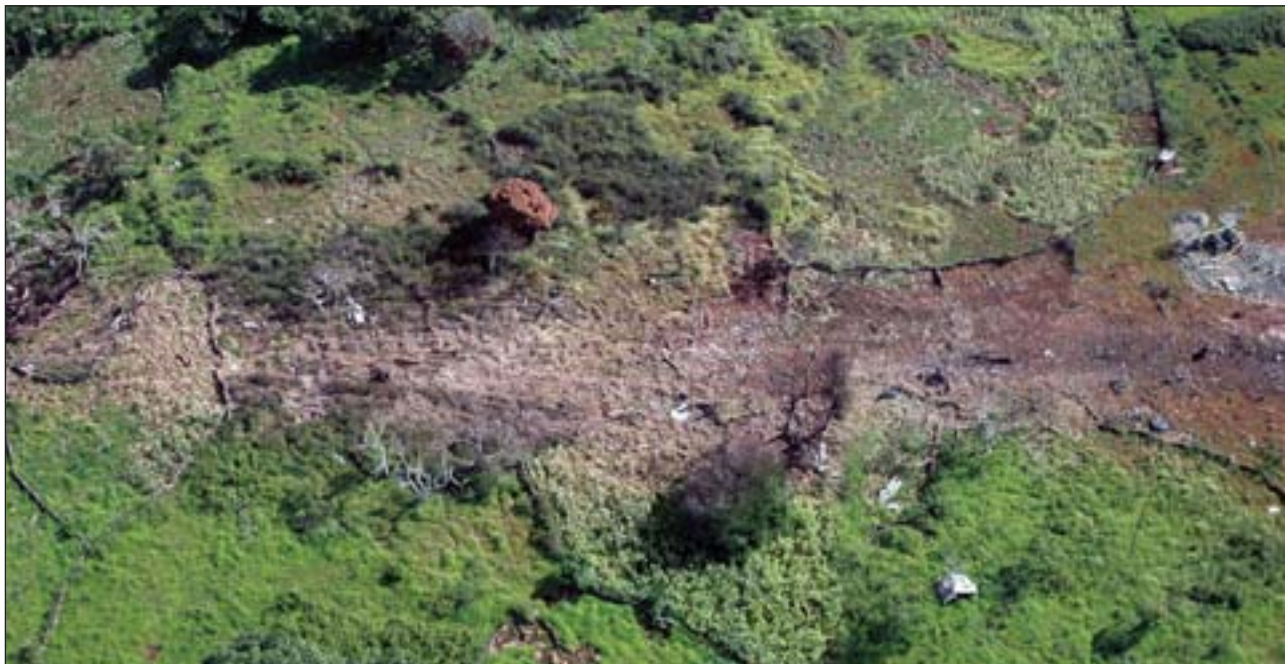
FIGURE 29:
Chemical damage from fuel spillage

Fuel spillage and misting occurred from the damaged and ruptured left wing following the impact with the trees at the beginning of the wreckage trail. The chemical damage from fuel spillage and misting resulted in the browning of much of the vegetation in and around the north-western and central areas of the wreckage trail (see Figure 29).

The intensity of the fuel-fed fires was such that most of the aluminium alloy components and structures within the wreckage were consumed or melted.

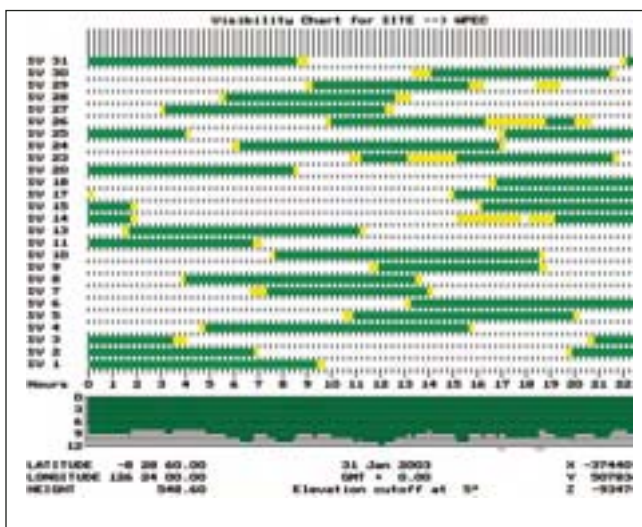
In certain locations, there are insufficient satellites in view to provide RAIM integrity monitoring. Those gaps in coverage are referred to as RAIM holes. There were 11 satellites in view at Baucau at the time of the occurrence (see Figure 35). Green signifies a satellite's elevation of greater than 5 degrees above the horizon and yellow signifies a satellite's elevation of between 0 degrees and 5 degrees above the horizon.

FIGURE 35:
GPS satellite coverage at Baucau

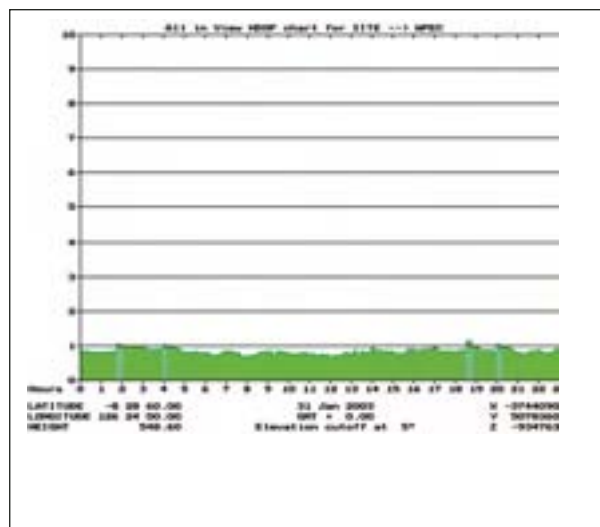
Dilution of precision may also affect the integrity of navigation data provided by a GPS, and its extent is dependent on the number of satellites in view to a GPS, and also the geometry of those satellites relative to the user. Under ideal conditions, the calculated position of a GPS will be at the point where two satellite range rings intersect. However, in reality the calculated position will be in an area of uncertainty, because of errors in the satellite ranges, and the area of uncertainty will become greater as the two satellites get closer to each other. Dilution of precision occurs in both vertical (VDOP) and horizontal senses (HDOP), with HDOP being more critical in terms of the integrity of lateral navigation solutions. The calculated HDOP at Baucau at the time of the occurrence was less than 1, and would have resulted in little effect on the integrity of lateral navigation data that was being provided by the aircraft's GPS (see Figure 36).

FIGURE 36:
Satellite HDOP at Baucau

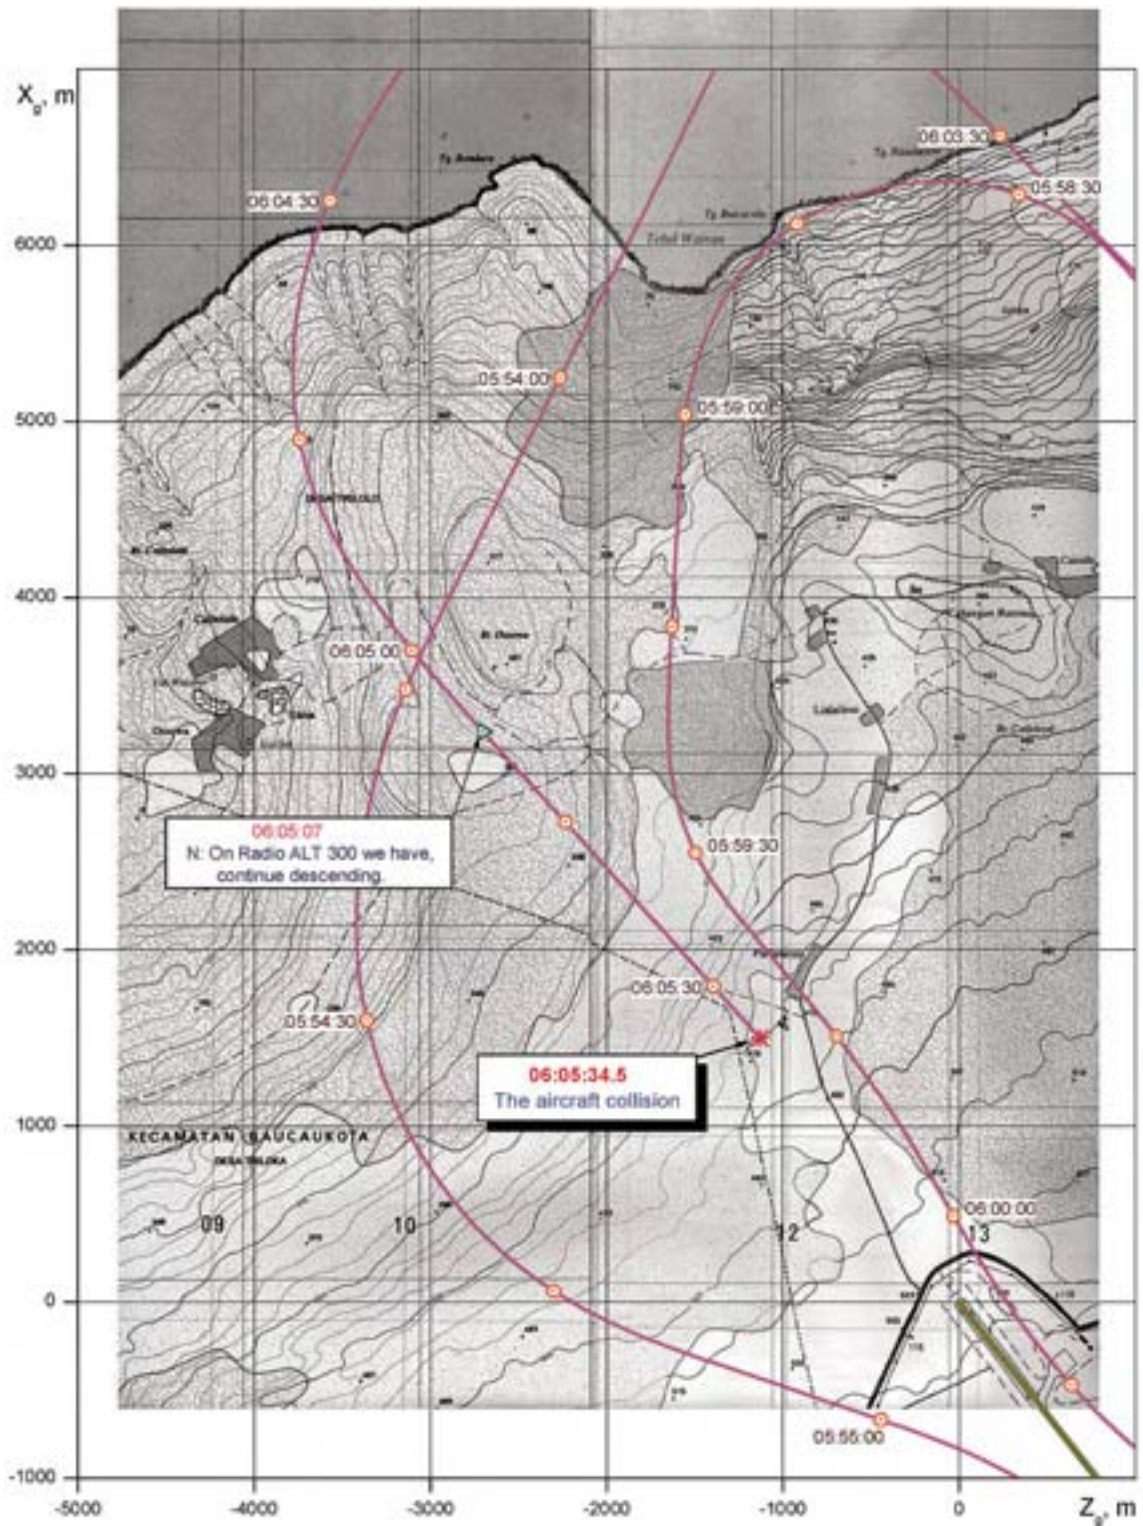
The IAC plotted the aircraft's flight path onto the Baucau, East Timor 2507-42 T754 Edition 2 topographic map. The map displayed contour elevations in metres AMSL. The IAC reported that it concurred with the Australian investigation team that the aircraft had been overhead the 320 m (1,050 ft) contour at time 06:05:07 (see Figure 37).

The IAC reported that at time 06:05:07 the aircraft was therefore at about 300 m (984 ft) barometric altitude with the altimeter subscales set at 714 mm Hg, and not at 300 m absolute altitude. The IAC concluded that under those circumstances, the flight navigator had mistakenly referred to barometric altitude as radio altitude. The Australian investigation team concurred with the IAC's conclusion.

FIGURE 37:
Aircraft position over the terrain at 06:05:07

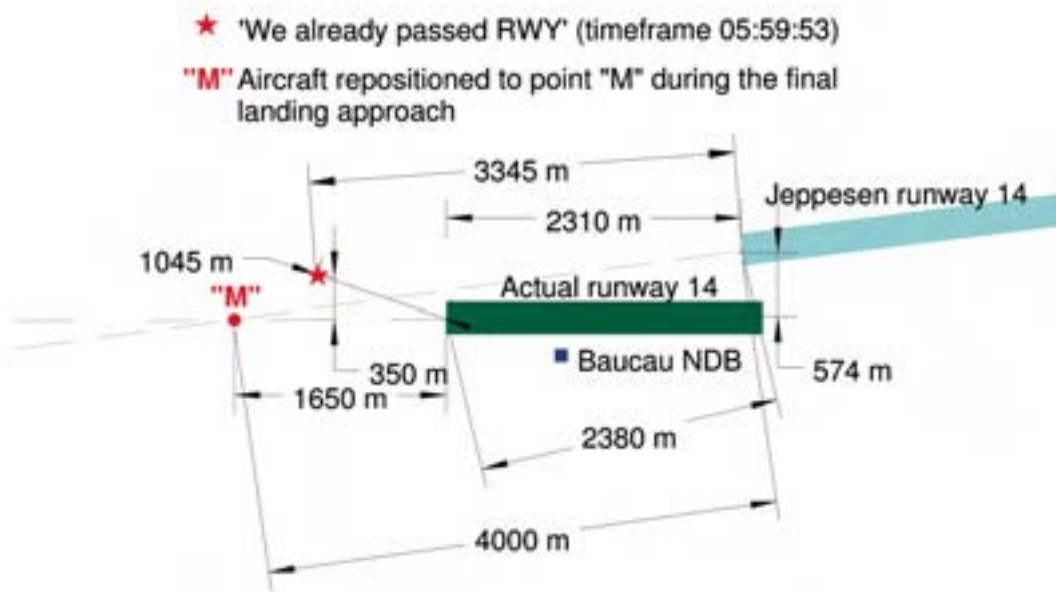
The flight navigator appeared to have assumed that the aircraft was overhead the runway when the pilot in command stated 'We already passed runway'. The aircraft was not overhead the runway at that point, but was still 1.04 km (0.56 NM) to the north of the threshold. The distance between the actual position of the threshold of runway 14 and its position as depicted on the Jeppesen chart, was 2.38 km (1.24 NM). At 05:59:53, the onboard navigation equipment would therefore have showed that the aircraft was still about 3.34 km (1.80 NM) from the Jeppesen runway 14 threshold (see Figure 38).

FIGURE 38:
Navigation distances for the actual position of runway 14 vs. the Jeppesen runway position

The CVR data revealed that the flight navigator decided to apply a 4 km (2.16 NM) correction to the Jeppesen data for the second landing approach. That decision was based on his assumption that the aircraft was overhead the runway at 05:59:53. The flight navigator therefore appeared to have reached a preconceived conclusion on the basis of limited information, and to have assumed that conclusion was correct without giving consideration to, or ignoring, other relevant information. Had the flight navigator visually confirmed when the aircraft was abeam the threshold of runway 14, at about time 06:00:05, the onboard navigation equipment would have shown that the aircraft was about 2.38 km (1.30 NM) from the position depicted on Jeppesen charts of where the runway 14 threshold was located. A correction of 2.38 km to the Jeppesen data would therefore have provided accurate navigation data to reposition the aircraft to the actual threshold of runway 14.

By applying the 4 km correction, the flight navigator was providing the pilot in command with inaccurate data, and resulted in the aircraft being repositioned towards point "M", depicted at Figures 38, and A5 and A6. That point was about 1.65 km (0.88 NM) northwest of the actual position of the threshold of runway 14. That incorrect data substantially increased the hazards of the user-defined approach procedure, and the risk of a CFIT event at that stage of the flight increased to a high degree. The flight crew did not appear to identify the hazards associated with the intended improvised approach procedure, and were therefore not in a position to manage the associated risks.

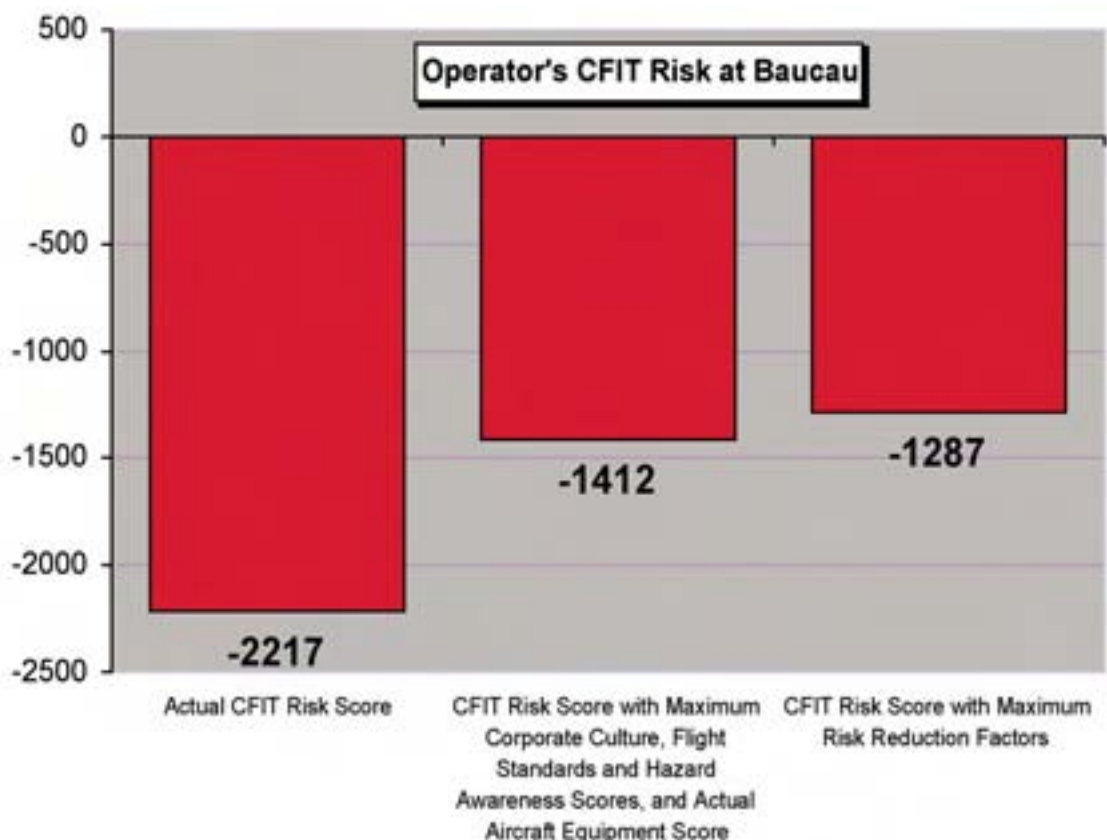
The alternative CFIT risk scores discussed above are depicted at Figure 39.

FIGURE 39:
CFIT Risk at Baucau

CFIT events involving transport-category aircraft will almost certainly result in major to catastrophic consequences involving fatal or life threatening injury, and damage to property and/or the environment, as this occurrence demonstrates. During the second landing approach at Baucau, the likelihood of CFIT increased to the point where it became unavoidable. The flight crew seemed unaware of the severity of the risk until they recognised that impact with terrain was imminent. At that stage, however, the risk could no longer be treated.

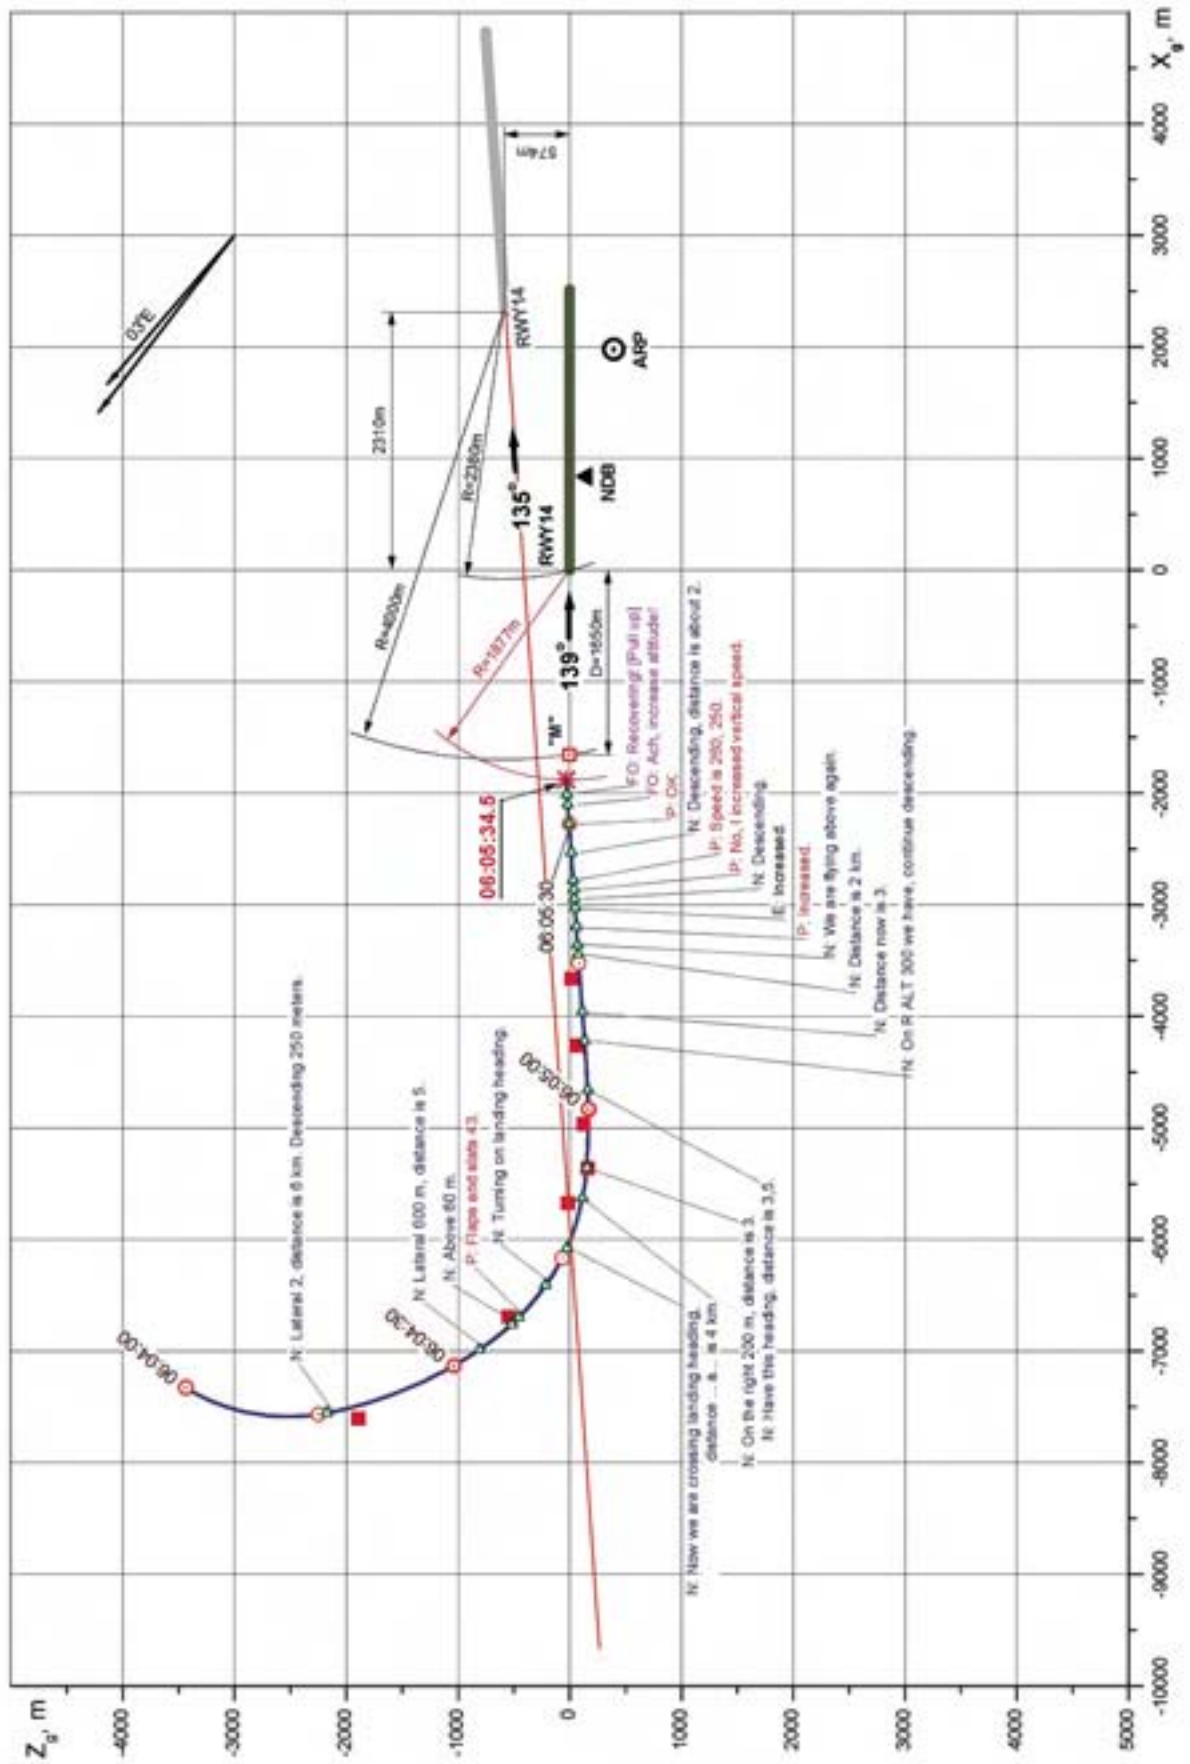
FIGURE A.5:
Aircraft flightpath during the final landing approach at Baucau
