Aircraft Type and Registration:	Raytheon 390 Premier 1, N200PR	
No & Type of Engines:	2 Williams FJ-44 turbo-jet engines	
Year of Manufacture:	2001	
Date & Time (UTC):	7 April 2004 at 0932 hrs	
Location:	Blackbushe Airfield, Hampshire	
Type of Flight:	Private	
Persons on Board:	Crew - 1	Passengers - None
Injuries:	Crew - None	Passengers - N/A
Nature of Damage:	Aircraft destroyed	
Commander's Licence:	FAA Private Pilot's Licence with Instrument Rating	
Commander's Age:	39 years	
Commander's Flying Experience:	4,511 hours (of which 413 were on type) Last 90 days - 60 hours Last 28 days - 12 hours	
Information Source:	AAIB Field Investigation

Synopsis

After takeoff the pilot was unable to raise the landing gear and was presented with failure indications affecting both the lift dump and anti skid systems. Following a successful landing at Farnborough, and discussions with the aircraft's maintenance organisation, the aircraft was flown to Blackbushe for further technical investigation. After landing on Runway 26 the aircraft left the runway, struck a series of obstructions and was destroyed: there was no fire and the pilot was uninjured.

The support bracket for the right main landing

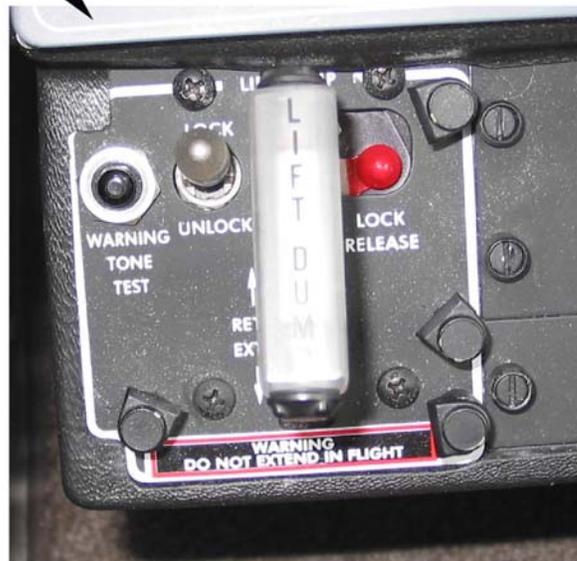
Figure 3 - Lift Dump and Speedbrake components

Lift Dump System (Figure 3)

Post Modification Lift Dump Handle as fitted to N200PR
