Statens haverikommission
Swedish Accident Investigation Board

Report RL 2005:07e

**Aircraft accident to SE-LNT
at Luleå/Kallax Airport, Norrbotten County,
Sweden, on 17 September 2003**

Case L-49/03

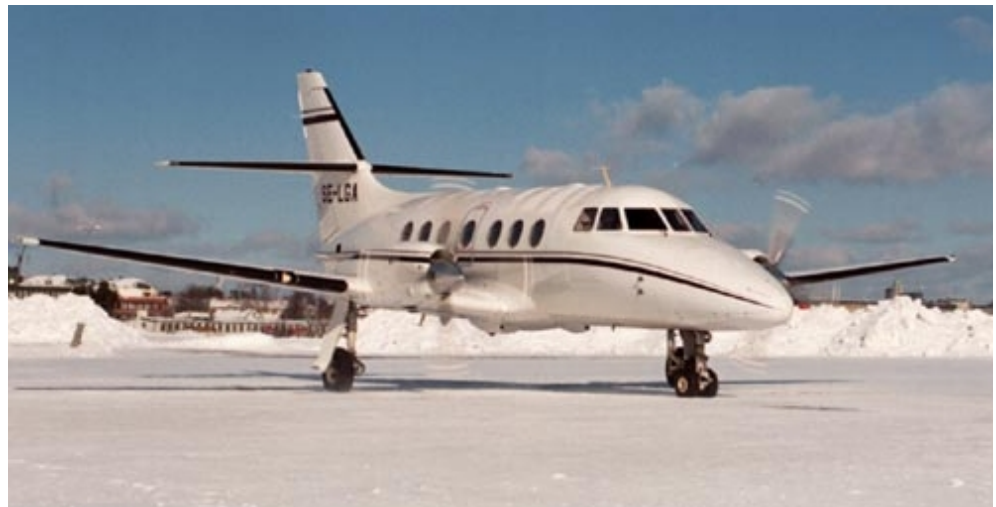
The aircraft type is a twin-engine passenger aircraft with space for nineteen passengers. It has turboprop engines and a pressurised cabin.
