**ATSB TRANSPORT SAFETY INVESTIGATION REPORT**  
Aviation Occurrence Investigation  
200400610

FINAL

**Aero Commander Div**  
**Shrike Commander**  
**19 February 2004**

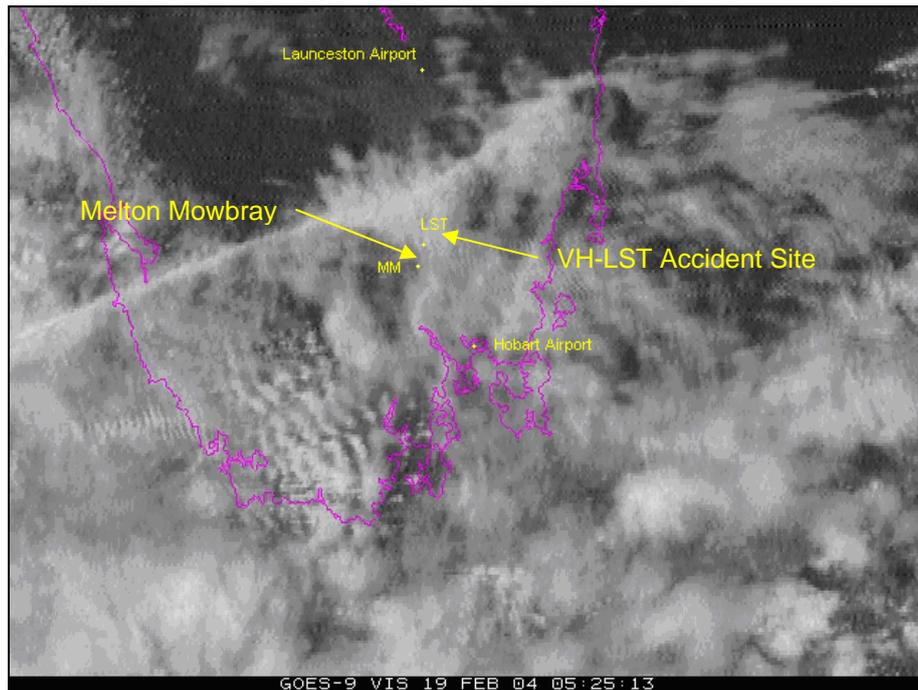
**Figure 2: Meteorological satellite photo taken at 1625 (courtesy of BoM)**

The BoM noted that there was mountain wave activity displayed on meteorological satellite photographs taken at 1549 and 1625, but that this activity was located south of the area of the accident (see Figure 2). They also indicated that mountain wave activity may have extended over the area at the time of the accident, but that it was not displayed on the photographs.

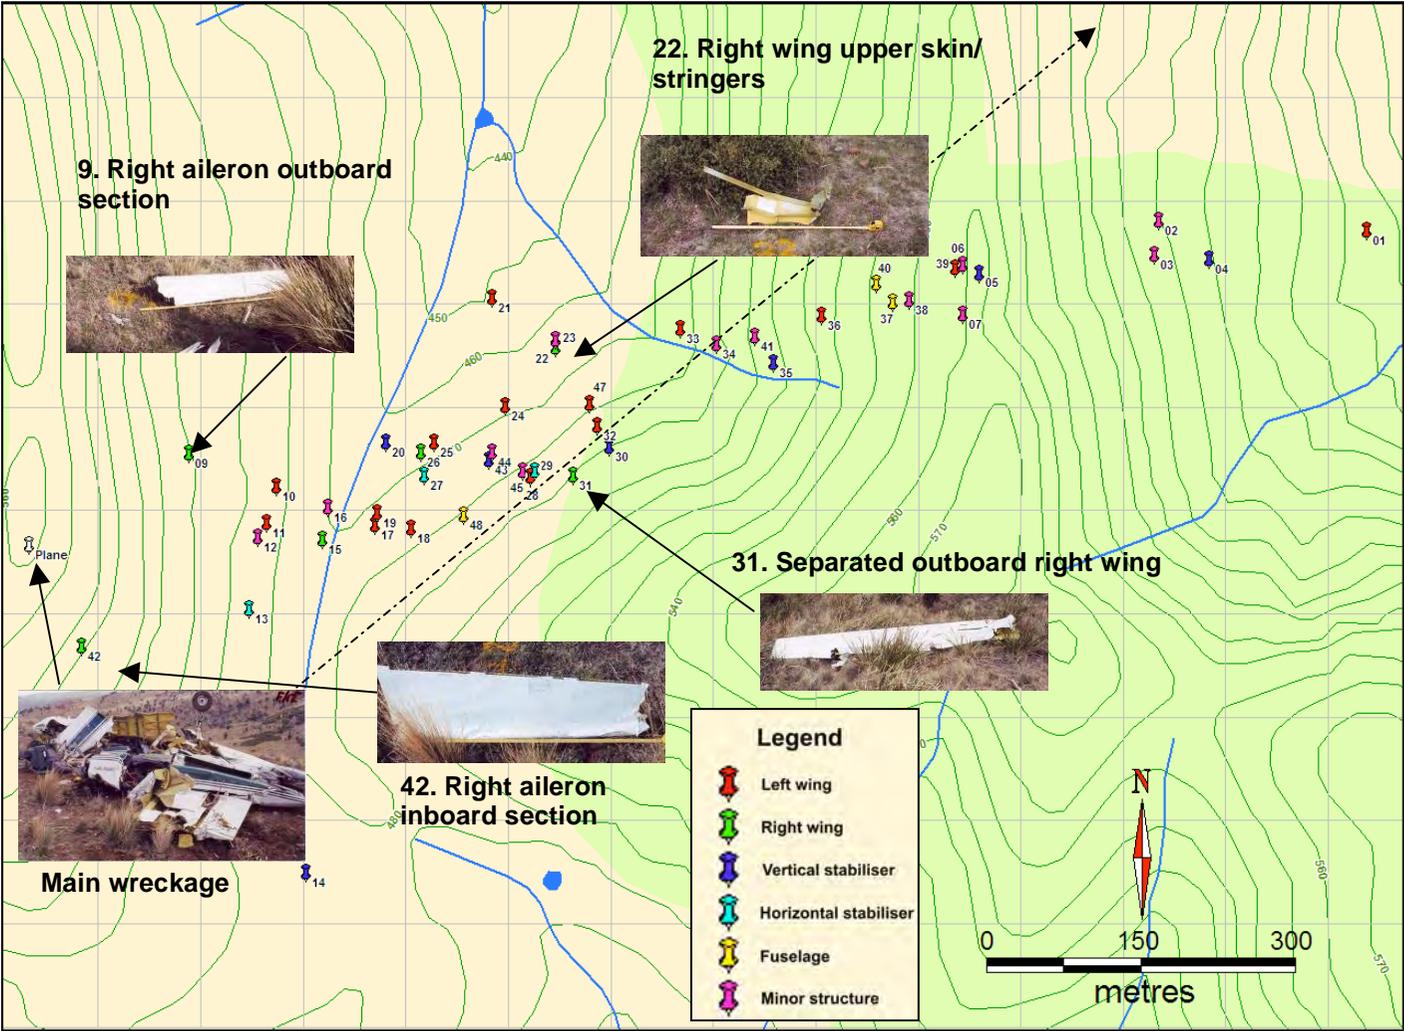
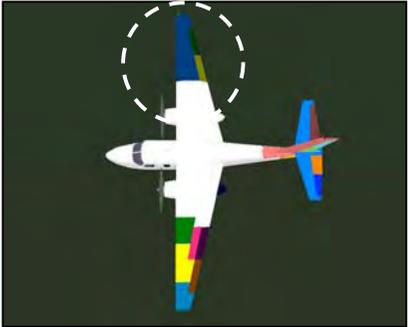
**Figure 3: Wreckage distribution map with photos of major right wing separated items (original map courtesy of Tasmania Police)**

Wreckage distribution and photographs of the major separated structure of the right wing, left wing and empennage/fuselage is shown in Figures 3 - 5 respectively.

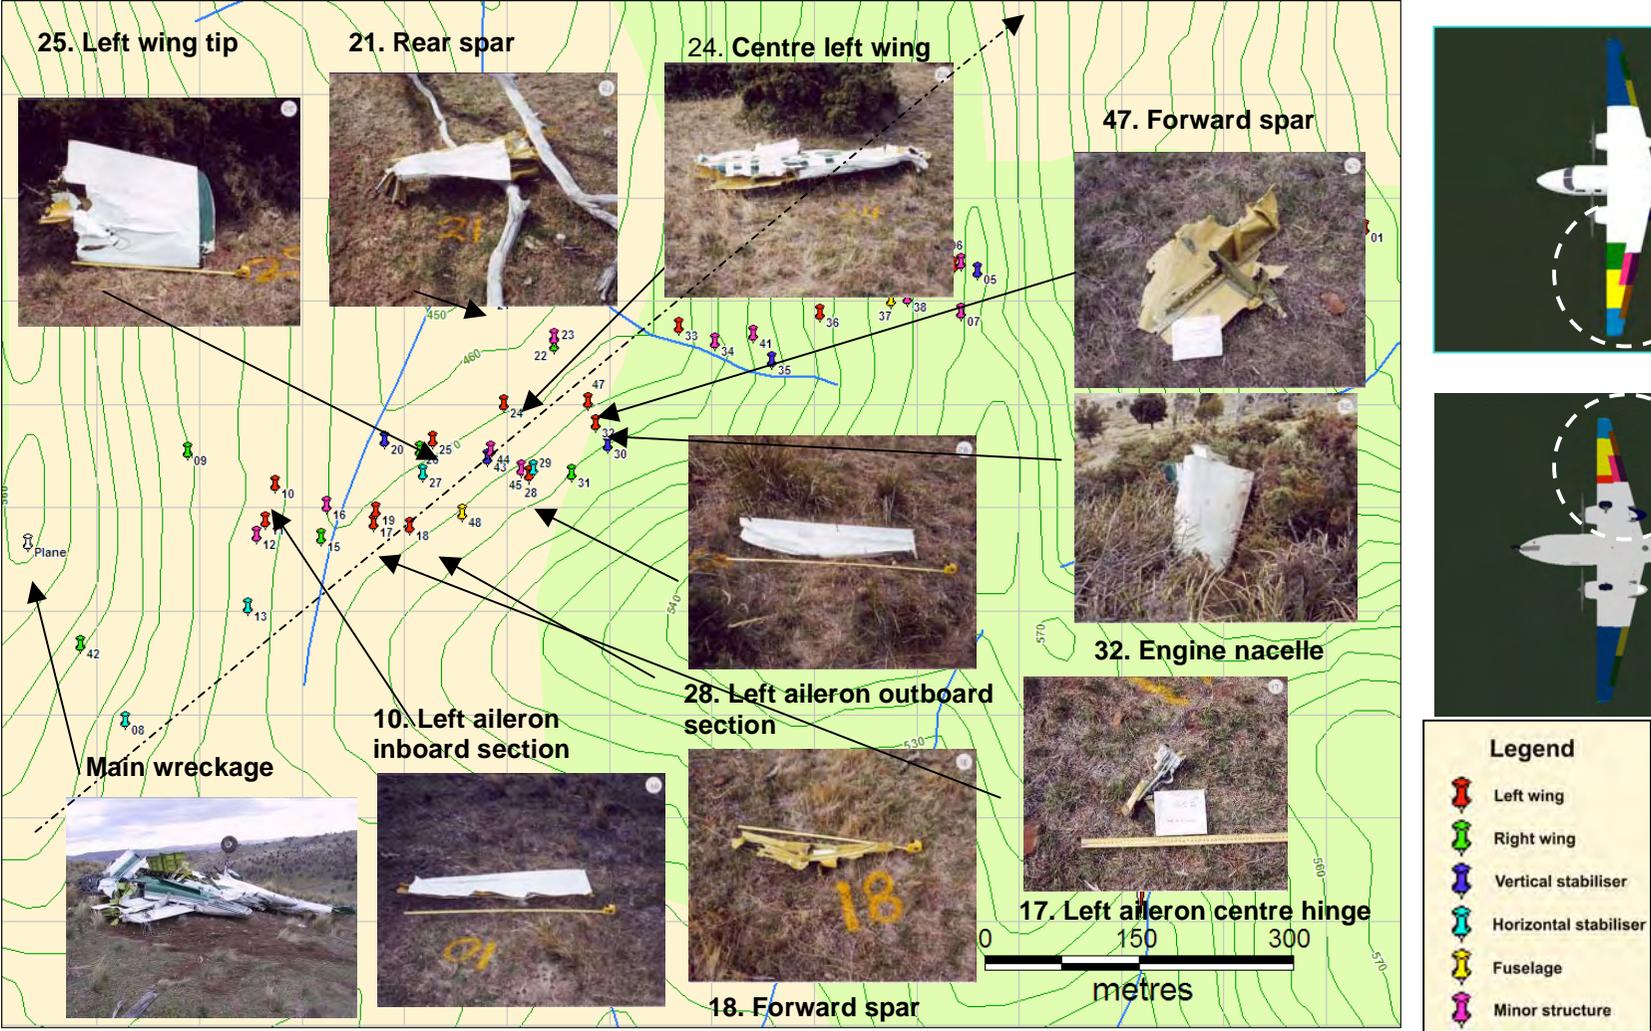
Figure 4: Wreckage distribution map with photos of major left wing separated items (original map courtesy of Tasmania Police)

Damage to the outboard left wing section indicated that, during the separation sequence, it had impacted the left main landing gear and fairing, before striking both the left horizontal stabiliser and vertical stabiliser leading edges. That subsequently resulted in the separation of the empennage from the aft fuselage in an upwards direction. The separation of the empennage resulted in distortion and tearing of the aft fuselage. There was no evidence of the right wing impacting any aircraft structure during the break-up sequence.

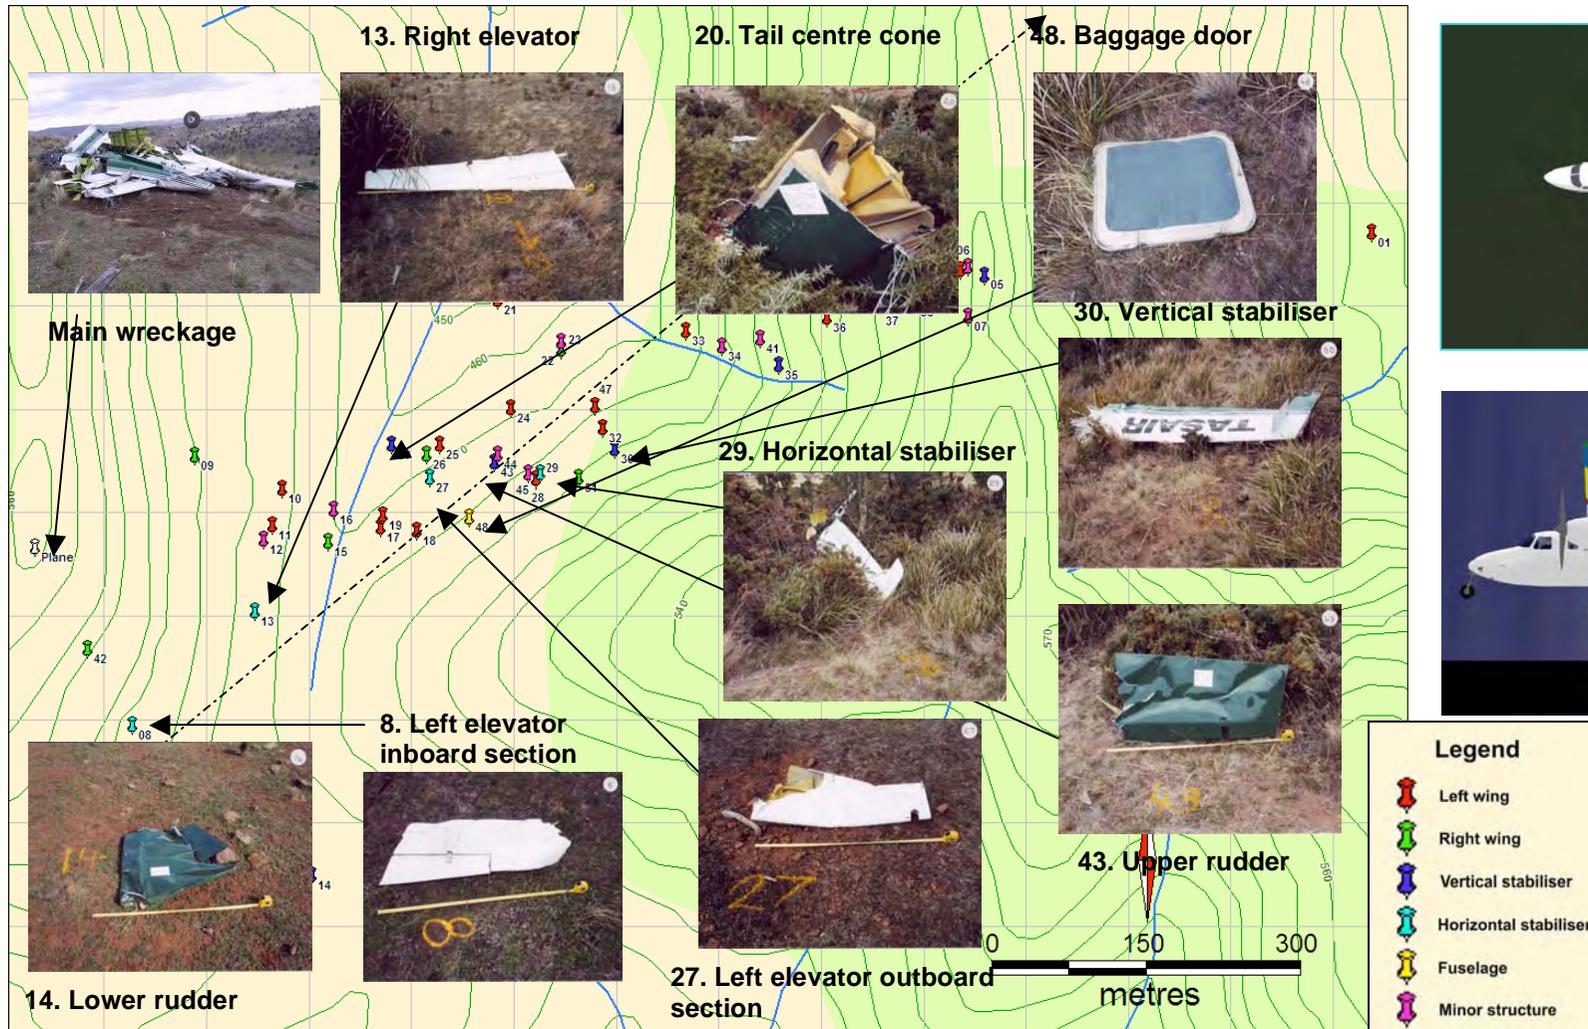
**Figure 5: Wreckage distribution map with photos of major empennage and fuselage separated items (TasmaniaPolice)**

The ailerons, rudder and elevator flight control surfaces all separated from their respective structures during the break-up sequence. All of the control surface hinges had failed as a result of overload, or had been torn from their supporting structures with no evidence of oscillatory movement indicative of flutter<sup>13</sup>. All control surface mass balance weights were intact.

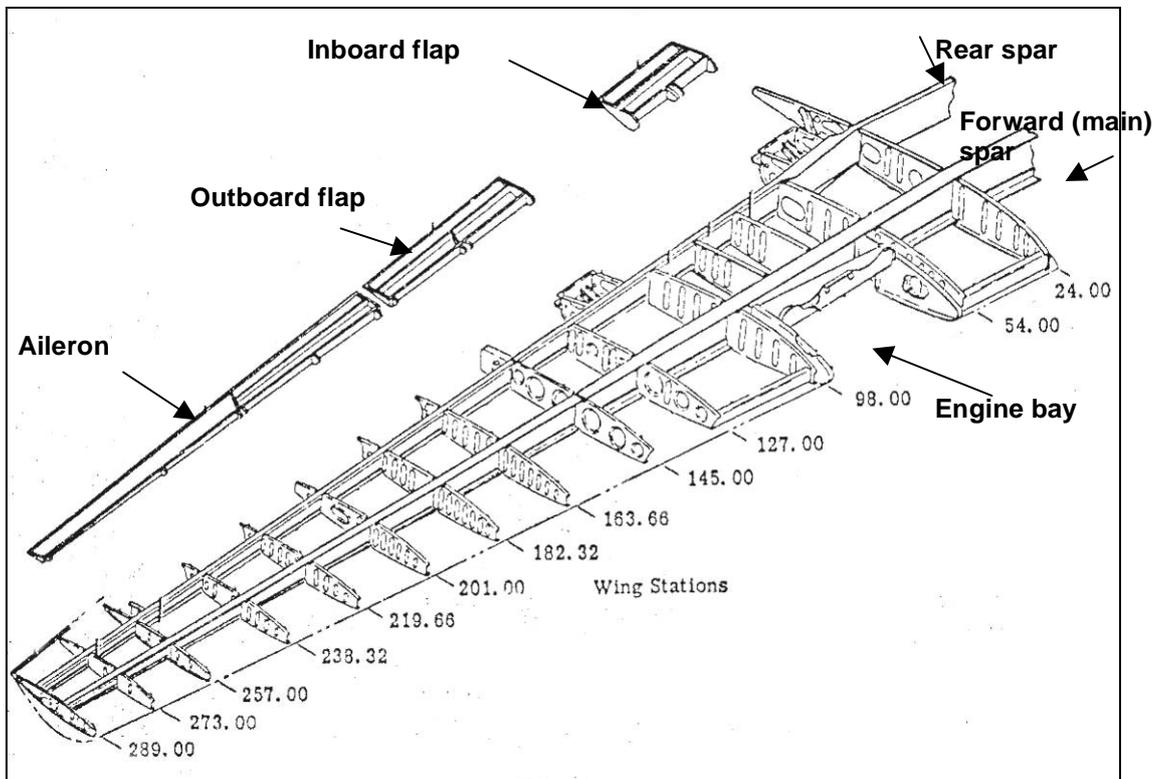
Figure 6: Aero Commander 500-S wing structure and stations (right wing shown)

The left and right wings failed in a symmetrical manner at a similar span wise location. The general span wise location of the wing spar failures was at WS145, coincident with the location of a spar splice at the outboard end of the flaps/ inboard end of the ailerons. The fracture of all wing spars was either at WS145 or at the end of doublers supporting the spar splice. The fractures were all consistent with ductile failures under overload conditions. No evidence of pre-existing defects at these locations was found. The wings failed in a downwards and nose down direction, moving rearwards at separation.

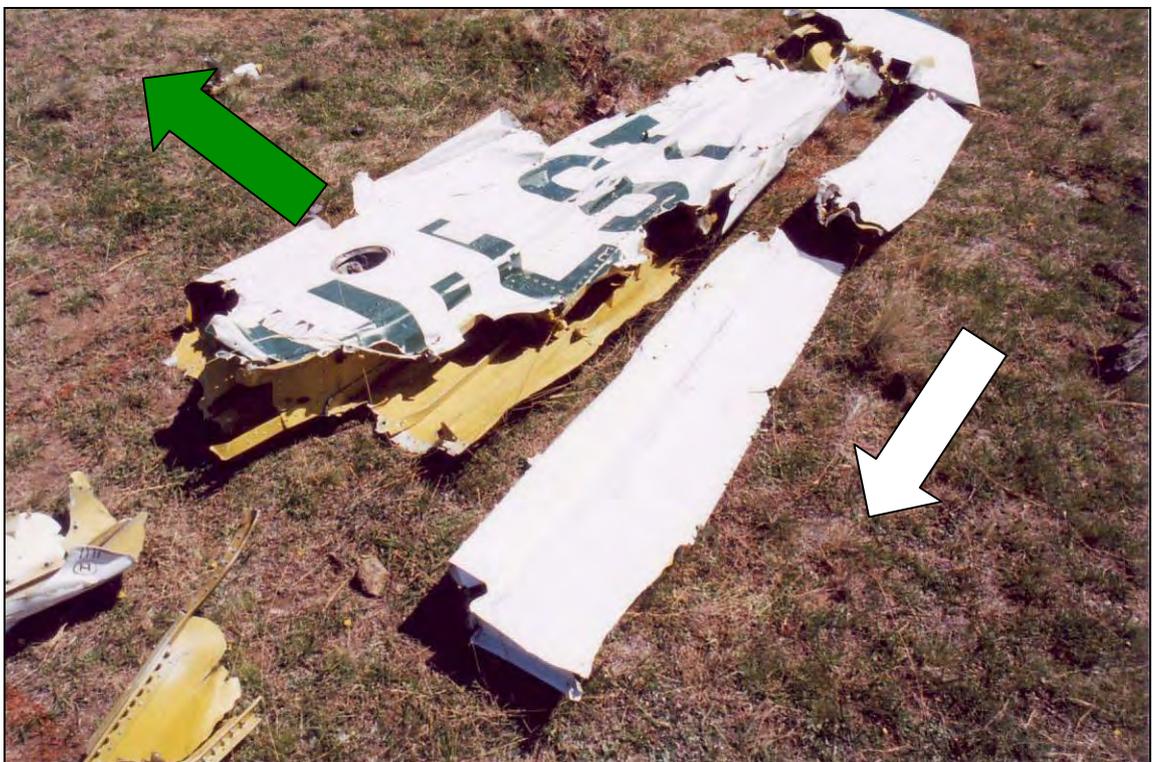
**Figure 9: Separated left wing sections in reconstruction. Lower wing surface shown**

The right and left wing sections outboard of the engine nacelles and flaps had separated from the aircraft at a similar span-wise location and in a downwards direction, indicating that the force was applied in a 'negative g'<sup>11</sup> direction. The wing failures had occurred in the vicinity of wing station 145<sup>12</sup>, where the inboard spar sections are joined to outboard spar sections. No evidence of corrosion, fatigue cracking, repairs or other pre-existing structural defects that could have degraded the strength of the structure was found in this location on either wing.

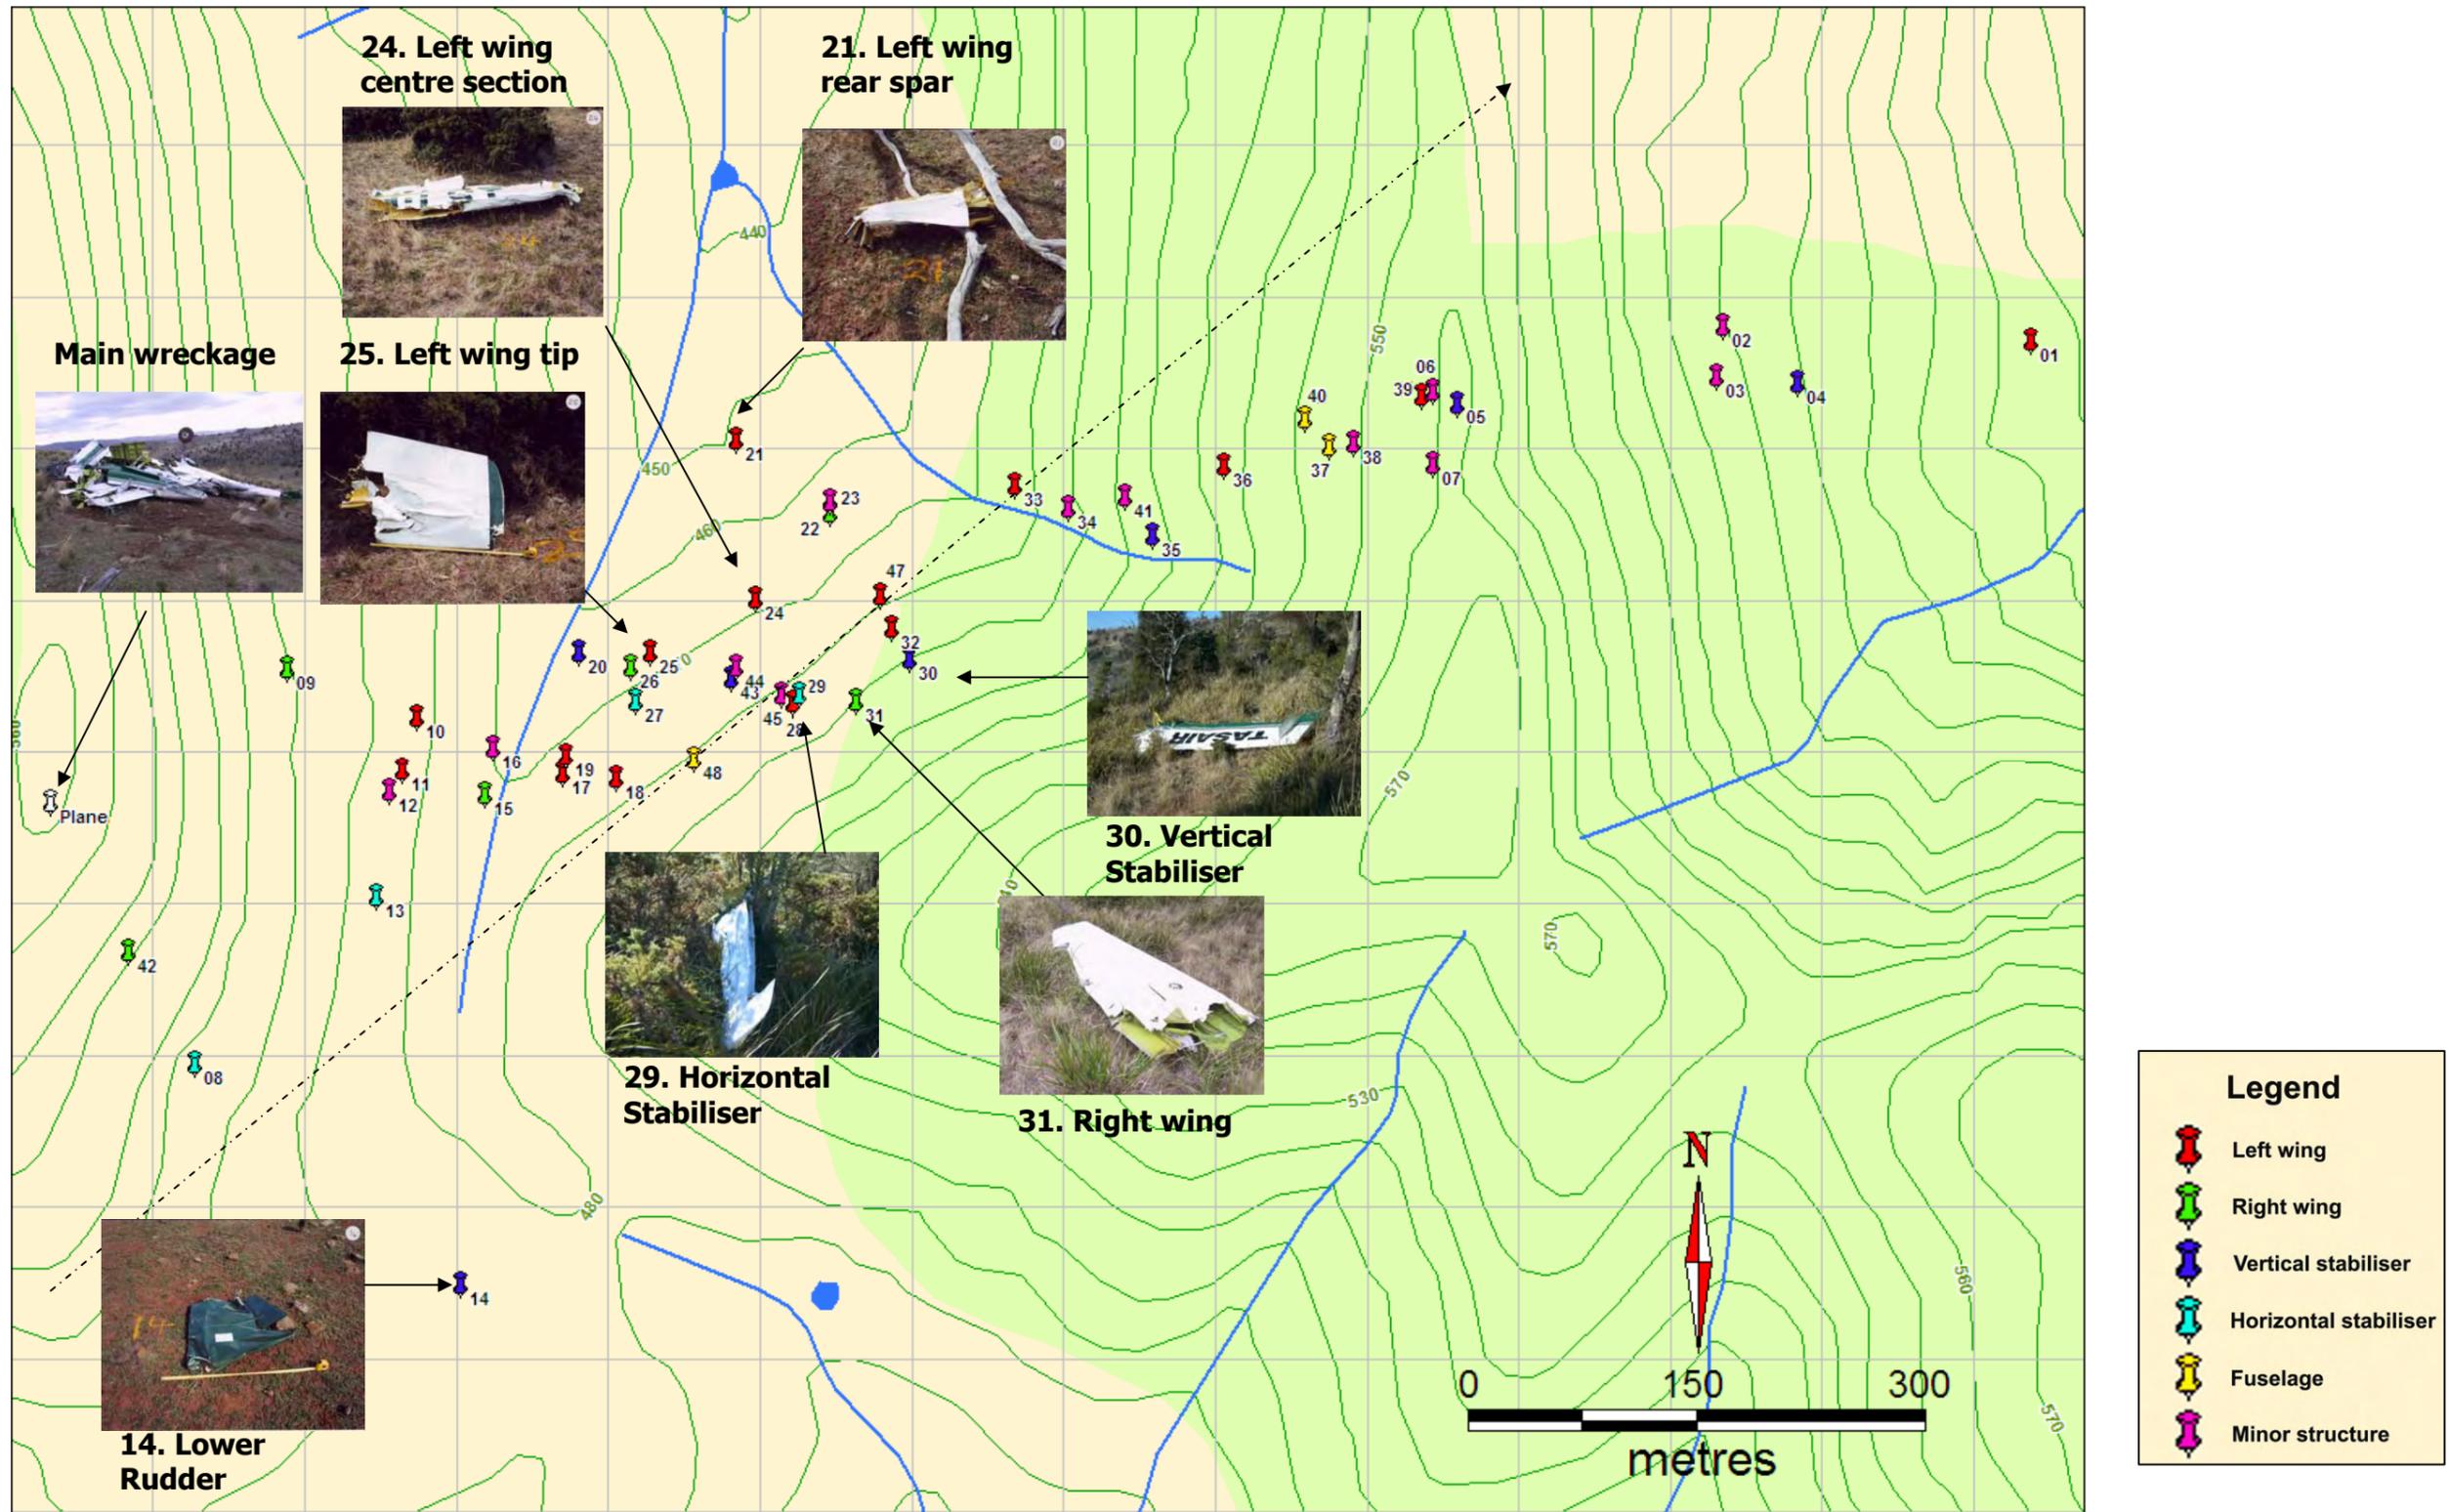
Attachment B-1: Wreckage distribution map with photos of main items (original map courtesy of Tasmania Police)

Table 2 shows that the break-up position of the aircraft was found to be 50 m east and 250 m south of the main wreckage final location. This occurred at an altitude of 3,200ft. The aircraft was on a heading of 335 and 030 degrees T with an airspeed of between 230 and 266 kts. This break-up position provided good correlation for the trajectory, impact and track of the main wreckage.

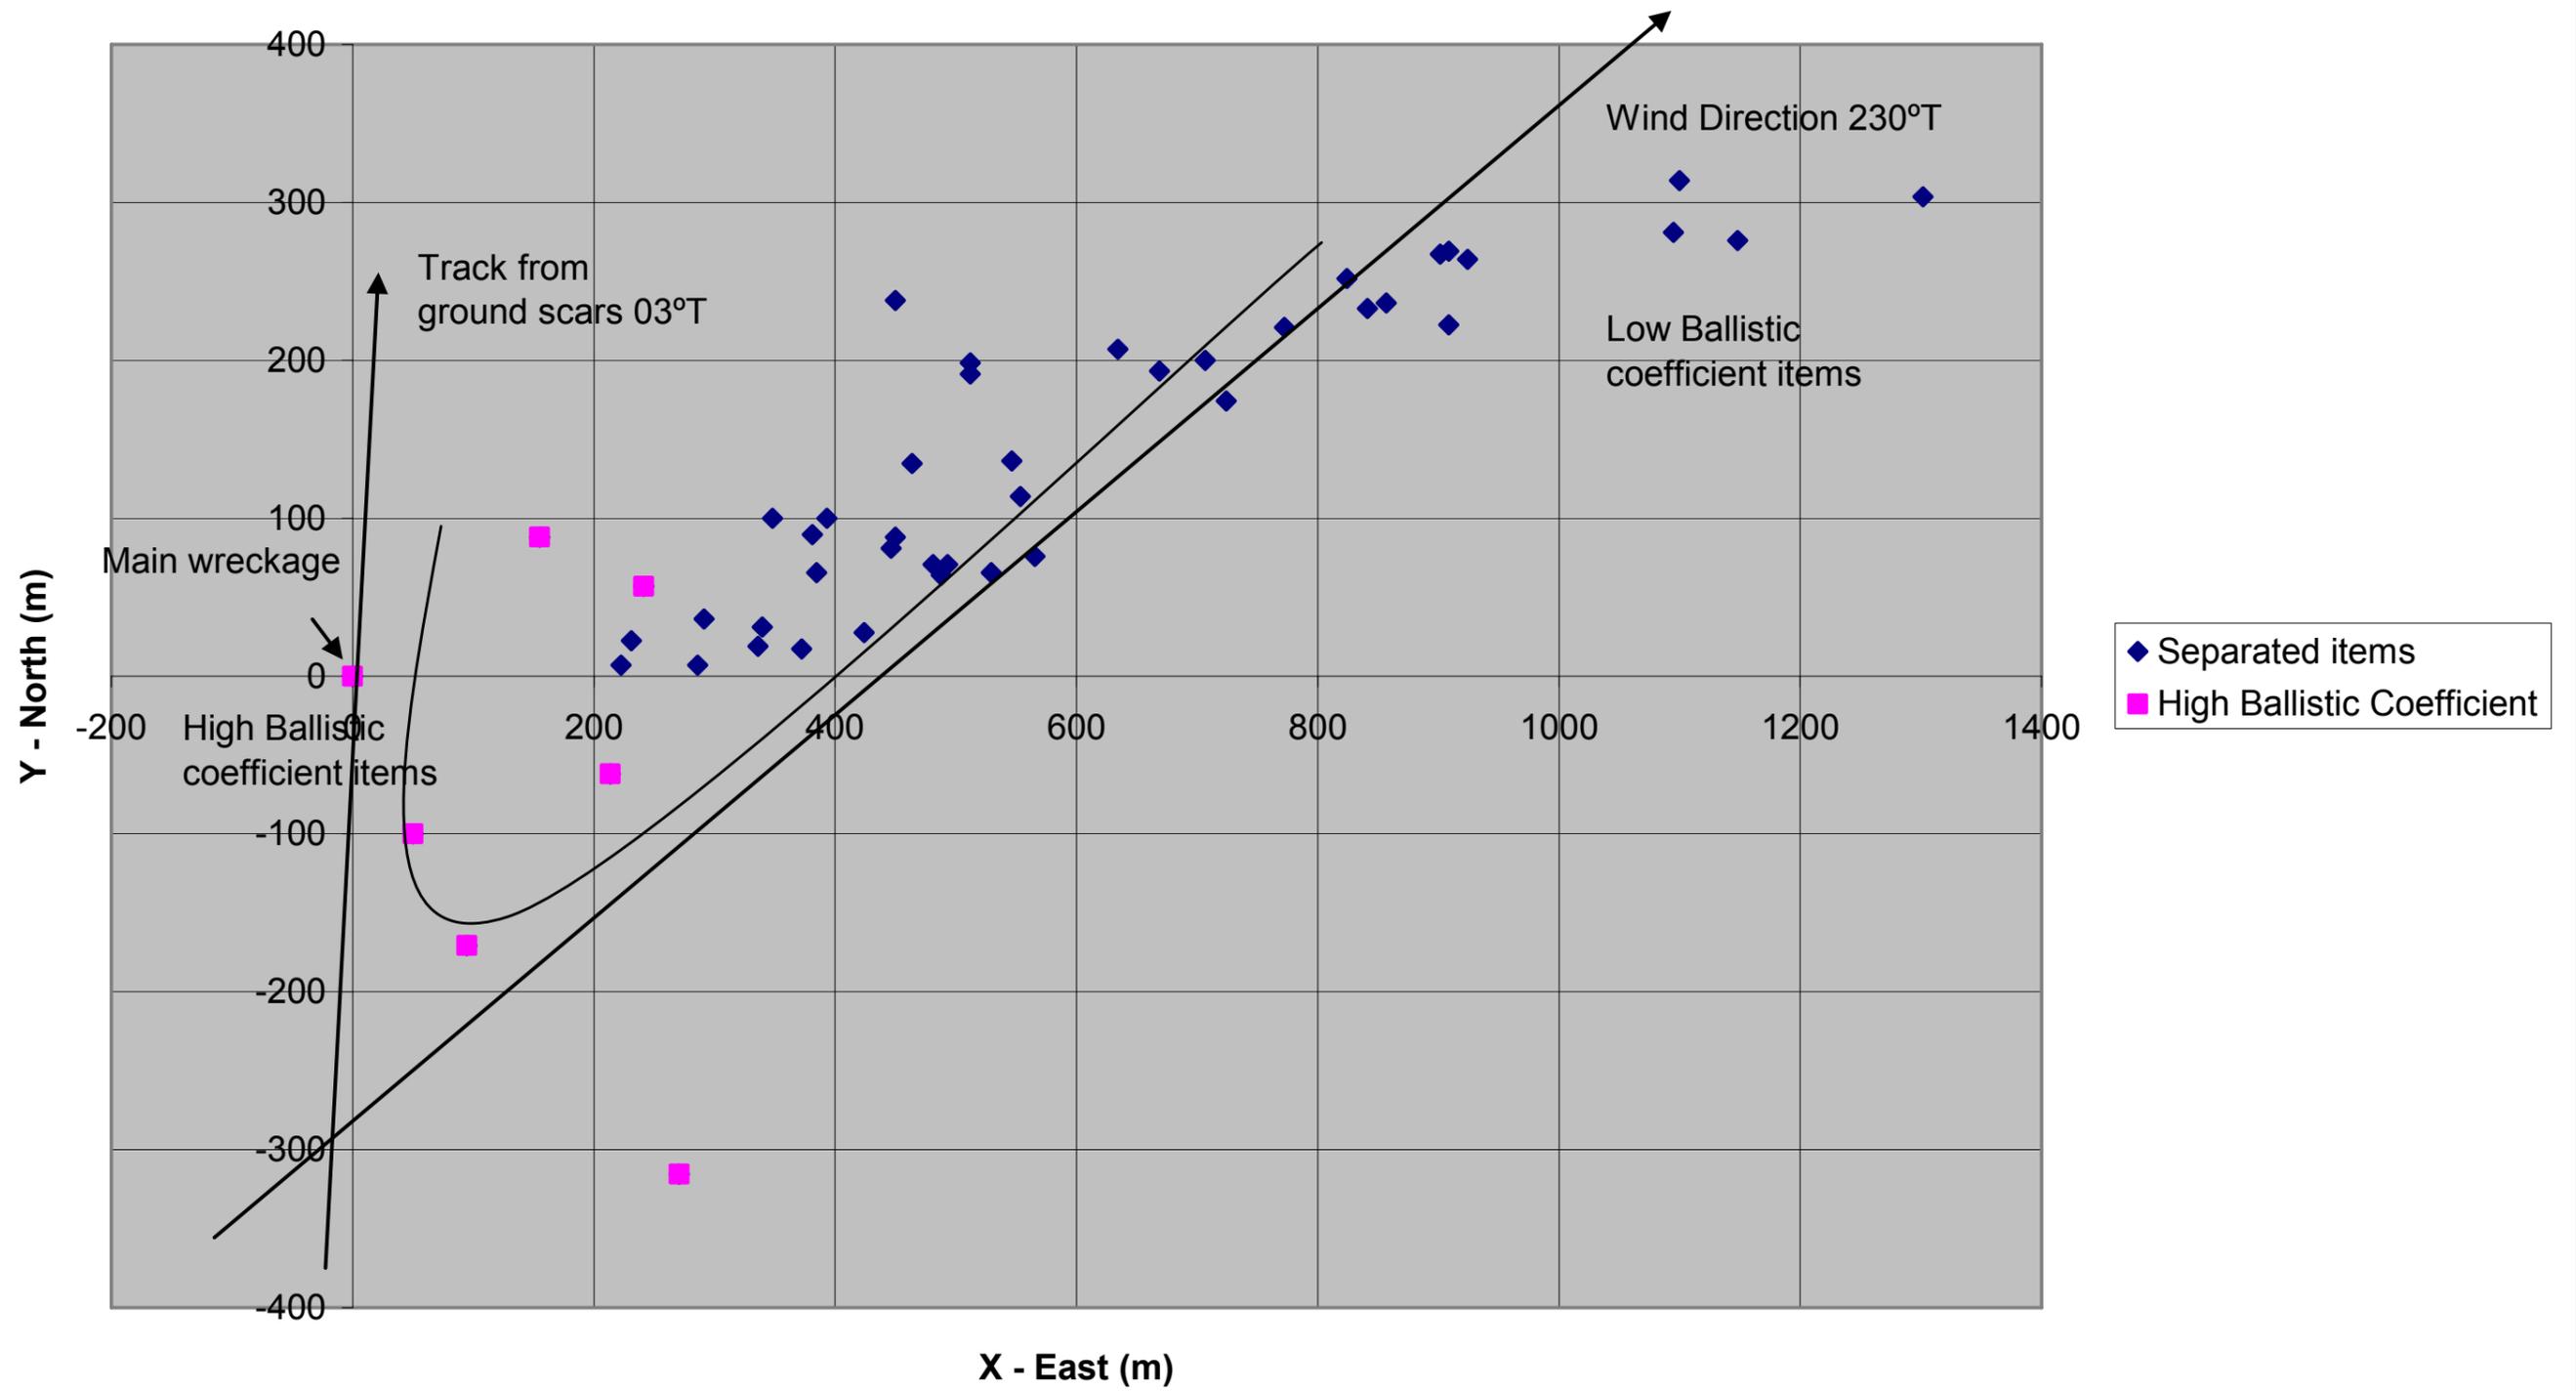
### VH-LST Wreckage Distribution - Ballistic Coefficients Curve

The initial position and velocity vector of an in-flight breakup can often be determined from the shape and size of the wreckage curve on the ground, assuming a common initial velocity and ballistic behaviour. A wreckage curve for the VH-LST wreckage distribution is shown at Attachment B-5.
