Aviation Occurrence Investigation – AO-2008-050

**Controlled Flight into Terrain
Near Benalla – 28 July 2004
Piper PA31T Cheyenne, VH-TNP**

ATSB report 200402797

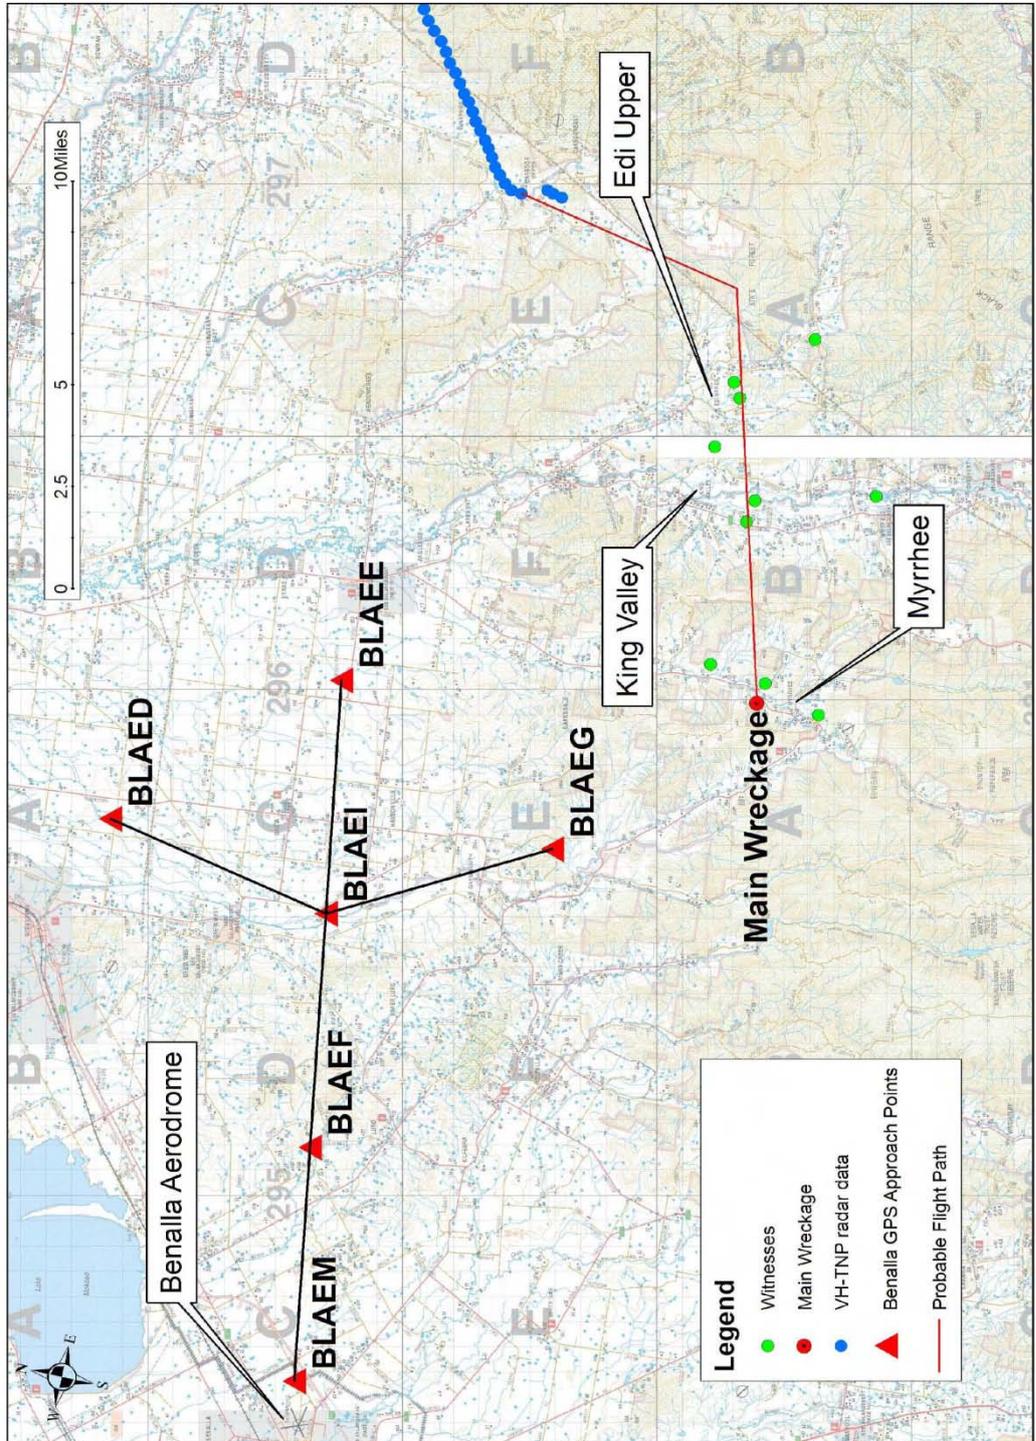
Figure 2: Locality map

The flight path of the aircraft over the latter part of the flight, as established by superimposing the legs of a GPS approach over the last radar return, the accident site and the location of a witness who reported seeing the aircraft pass directly overhead (Figure 2), appeared to conform to the lateral profile of the Benalla Runway 26L GPS non-precision approach. In conjunction with the left turn recorded on radar, the pilot's broadcast intention to make a GPS approach, and the configuration of the aircraft at impact, there can be little doubt that the pilot believed that he was flying that procedure, but unaware that he was 34 km from the correct location.

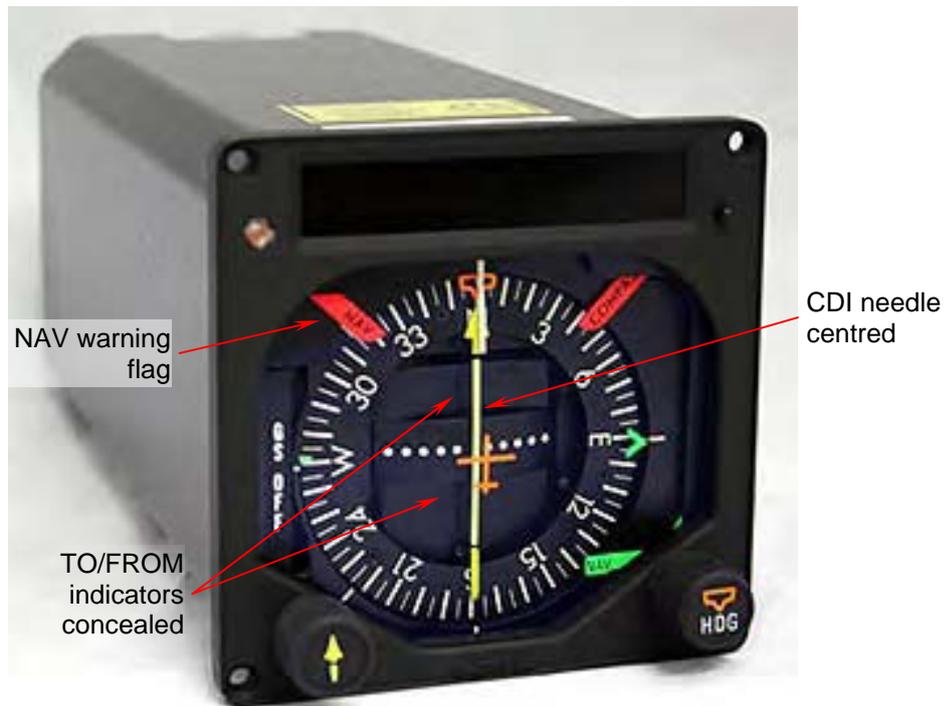
Figure 9: Pictorial Navigation Indicator showing the invalid navigation indications

The GPS supplement for the aircraft's approved flight manual advised that "If the TNL-2101 (IO) Approach GPS, navigation is flagged¹⁹, the remaining operational navigation equipment must be used" and "If in the event the GPS is commanding the autopilot, and the system becomes flagged the autopilot 'fail-safes' into heading mode on the HSI". In effect, when the GPS receiver was navigating by DR, the navigation function switches for the PNI and autopilot would automatically revert to HSI - NAV and AP - HDG (Figure 6). The CDI on the PNI would then display tracking guidance from a selected VHF source, either VOR or Localiser/Instrument Landing System, if the selected ground-based aid was within range. When the aircraft was outside the range of a selected VHF navigation aid, the invalid navigation indications appeared on the PNI (Figure 9), i.e. the NAV warning flag displayed, the CDI centred²⁰ and the TO/FROM indication was concealed.

Should a pilot not consciously check and read those messages, there was a possibility of overlooking the DR navigation message, and continuing to follow the GPS-based guidance. However, in TNP, the NAV warning flag on the pictorial navigation indicator would have provided an unmistakable cue, as to the invalid GPS navigation (Figures 9 and 24). In addition, as there were no useable ground navigation aids, the CDI needle would have remained centred and the TO/FROM indication would have been obscured.

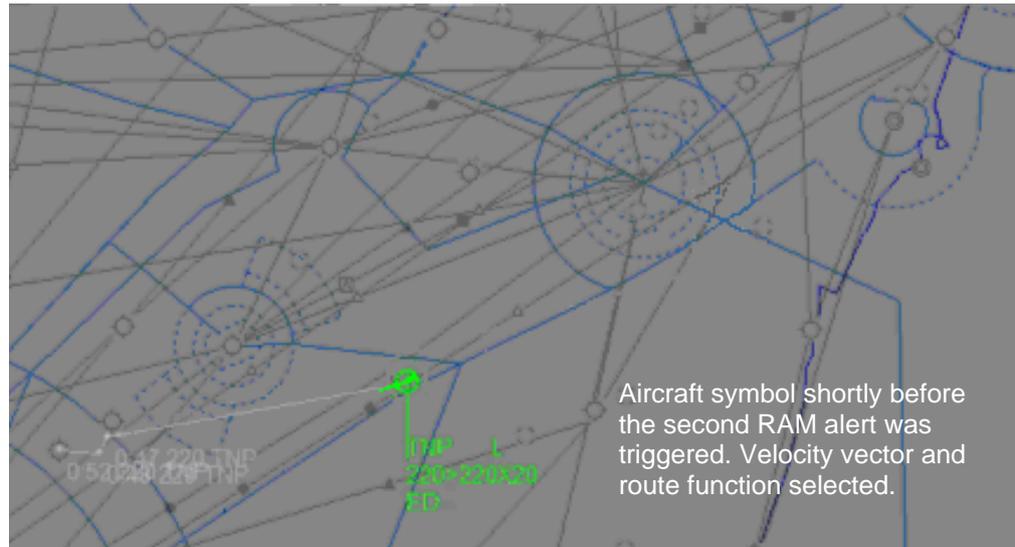
Figure 20: PC Playback representation of TAAATS data at 1023

At 1023, the RAM alert activated on both the Benalla and Snowy/Ovens Sector controller's ASDs when the aircraft was near Corryong (Figure 1) at FL220 in Class A airspace. The pilot had requested and been cleared to track direct to ED. The Benalla Sector controller acknowledged³⁴ the alert, which silenced the

associated audio alarm. The Snowy/Ovens Sector controller then accepted jurisdiction of the aircraft and acknowledged the RAM alert on his console. The Snowy/Ovens Sector controller believed that the aircraft was on track and acted to verify his understanding of the situation. He used the velocity vector³⁵ of the ASD to compare the aircraft's actual track with the planned track, as indicated by the route function (Figure 20)³⁶. The controller did not recognise the deviation between the velocity vector and the route function. He also did not interpret the RAM alert as indicating that the aircraft was off track, or tracking incorrectly for waypoint ED.

³⁶ The use of PC replay pictures in figure 20 and 21 illustrates the difficulty that the controller would have experienced in observing the variation between the velocity vector and the route function. They may not be fully representative of the Air Situation Display modes and selections made by the air traffic controllers at the time.

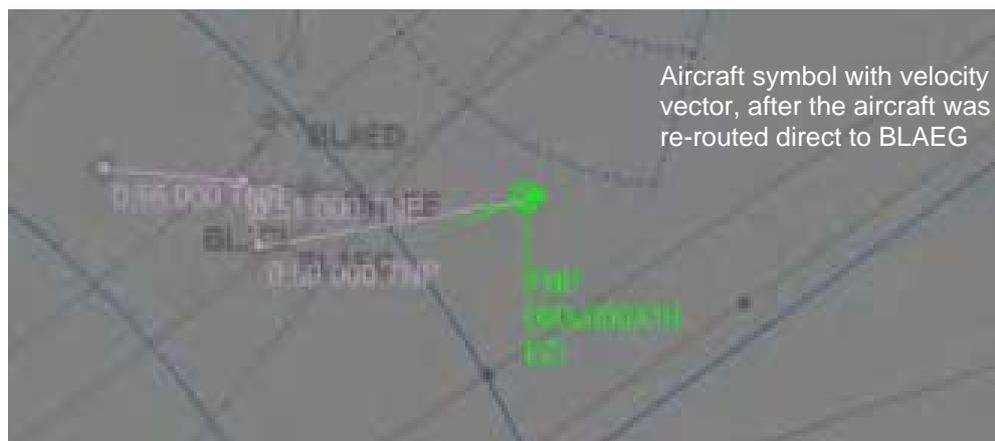
Figure 21: PC Playback representation of TAAATS data at 1042:27

At 1042, the RAM alert again activated on the Snowy/Ovens Sector controller's air situation display while the aircraft was descending in Class G airspace towards Benalla. At that point the distance from ED was much less and therefore the relative track error was more apparent (Figure 21).

The controller later reported that he had always believed the pilot was tracking to EG and that the aircraft was on track for that waypoint. In G Airspace, the controller was not required to have any further interaction with the pilot and did not ask for confirmation of the waypoint to which the pilot was tracking.

In contrast to the time taken to consider the previous RAM activation, where the controller considered the deviation for over ten minutes, the elapsed time between the third RAM alert activating and the controller rerouting the flight data record was only six seconds.

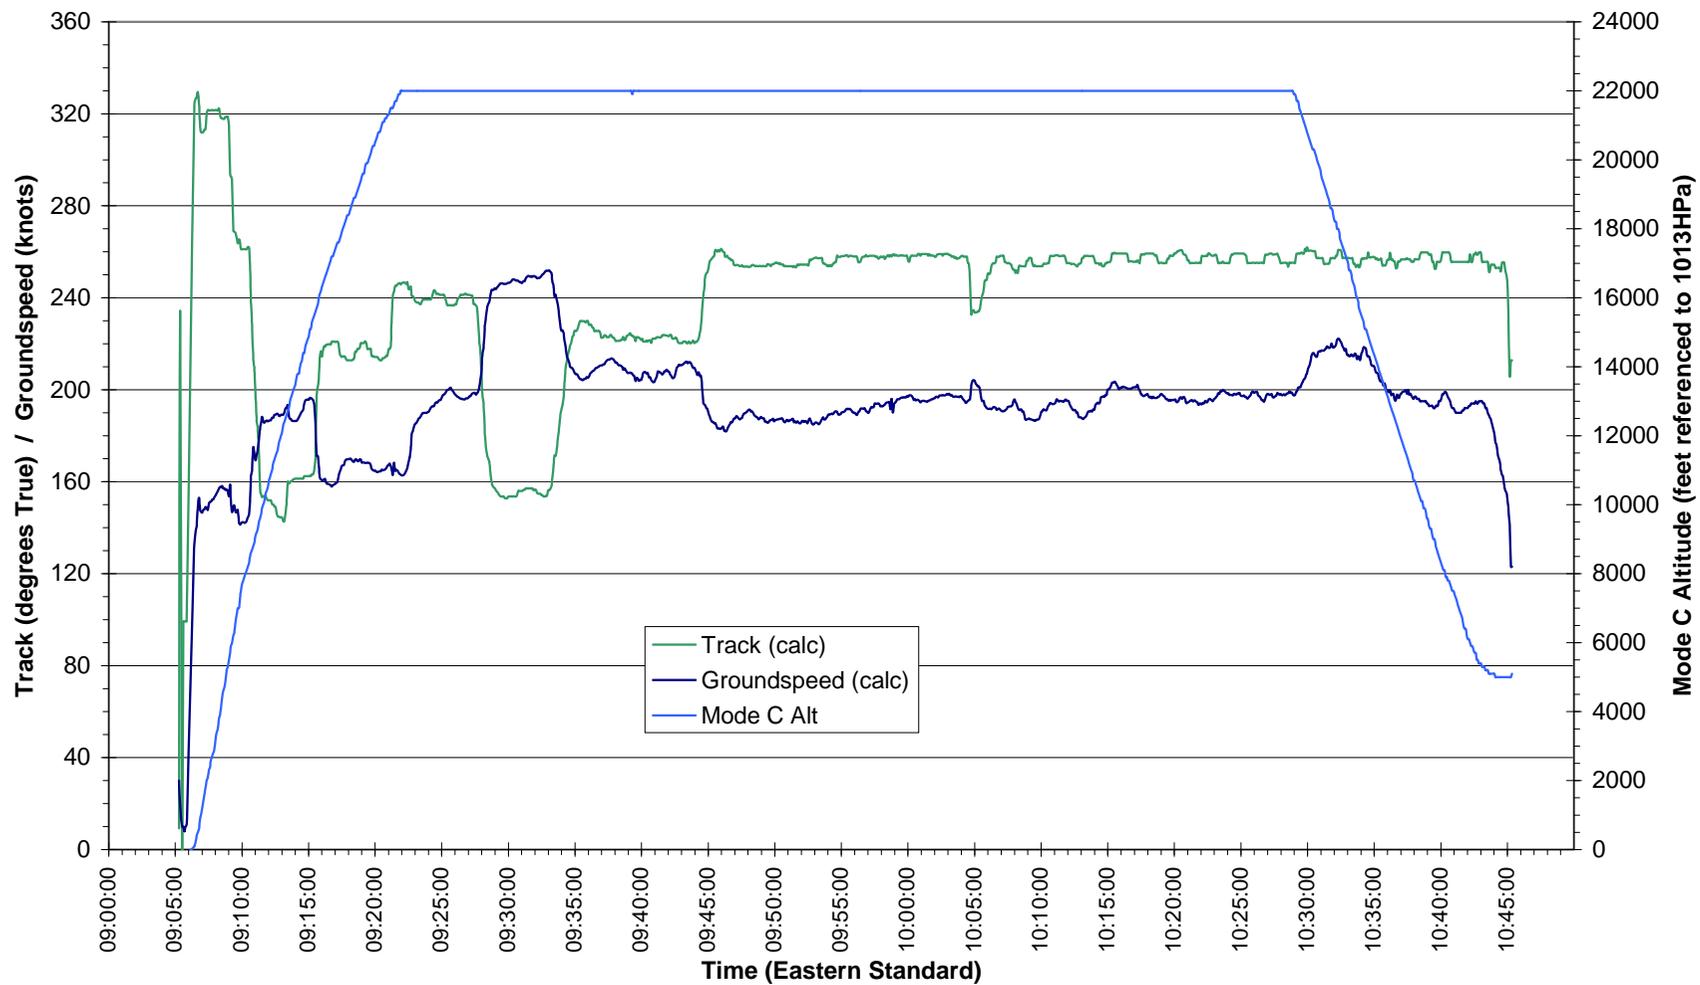
Figure 22: Recorded radar data for 28 July 2004

System and local radar data relating to flights in TNP on 7 July and 28 July 2004 were examined. Recorded radar data on 28 July 2004 showed that the aircraft had diverged left from the planned track at the reporting point CORDO. A characteristic of that data, that was not present on previously recorded flights, was a consistent lateral oscillation of the aircraft's track throughout the flight (Figure 22). That movement of up to approximately 0.2 NM either side of track was consistent with the hysteresis³⁸ that can occur with heading coupling into the autopilot operation.

Piper PA-31T Cheyenne, VH-TNP, Flight from Bankstown to Benalla 28 July 2004

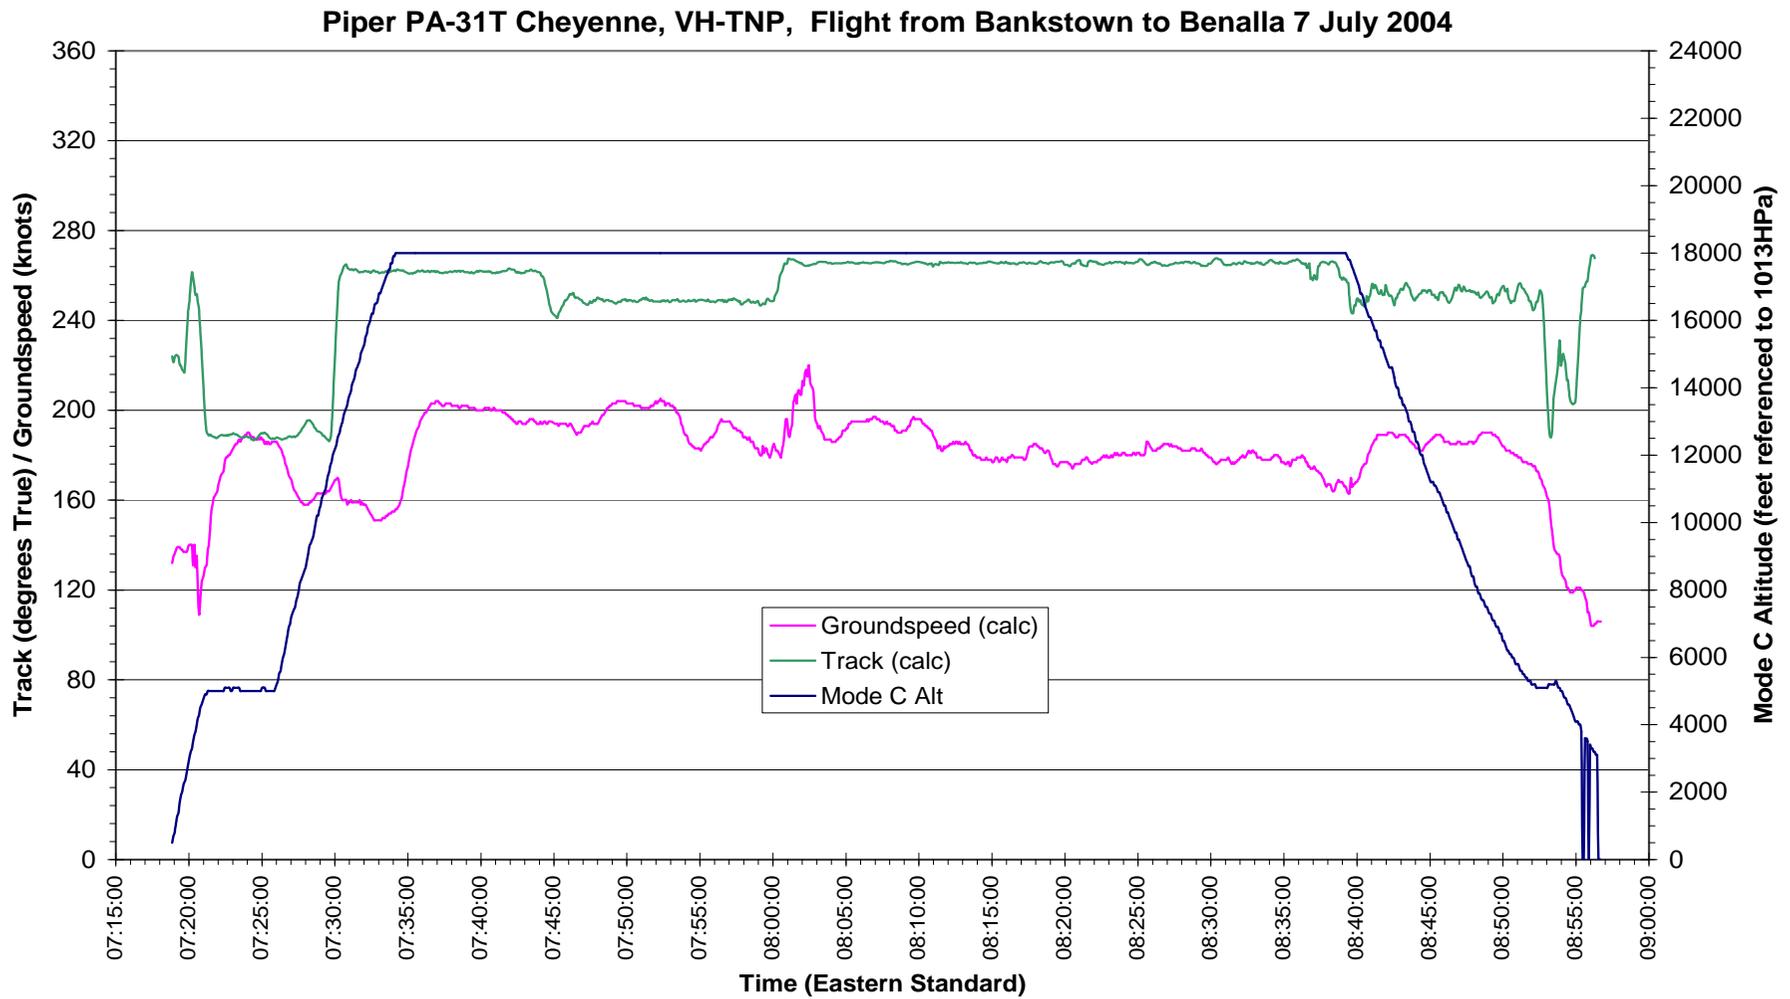
Figure 23: Recorded radar data for 7 July 2004

Radar data from the flight on 7 July 2004³⁹, that had followed the pilot's usual route from Bankstown to Benalla, did not exhibit the track oscillations seen on the accident flight (Figure 23).

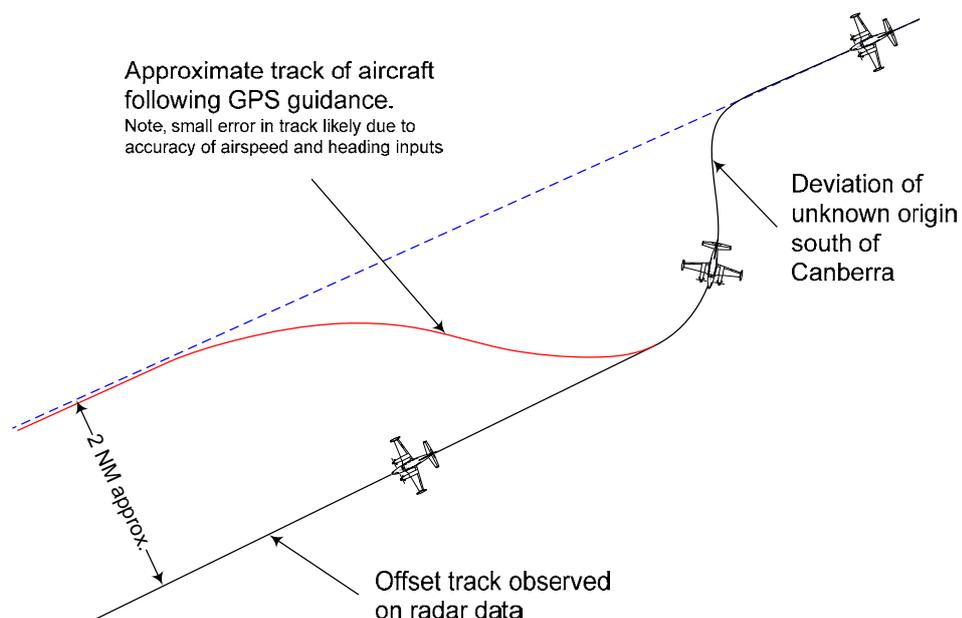
Figure 25: Diagram of track deviation south of Canberra

The recorded radar data also displayed a significant difference in the characteristics of the aircraft's tracking after this deviation. A consistent hysteresis observed in the aircraft's track following that deviation was more likely explained by a changed selection in the automatic flight system, rather than any change to the GPS receiver navigation.

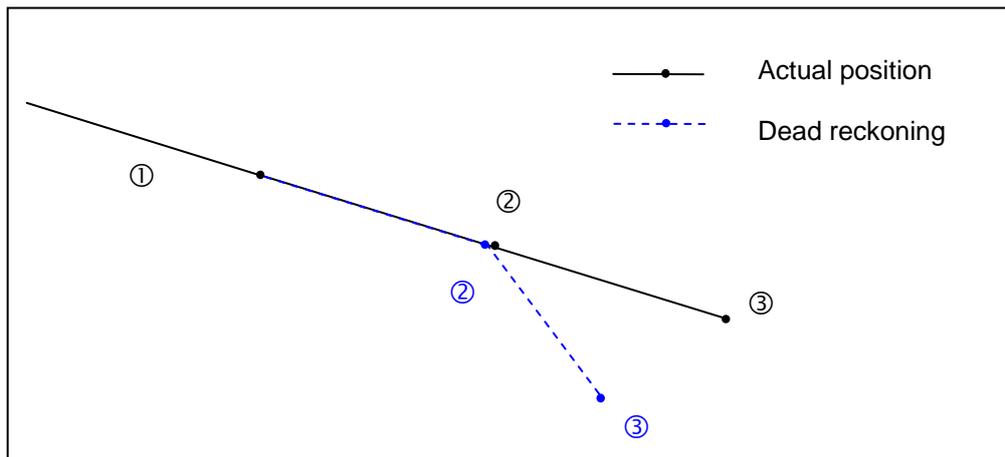
Figure 4 – Change in flight plan course

Some aviation GPS systems will continue to navigate through a flight plan if one was active at the time it entered dead reckoning mode. If the GPS is not supplied with the airspeed vector, these systems will maintain the ground speed value and change the assumed heading when a waypoint is passed (Figure 4). The resulting error in the position estimate can thus become quite large if the aircraft is not manoeuvred to match.

Additionally, if there is a change of course in the flight plan route, and the aircraft is not manoeuvred to track that change (figure 4), the GPS will determine that it is not on track and will provide guidance to regain the flight plan route.

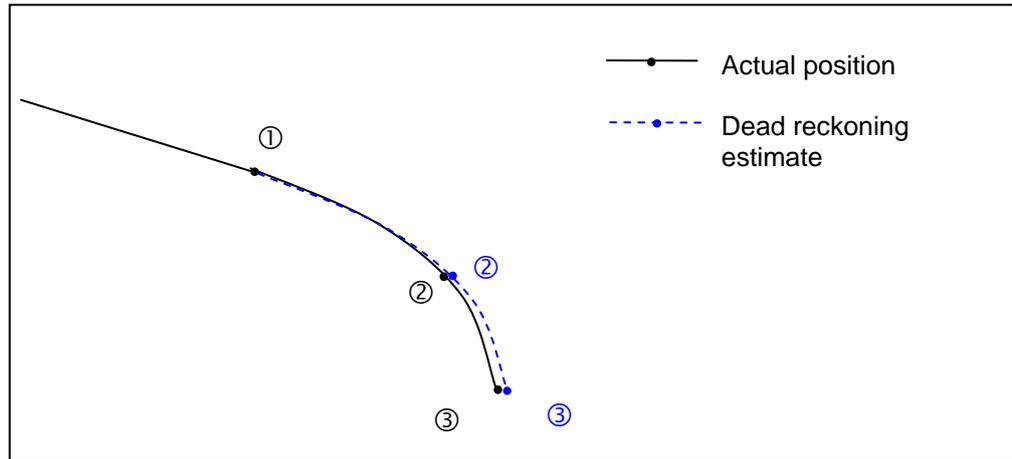
Figure 5 – Dead Reckoning with true airspeed and heading reference

Using this dead reckoning method, the computer can make a reasonable estimate of the aircraft's position even if it makes a turn (Figure 5). The accuracy of the navigation is affected by the accuracy of the true airspeed and heading sources and to a greater extent changes in the actual wind vector.

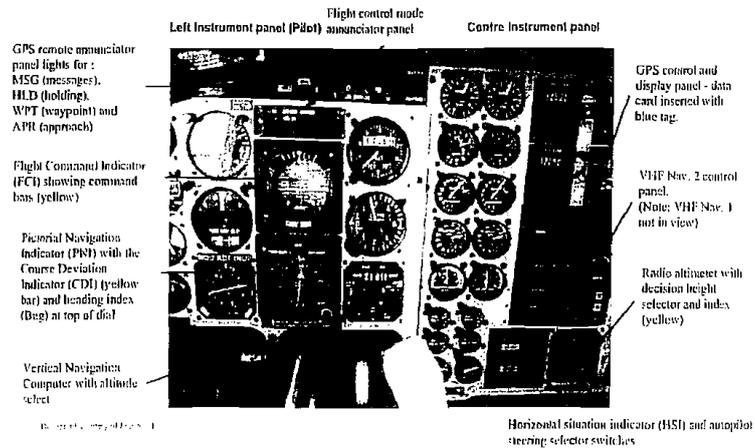
Figure 7: View of TNP's instrument panel

The GPS receiver display unit (RDU) was installed in the centre instrument panel (Figure 7) to the right of the pilot's instrument scan. During flight the small symbols and print on the RDU were not as readable as information on the PNI, directly in front of the pilot.

The annunciator line contained the message (MSG), approach (APR), holding (HLD), parallel tracking (PTK) and WPT annunciators. The MSG, APR, HLD and WPT annunciators were duplicated as a set of remote light indicators located above the left instrument panel (Figure 7), directly in front of the pilot, to comply with the GPS installation regulatory guidelines¹⁶. That was necessitated by the location of the receiver unit on the lower central panel, to the right of the pilot's primary field of view.

- a) Autopilot – The flight control mode annunciator panel would indicate to the pilot what mode the autopilot was operating in. It is directly in front of the pilot above the attitude indicator. Using the GPS mode the pilot can set the auto pilot to fly the GPS approach tracks such as the those required for the GPS approach into Benalla.

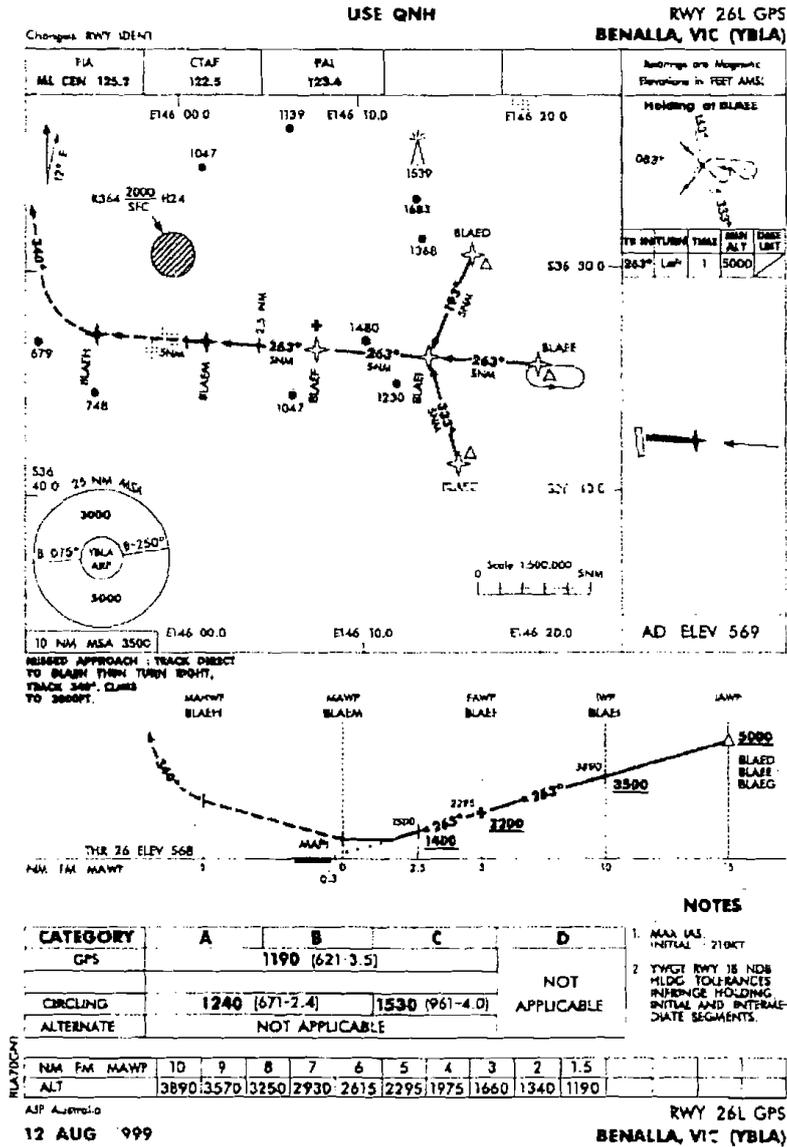
Figure 13: Benalla Runway 26L GPS instrument approach chart

The Airservices Australia Benalla Runway 26L GPS approach chart (Figure 13), indicated that when the aircraft was on profile and at 1,500 ft, it should have been 2.5 NM from the missed approach waypoint (BLAEM), or 7.5 NM from the intermediate approach point (BLAEI). Measurement shows that the accident site was about 9.5 NM from the apparent BLAEI waypoint (Figure 2). From this it can be deduced that the groundspeed used in the GPS calculation was slower than the aircraft was actually travelling.
