AIRCRAFT ACCIDENT FINAL REPORT # A0619890

Landing Gear System Failure

**Cambridge Air Services Limited
Cessna 402C C6-KEV
Freeport, Grand Bahama,
Bahamas**

April 21, 2006

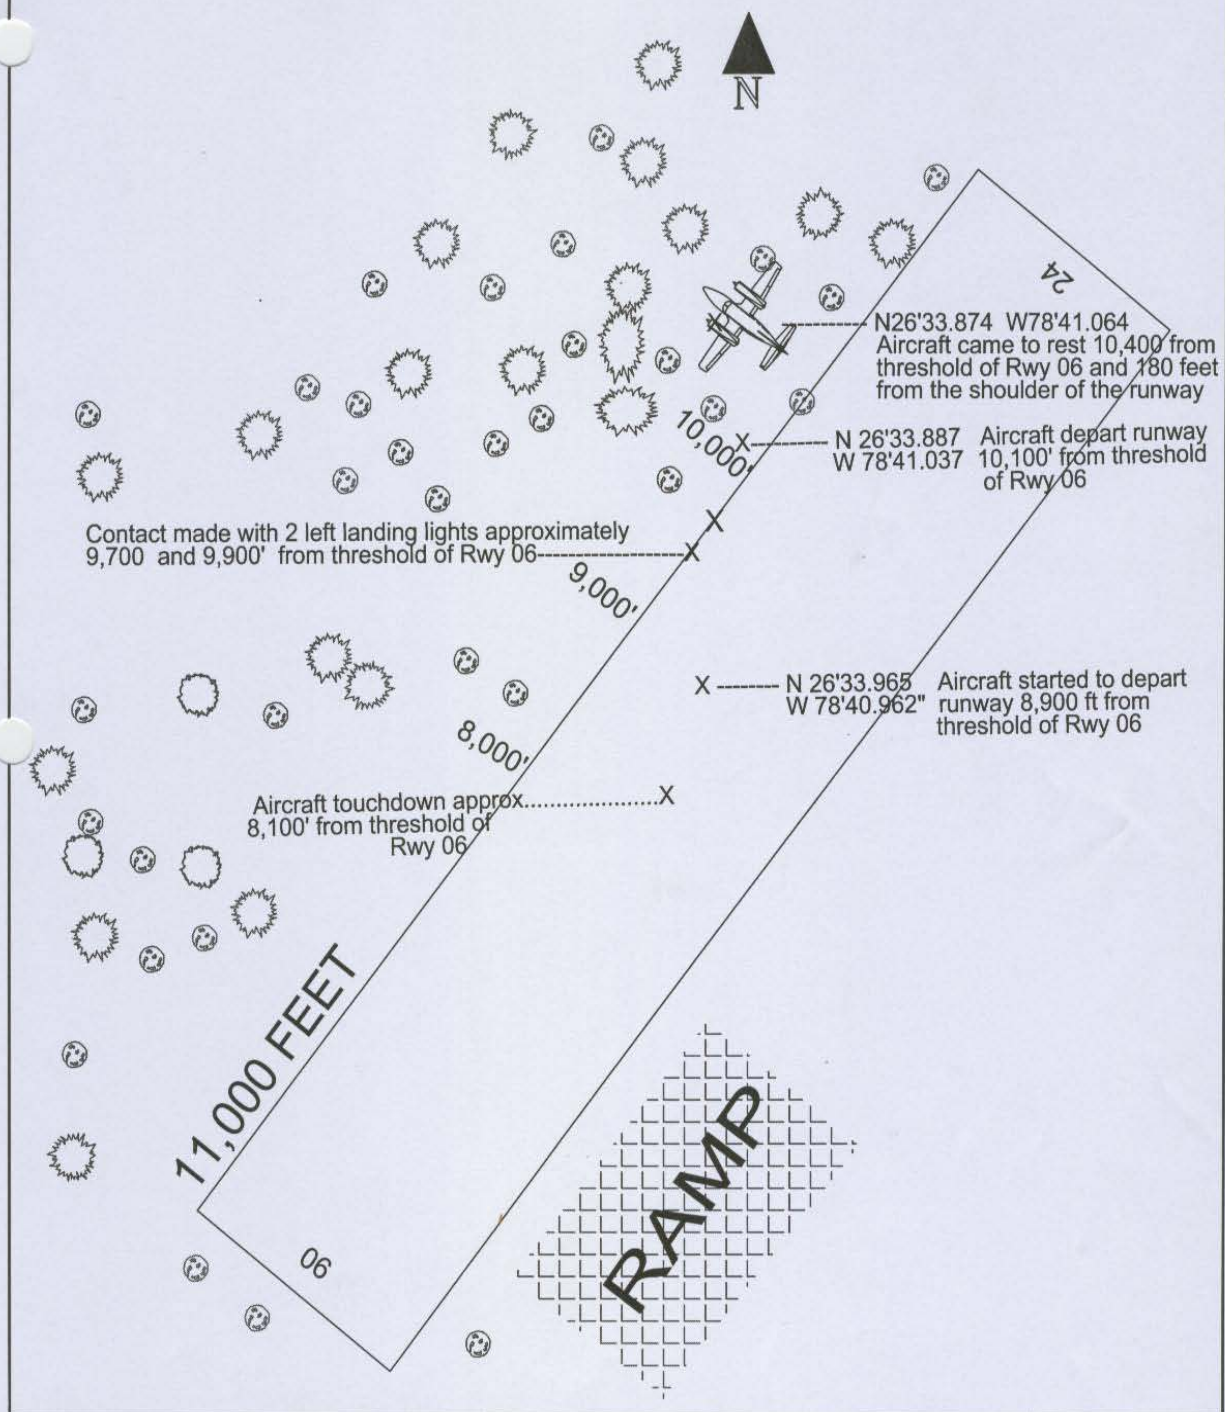
CASE NUMBER: A0619890

The aircraft departed the runway approximately 9,700 feet from the threshold of Runway 06. Aircraft came to rest approximately 10,400 feet from the threshold of Runway 06 and 180 feet from the shoulder of the runway. Aircraft hit trees and rock prior to stopping. Aircraft burst into flames on the left side shortly thereafter.
