**KNKT/05.24/09.01.38**

**AIRCRAFT ACCIDENT REPORT**

**PT. Mandala Airlines; MDL 091**

**Boeing B737-200; PK-RIM**

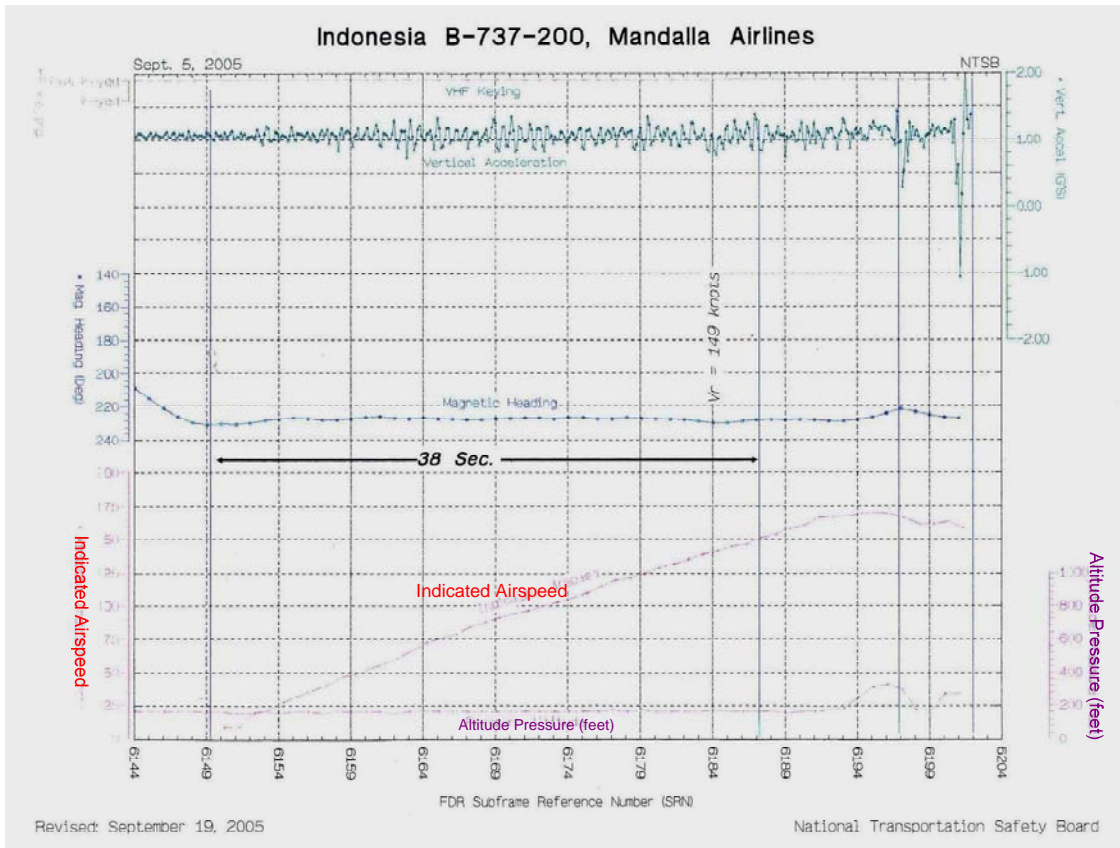
FDR readout from accident flight at 5 September 2005

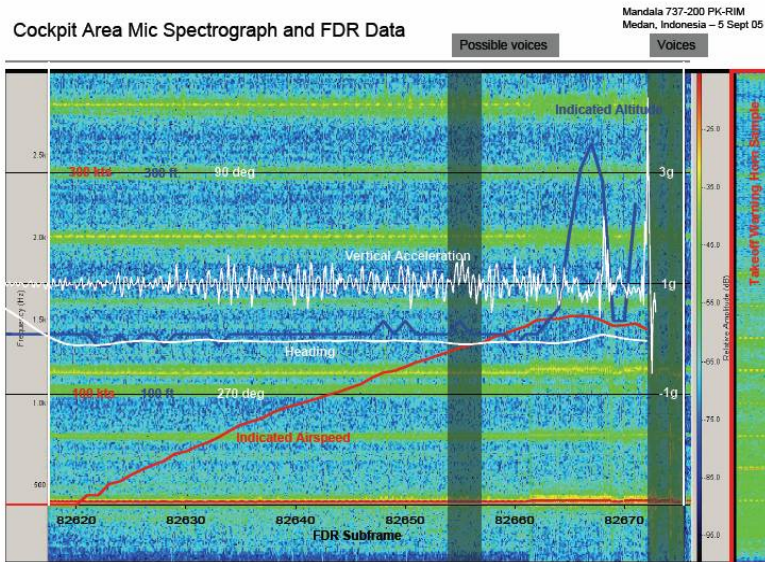
The reason for the lack of take off configuration warning horn cannot be determined through sound analysis.

The following picture represents the superposition of sound spectrum taken from the CVR and the FDR data.
