Final Report

On the accident on **1st June 2009**
to the **Airbus A330-203**
registered **F-GZCP**
operated by **Air France**
flight AF 447 Rio de Janeiro - Paris

BEA

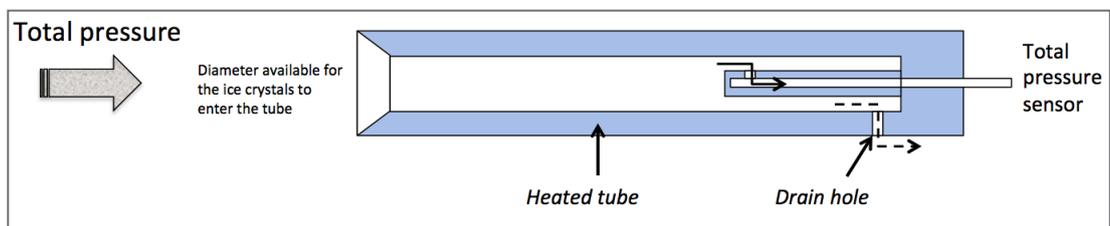
Figure 8: Pitot probe diagram

When highly specific climatic conditions are met, in particular with the presence of ice crystals in excessive quantities, the conditions for use of the probes can exceed the conditions for qualification and robustness. In this type of situation, a partial obstruction of the total pressure probes in icing conditions and at high altitude (above 30,000 feet) can occur. This results in a temporary and reversible deterioration of total pressure measurement.

In the presence of ice crystals, there is no visible accretion of ice or frost on the outside, nor on the nose of the probe, since the crystals bounce off of these surfaces. However, the ice crystals can be ingested by the probe air intake. According to the flight conditions (altitude, temperature, Mach) if the concentration of crystals is greater than the capacity for de-icing of the heating element and evacuation by the purge holes, the crystals accumulate in large numbers in the probe tube.

As soon as the concentration of ice crystals is lower than the de-icing capacity of the probe, the physical barrier created by the accumulation of crystals disappears and measurement of the total pressure becomes correct again.

Experience and follow-up of these phenomena in very severe conditions show that this loss of function is of limited duration, in general around 1 or 2 minutes.

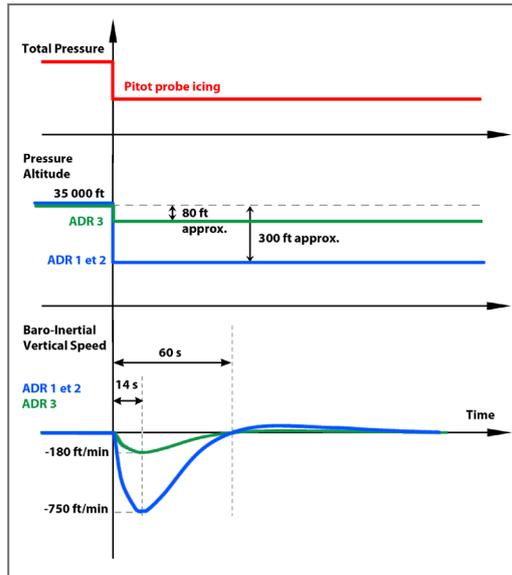
Figure 10: Effect of a drop in total measured pressure on standard altitude and vertical speed

The first consequence of a drop in measured total pressure is a drop in the Mach and the CAS. The drop in Mach leads to a drop in standard altitude due to the correction of the measured static pressure. This drop is different according to the ADR under consideration: in the flight conditions of the event, it is of the order of 300 to 350 ft for the ADR 1 and 2 and of 80 ft for ADR 3.

The drop in indicated standard altitude also causes a transient variation in Vzbi. Just as the drop in standard altitude is lower for ADR 3 than for ADR 1 and 2, the variation in Vzbi is lower for ADR 3 than for the two others, as illustrated by the graph below:

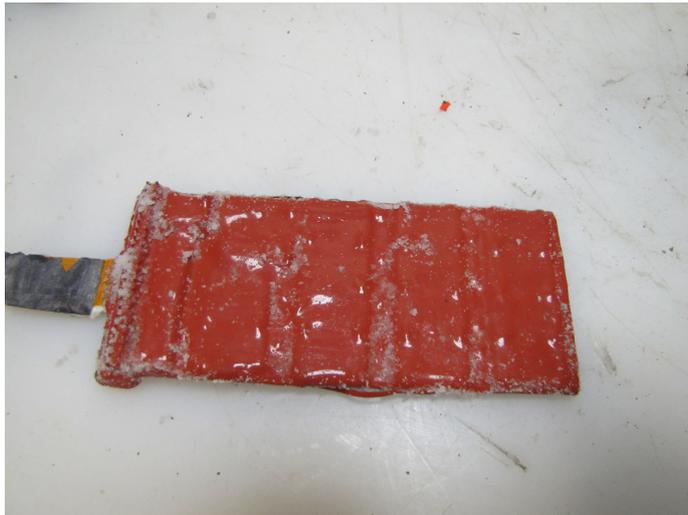
Figure 19: FDR memory board

The memory board was cleaned. Visual inspection did not reveal any damage to the board. The board was placed in an oven for 36 hours in order to remove the moisture in the components and the printed circuit board. The impedance measurements that were then made on the input connector were in accordance with the measurements made on reference units.

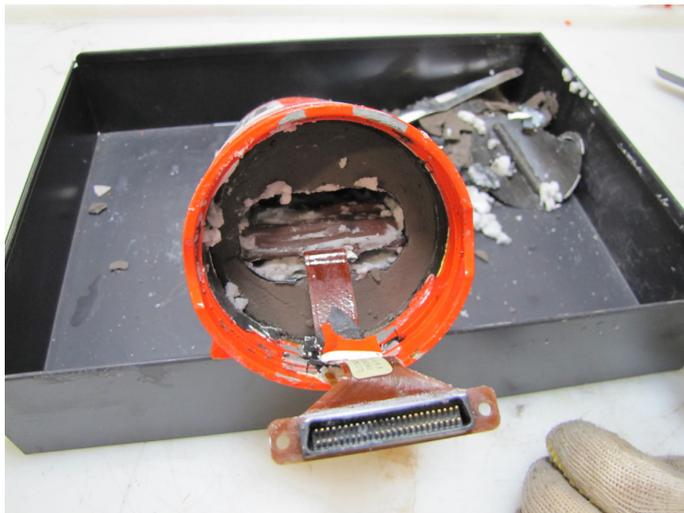
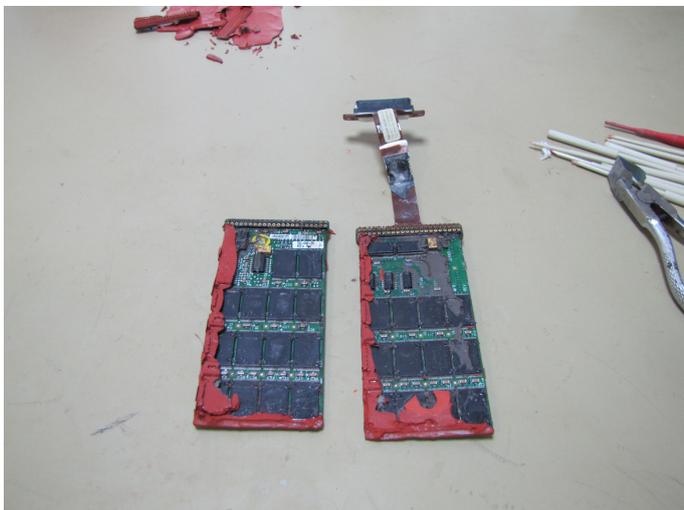
Figure 22: CVR memory board after removal of thermal protections

Visual inspection of the boards revealed damage: a capacitor and a resistor were cracked on one of the boards; two decoder-type components were damaged on the other board.

The boards were placed in an oven for 42 hours. The damaged components were unsoldered and replaced. The impedance value measured at the input connector complied with the measurements made on reference boards. The memory boards were then connected separately to the BEA's memory reader. A few memory components selected previously were addressed and read entirely. The consistency of the binary contents of each memory could then be checked using the manufacturer's hardware and software. The boards were then connected to the BEA's chassis and the data was extracted and decompressed using the manufacturer's official hardware.

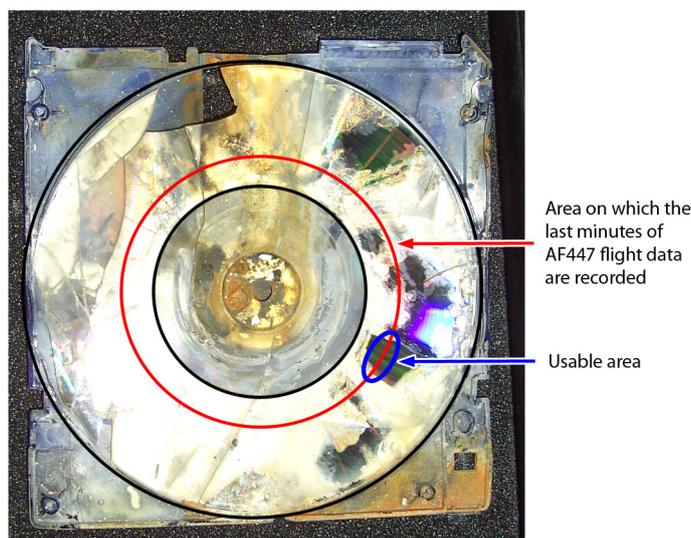
Figure 29: Optical disk showing the location of the readable zones

This computer is an unprotected parameter recorder used for flight analysis purposes by the operator. The data was recorded on a magneto-optical disk which was removed from the computer. The disk was so badly damaged that it was impossible to use traditional reading methods. It was therefore examined in collaboration with the solid-state physics laboratory at Paris-Sud University, and in conjunction with the manufacturer, Thales.

Readable zones were identified. The only zone likely to contain flight data was analysed. It relates to one second of information recorded every 100 seconds. Very little information could thus be recovered, and this data did not supplement the elements recovered by other means. The examination was therefore terminated after this feasibility study.

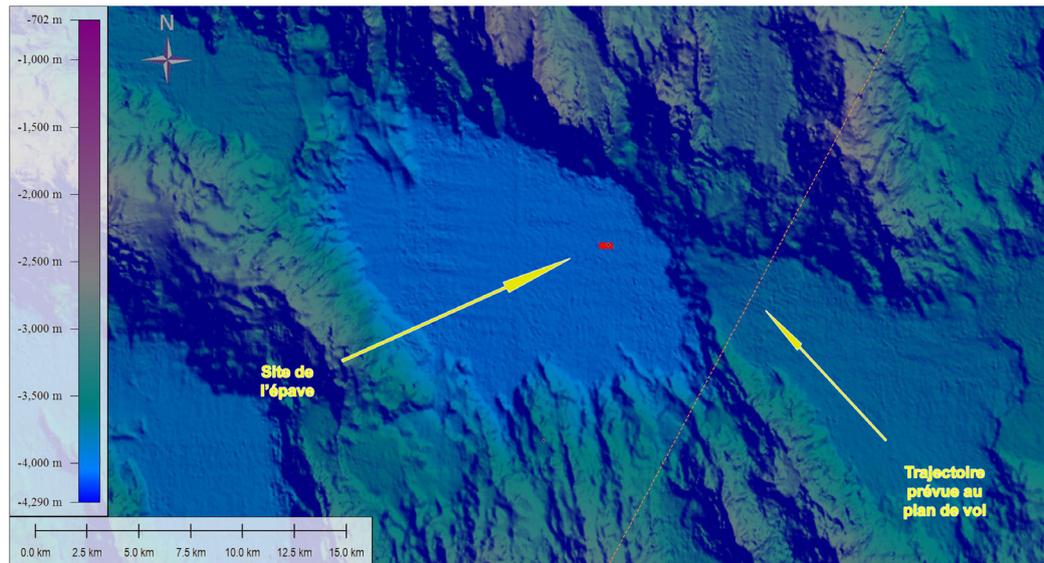
Figure 32: Wreckage localisation

The aeroplane wreckage was found about 6.5 NM on the radial 019 from the last known position, slightly to the left of the planned route. The wreckage rested on an abyssal plain at a depth of 3,900 metres. This plain, surrounded by terrain, made of clay type sediment, was around 15 km wide and was located west of the scheduled aeroplane flight path.

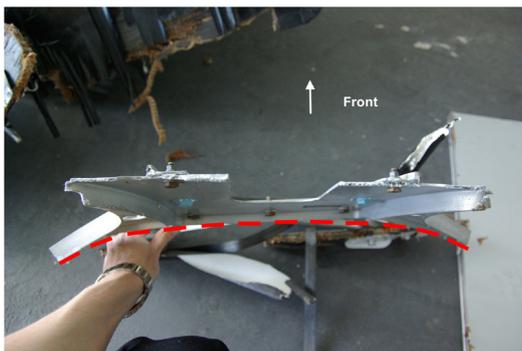
Figure 36: Luggage rack fitting deformed towards the front Toilet door (L54)

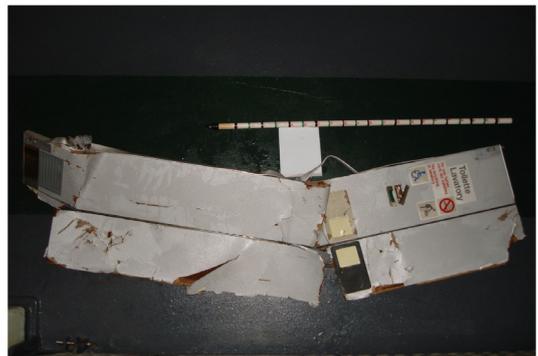
Figure 37: Metallic stiffeners deformed by buckling

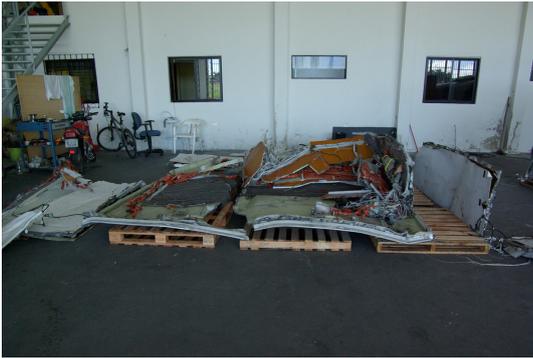
The wall fragments were crumpled. The reconstitution of the ceiling showed it was bent downwards and the floor bent upwards.

These deformations were symmetrical on the left and right sides with respect to the aircraft centreline.

Figure 38: Floor of the LDMCR:
with bottom-upwards deformation

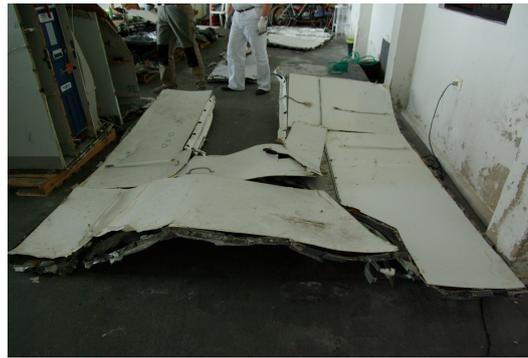
Figure 39: Ceiling of the LDMCR:
with top-downwards deformation

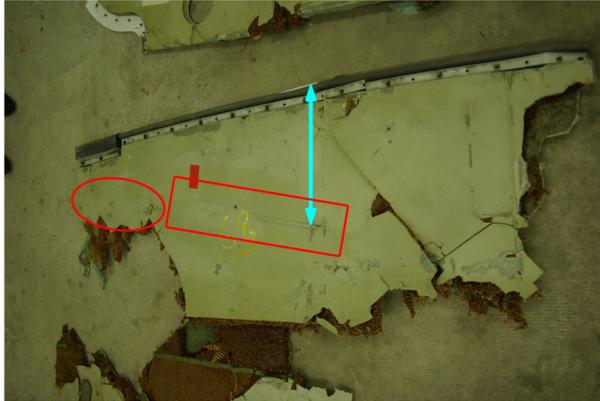
Several parts of the flap extension mechanism fairing were found. There were marks on two of them (positioned at the level of flap track N°3), made by the flap extension track on impact. Analysis of these marks (morphological and dimensional examinations) and comparison with an identical aeroplane made it possible to determine that the flaps were in the “retracted” position (see photo below) at the time of impact with the water (measurement of the distance between the track and the lower surface of the flap, position of the carriage on the track).

Figure 43: Part of the No. 3 flap track fairing on the left wing

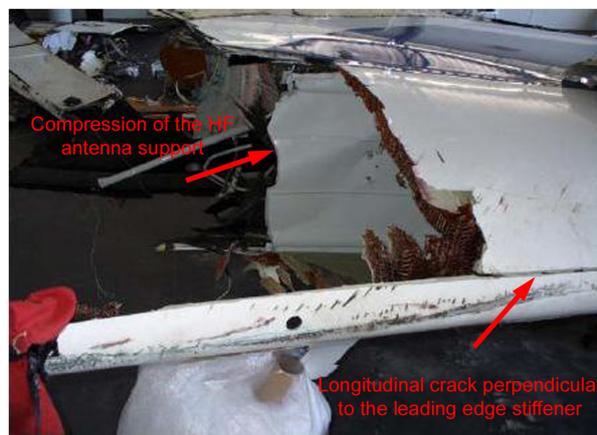
Figure 46: HF antenna support

- ❑ Failure of the leading edge right- and left-hand panels
- ❑ Longitudinal cracking of the leading edge stiffener
- ❑ HF antenna support (attached to the forward spar): failure of the lower part, crumpling indicating bottom-upwards compression loads.

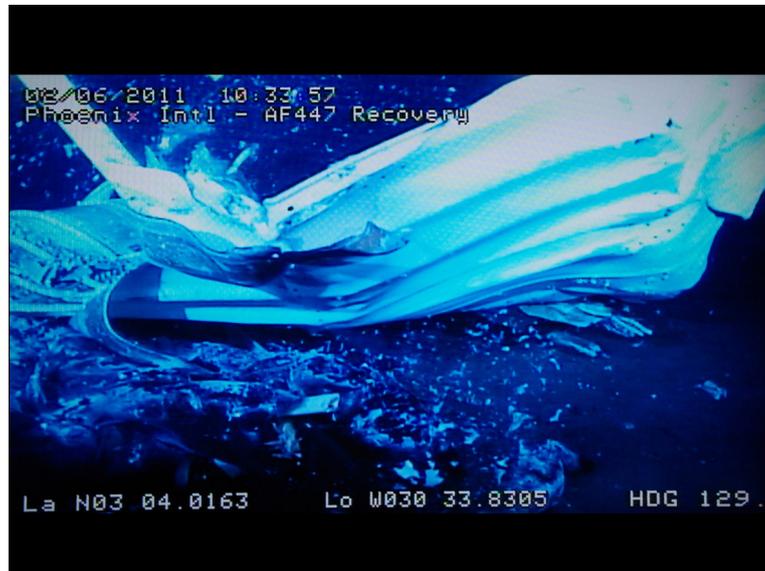
The lower elements of the fuselage were badly broken up and deformed. In these areas, crushing of the sheet-metal between the ribbing was noted, which indicates a vertical component at the time of impact.

Figure 56: Parts of the fuselage

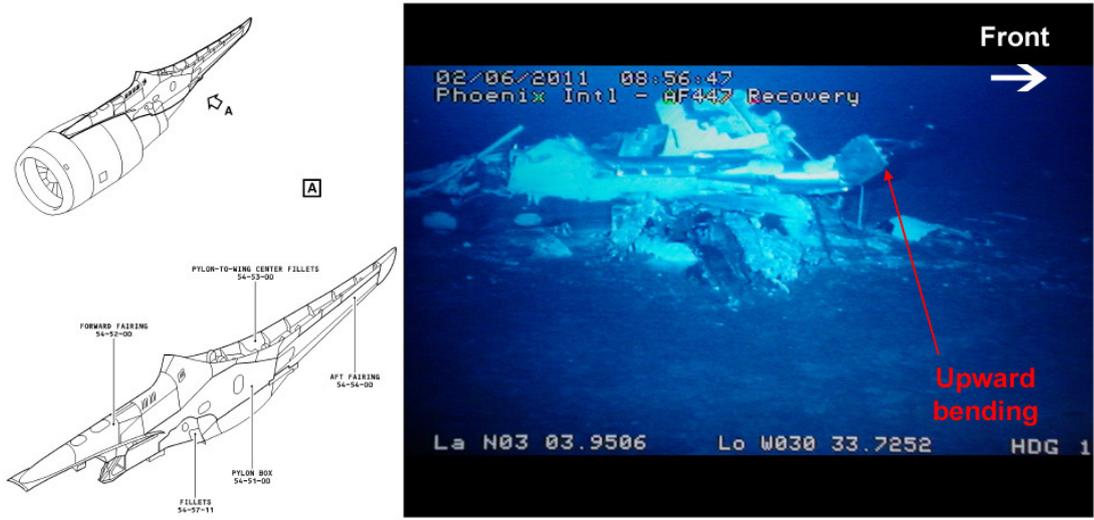
The engine pylons were found separated from the wings. They had deformations compatible with loads on the engines from below to above.

Figure 58: Engine pylon

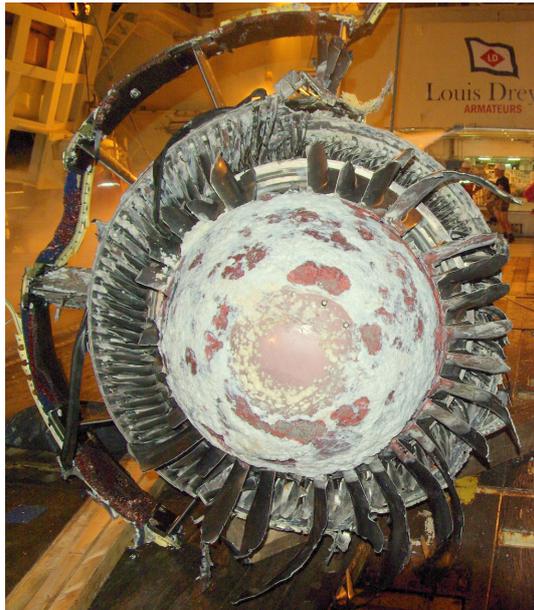
The visual examination of the two engines showed that they were at high RPM at the moment of impact with the sea.

Figure 60: Front view of engine

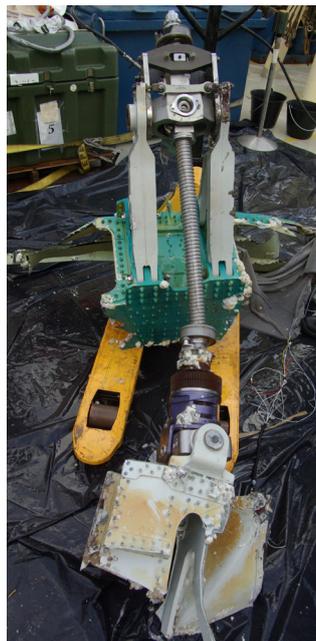
According to the manufacturer's technical documentation, the relative position of the actuator and the THS screwjack corresponded to a THS position of between 13° and 13.5° nose-up.

Figure 61: Trimmable horizontal stabiliser screwjack after being raised on board

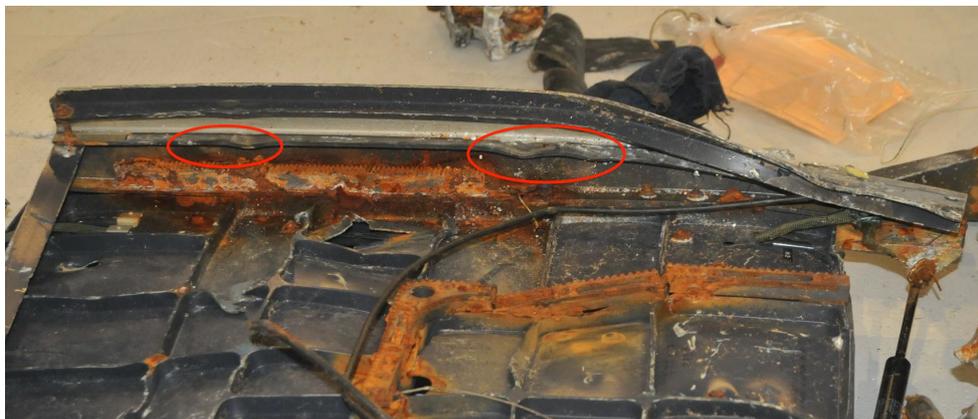
The marks left by the adjustment mechanism under the seat cushion enabled the horizontal position of the seat on impact to be determined: the seat was pushed back and moved to the left (in the "storage" position).

Figure 80: Roller marks on the guidance rail

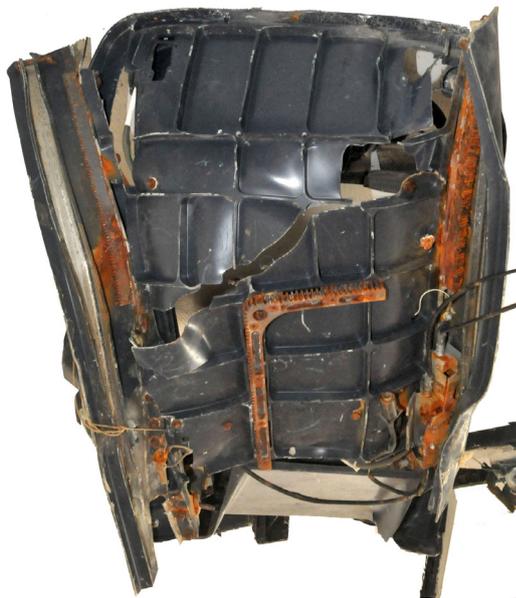
Figure 81: Right side seat cushion

The marks left by the adjustment mechanism under the seat cushion enabled the horizontal position of the seat on impact to be determined. The seat was positioned 5.5 cm from the most forward position.

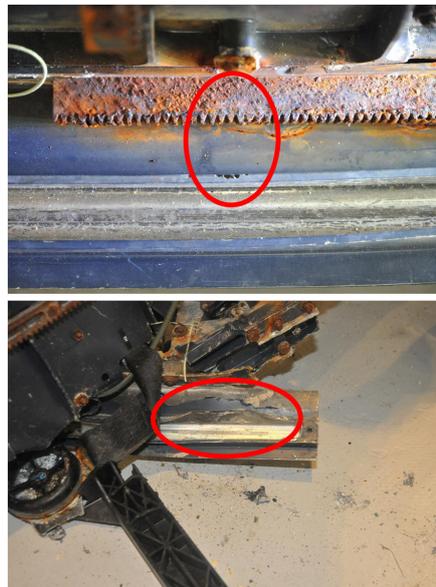
Figure 82: Marks on the adjustment mechanism

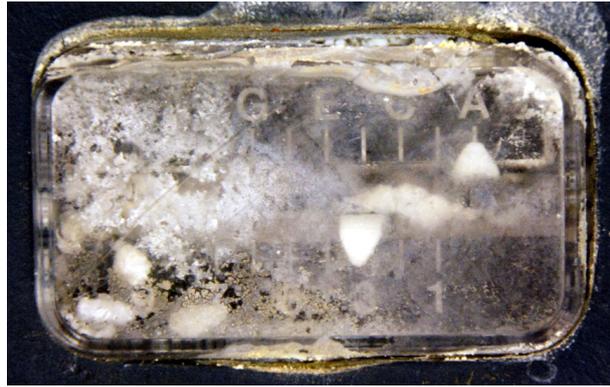
The armrest was recovered in the up position, a probable consequence of the impact. The armrest position was indicated on the dial dedicated to this function. The needles were positioned on A values (adjustment from A to K for height) and 3 (adjustment from 1 to 9 for tilt angle). The armrest cladding was dismantled in order to check mechanism integrity and validate the needle positions. The mechanisms were demonstrated to be irreversible during certification tests, that is to say that leaning on the armrest did not modify the adjustments made with the knobs.

Figure 83: Dial indicating armrest position

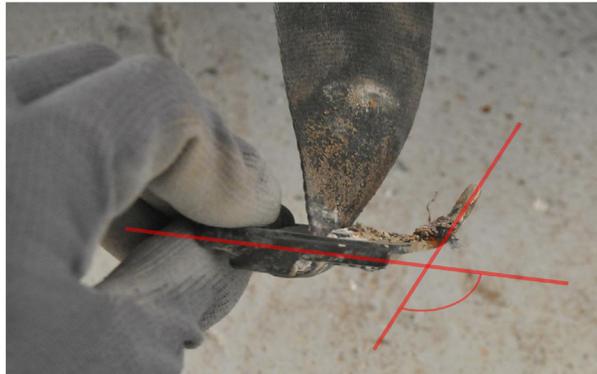
The shoulder straps, the left lap belt and crotch belt were recovered detached. Examinations showed that on impact the left lap belt and crotch belt were locked and that the shoulder straps were not.

Figure 84: Malformation of the crotch belt fastening

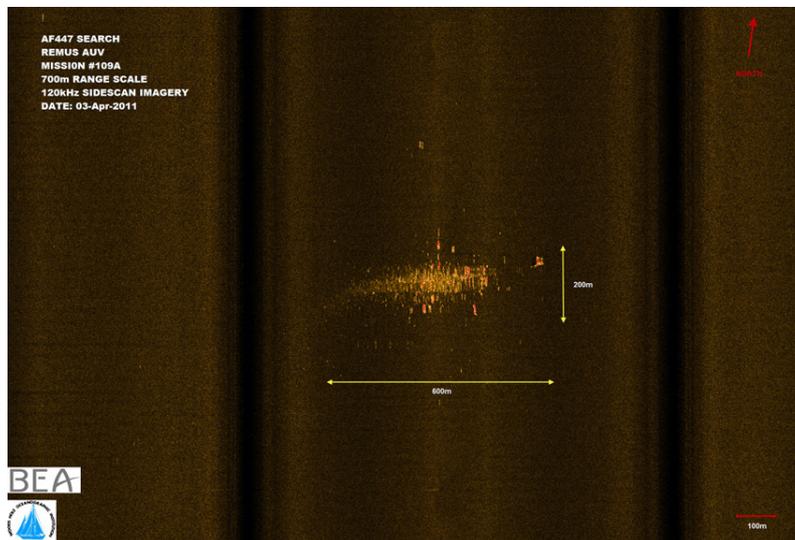
Figure 92: General view using sonar imaging: 120 kHz, range of 700 m

The first passage brought to light a concentration of backscattered data over an area of around 600 metres by 200 metres.

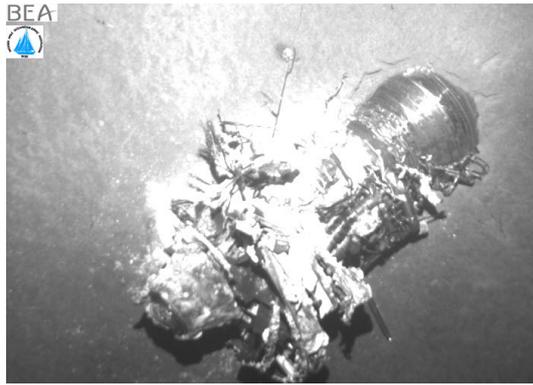
Figure 93: Engine

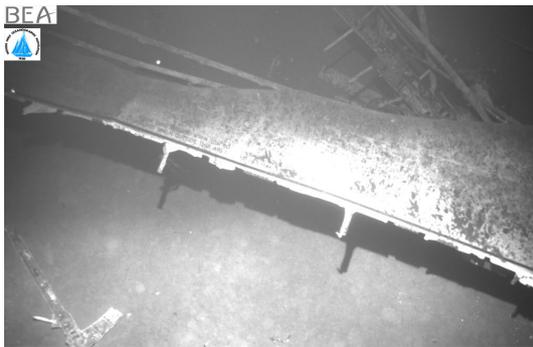
Figure 94: Wing

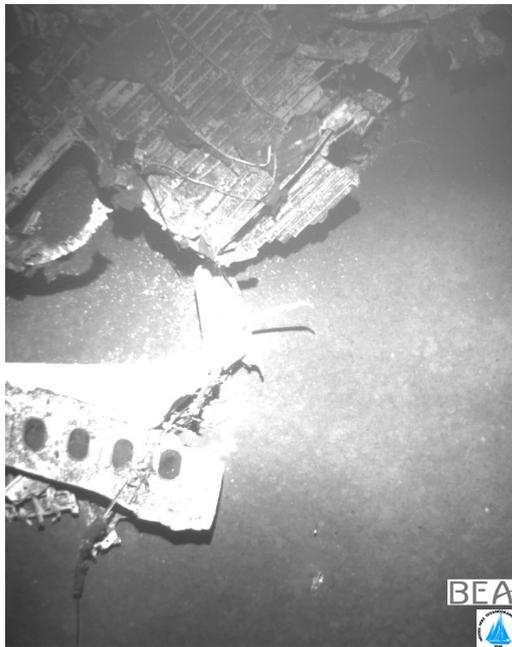
Figure 95: Section of fuselage

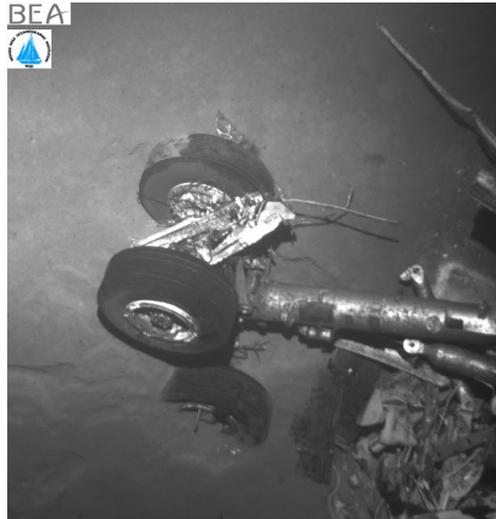
Figure 96: Landing gear

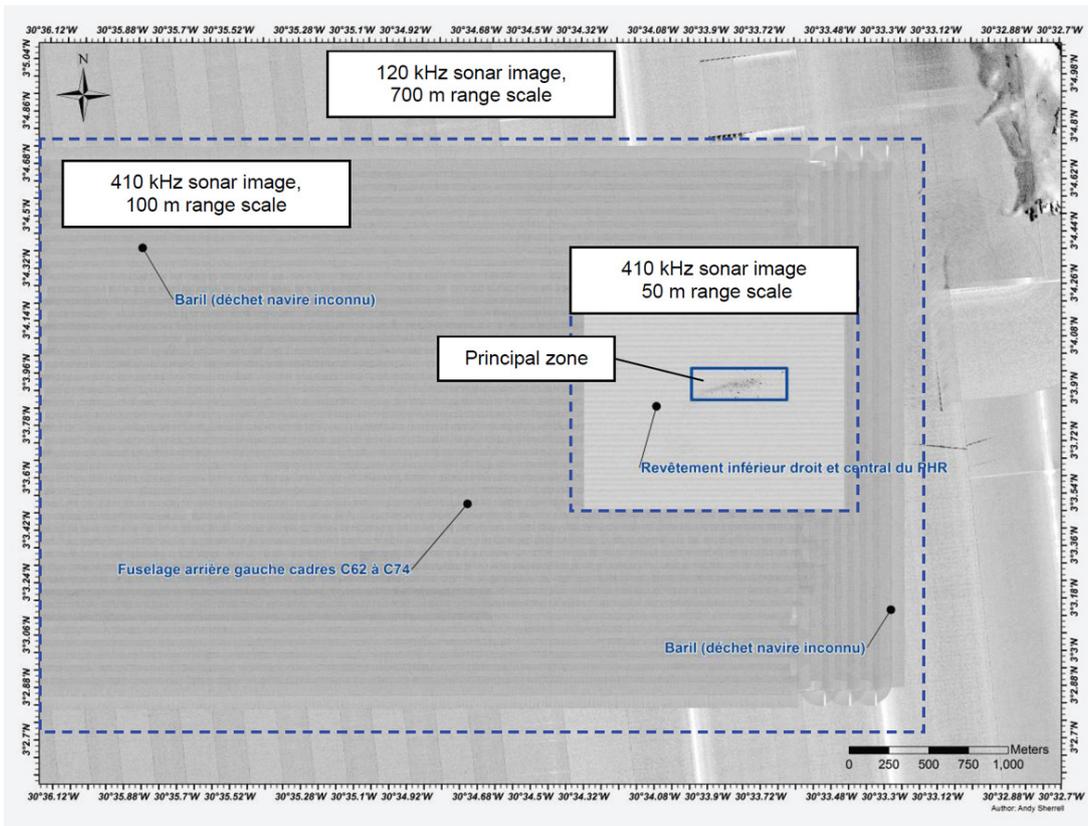
During phase 4, the area was scoured several times by the REMUS AUVs with different sonar settings to make sure that no possible debris, located beyond the main zone, was forgotten. This exploration made it possible to localize a part of the fuselage about two kilometres from this zone as well as objects such as oil drums that did not come from the aircraft (see the following figure). The initial imagery was subsequently enhanced by high resolution 410 kHz sonar images at various range scales.

Figure 97: Overlay of sonar images taken with various settings:
120 kHz, 700 m range scale - 410 kHz, 100 m range scale - 410 kHz, 50 m range scale

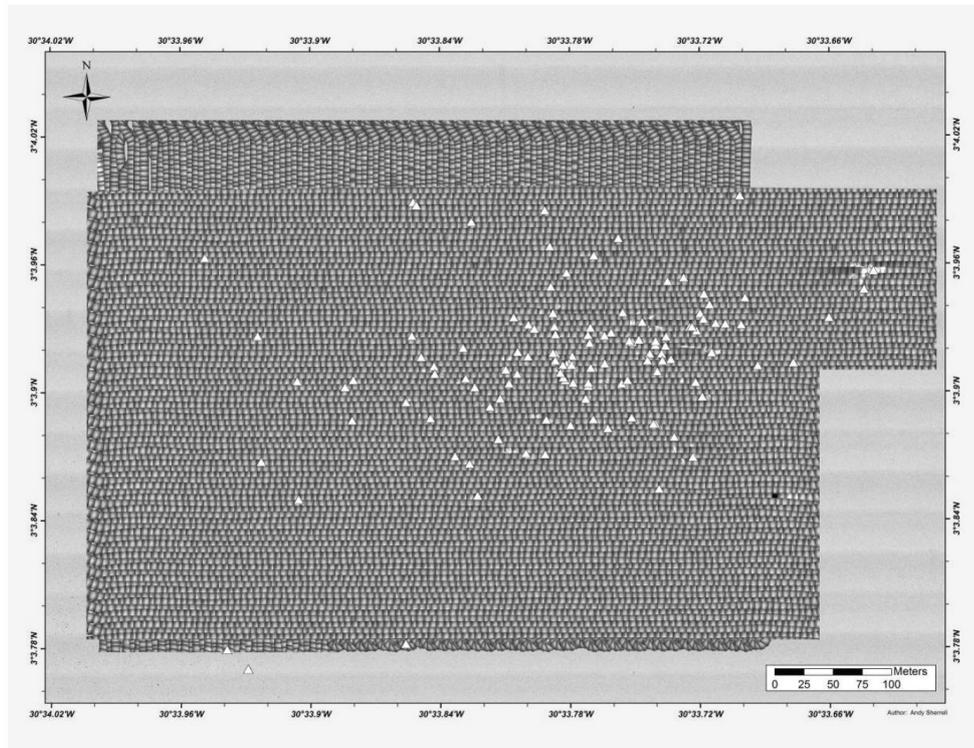
Figure 98: Visualisation of the photo mosaic obtained with REMUS AUV images and the aeroplane debris identified by using the REMORA ROV
