MINISTRY OF CIVIL AVIATION

The final technical report of the accident of the cargo aircraft operated by AERO LIFT registered S9-SVN of type : AN-12B while taking off from the runway 02 in Luxor airport Flight No. LFT 1015, destined to the airport NIKOLAEV ,Ukraine in 20/2/2009

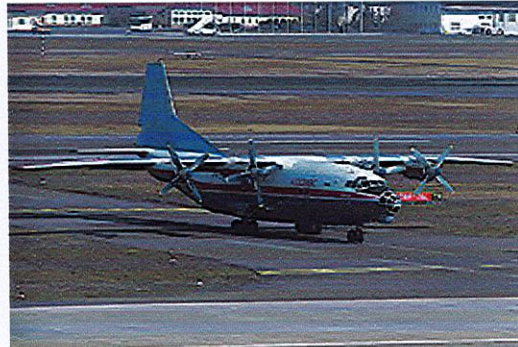
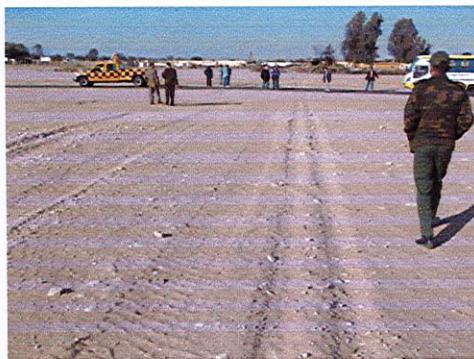
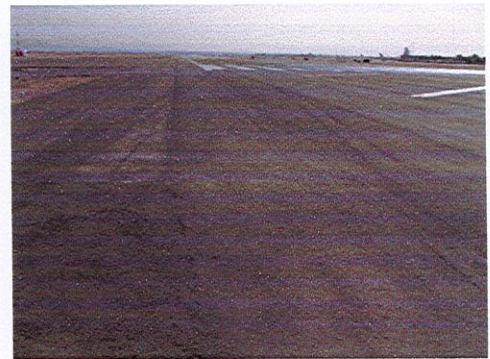
- The aircraft started rolling on the runway 02 for take off but it kept rolling on it till it reached its end. The aircraft continued rolling in the sand drifting from the runway centerline to the right, crossing a service road to crash into a military zone (500 meters from the runway end).

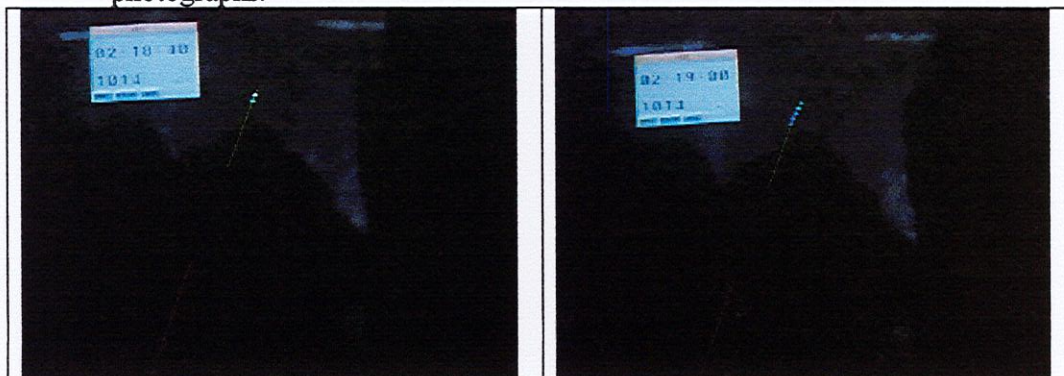
- The aircraft appeared on Luxor airport radar screen near to the end of the runway at 02 18 37 UTC. The drift in its path to the left appeared on the screen till it disappeared on the screen at 02 19 00 UTC as in the following photographs.

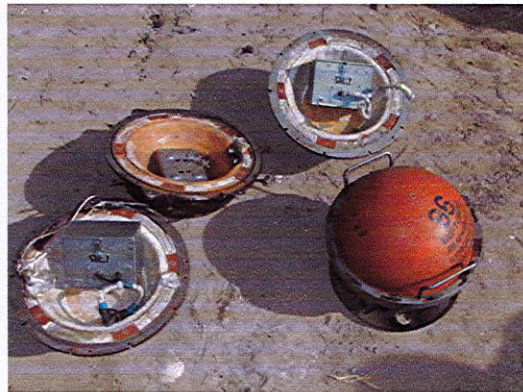
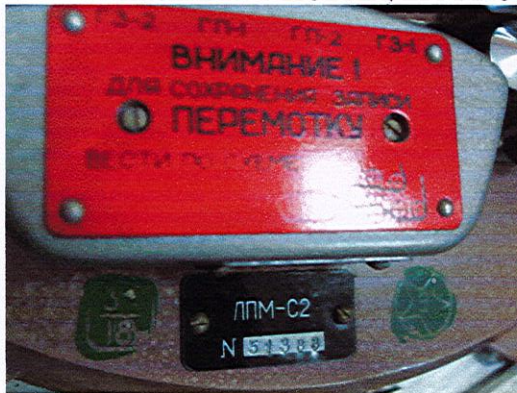
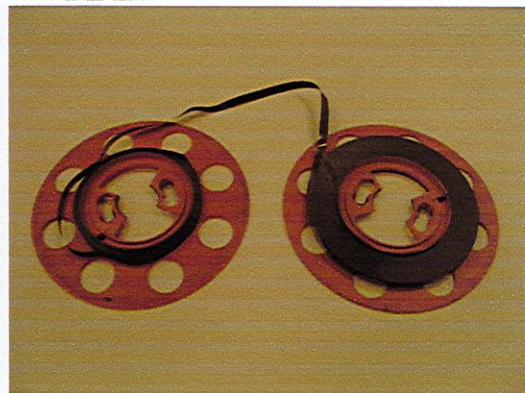
- The aircraft is supplied by 2 FDR devices composed of magnetic tape of MSRP-12 type.
- The first tape is delivered on two spools (which is disassembled from its place on the aircraft) and the second tape delivered on one spool (which is the one which was found between the wreckage of the aircraft in the accident location)
- Both tapes had no signs of being subjected to high temperature influence or mechanical damage. On one of the first tape spool, the following was written: 26098 HOBAR, LPM NO. 33631 IMF.

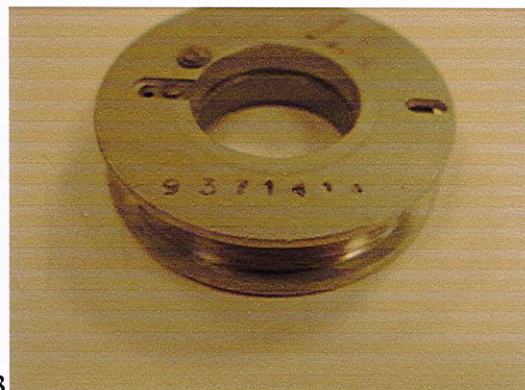
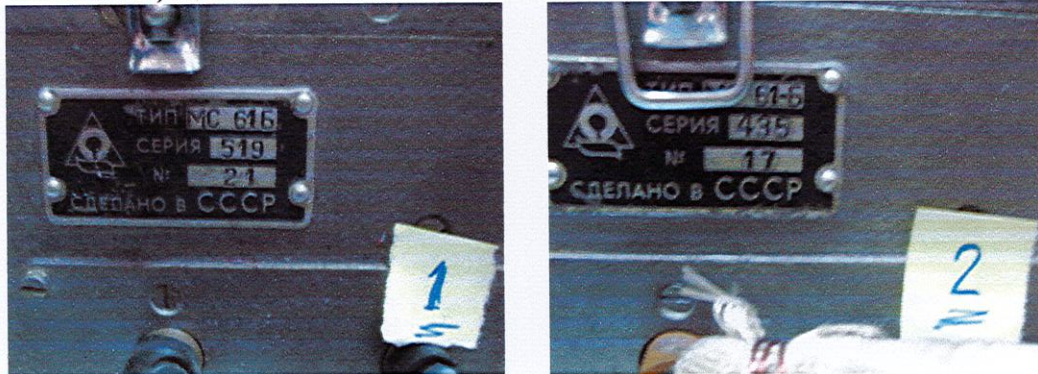
- The aircraft is supplied with two devices; one is the main and the other is standby and both are of type: MS-61B.
- The CVR is composed of a metal wire connected and wound on two pairs of spools. The wire was sound with no signs of high temperature influence.

- For the main recorder; the feeding spool (code: 003 and serial No. 8779204) there was no metal wire but the receiving spool (serial No. 9371414), 0.75 of the wire is winded around it.
- For the standby recorder; feeding spool (serial No. 9231673), 0.85 of the wire is winded around it and for the receiving spool (serial No. was not clear) 0.15 of the wire is winded around it.

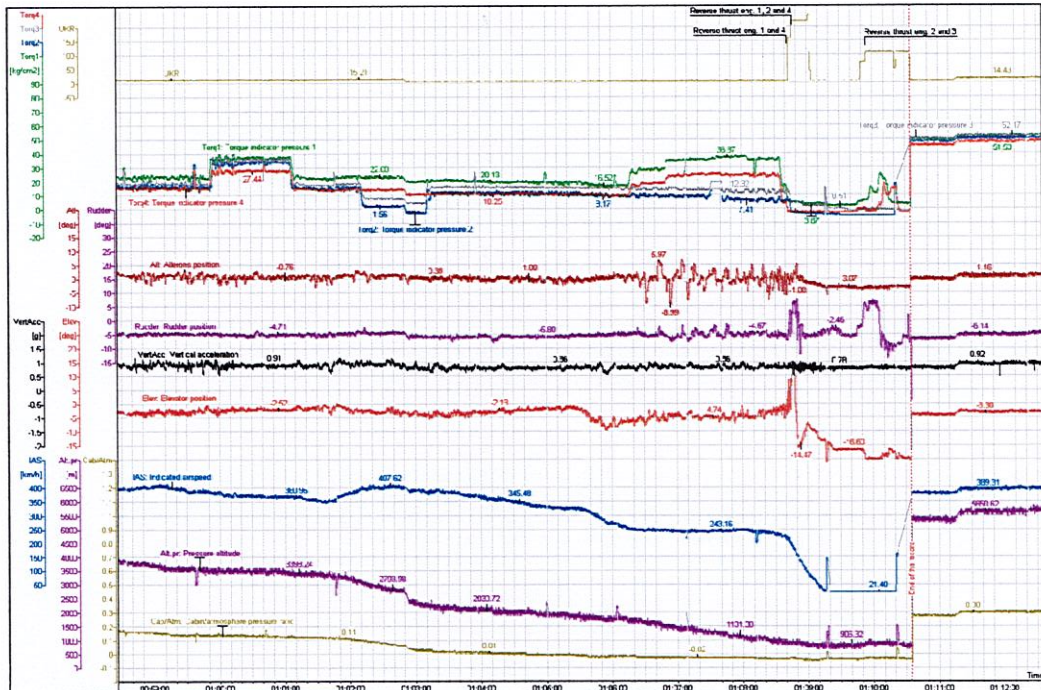
Fig 19. The FDR MSRP-12 of the aircraft An-12B SR-DVA flight information.

- The FDR tape was in a good condition.
- The list of parameters resulting from unloading the FDR is the same as the actual list of the FDR type.
- The duration of the data recorded is 1 hour and 15 minutes.
- There was no recorded data related to the accident.
- The system MSRP-12 recorded data showed information about level flight and approach and landing. This was the last recorded flight on the tape.
- The recorded flight Data showed that the landing was normal without any failures in an airport with a height of 900 meters.
- From the previously mentioned, it is clear that the magnetic tape of type MSRP-12 which was disassembled from its place on the aircraft does not have any data that relates to the accident.

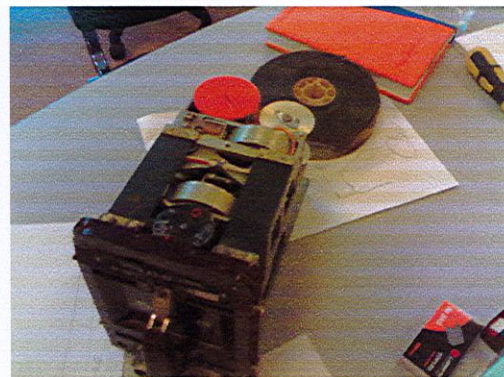
- The FDR is sound.
- The list of parameters resulting from unloading the FDR is the same as the actual list of the FDR type.
- The duration of the data recorded is 2 hours and 9 minutes.
- The system MSRP-12 recorded data showed information about climb, level flight, and approach and landing. This was the last recorded flight on the tape.
- From the previously mentioned information, it is clear that the magnetic tape of type MSRP-12 which was disassembled from its place on the aircraft does not have any data that relates to the accident.

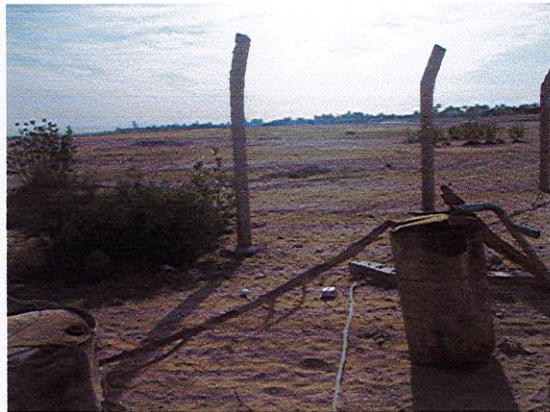
- The aircraft rolled to the end of the runway 02 and got over it to a sandy area then crossed the road around the airport (service road), and then another sandy area till it crashed into the airport fence to get over it to enter a military zone for about 500 meters.
- The aircraft kept moving 100 meters after the airport fence till it crashed into the military zone fence on the Tiba-Luxor road and was destroyed as a result of that. The longitude and latitude of the place where the aircraft stopped at are: 18.86'25 41N, 56.64'32 42E.
- The wreckage was scattered on an area of 150 meters x 10 meters and there was no wreckage outside this area except the left wing lying across Tiba-Luxor road.
- After entering the military zone, it rolled for 90 meters away from the used runway 02 center line.

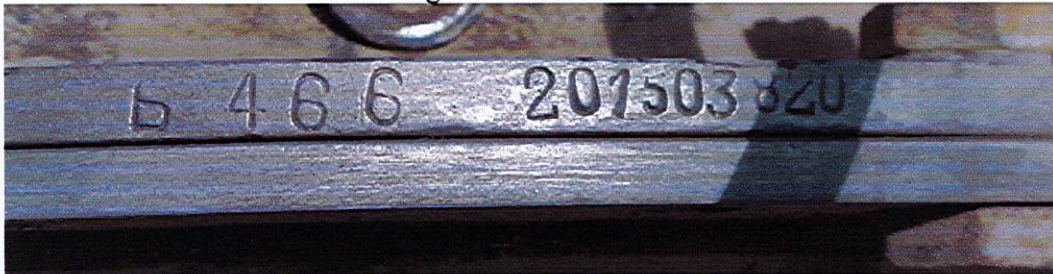
Engine No.1

- The number on the engine matches the data at the Moldavian CAA.

- The inspection showed that the compressor blade had no damage.

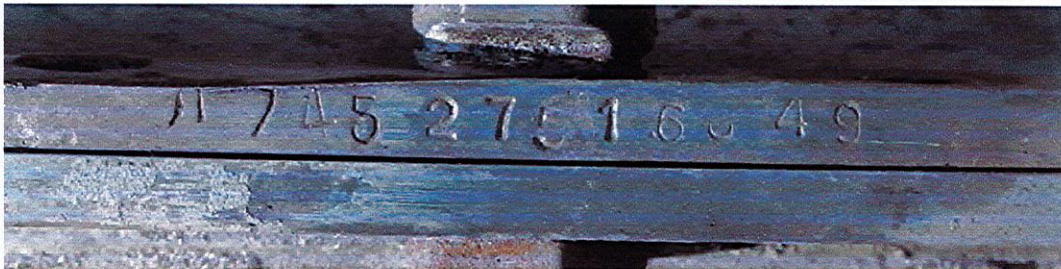
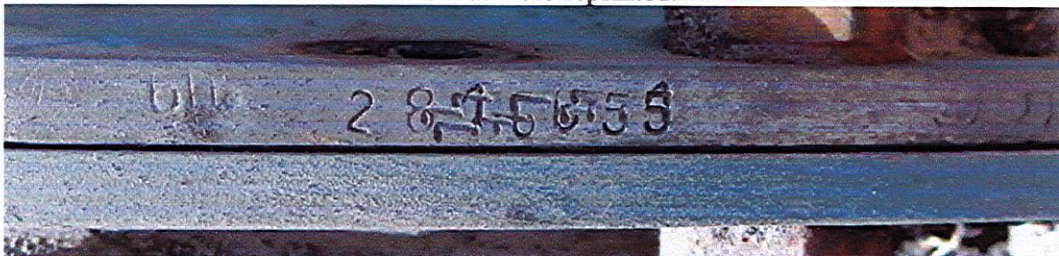
Engine No.2

- The number on the engine matches the data at the Moldavian CAA.

- But there are numbers that were reprinted.

- The blades were sound but starting from the fifth stage there was a layer of soot which indicates that the engine was in surge.

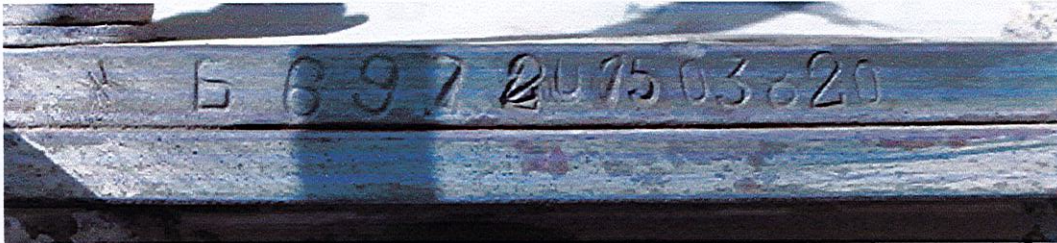
Engine No.3

- The number on the engine matches the data at the Moldavian CAA.

- The fires of the first stage of the compressor are damaged.

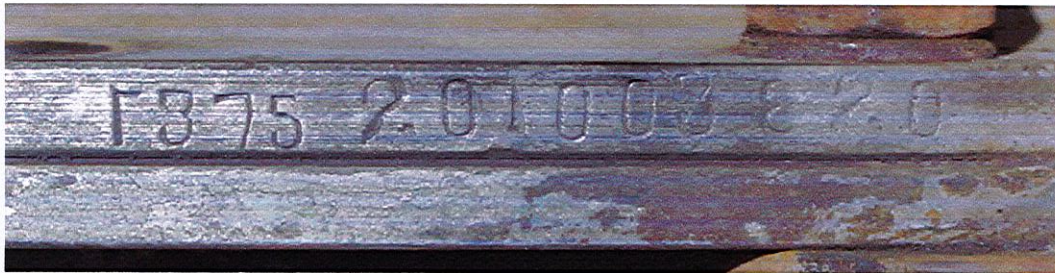
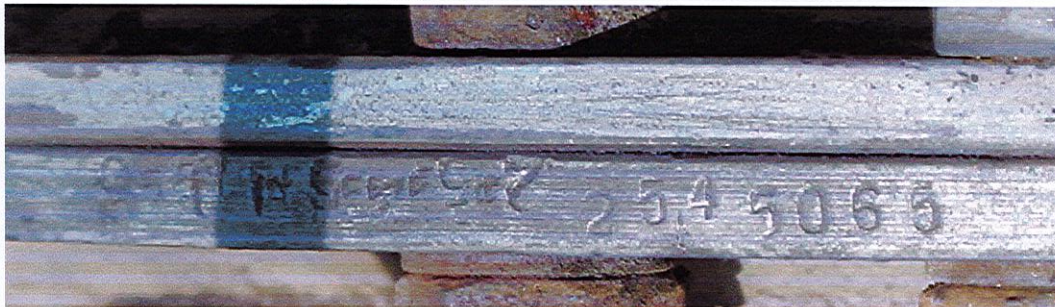
Engine No.4

- There were several numbers on the engine:
 - Г 375 201003820

- 1K 2525189

- None clear number.
- 2545065
- The compressor blades are in normal state and fixed.
- There was a layer of soot on the blades of the second stage which indicates that the engine was not running during the accident.

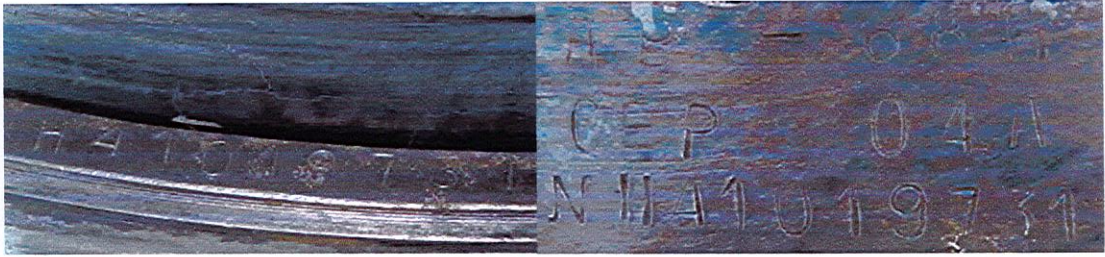
Propeller No.1

- Serial numbers:
 - Number on the propeller hub N 41019731
 - Number on the cylinder nut N 41019731
 - Number on the coupling N 41019731

- The propeller was in the highest temperature area which caused the blades to melt and Blades, the cylinder had a hole with irregular shape 15 to 17 squared centimeters in the radial part which caused the cylinder case to melt and the butts to separate leaving the propeller in a "rotating freely" state and because of the failures in the cylinder, there was no oil in it.
- And by the assembly of the propeller, it was clear that:
 - The piston stroke is 49 mm.
 - The slotted protrusion of the mechanic stop is 31 mm.
- And it was clear that the propeller was in the operation mode.

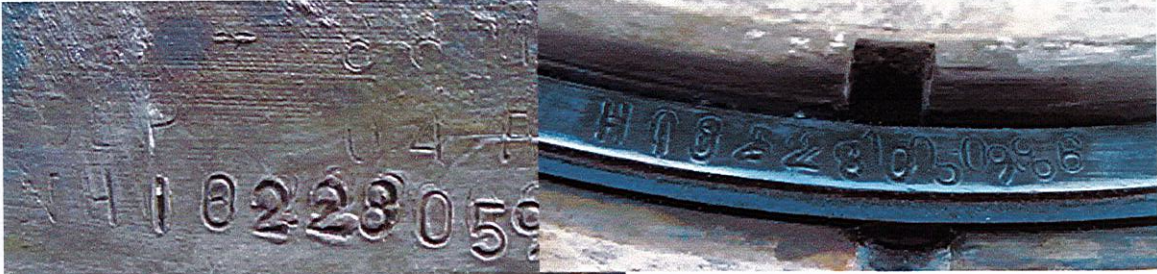
Propeller No.2

- Serial numbers:
 - Number on the hub N 102280596
 - Number on the cylinder nut N 102280596
 - Number on the coupling N 102280596 (sleeve 1)
 - There was evidence of number reprinting on the cylinder nut, on the third sleeve coupling and on the hub case.

- The propeller was in the fire area, in a melting state and the cylinder had a crack along the perimeter; 50 mm length and 2mm width in the lower part. Also one rod was ripped off and the blades butts were rotating freely.

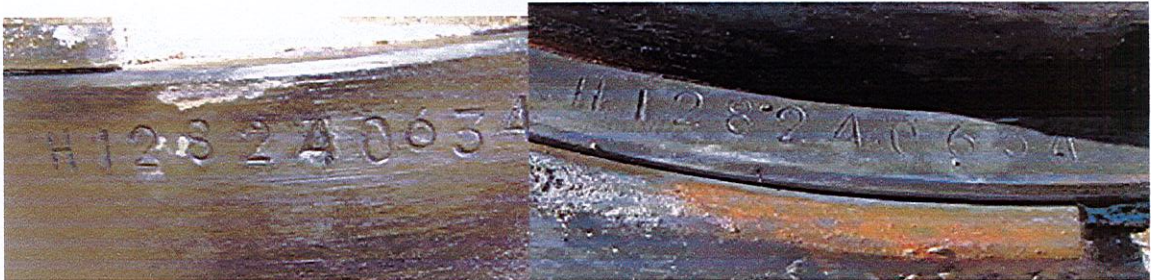
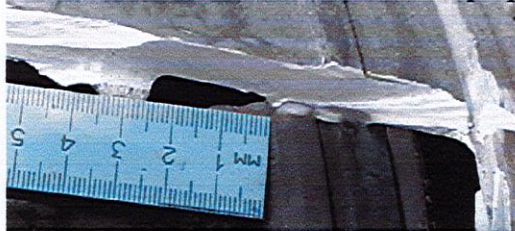
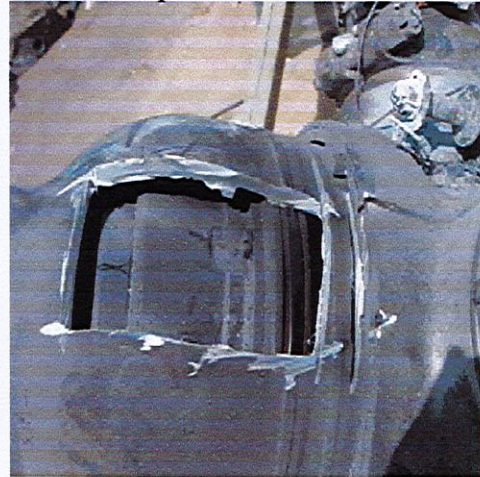
Propeller No.3

- Serial numbers:
 - Number on the hub N 128240634
 - Number on the cylinder nut N 128240634
 - Number on the coupling N 128240634 (sleeve 3)
 - It is suspected that the first figure «4» was reprinted

- The propeller was in the lower temperature area and all the blades had mechanical and thermal deformation along the blades and also the connecting rods were ripped off and the blades were rotating freely.

- And it was clear that the propeller was in the operation mode.

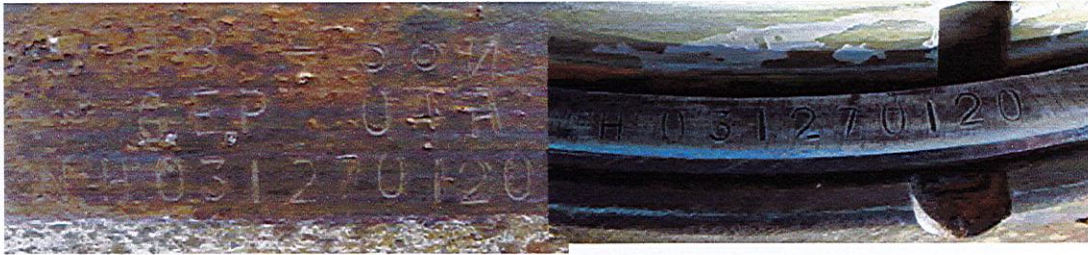
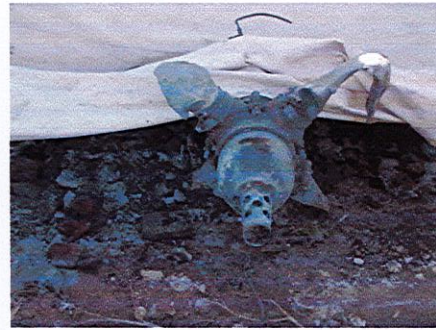
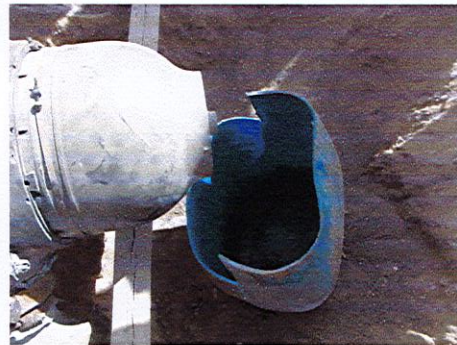
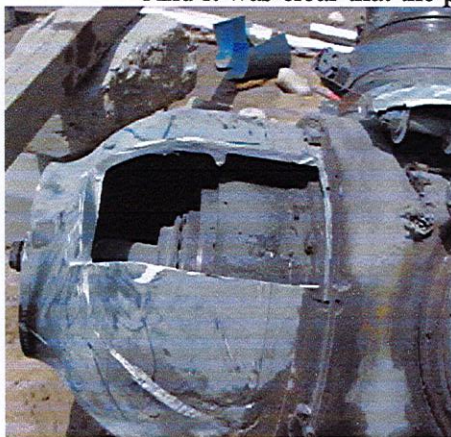
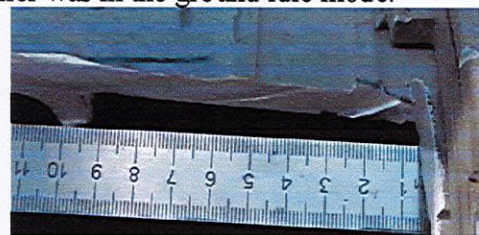
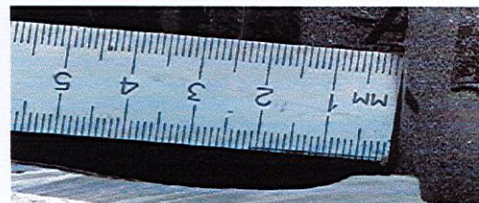
Propeller No.4

- Serial numbers:
 - Number on the hub N 031270120
 - Number on the cylinder nut N 031270120
 - Coupling band (sleeve 4) N 031270120
 - Number on the coupling N 121270677 (sleeves 1, 3)

- The propeller was in the fire area and the blades melted.
- The cylinder had thermal deformation in the lower part and also the connecting rods were ripped off and the blades but were rotating freely.

- There was no oil in the cylinder.

- And by the assembly of the propeller, it was clear that:
 - The piston strokes are 4 mm.
 - The slotted protrusion of the mechanic stop is 16 mm.
- And it was clear that the propeller was in the ground idle mode.

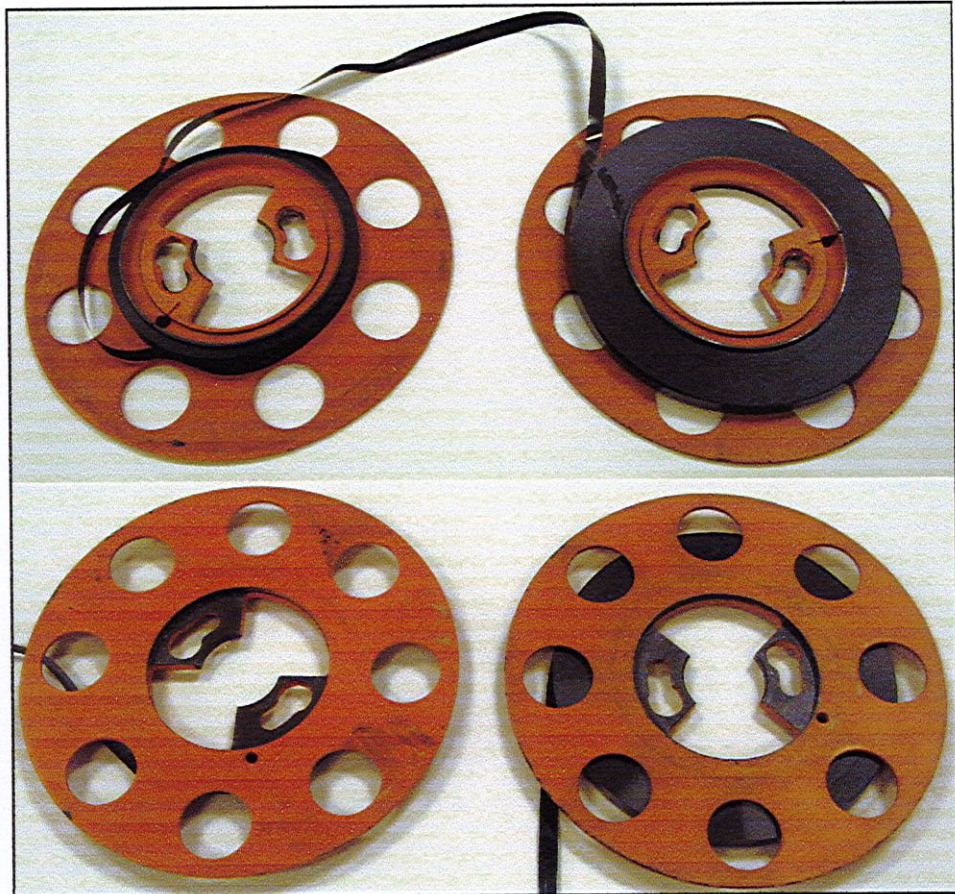
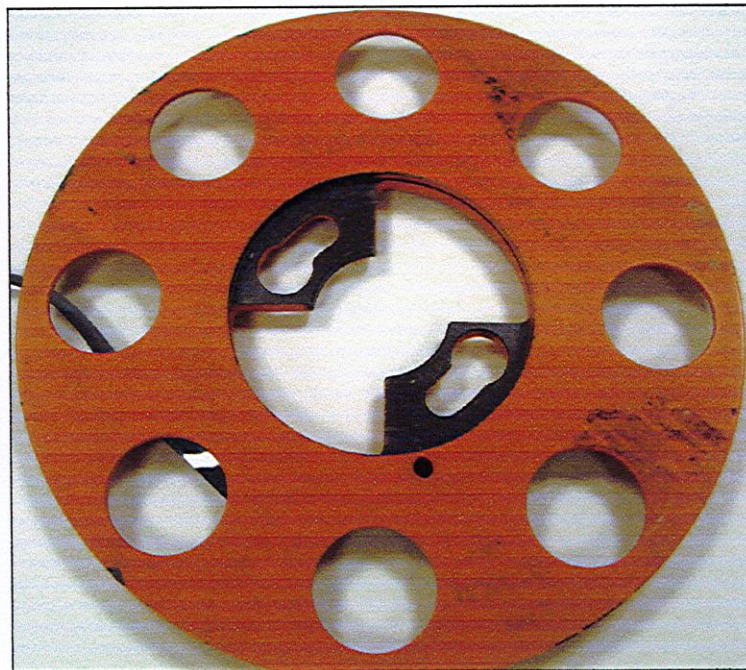
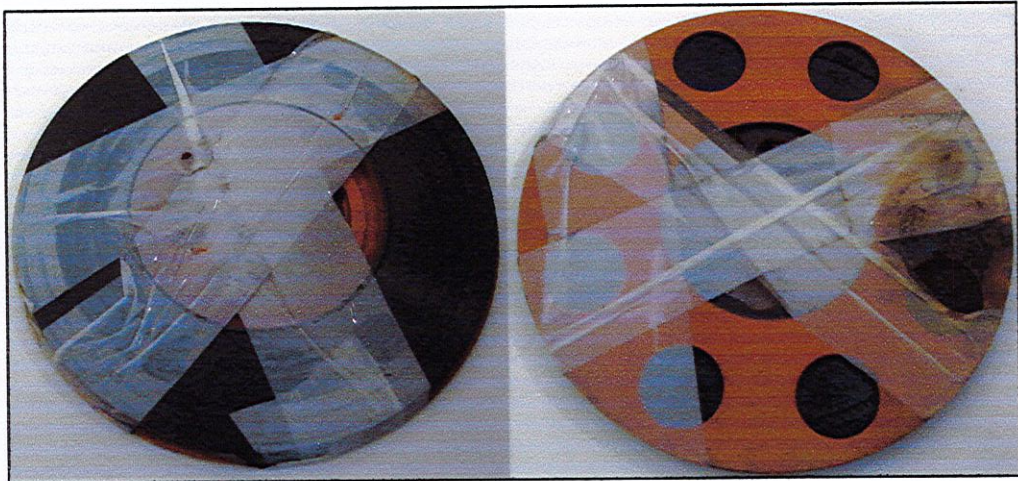
FDR: The magnetic tape of the FDR MSRP-12 was delivered on two spools (was recovered from installation place) and another tape on one spool (was found at the accident site). Magnetic tapes are in a good condition (Fig. 1...3). There are no evidences of high temperature influence or mechanical damages. One of two spools has signs "26098 Новая" and "LPM №33631 imf", made by pencil (Fig. 2).

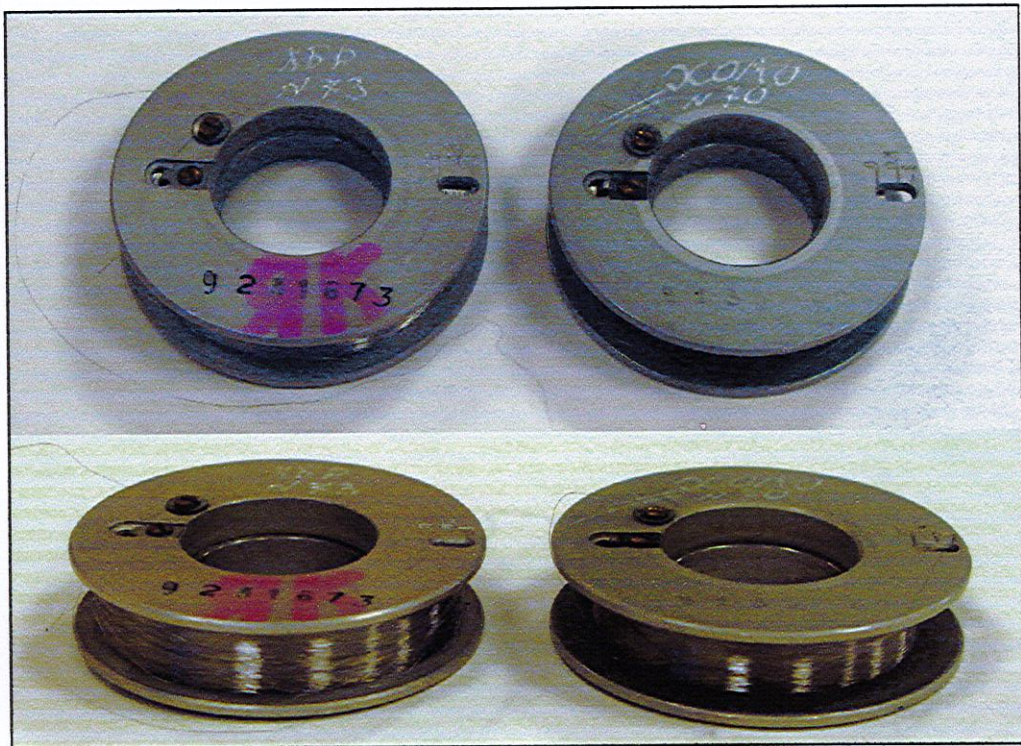
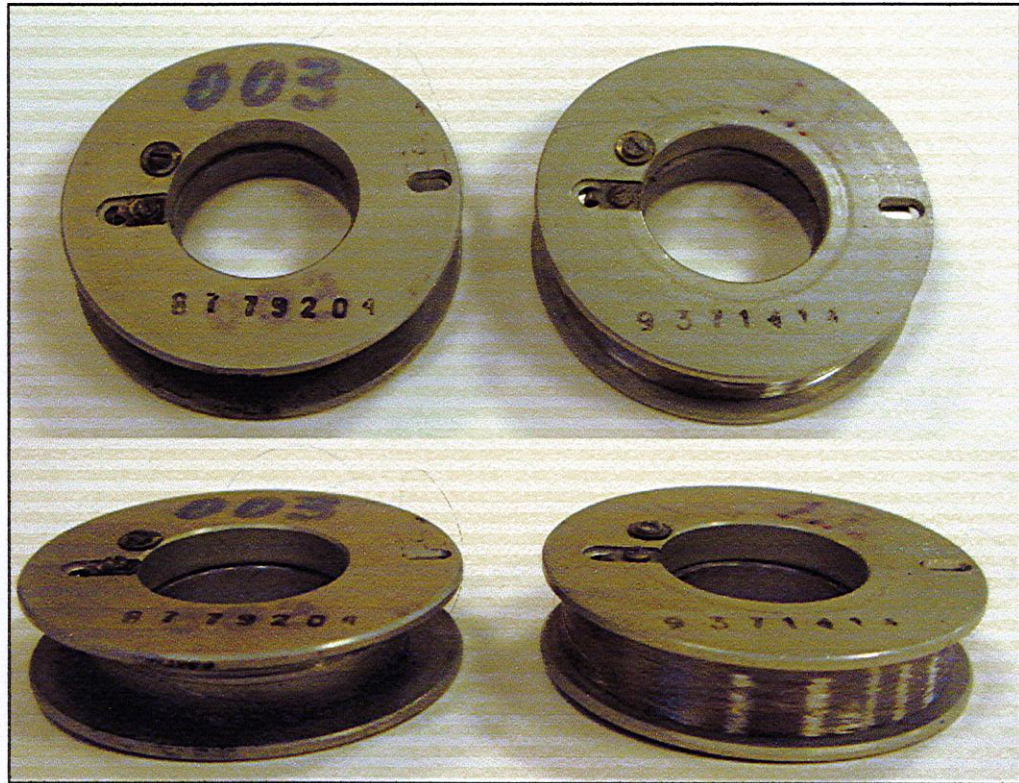
CVR: The metal wire was delivered on two pairs of spools of the CVR MS-61B. The wire is in a good condition (Fig. 4...5). There are no evidences of high temperature influence. The first pair of spools: there was practically no any metal wire on the feeding spool; feeding spool has sign "003" and serial number 8779204. The receiving spool wire amount was 0.75 (scale: «0»÷«1»), the receiving spool has serial number 9371414 (Fig. 5). The second pair of spools (from stand by recorder): The feeding spool wire amount was 0.85 (scale: «0»÷«1»); the feeding spool has sign "ЯК", serial number 9231673 and marking "ХБР N73". The feeding spool wire amount was 0.15 (scale: «0»÷«1»); the feeding spool has serial number 913xxxx (four numbers unreadable) and marking "ХОЛО N70" (Fig. 4).

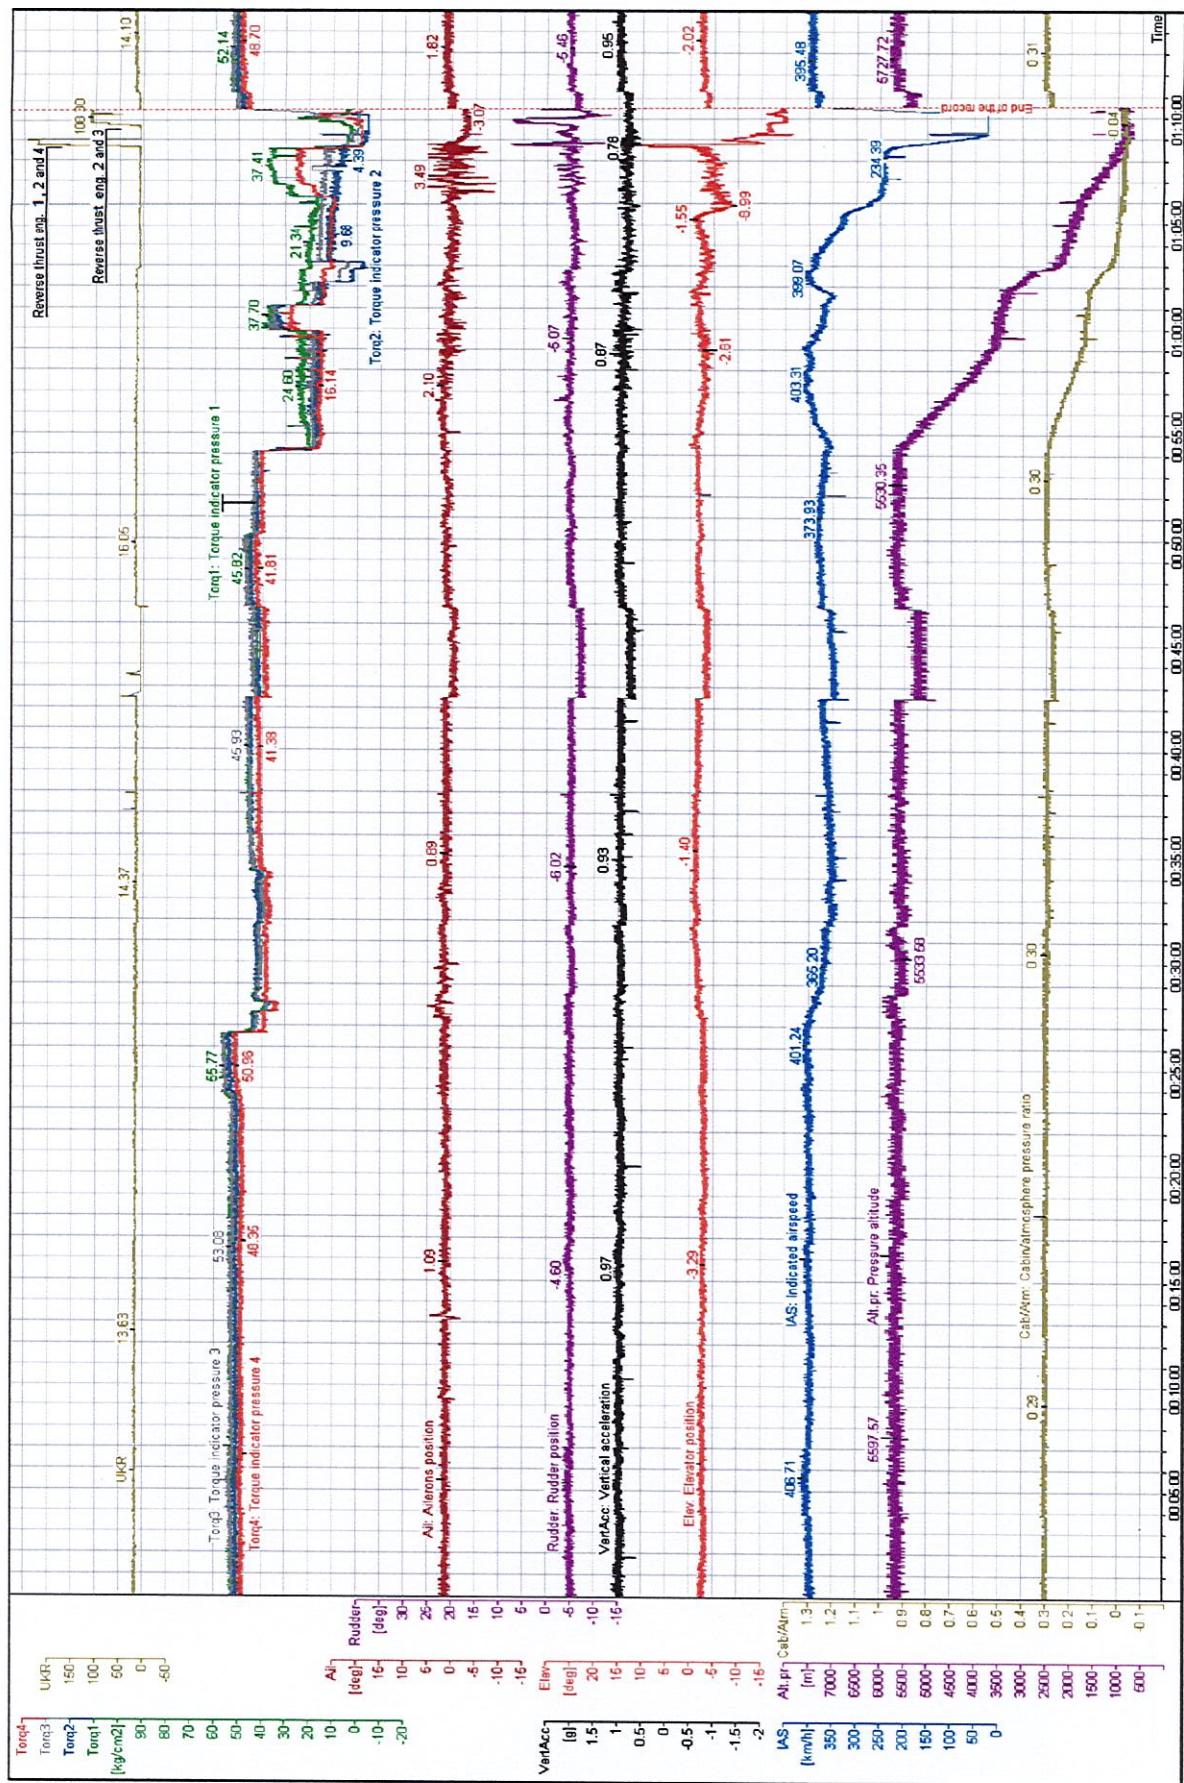
Fig 18. The FDR MSRP-12 of the aircraft Ar-12B S9-SVN flight information (all recorded information).

- the record is of a good quality;
- the list of parameters recorded by system MSRP-12 corresponds to the actual list of aircraft An-12 (see Registered parameters list);
- the total duration of the record is approximately 1 hours 15 minutes (Fig. 18);
- during all record there is no information about take off of the aircraft;
- the system MSRP-12 recorded information about level flight, approach and landing;
- according to the record the landing was normal, without any failures;
- according airport elevation (about 900 meters), the landing was not in Luxor airport (it's elevation is about 100 meters);
- the information analysis showed, that the magnetic tape of the system MSRP-12 recovered from installation place contained no information about the accident.

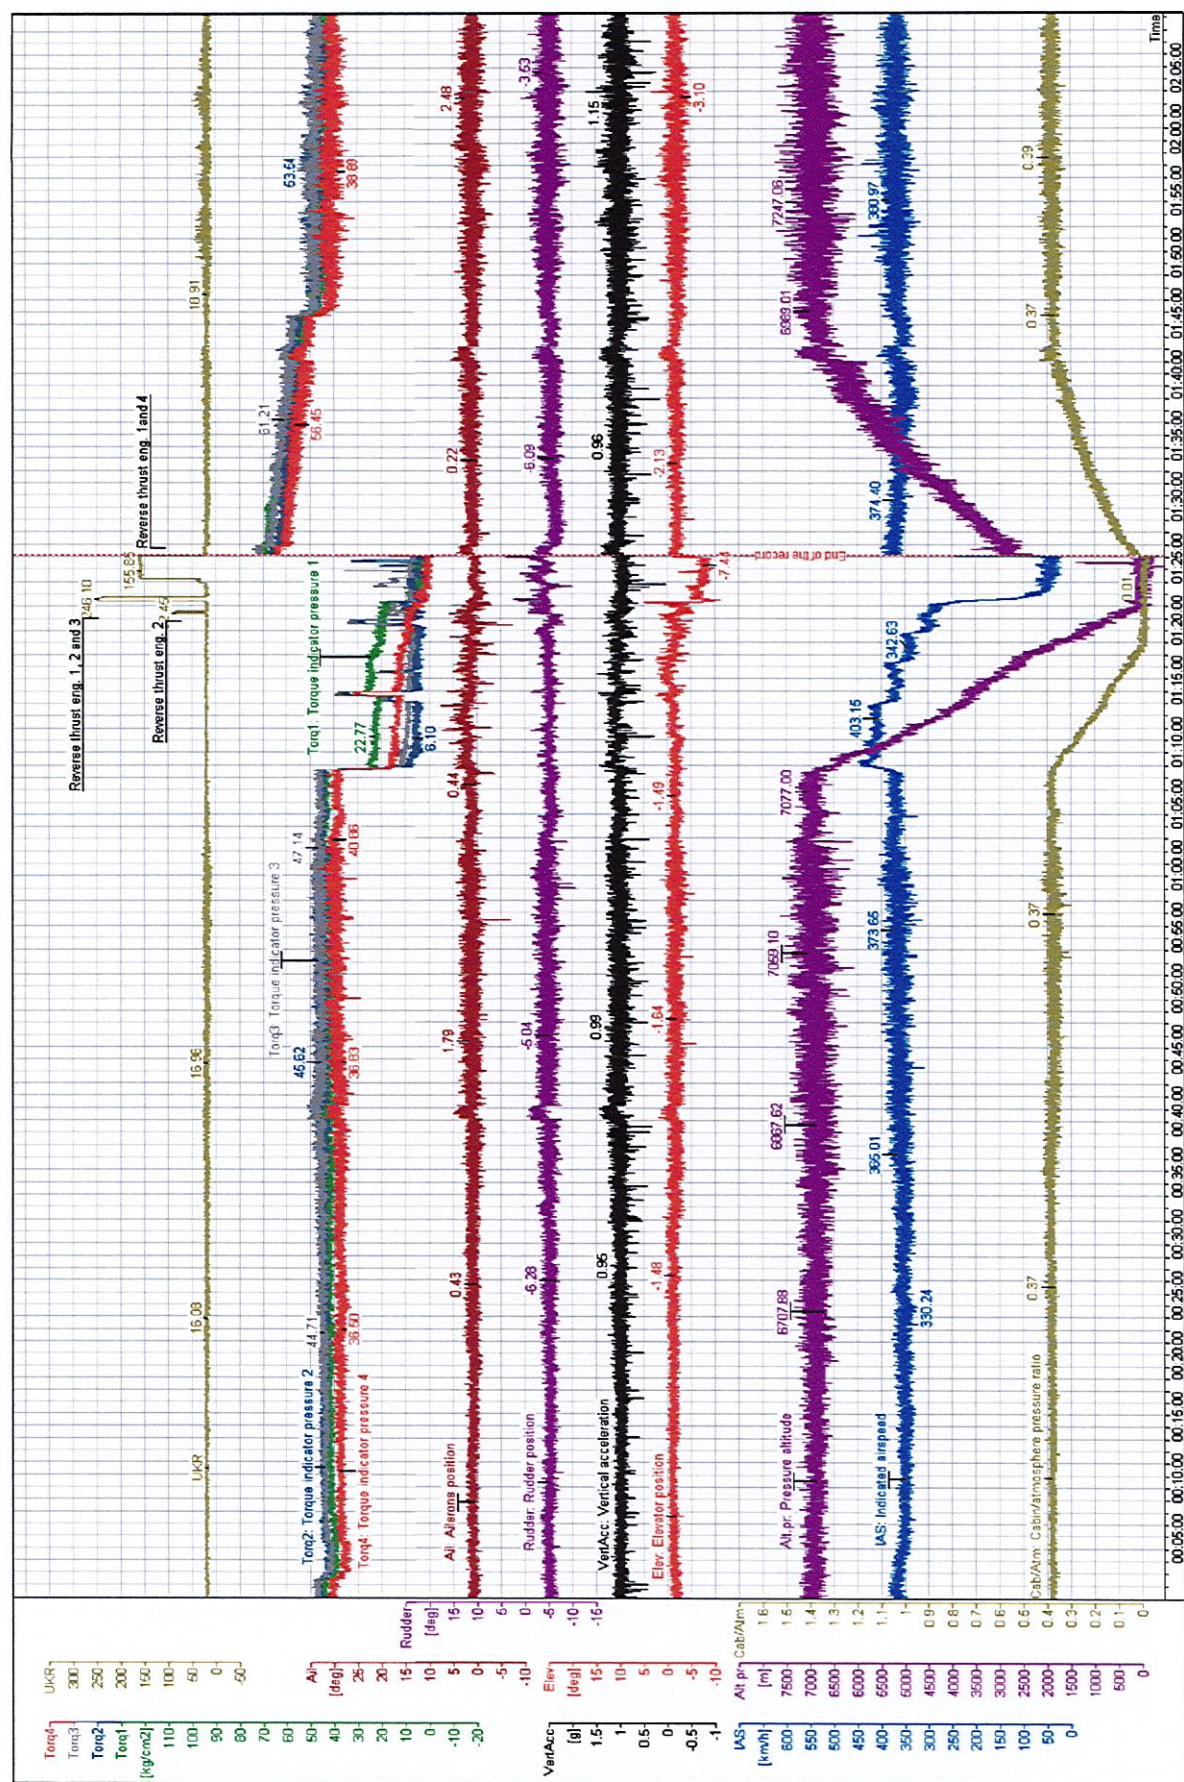
Fig.20. The FOR MSRP-12 of the aircraft An-12 flight information (second magnetic tape).

- the record is of a good quality;
- the list of recorded parameters corresponds to the actual list of aircraft An-12;
- the total duration of the record is approximately 2 hours 09 minutes (Fig.20);
- the system MSRP-12 recorded information about climb, level flight, approach and landing;
- according to the record there were no failures;
- the information analysis showed, that the magnetic tape of the system MSRP-12, found at the accident site, contained information about one of the previous flights of the aircraft An-12.
