**AIR ACCIDENT INVESTIGATION & AVIATION SAFETY BOARD**

**ACCIDENT REPORT  
A/C SX-SKY  
AT HERAKLION AIRPORT  
“N. KAZANTZAKIS”  
12<sup>TH</sup> FEBRUARY 2009

Report no 08 / 2009**

**Accident of the a/c SX-SKY of Sky Express  
at the Heraklion Airport “N. Kazantzakis” on 12<sup>th</sup> February 2010**

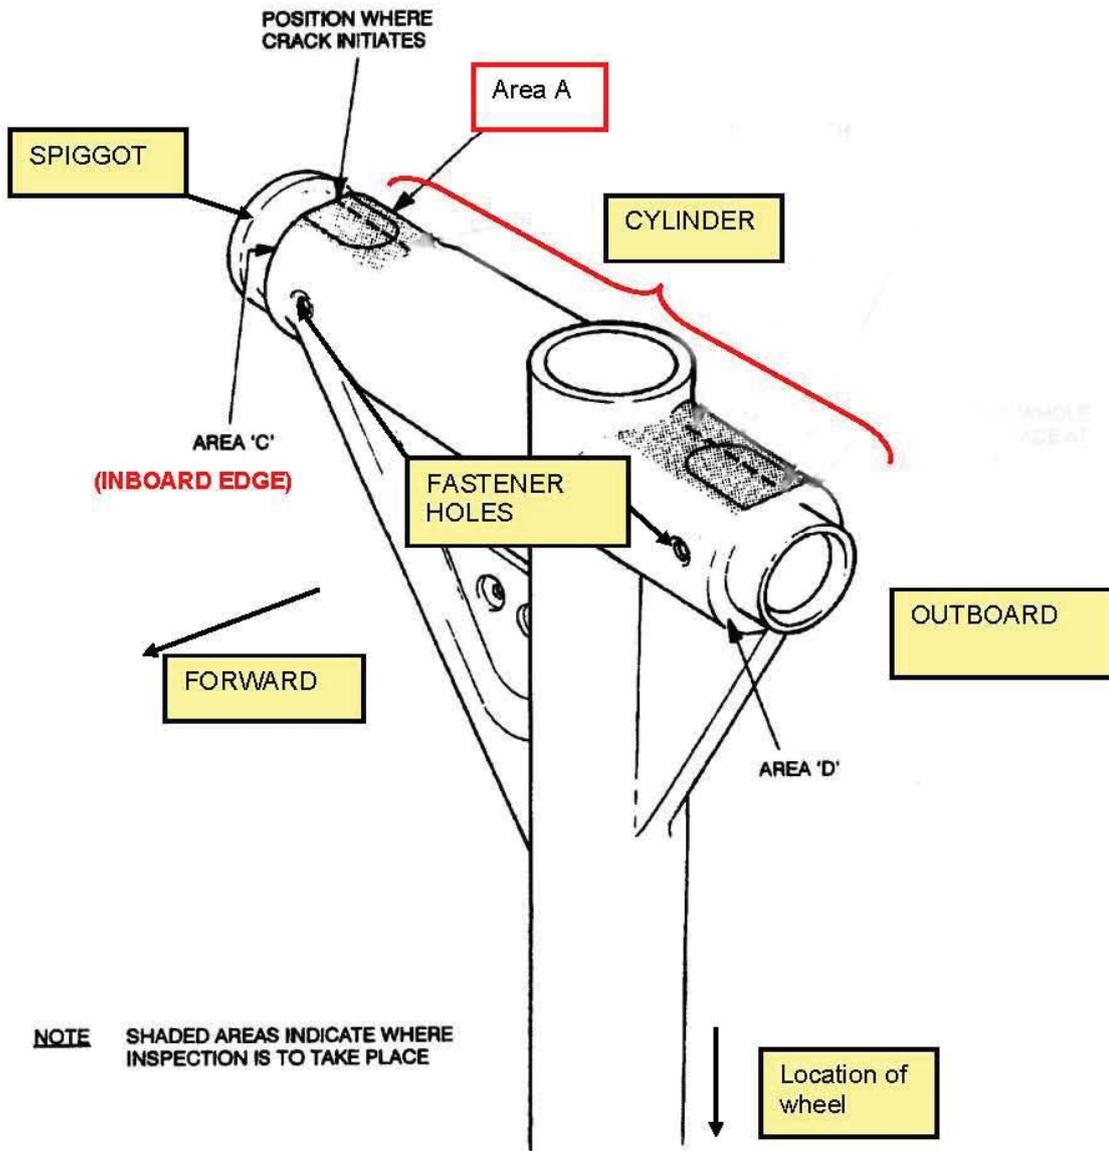
Figure 1: Showing the undercarriage cylinder (Reference C).

3.1. The undercarriage cylinder was fitted to two steel spigots by means of a pair of threaded fasteners, Figure 1. The cylinder and the attached spigots rotated in a clockwise direction looking inboard everytime the undercarriage was lowered. Subsequently the cylinder was loaded by the fasteners every time the aircraft landed, Figure 2. The cylinder would have experienced a bending stress in the region of 'Area 'A'', Figure 1, and compressive stresses at the fastener holes. The cylinder had been reduced in thickness in the region of 'Area 'A'', Figure 1 in order that the anticipated fatigue cracking resulting from the cyclic loading would occur at this location. The cylinder was regularly NDT tested in 'Area 'A'', Figure 1, in order to detect the fatigue cracking (Reference C).

5.2. The chevron markings on fracture surfaces 'A2' and 'B2' "pointed back" to the inboard edge of the cylinder indicating that initiation had taken place at this location. These fracture surfaces were more heavily corroded than 'A1' and 'B1' were likely to have been formed prior to the two cracks that had formed 'A1' and 'B1'. Therefore fracture surfaces 'A2' and 'B2' formed the first crack in the failure sequence. This first crack initiated and propagated in Region 'A', Figure 1, as would be anticipated since this was the region where the NDT was carried out. The first crack propagated from the inboard edge of the cylinder, increasing the loading upon the cylinder material surrounding the threaded fasteners, sites of stress concentration. The second and third cracks then initiated at these sites of stress concentration and propagated within the cylinder to form fracture surfaces 'A1' and 'B1'. In support of this the chevron markings on fracture surfaces 'A1' and 'B1' pointed back to the regions of the threaded fasteners.
