Accident Final Report

State File Number: Type of Occurrence: Date of Occurrence: Place of Occurrence: Aircraft Type: Registration: Operator: A13880431UPI6208 Accident July 22th 2009 I.R.IRAN - Mashhad IL-62M UP-I6208 Aria

Final Report

Type of occurrence:	Accident
Date:	24.Jul.2009
Location:	Mashhad International Airport/ I.R of Iran
Aircraft:	Airplane
Model:	IL-62M
Registration:	UP-I6208
Owner:	DETA Airline
Operator:	ARIA Airline
Date of Issue:	05 Jun 2010

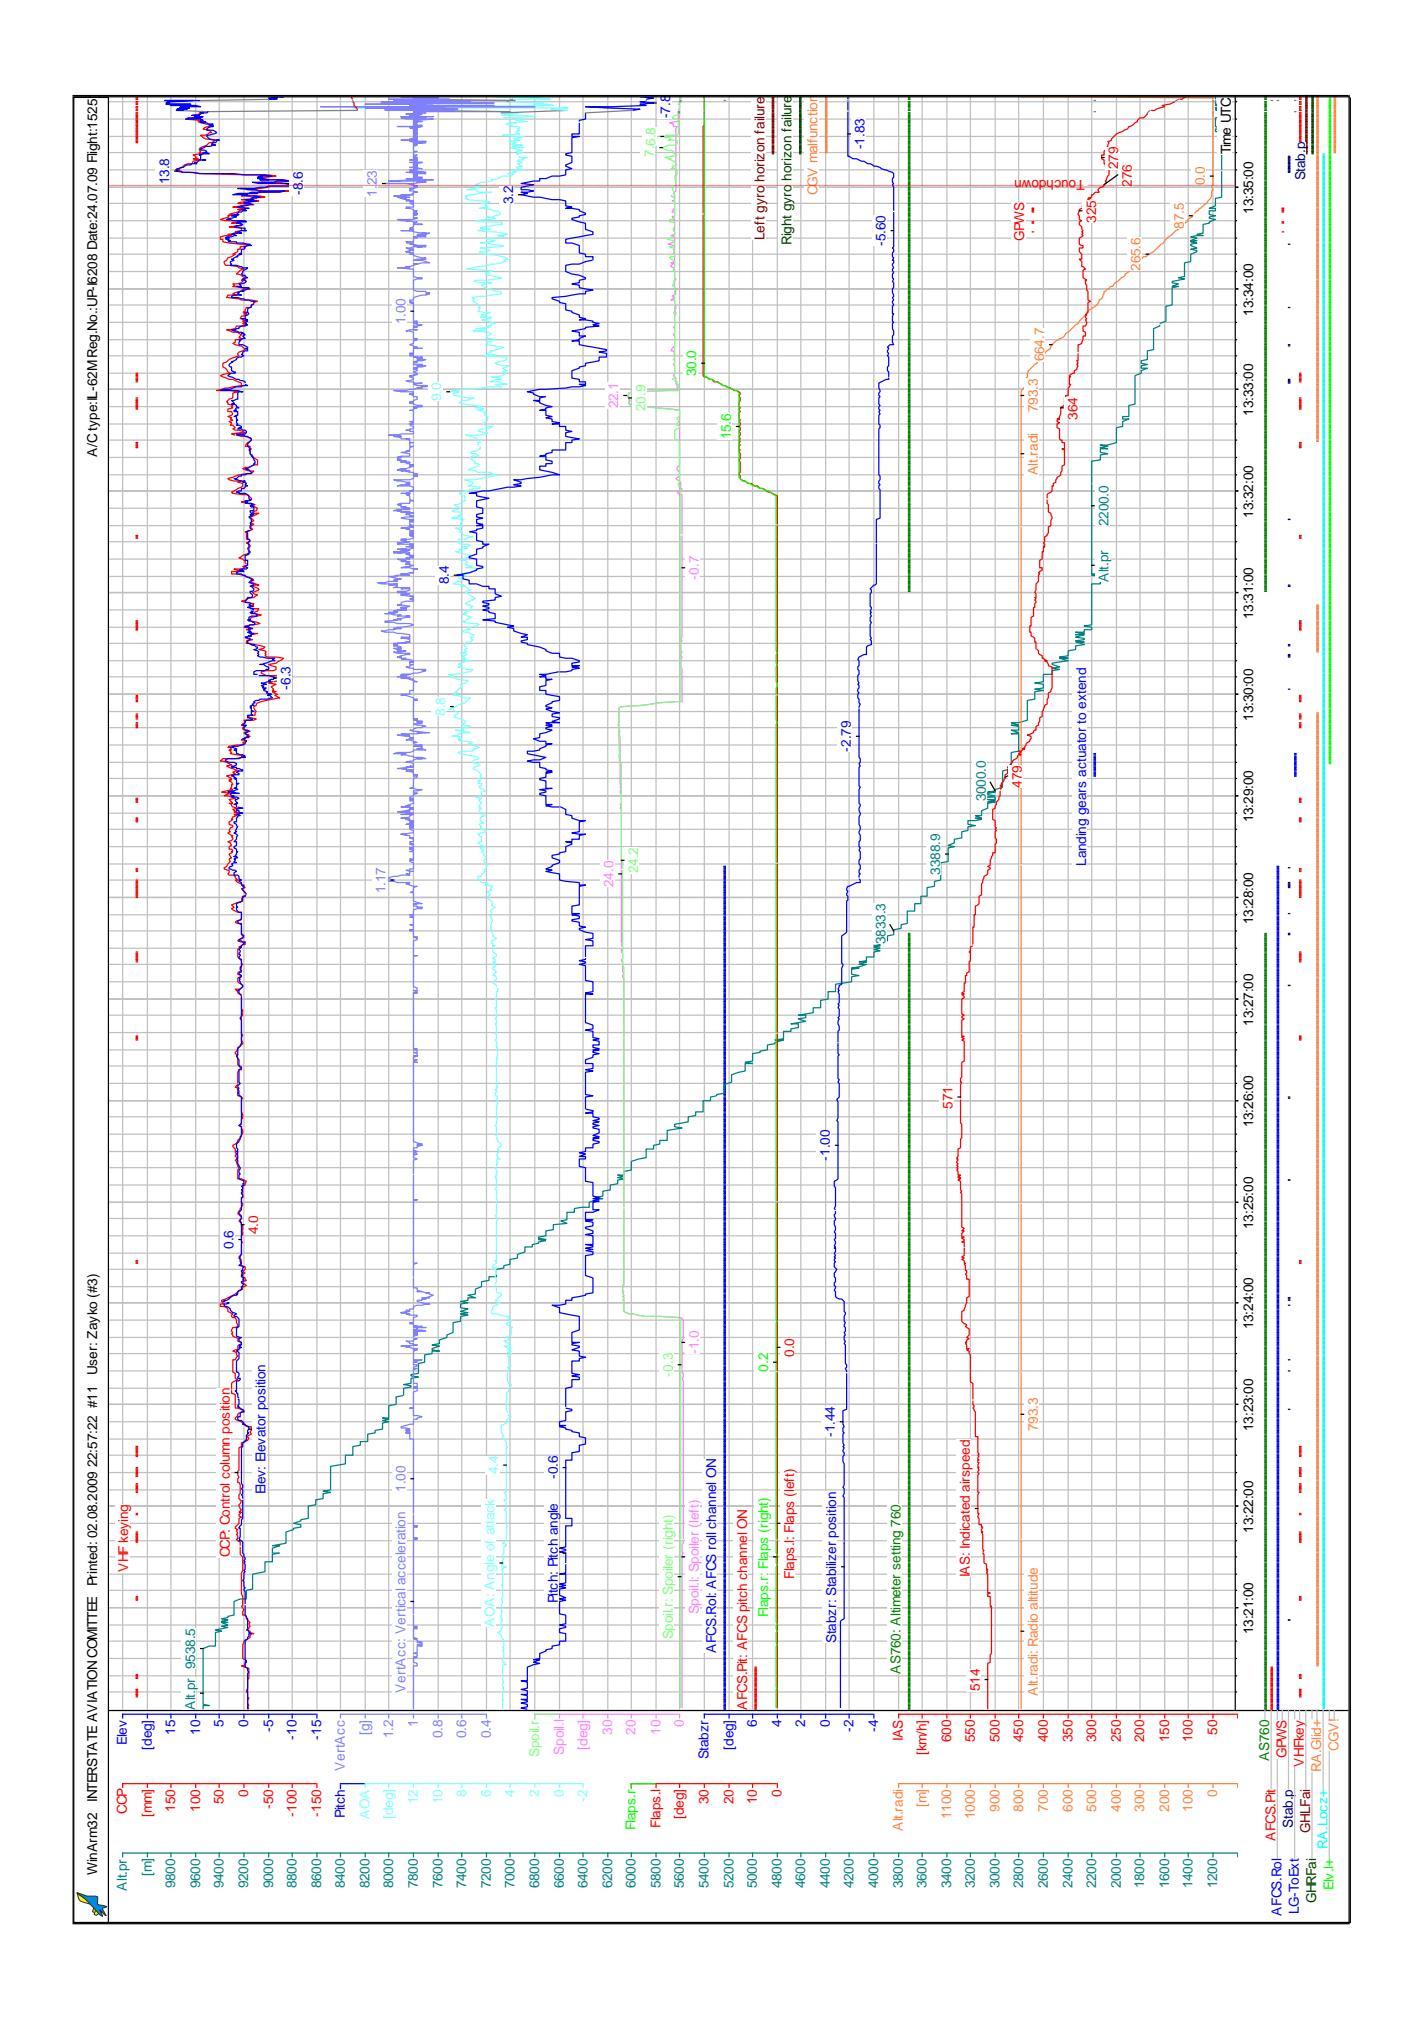
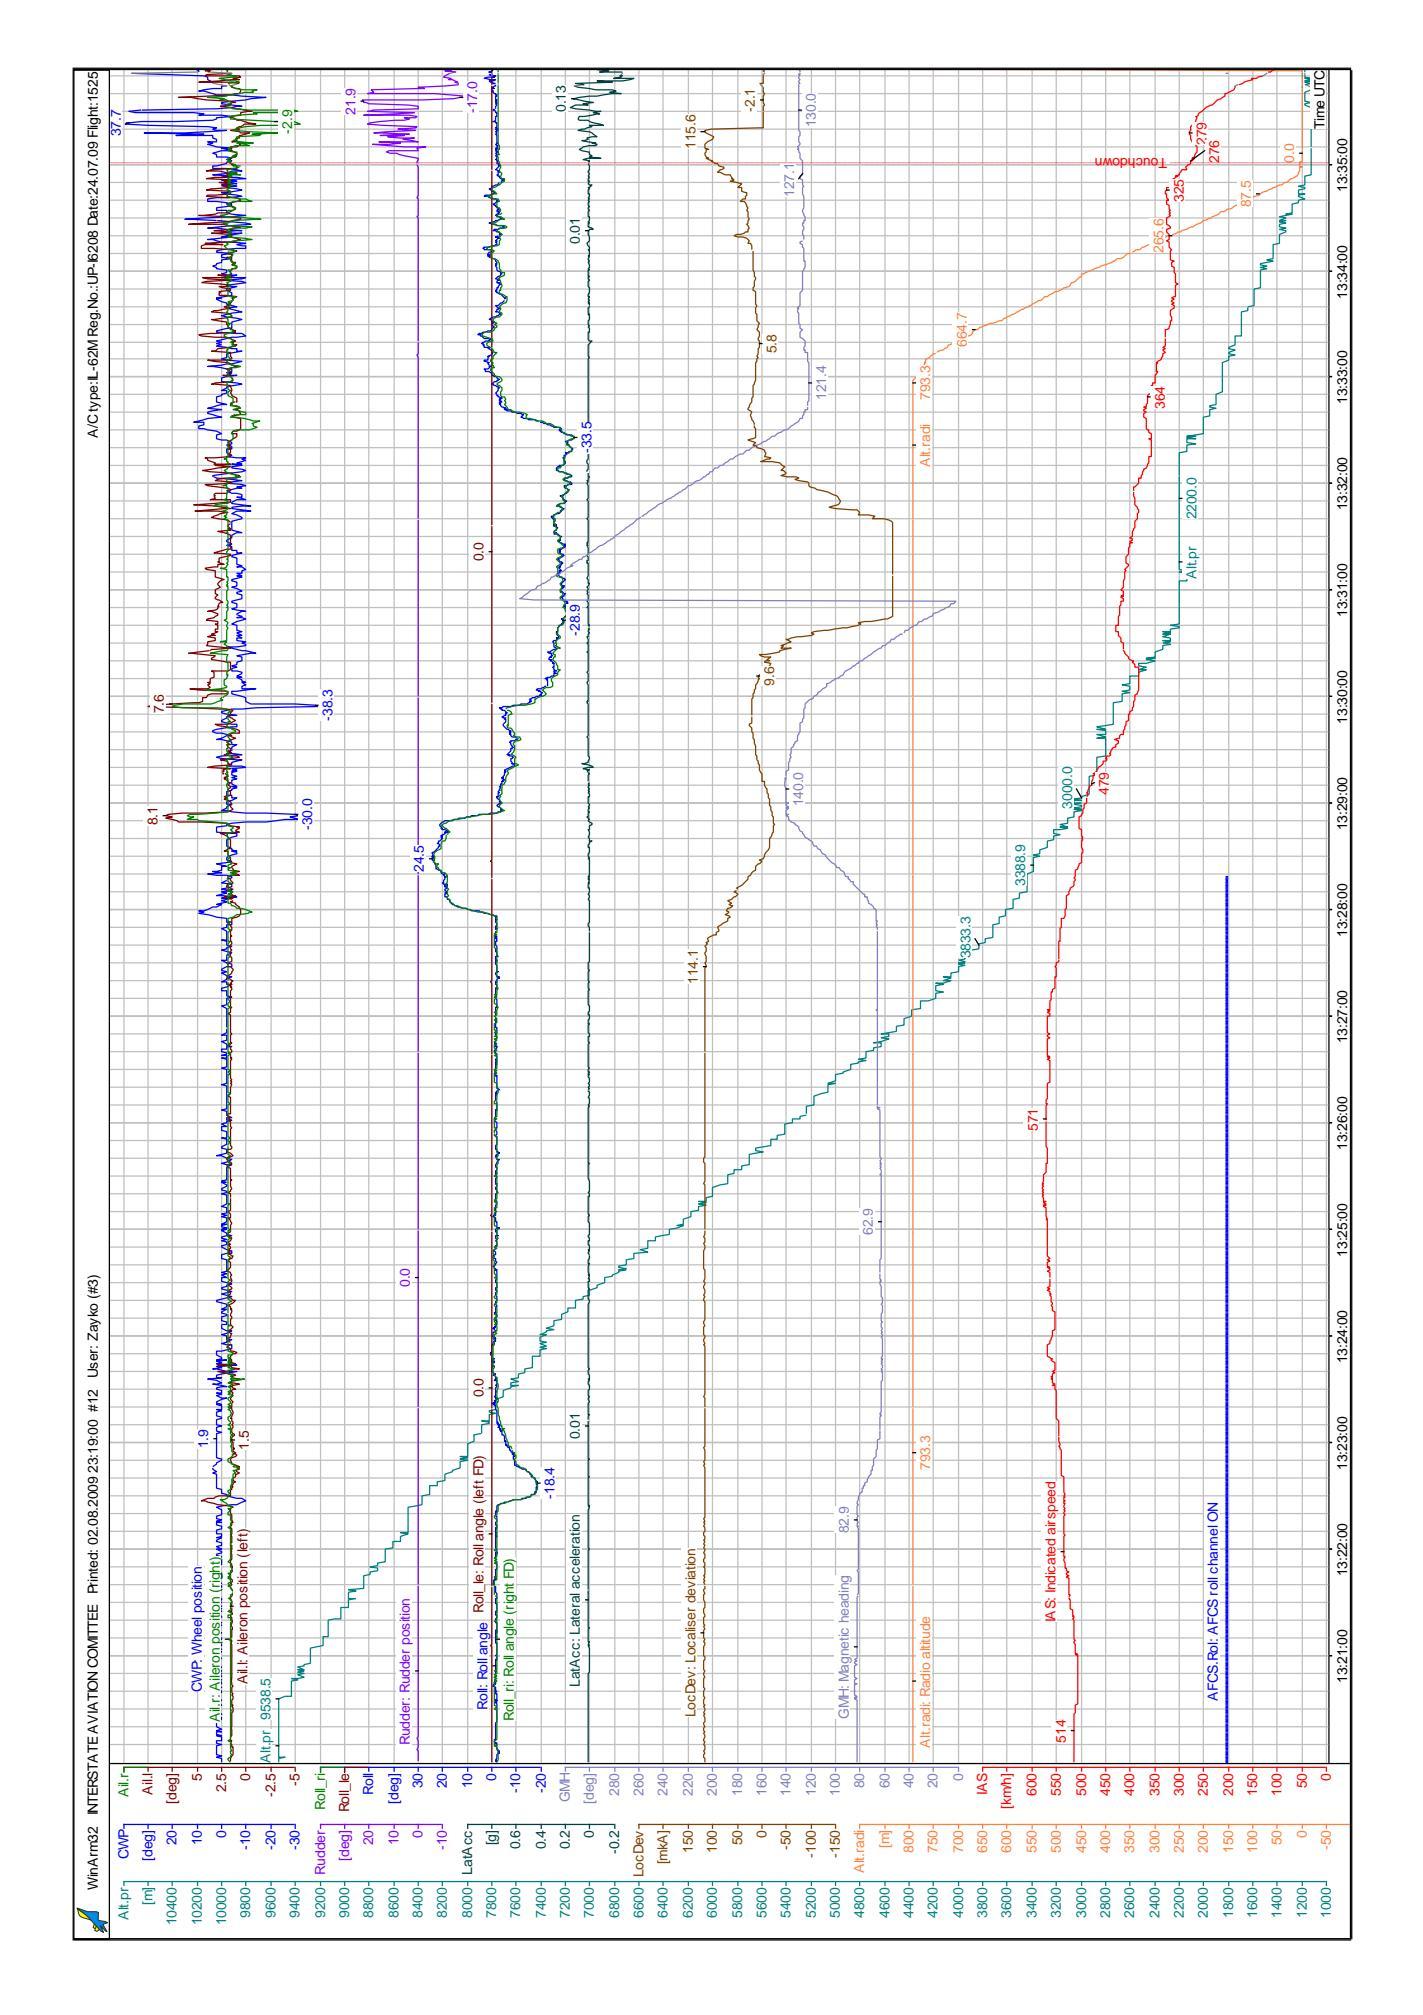
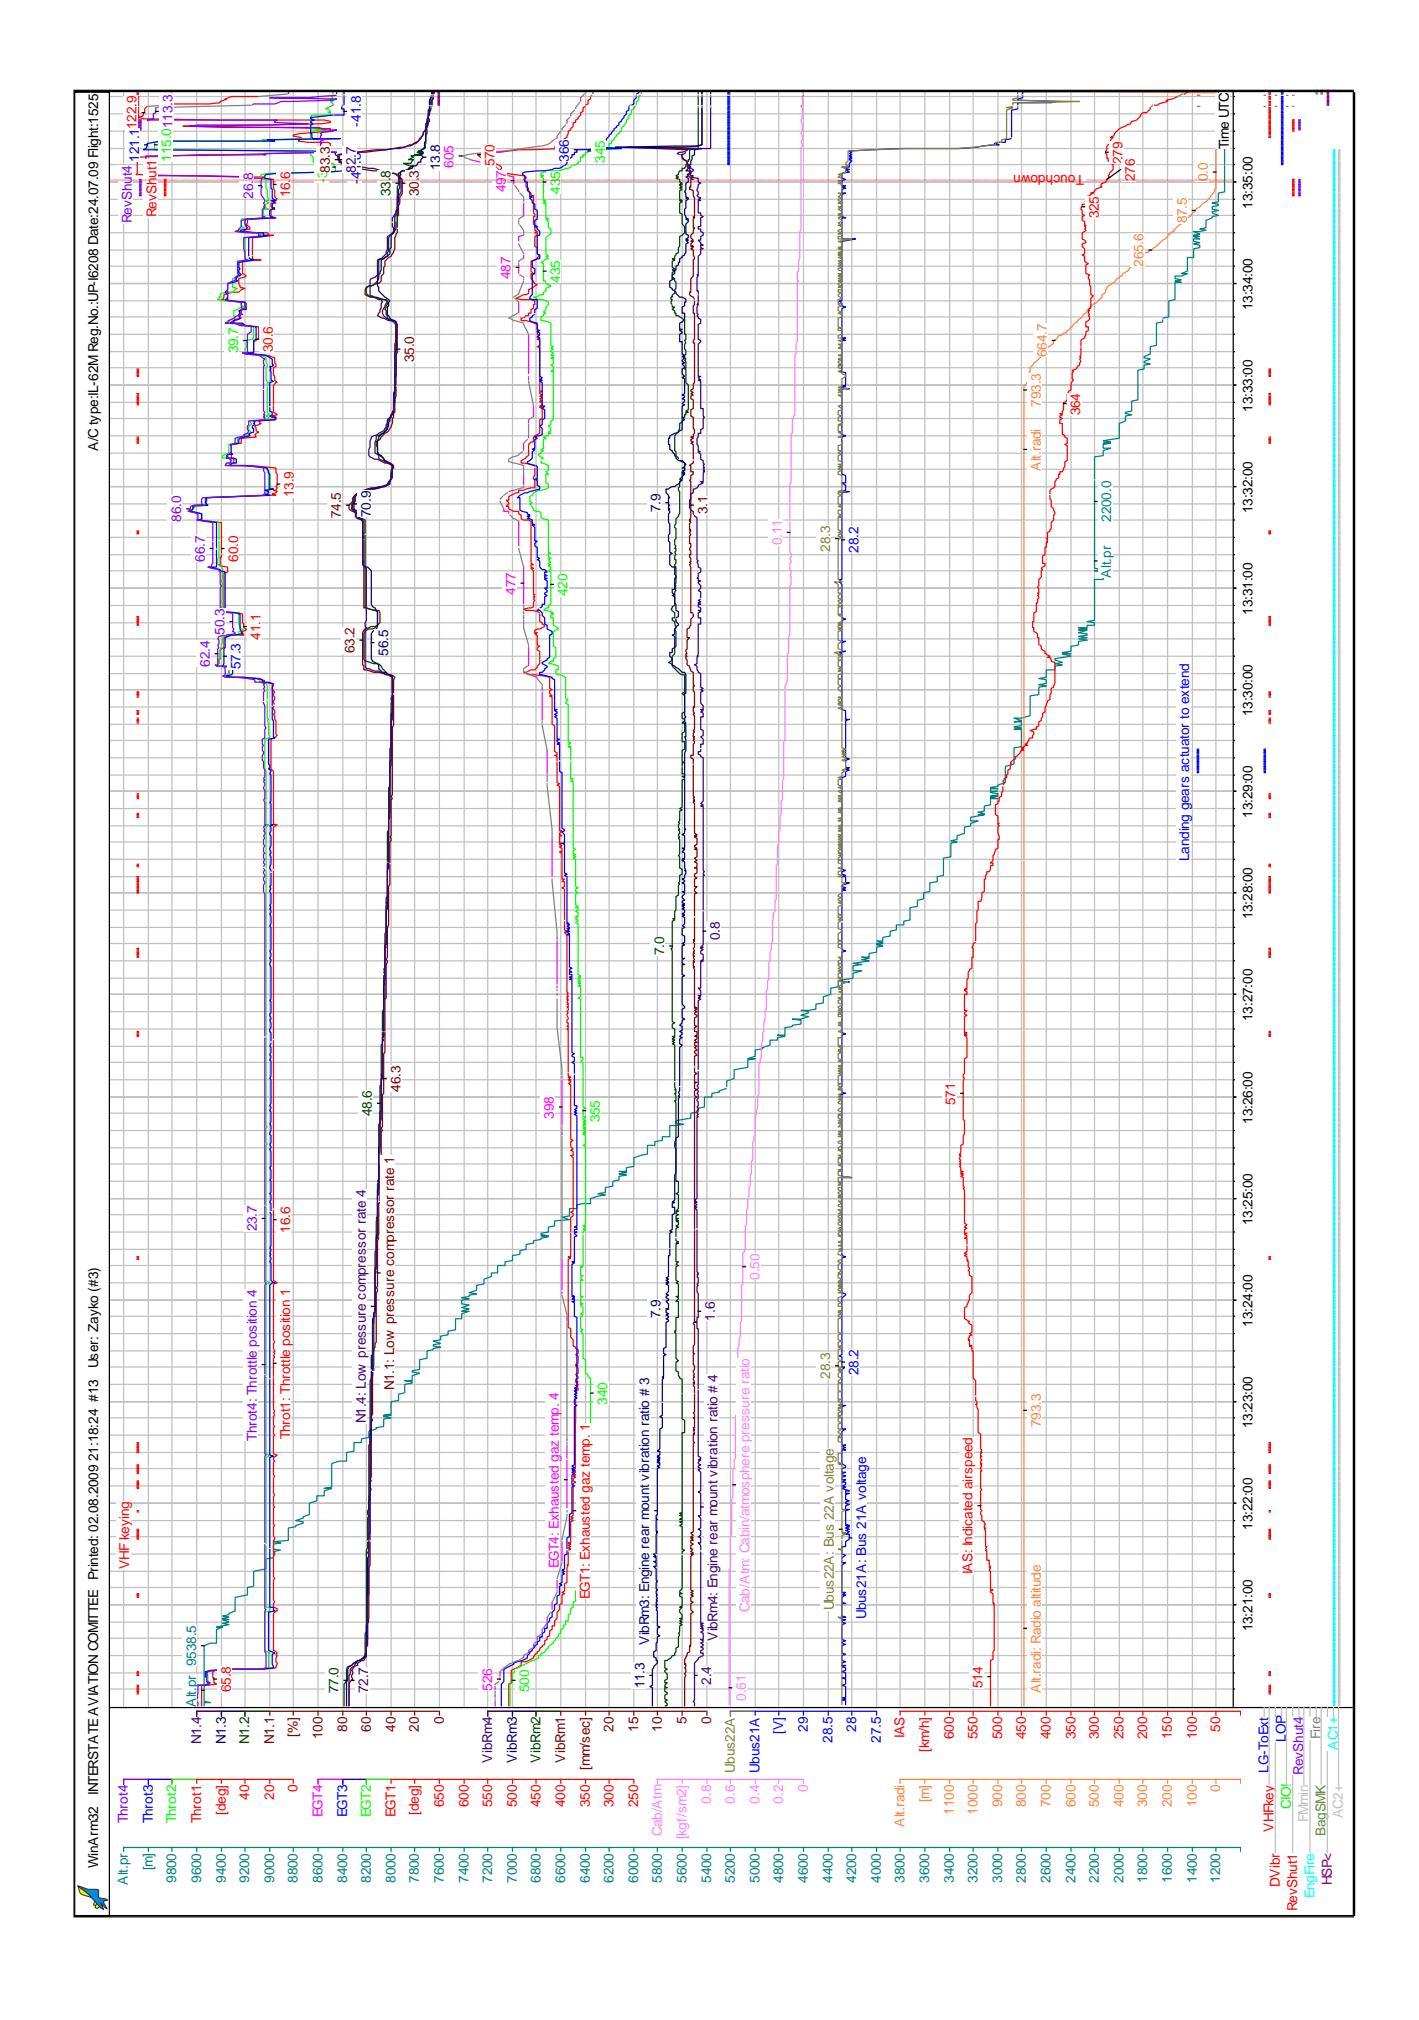
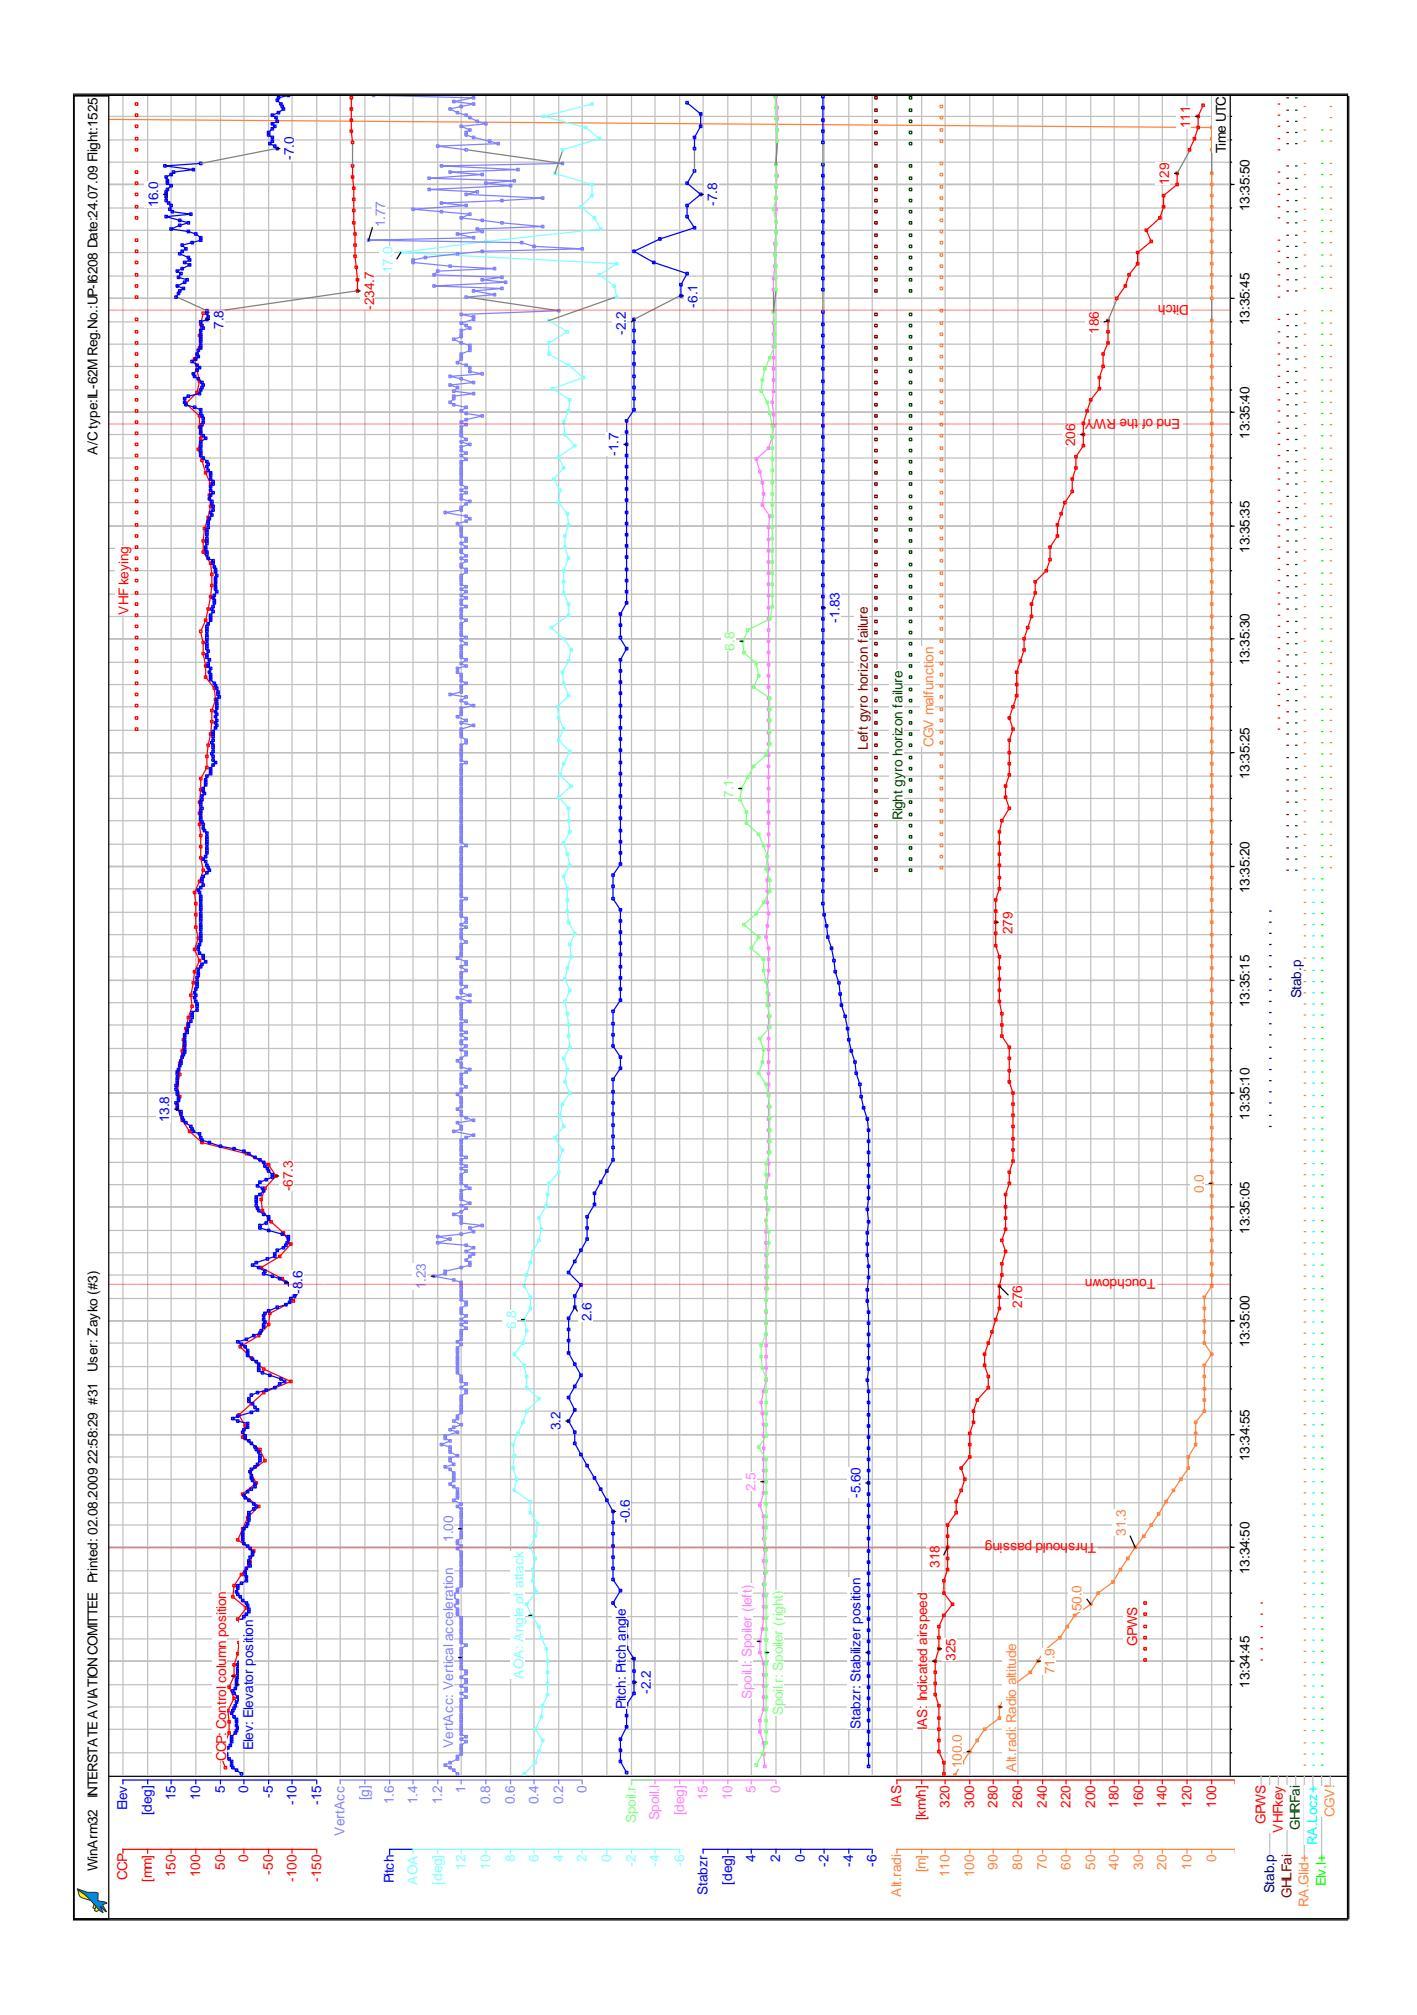
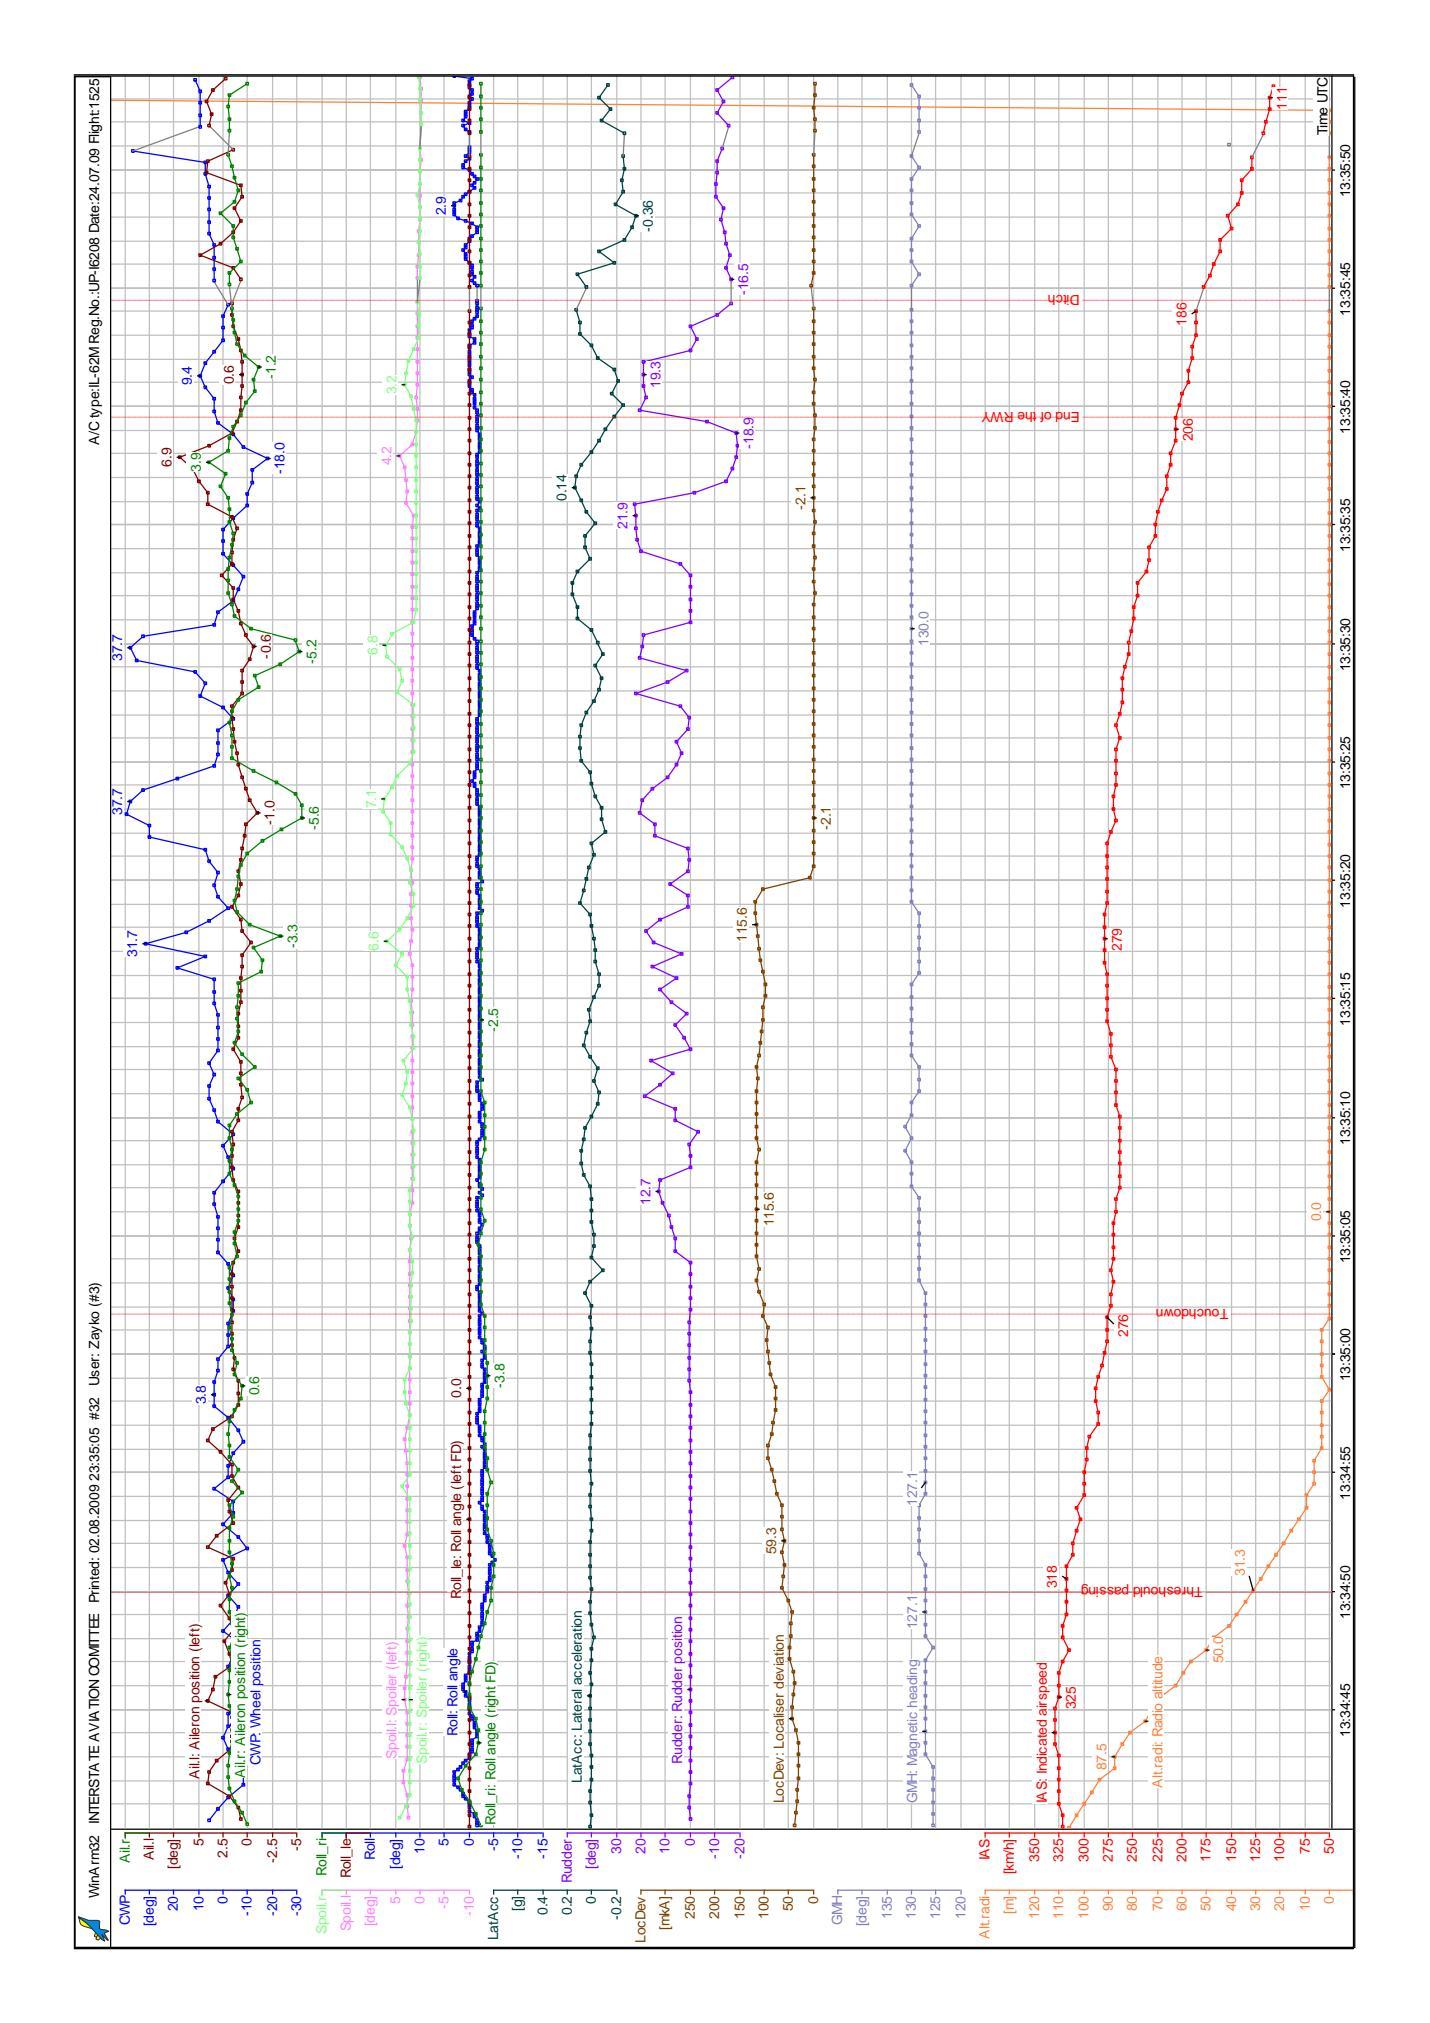
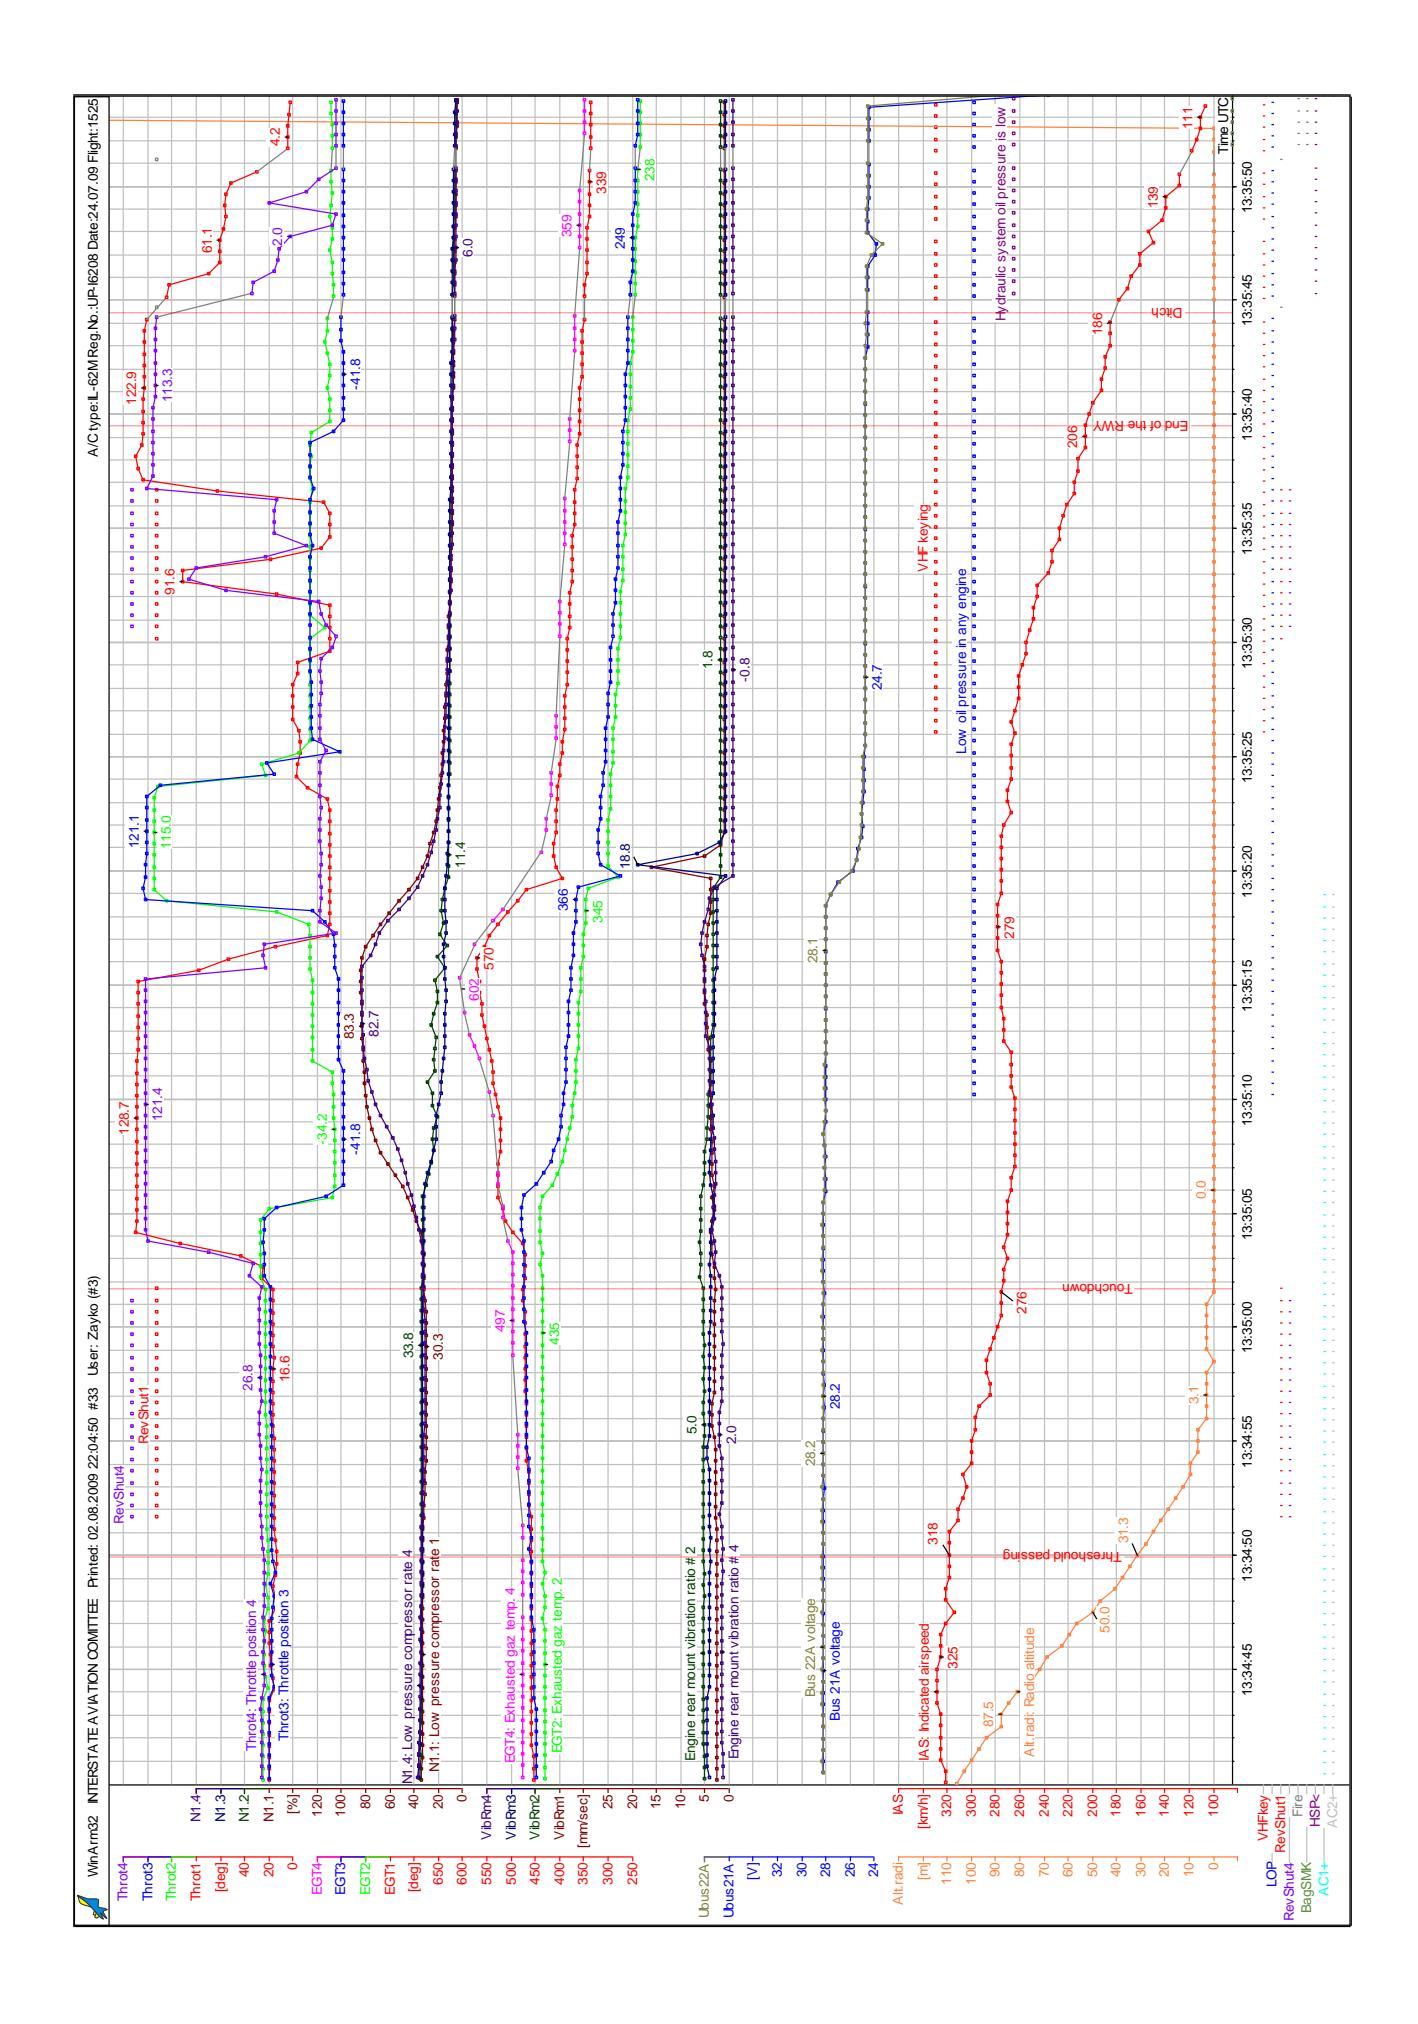
<u>FDR</u>

The aircraft was equipped with flight data recorders MSRP-64 and MSRP-12-96. A tripartite recorder K3-63 was not installed in the aircraft. The recorders were retrieved from the accident site by Iranian accident investigation team. Data readout was carried out at a facility of the "PARS Aviation Service" company. The information from the MSRP-12-96 recorder was not downloaded. The cassette KS-13 of the accumulator KBN as well as the magnetic tape of the tape media MLP-14-5 of the onboard recorder MSRP-64 were in satisfactory condition and had the parametric accident flight data recorded on them. On the pictures below some readout results are shown:
